# VEOLIA Emerald Park Landfill Audit Summary

**TO:** Veolia Emerald Park Landfill Standing Committee, City of Muskego  
**FROM:** Anna Krajcik  
**COPIES:** File  
**DATE:** 01/30/13  
**PROJECT NUMBER:** 1012.10030

VEOLIA EMERALD PARK LANDFILL  
LANDFILL OPERATIONS AUDIT FORM  
CITY OF MUSKEGO

**VEOLIA EMERALD PARK LANDFILL  
AUDIT PHOTOS  
CITY OF MUSKEGO**

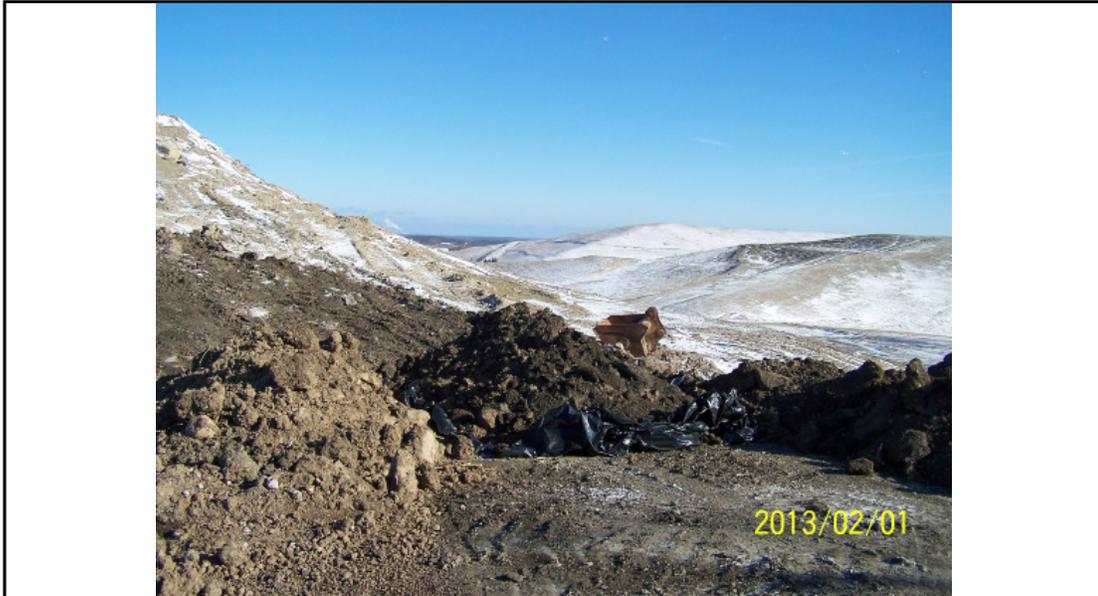
Bio soils being received in Phase 3

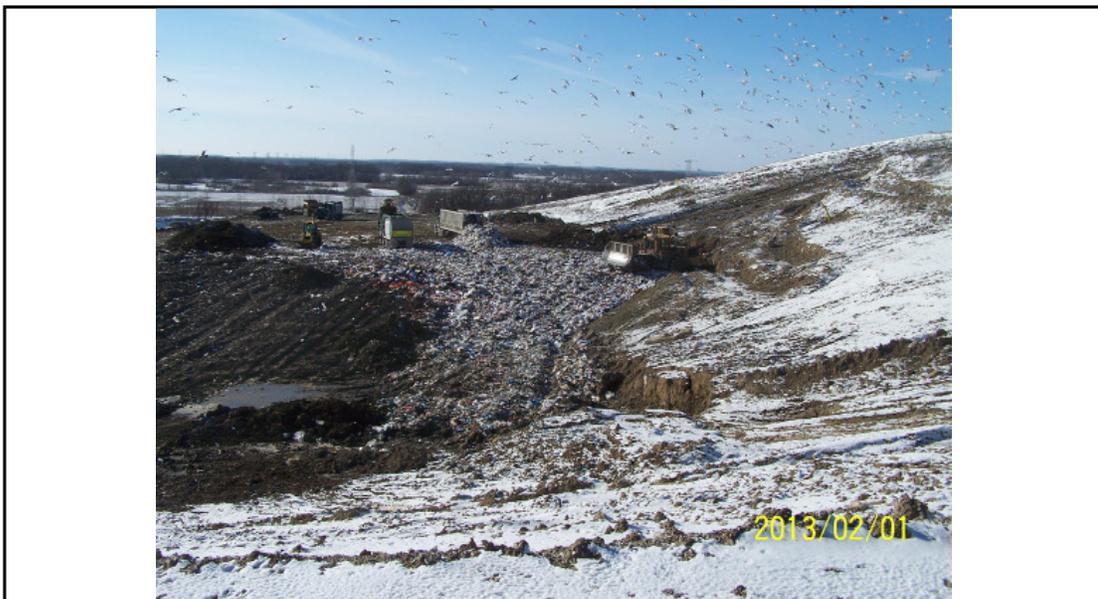
Working face against junction with Phase 3

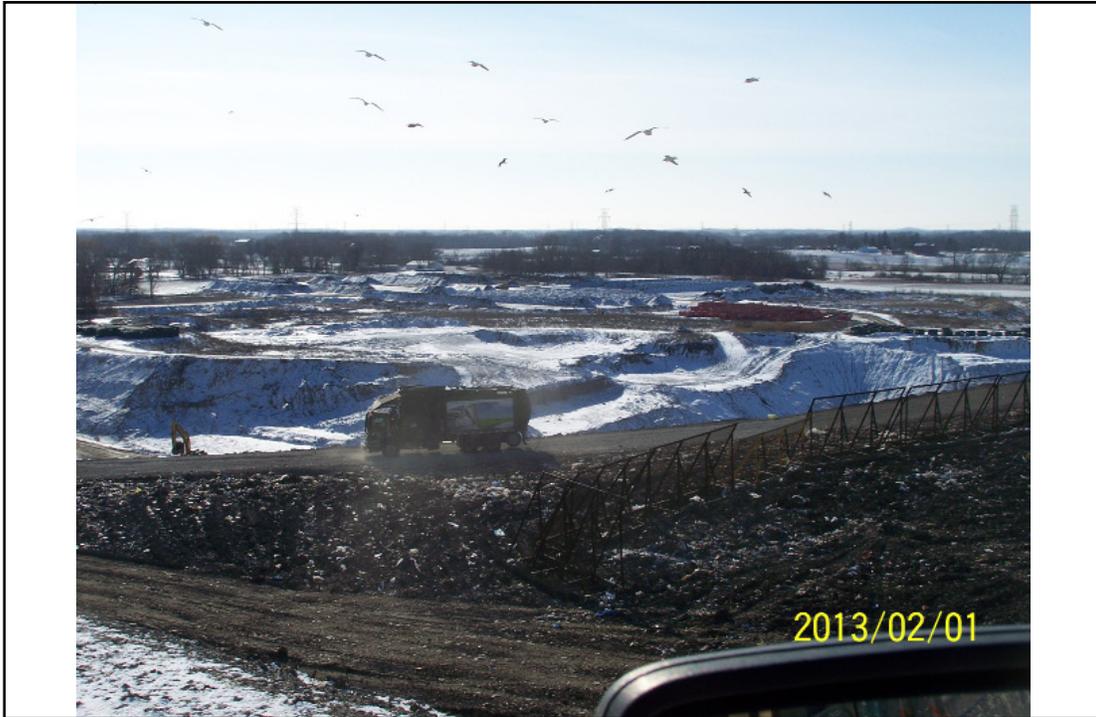
Ramp to active area

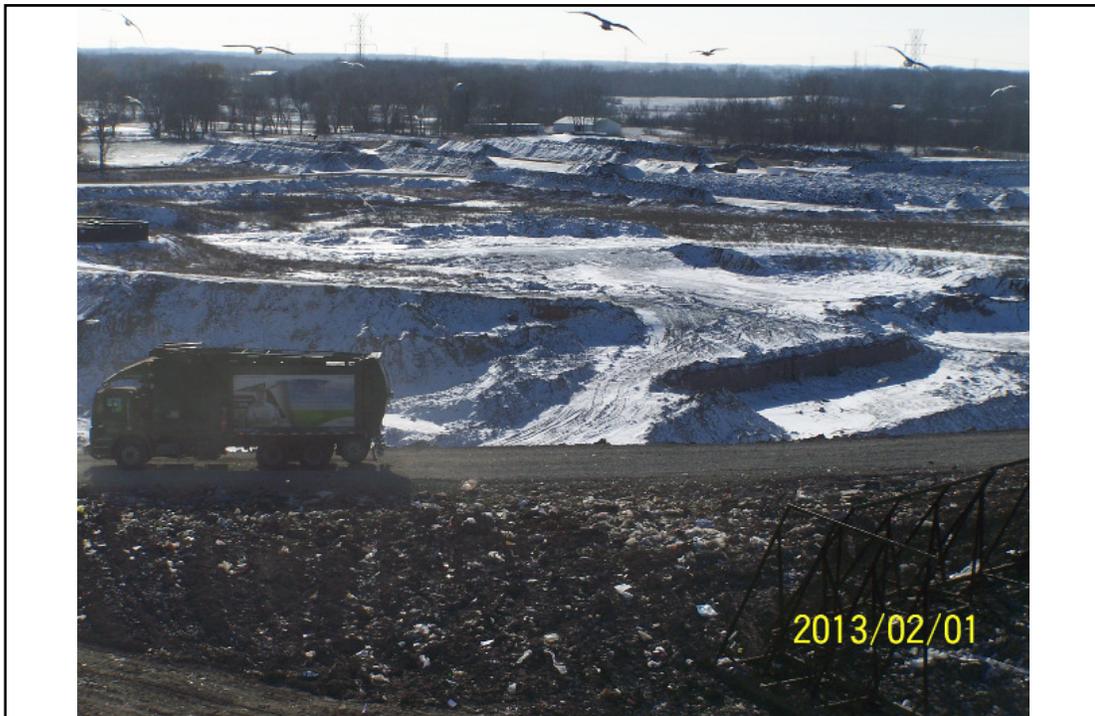
New access ramp in Southeast corner.

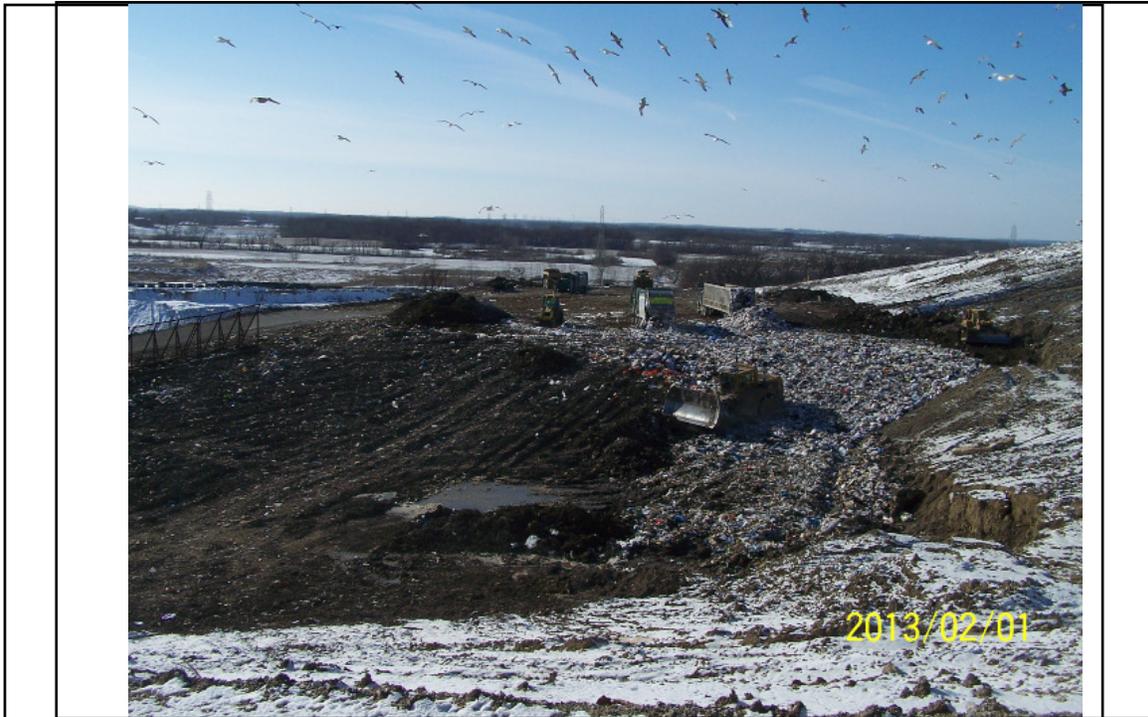
Waste packed inplace, prior to cover

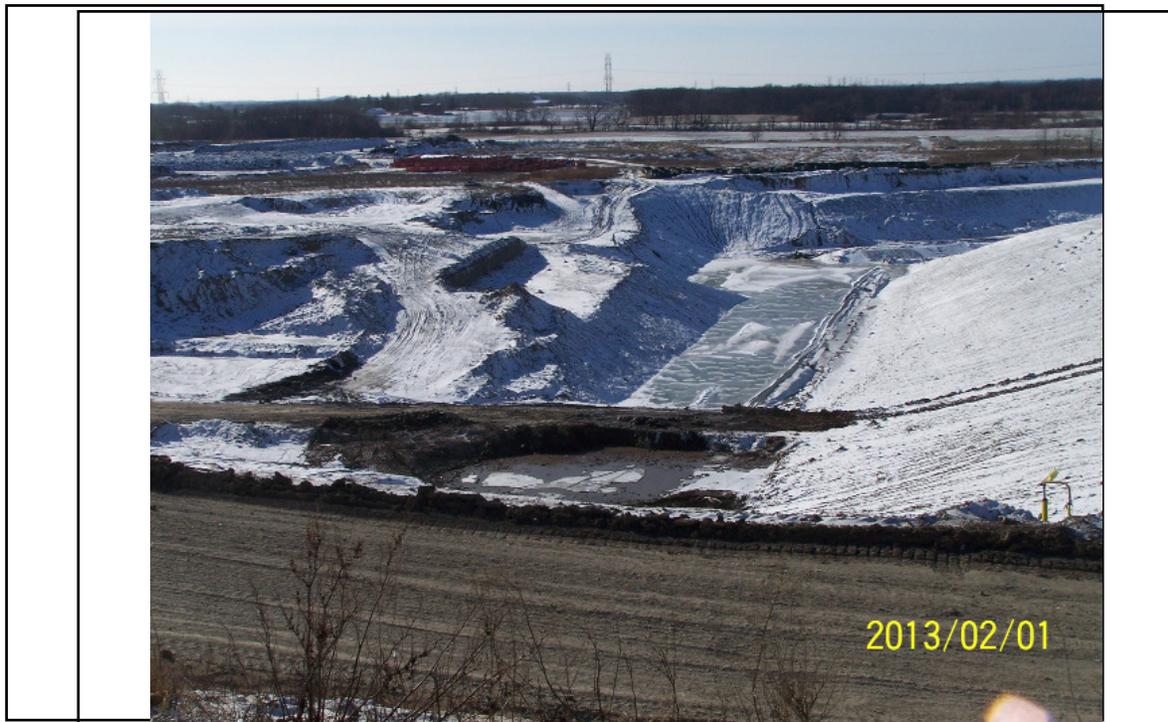
\* Temp sed basin cleanup ongoing. frozen conditions slowed liquids removal, No threat to public. Temp Sed basin impacted is the Eastern most, Not hydraulically connected to larger basins.

West temp. sed. basin contaminated with leachate, but not hydraulically connected to anything. Cleaned by pumper trucks and excavator.

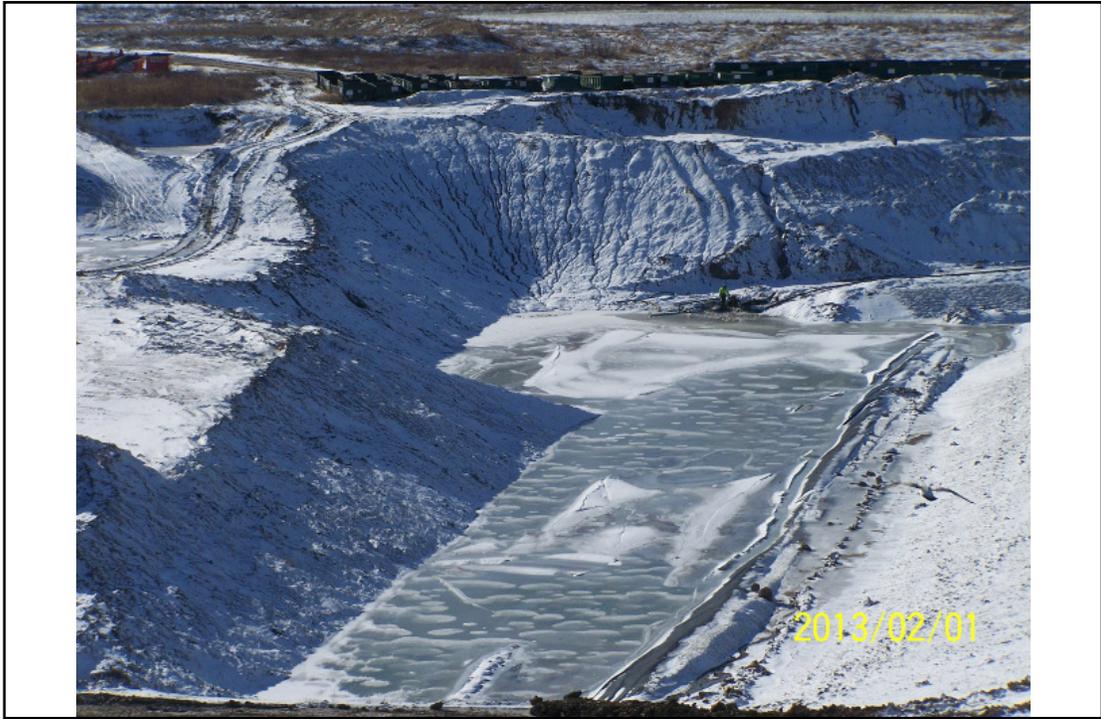
Western temp sed basin, nearly full, but not contaminated with leachate
