# VEOLIA Emerald Park Landfill Audit Summary

**TO:** Veolia Emerald Park Landfill Standing Committee, City of Muskego  
**FROM:** Anna Krajcik  
**COPIES:** File  
**DATE:** 01/30/13  
**PROJECT NUMBER:** 1012.10030

Attached is the audit report for activities at the Veolia Emerald Park Landfill for the week of January 21, 2013. The audit was performed at 3:20 pm on **January 24, 2013** by Jo Spear Jr. in the presence of David Geier.

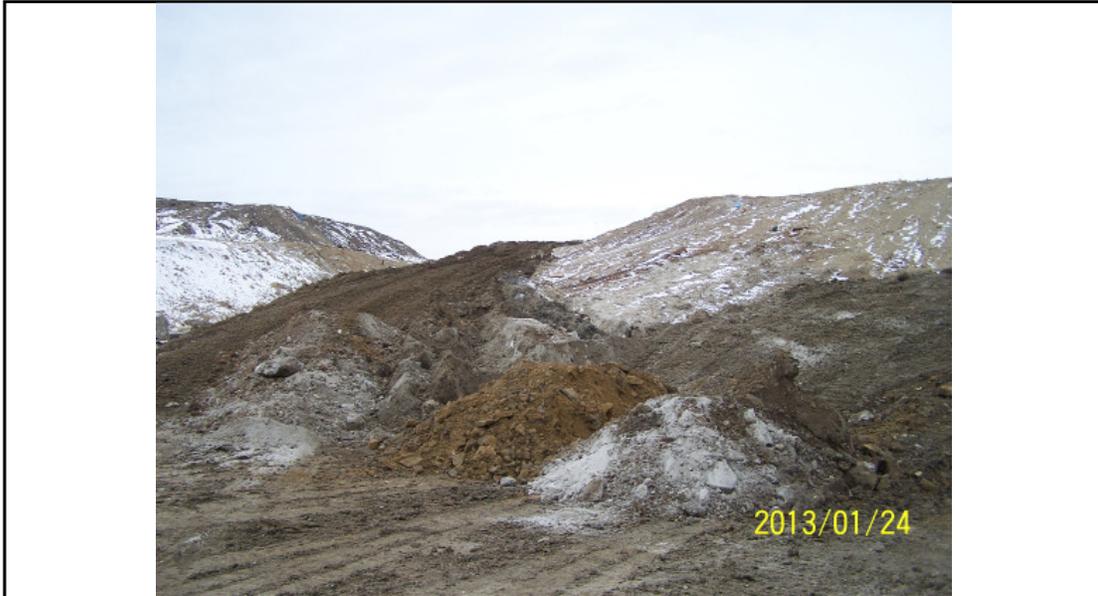
Bio soils being received in Phase 3

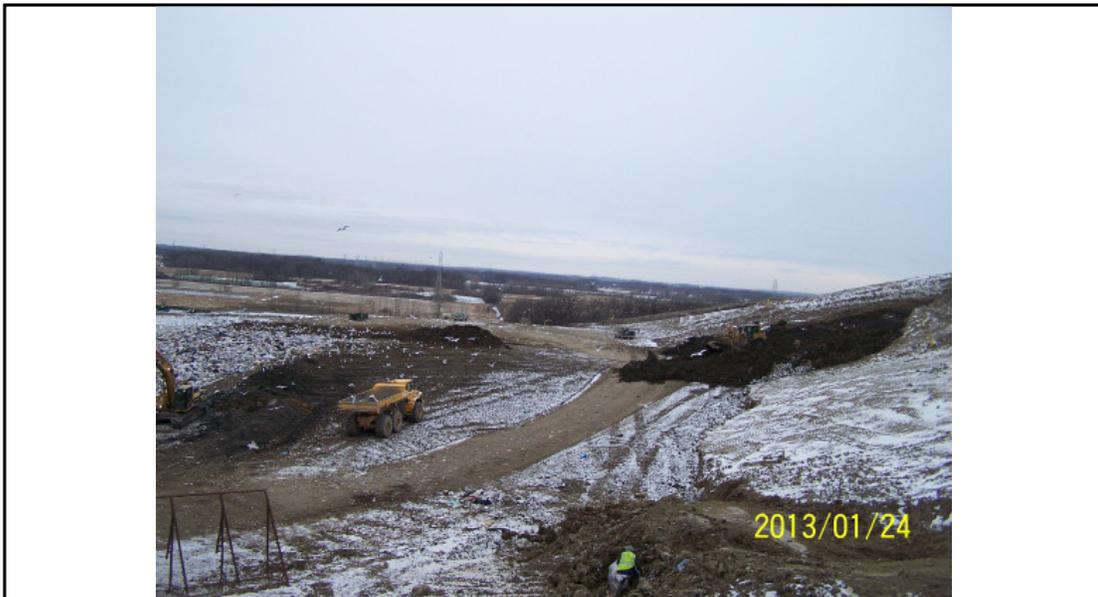
Active area and ramp construction

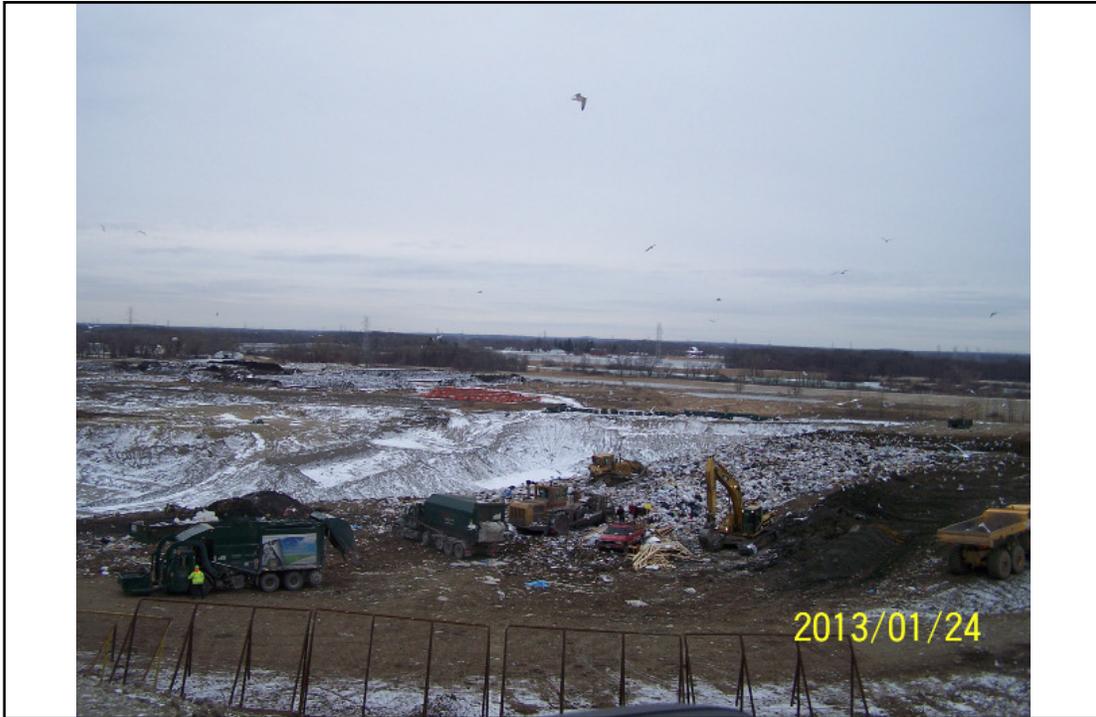
Active Area, new ramp construction to right

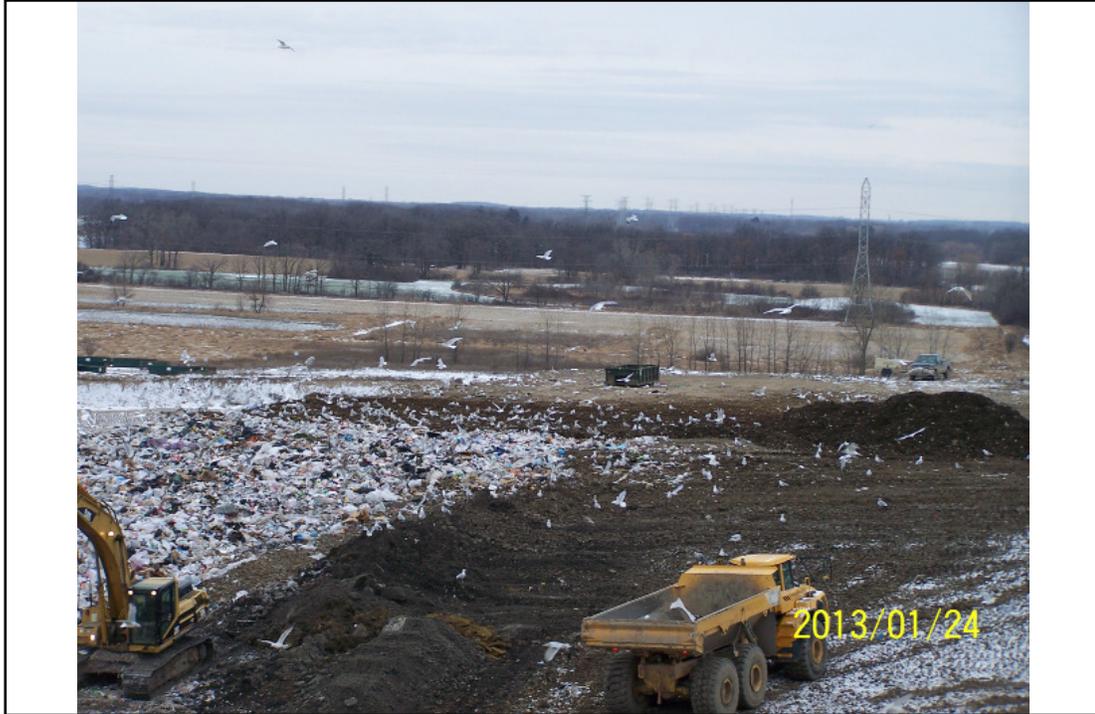
Active area

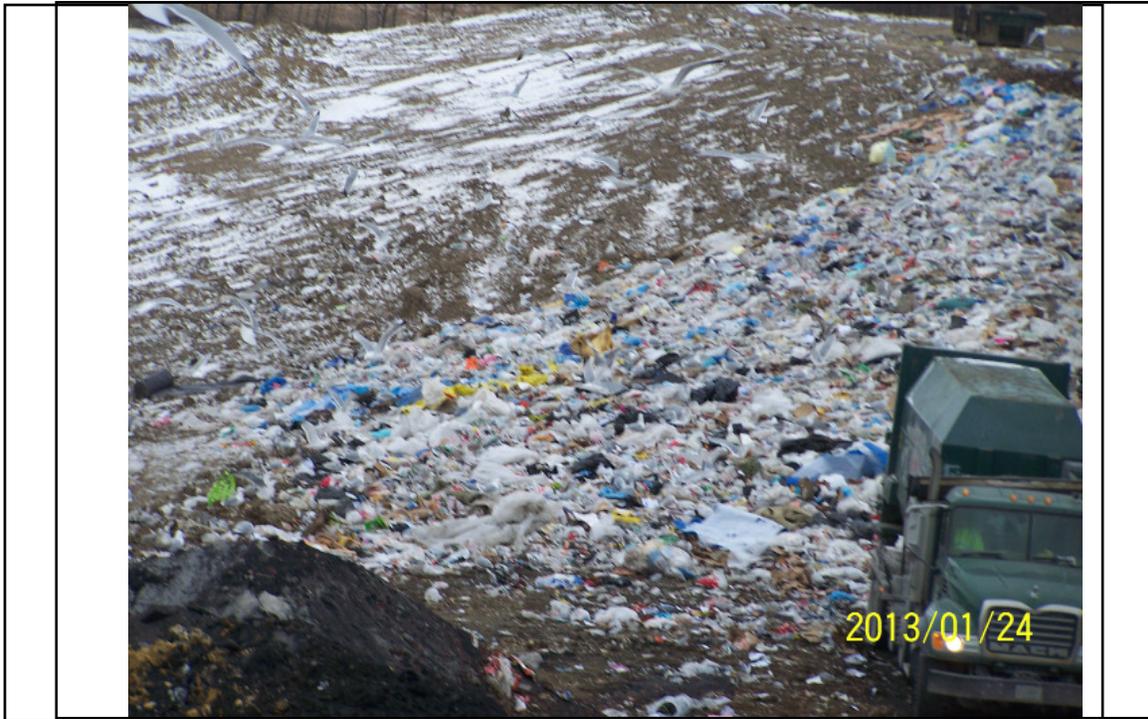
Waste packed in place, prior to cover

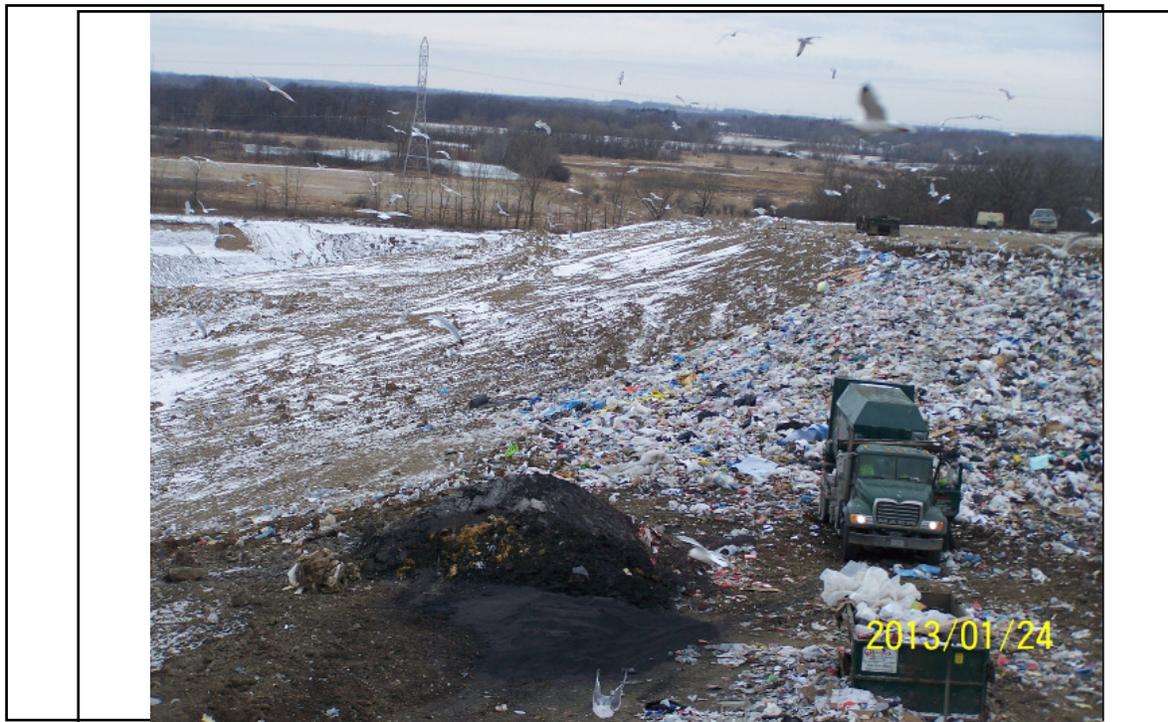
Working face at outboard slope, shaped and compacted by dozer

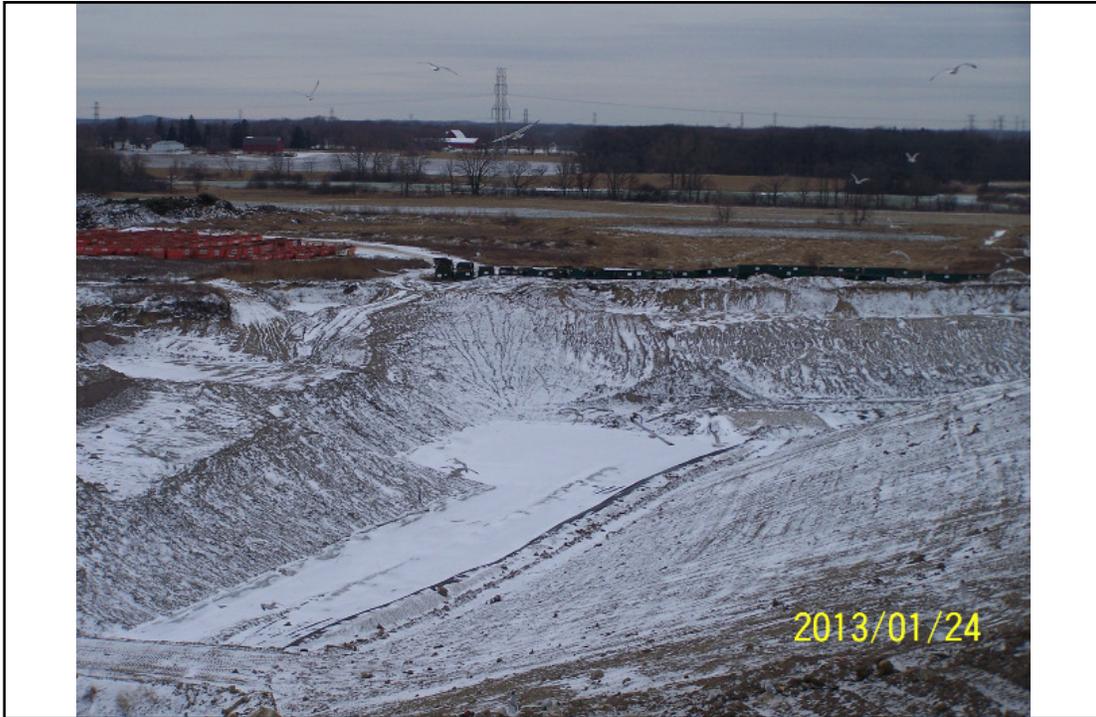
Temp basin drained of flowing water, ice and snow remain
