VEOLIA Emerald Park Landfill Audit Summary

TO: Veolia Emerald Park Landfill Standing Committee, City of Muskego
FROM: Anna Krajcik
COPIES: File
DATE: 02/25/13
PROJECT NUMBER: 1012.10030

VEOLIA EMERALD PARK LANDFILL
 LANDFILL OPERATIONS AUDIT FORM
 CITY OF MUSKEGO

**VEOLIA EMERALD PARK LANDFILL
AUDIT PHOTOS
CITY OF MUSKEGO**

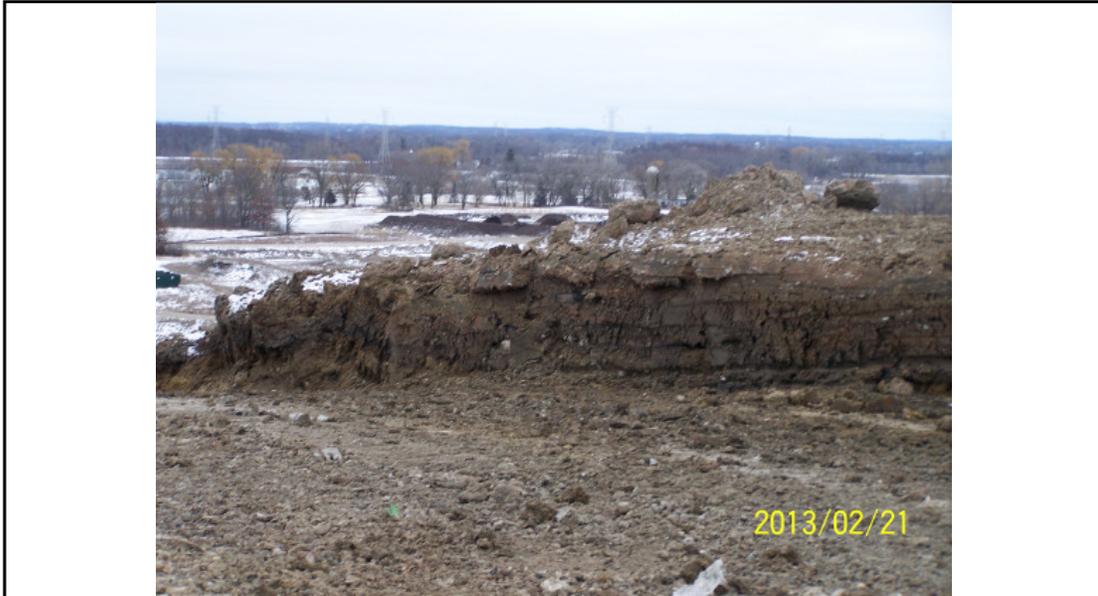
Previously tipped soils being cut for daily cover

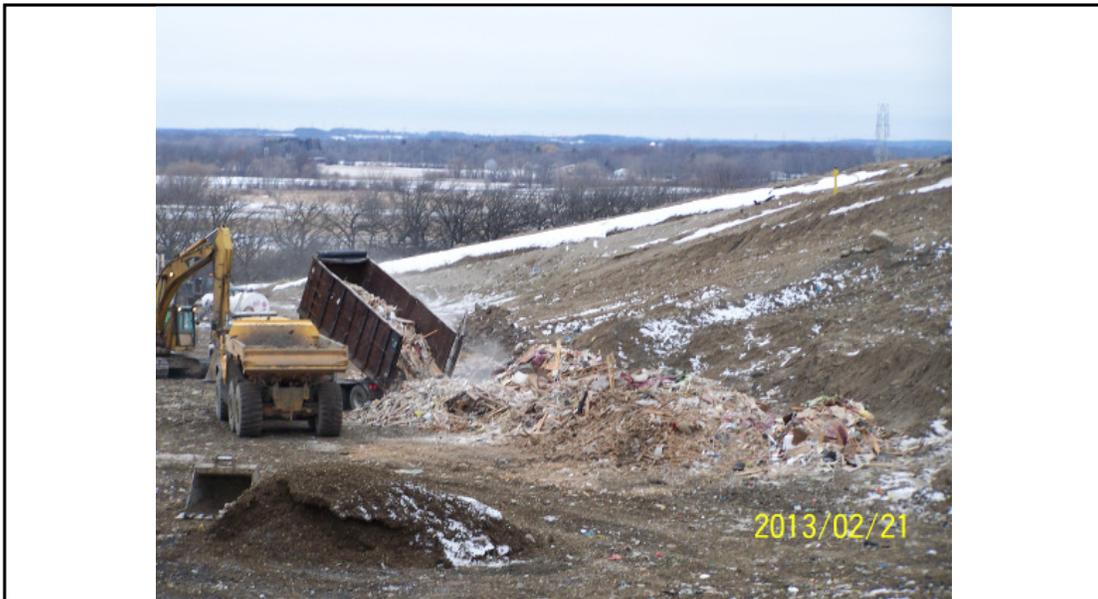
C&D load being tipped outside working face, for beneficial reuse

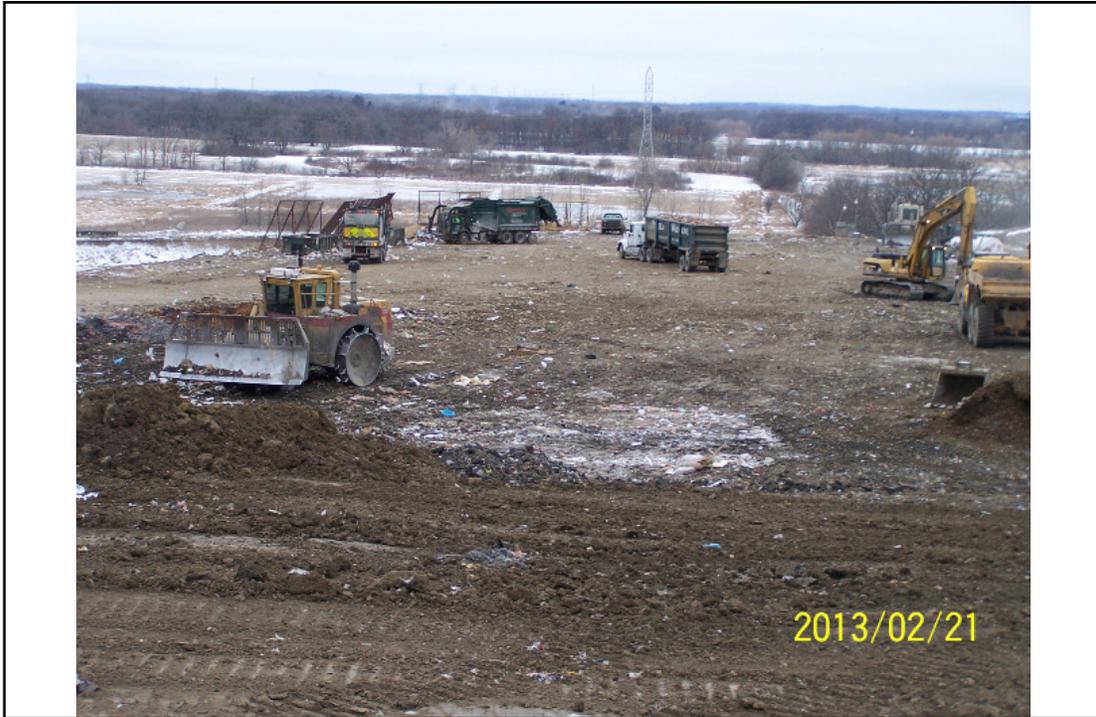
Active area

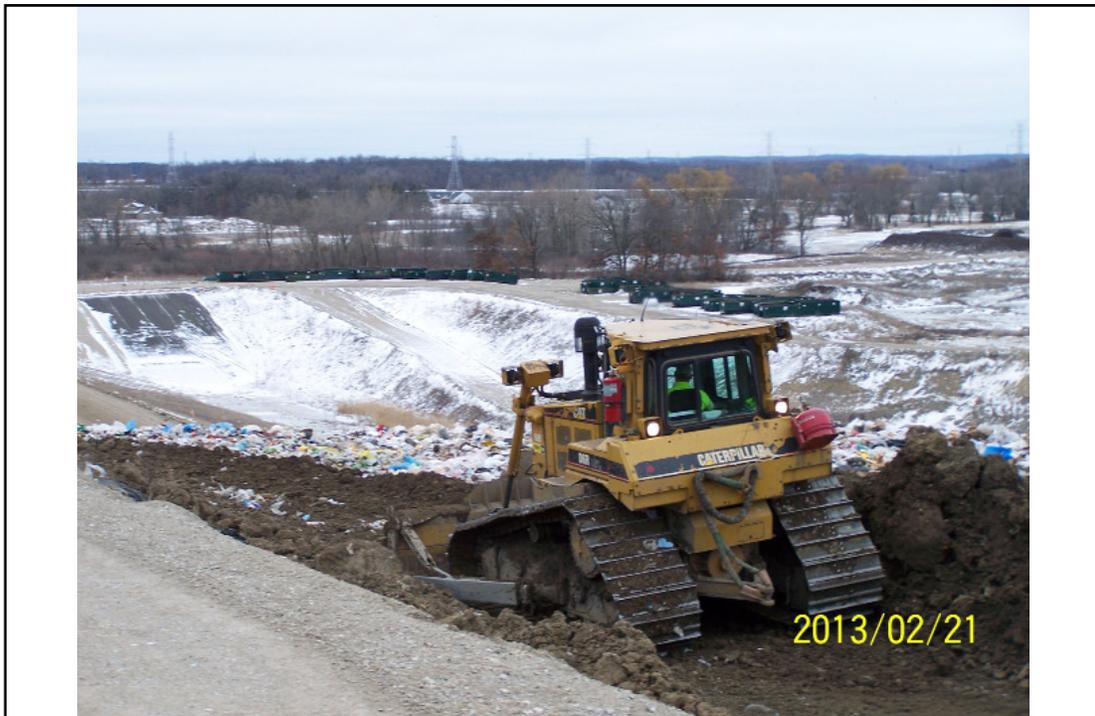
Dozer pushing soils for daily cover

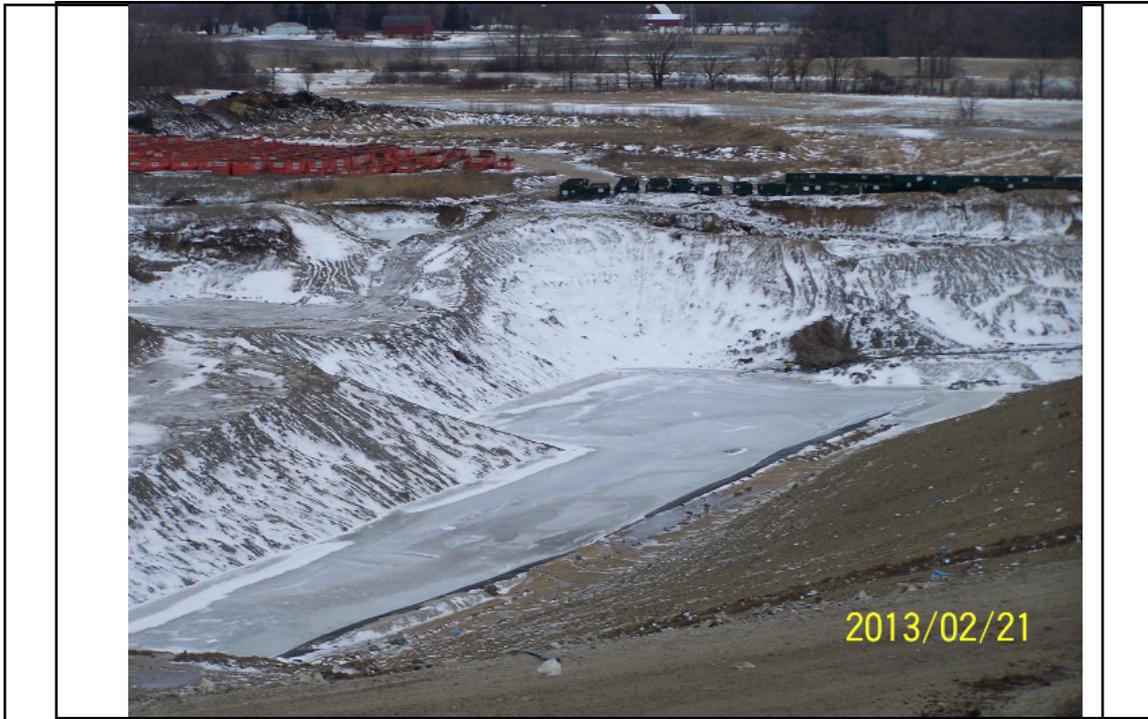
Temp sed basin West of equipment access to Phase 7
