VEOLIA Emerald Park Landfill Audit Summary

TO: Veolia Emerald Park Landfill Standing Committee, City of Muskego
FROM: Anna Krajcik
COPIES: File
DATE: 02/11/13
PROJECT NUMBER: 1012.10030

VEOLIA EMERALD PARK LANDFILL
LANDFILL OPERATIONS AUDIT FORM
CITY OF MUSKEGO

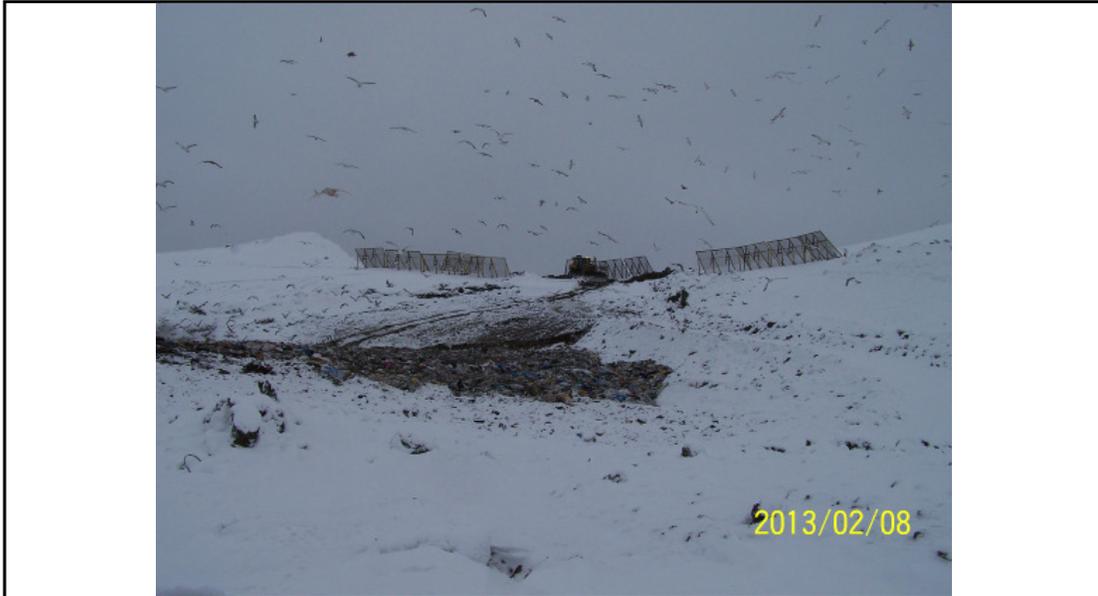
Working face

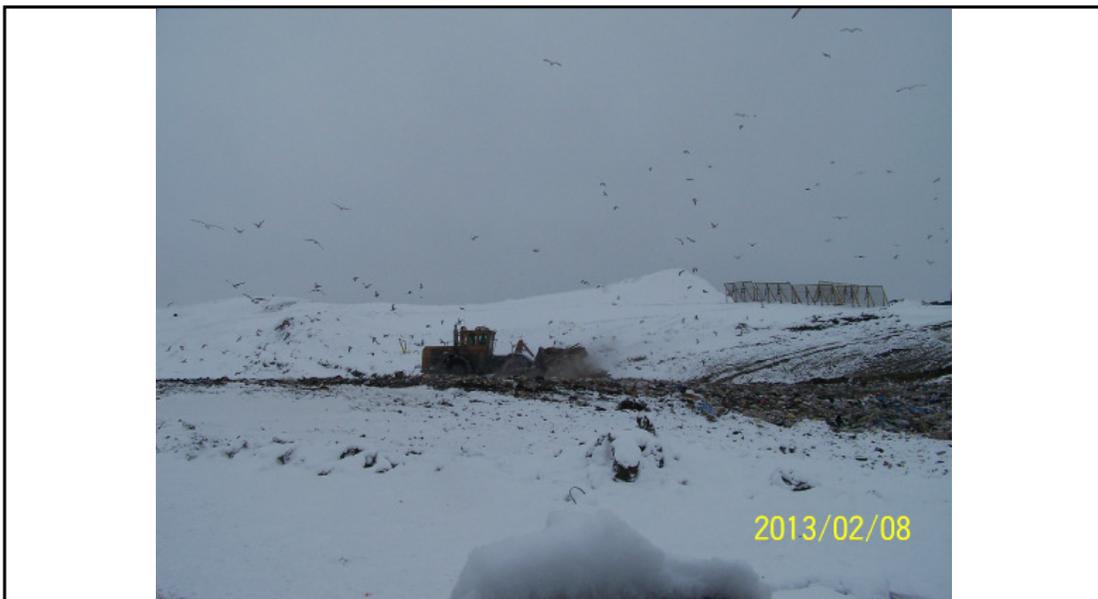
Active area

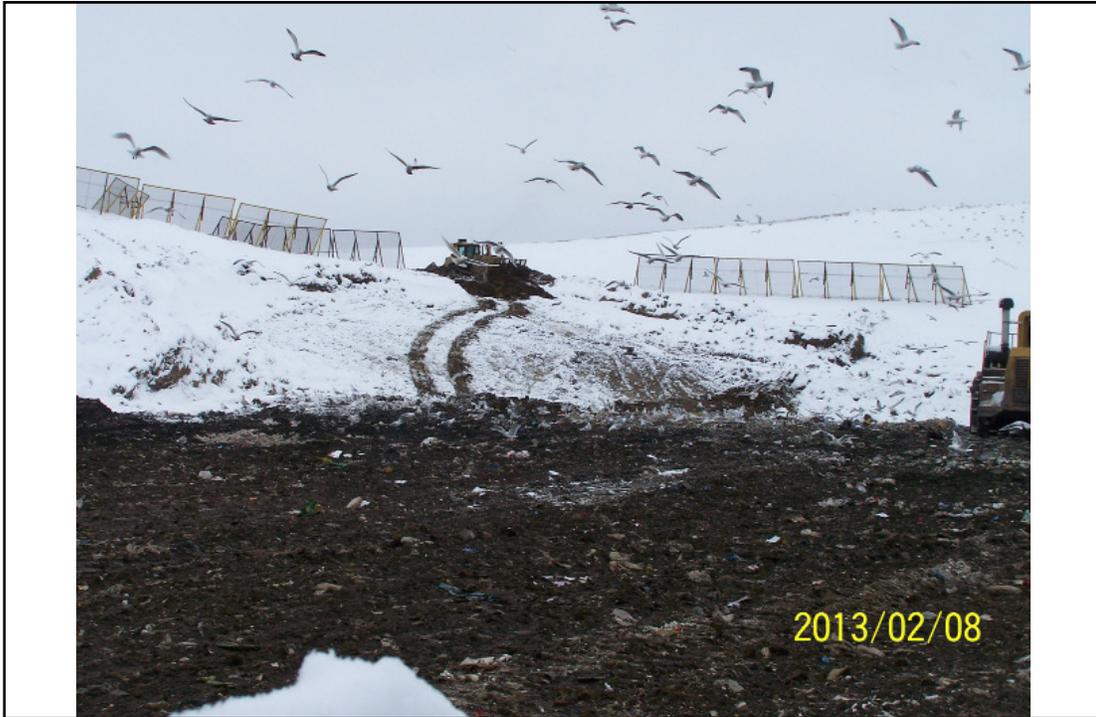
Soils being cut for cover and ramp construction

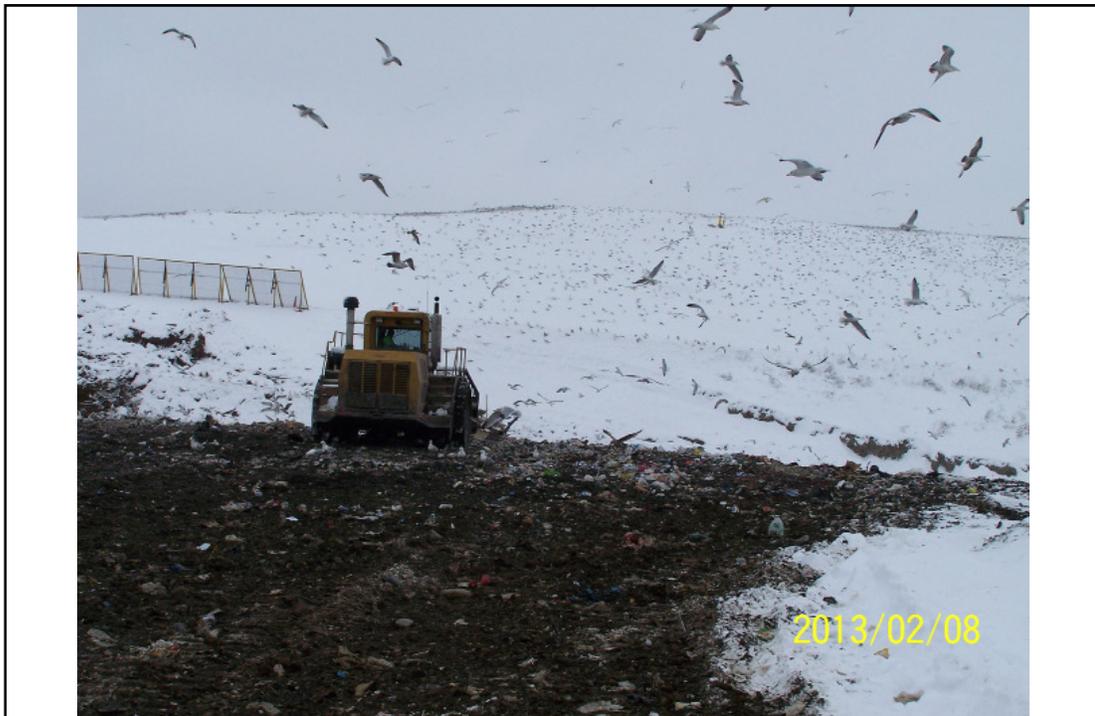
Compactor at working face

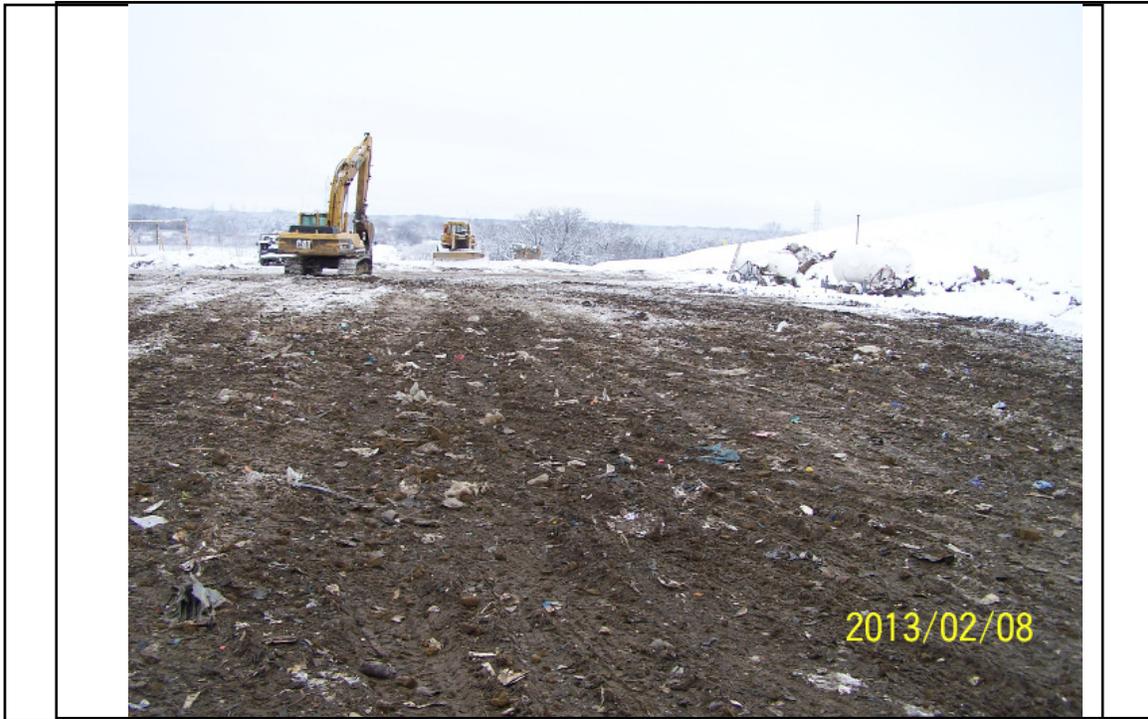
Daily cover over Active area

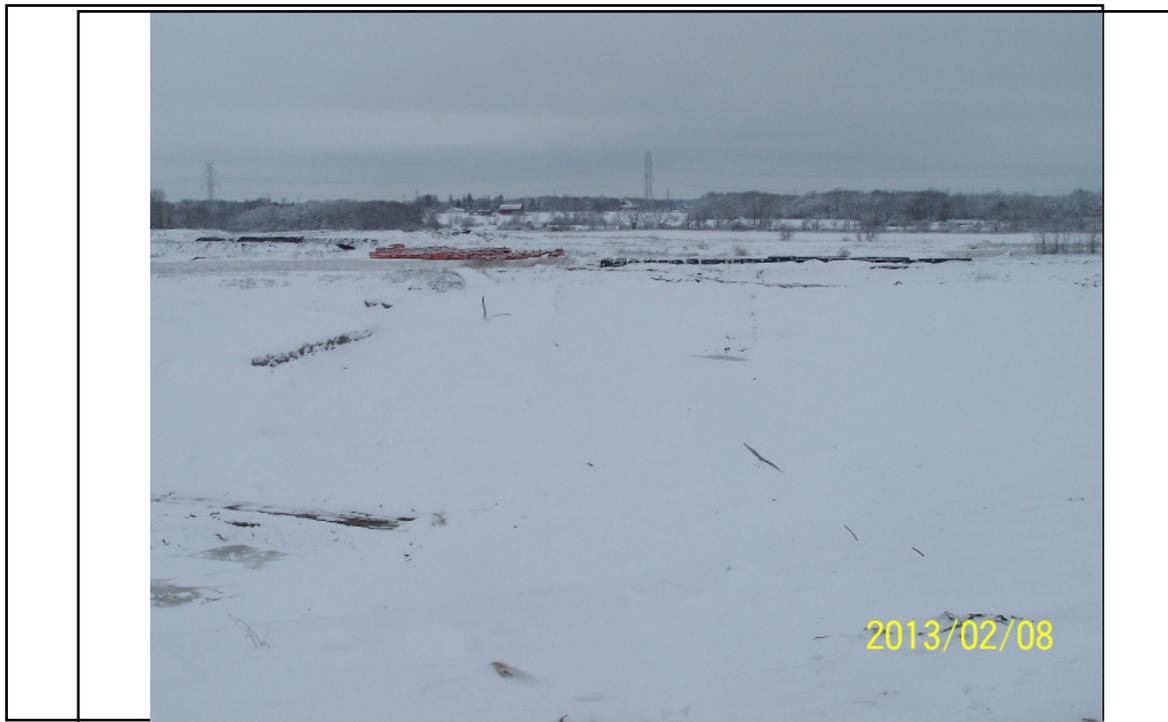
Snow storm on 2/2 of approximately 8" site
& basins snow covered. No flowing water

Temp sed basin snow covered and frozen
