VEOLIA Emerald Park Landfill Audit Summary

TO: Veolia Emerald Park Landfill Standing Committee, City of Muskego
FROM: Anna Krajcik
COPIES: File
DATE: 02/11/13
PROJECT NUMBER: 1012.10030

VEOLIA EMERALD PARK LANDFILL
 LANDFILL OPERATIONS AUDIT FORM
 CITY OF MUSKEGO

**VEOLIA EMERALD PARK LANDFILL
AUDIT PHOTOS
CITY OF MUSKEGO**

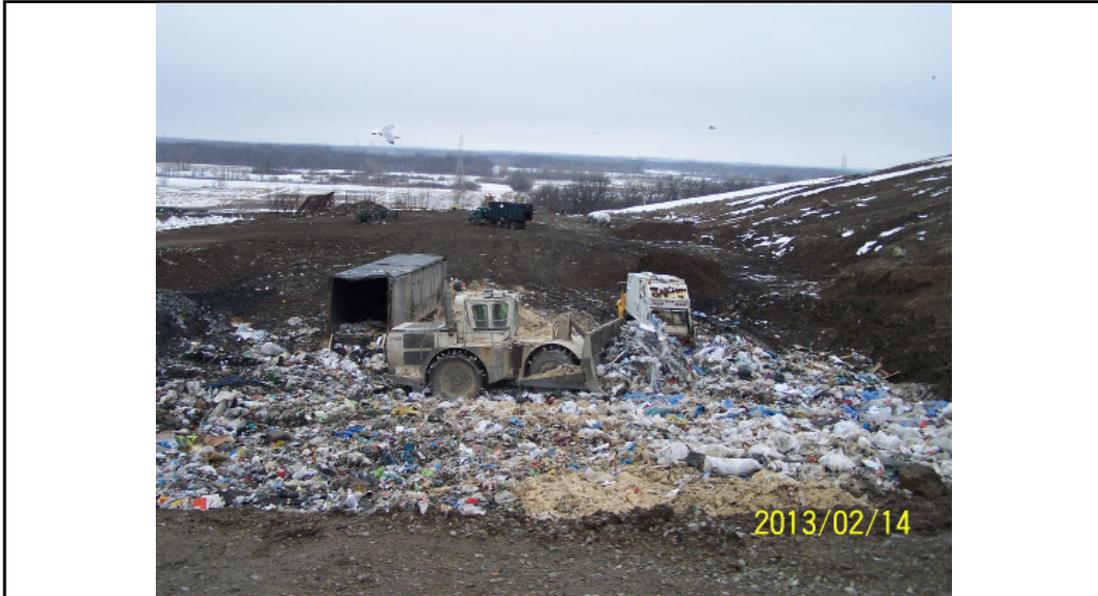
Working face

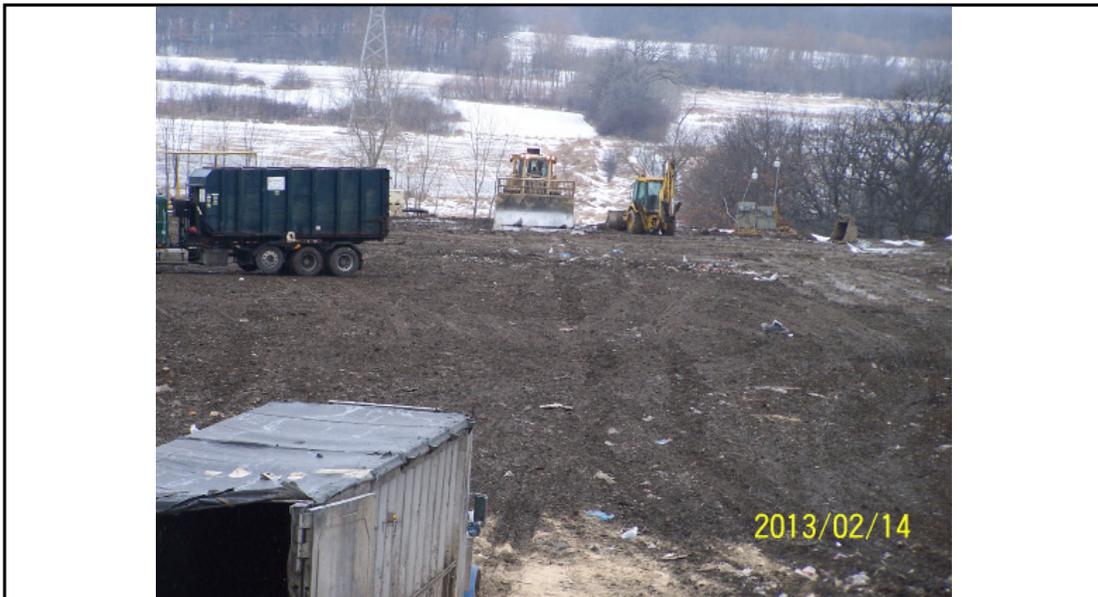
Active area

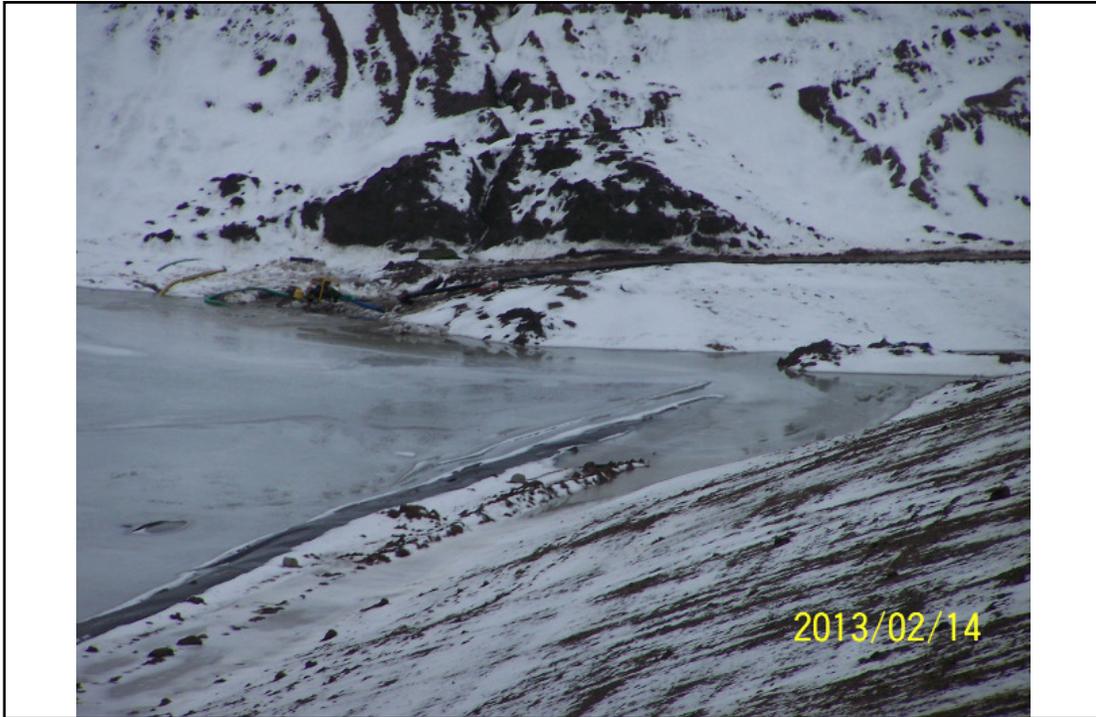
- Temporary sediment basins appear to have hydraulic connection to leachate collection. Will watch for thawing.
- Temporary sediment basin pumping ongoing with pump issues; tankers used when necessary

* Temp sed basin appears to have hydraulic
connection to leachate collection. Will watch
for thruway

Temp sed basin, possibly hydraulically connected to leachate collection system of Phase 7, will watch when thawing.

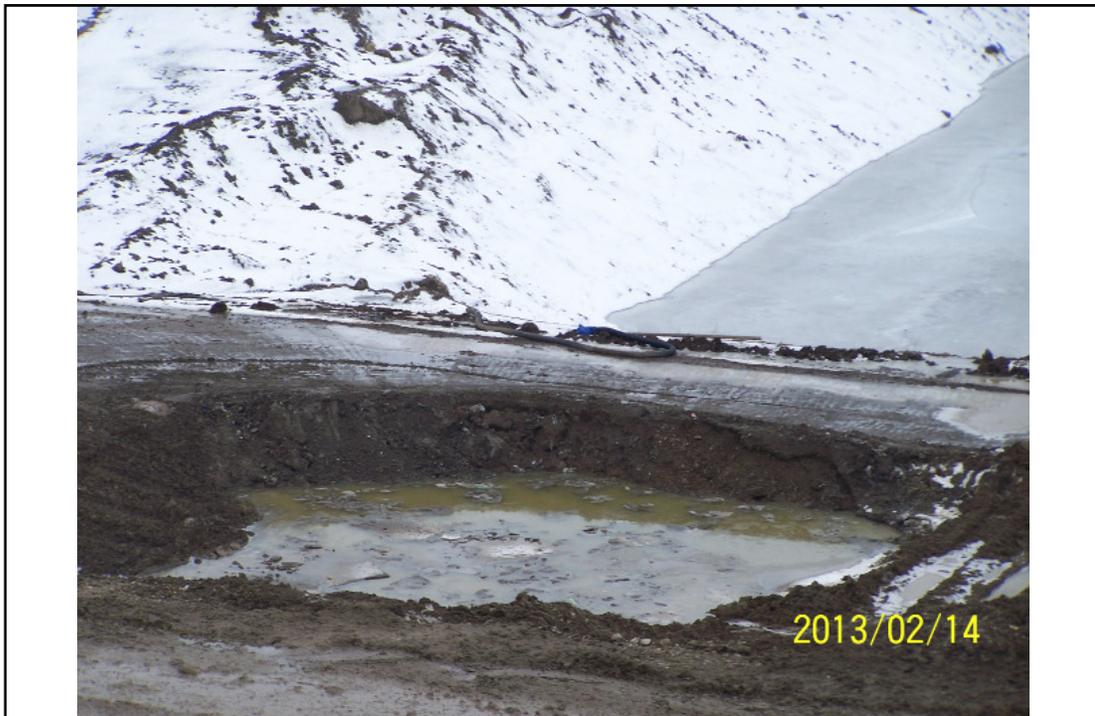
Temp sed basin East of equipment access to phase 7. Received additional runoff and needs to be pumped and scrapped for NON

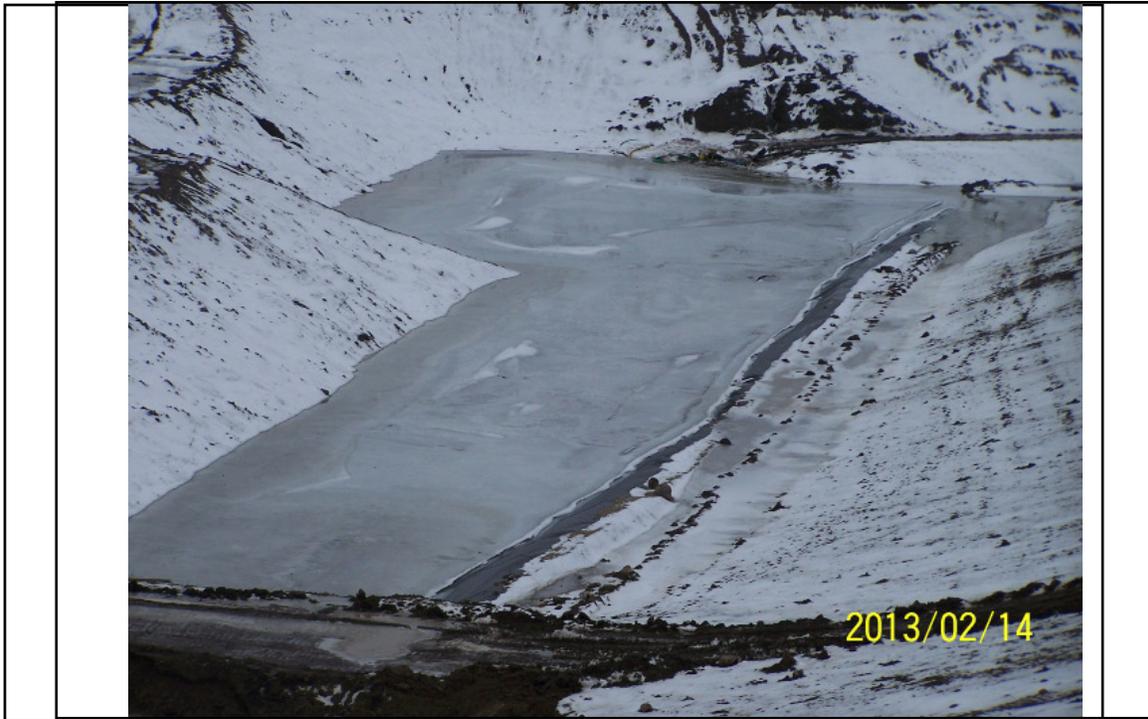
Temp sed basin West of equipment access to Phase 7

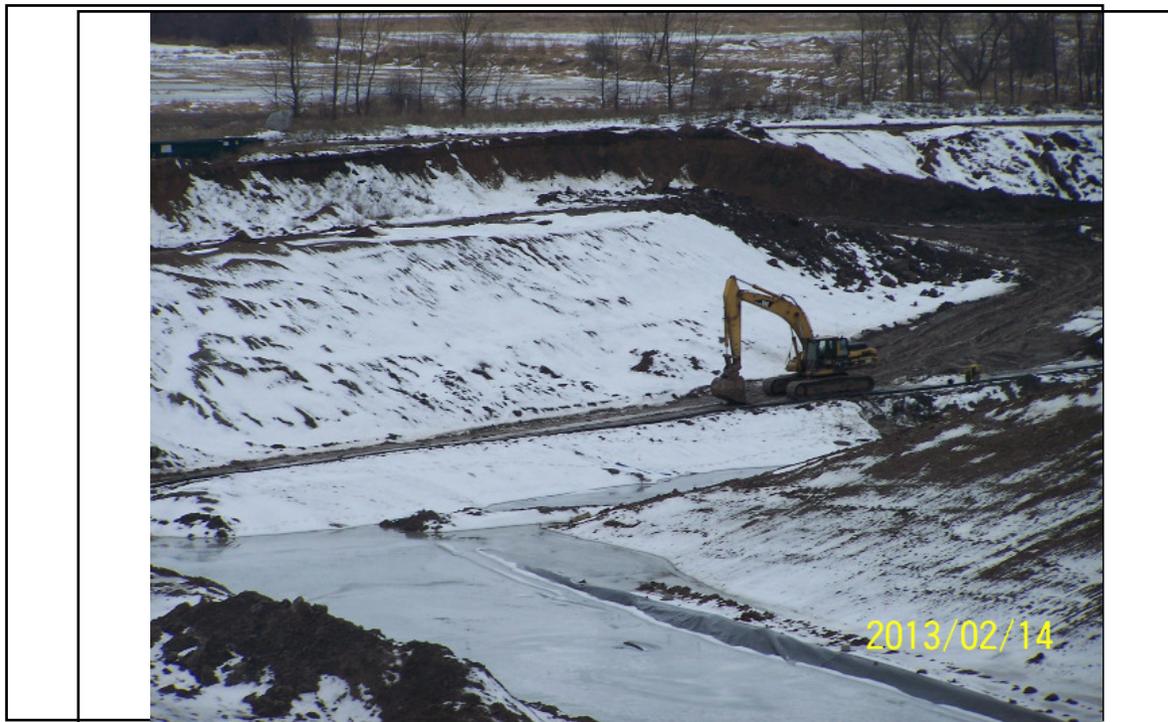
* Temp sed basin pumping ongoing with
pump issues, Tankers used when necessary

Operators working to clear pumping pipe of ice and other debris to drain temp sed basin under ice
