VEOLIA Emerald Park Landfill Audit Summary

TO: Veolia Emerald Park Landfill Standing Committee, City of Muskego
FROM: Anna Krajcik
COPIES: File
DATE: 04/03/13
PROJECT NUMBER: 1012.10030

ADVANCED DISPOSAL SERVICES EMERALD PARK LANDFILL
 LANDFILL OPERATIONS AUDIT FORM
 CITY OF MUSKEGO

**ADVANCED DISPOSAL SERVICES
EMERALD PARK LANDFILL
AUDIT PHOTOS
CITY OF MUSKEGO**

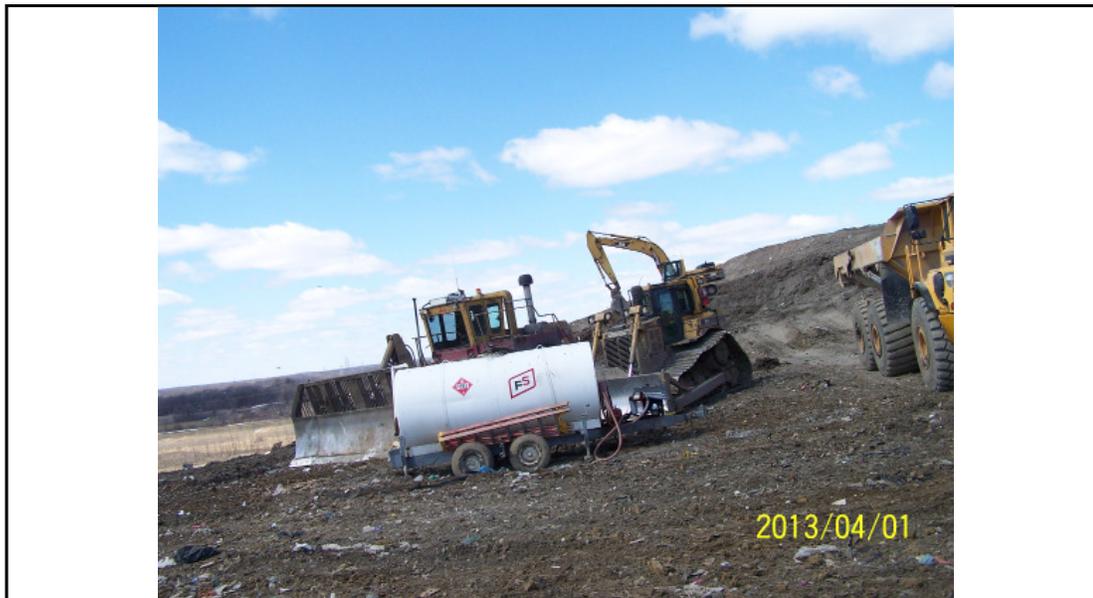
Excavator harvesting previously tipped landfill direct soils

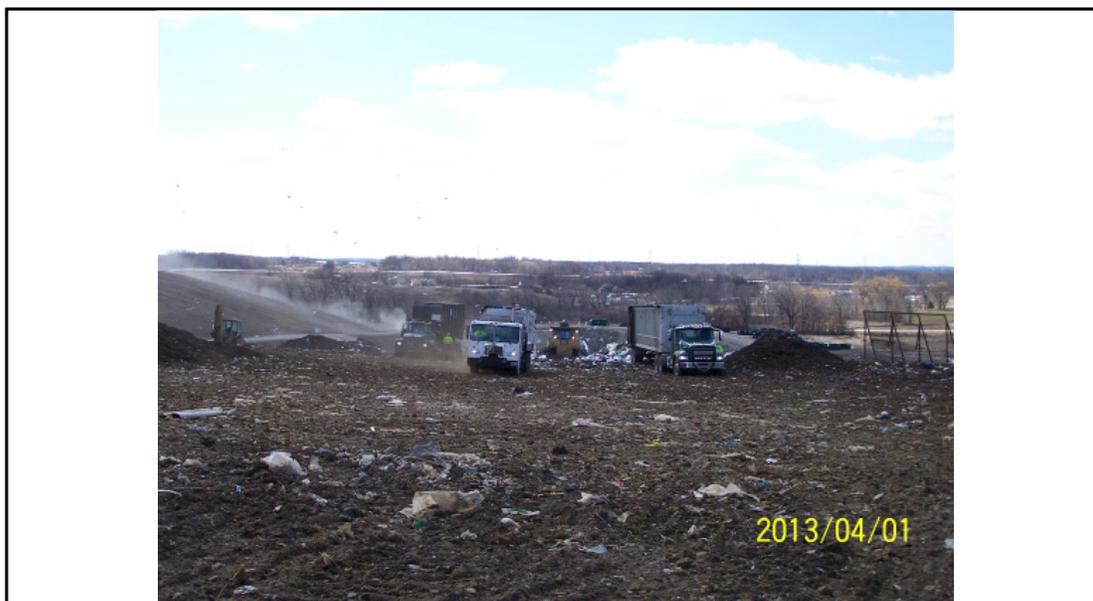
Tipping trucks

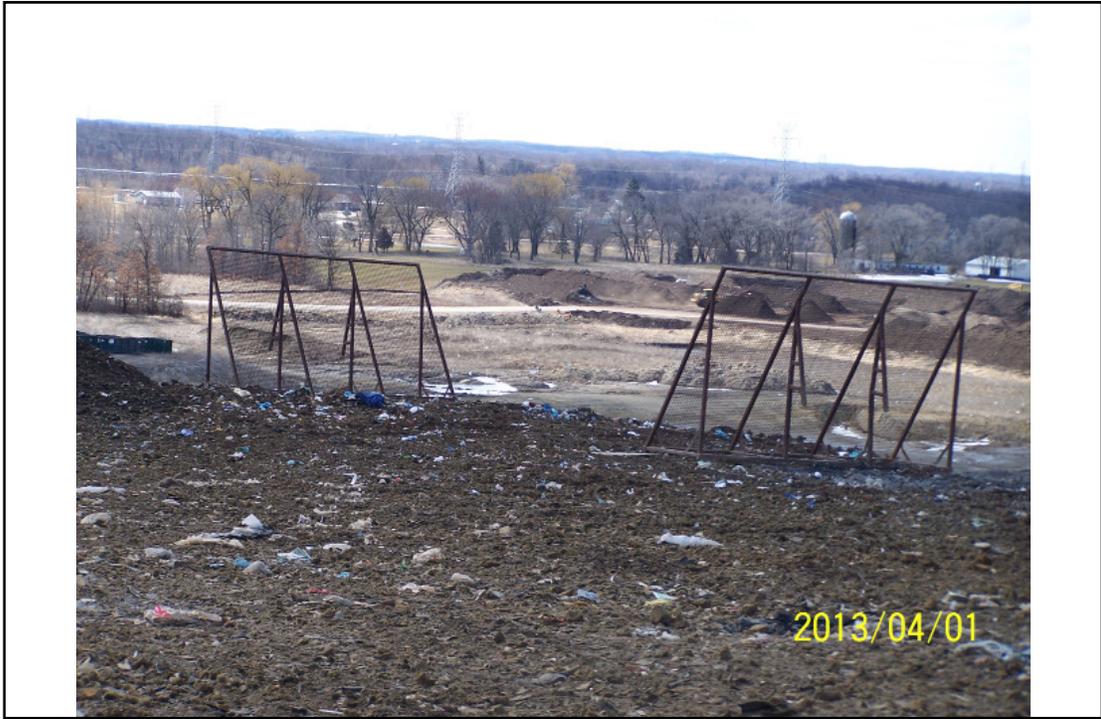
Truck clean out

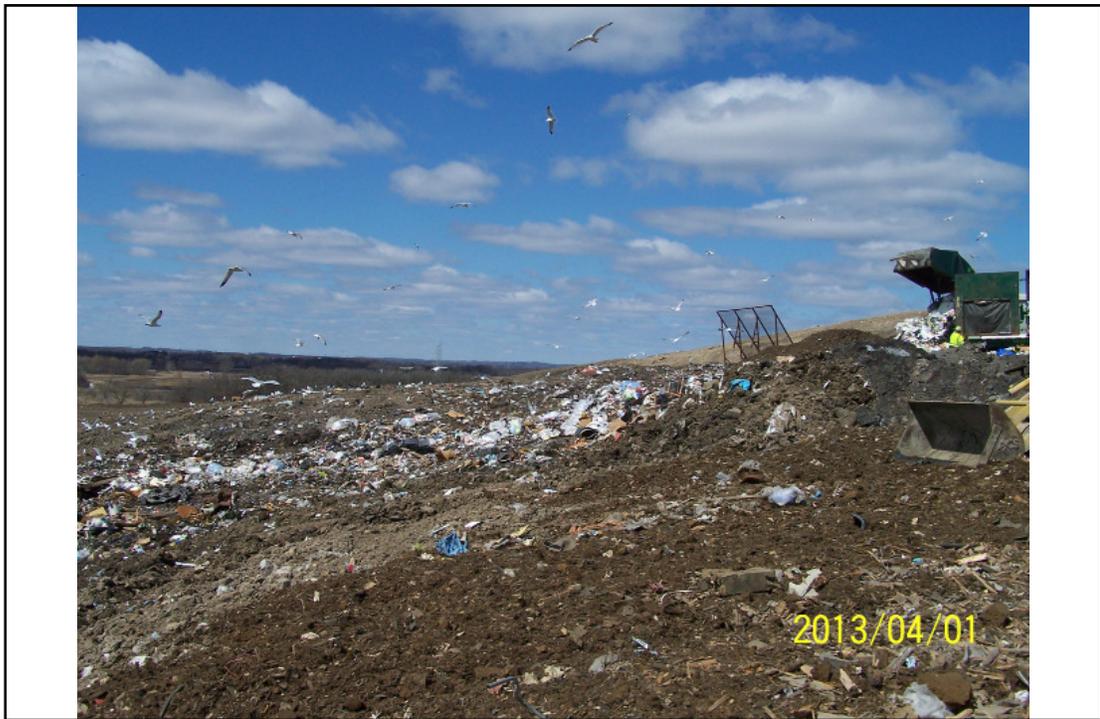
Tipping area above compactor

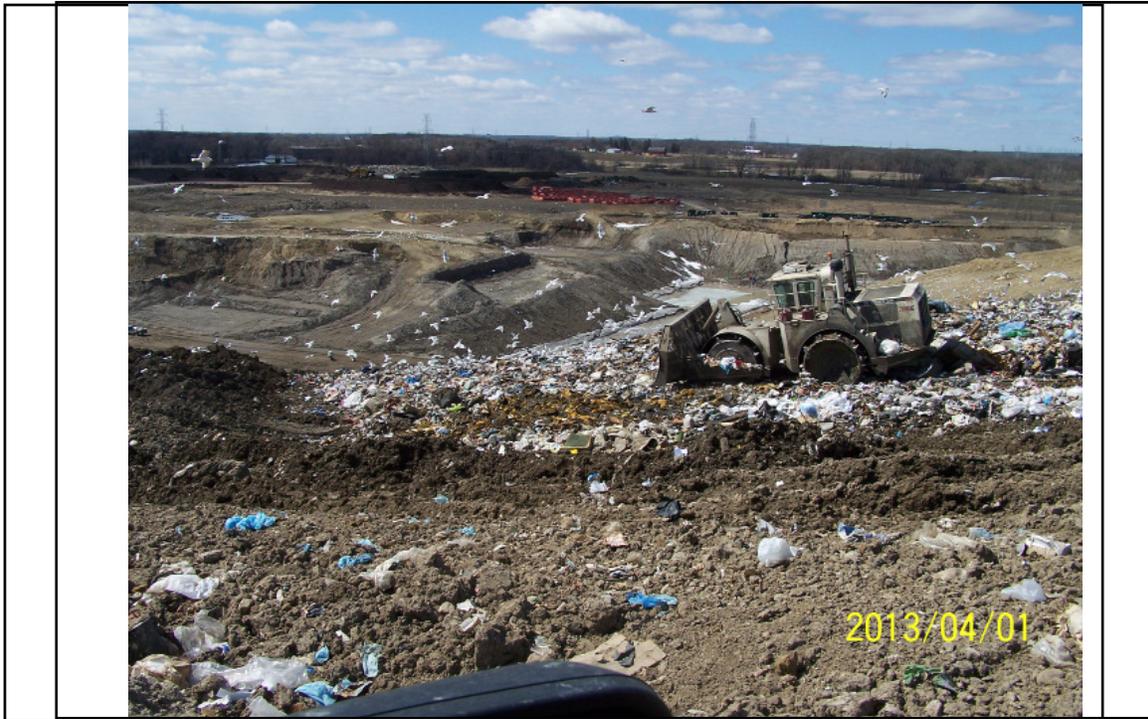
Working face in Northeast corner,
filling location of previous ramp
into Active Area. Phase 7 is the only
working face.

Working face over old road access/ramp

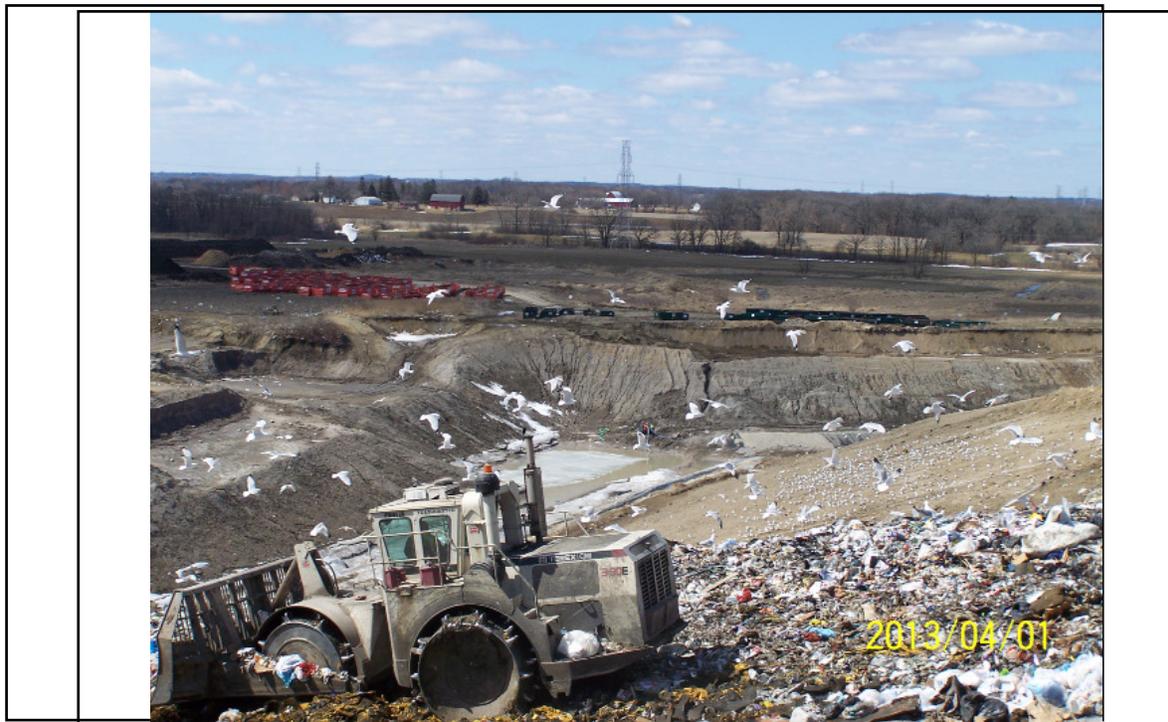
Working face, compactor pushing down.

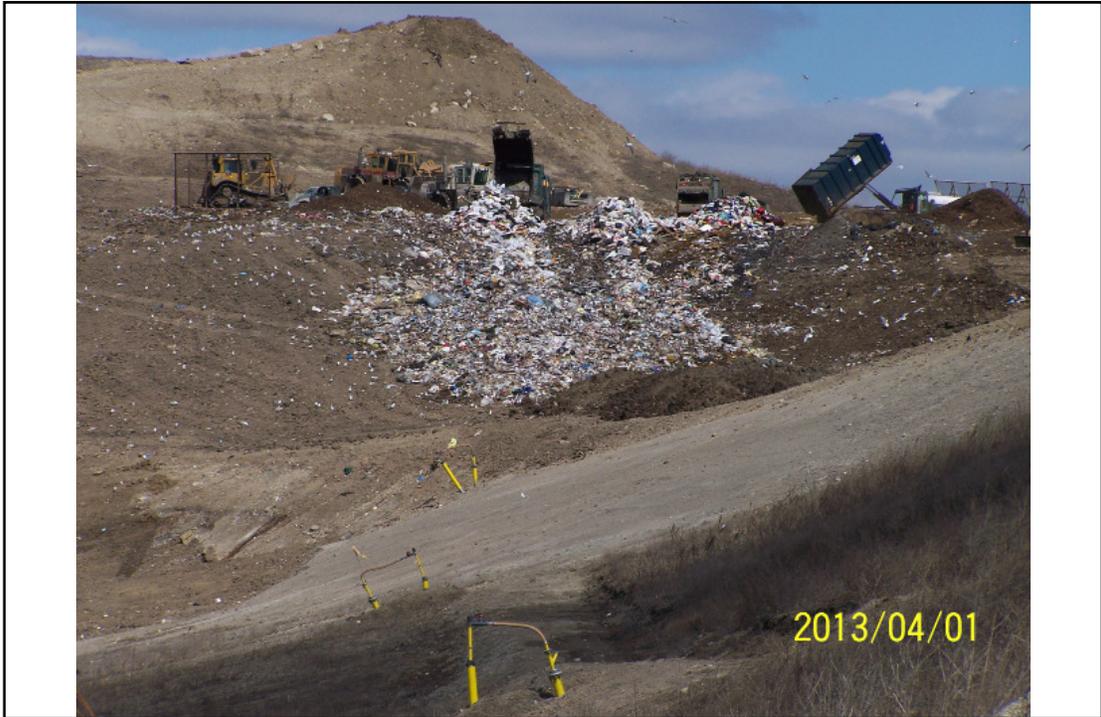
Working face

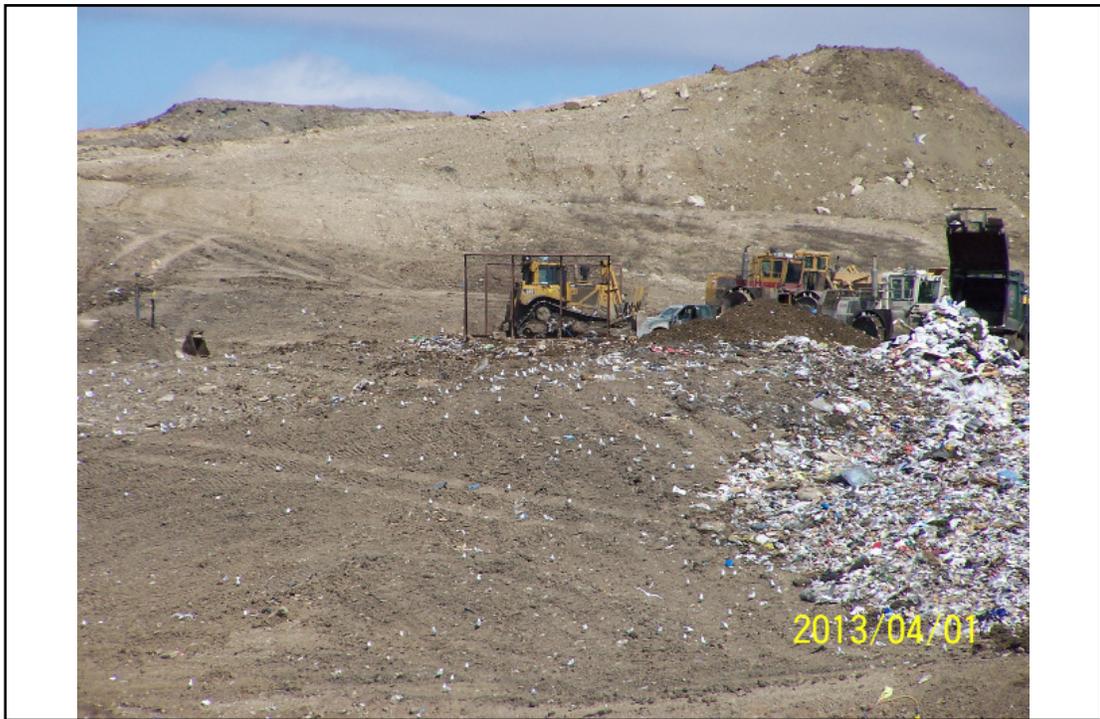
Active area outside of working face

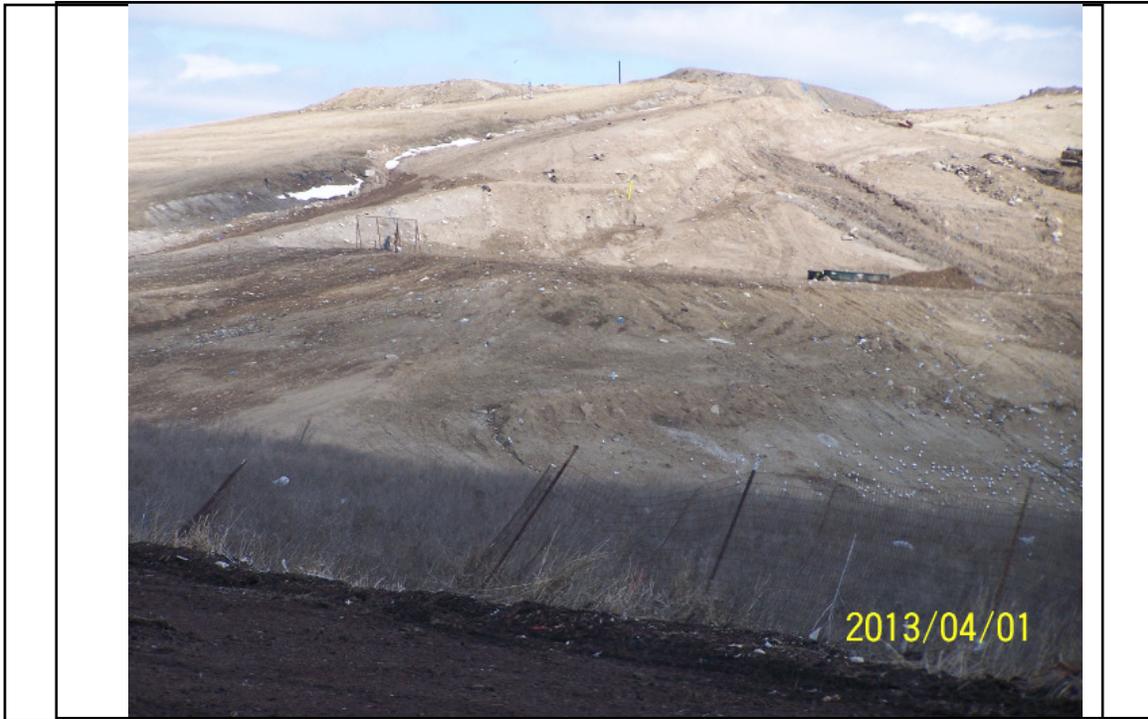
Southwest corner of Phase 7

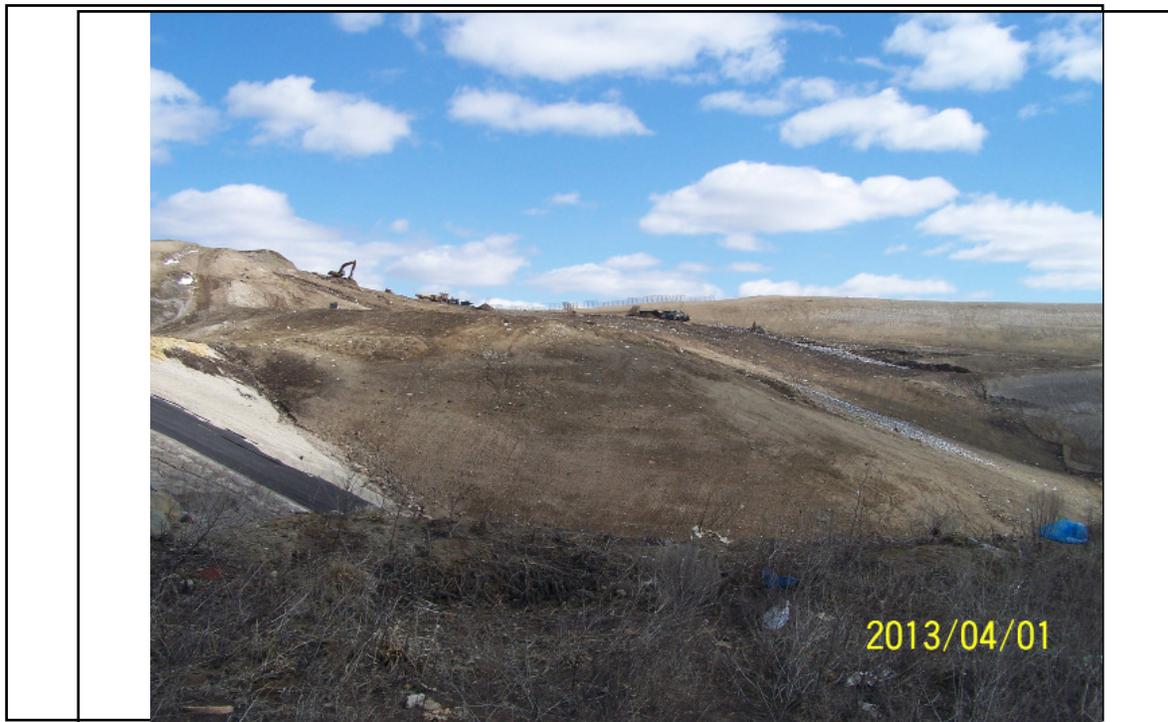
Western slope of Phase 7
