VEOLIA Emerald Park Landfill Audit Summary

TO: Veolia Emerald Park Landfill Standing Committee, City of Muskego
FROM: Anna Krajcik
COPIES: File
DATE: 02/25/13
PROJECT NUMBER: 1012.10030

Attached is the audit report for activities at the Veolia Emerald Park Landfill for the week of March 18, 2013. The audit was performed at 2:33 pm on **March 22, 2013** by Jo Spear Jr. in the presence of David Geier.

VEOLIA EMERALD PARK LANDFILL
LANDFILL OPERATIONS AUDIT FORM
CITY OF MUSKEGO

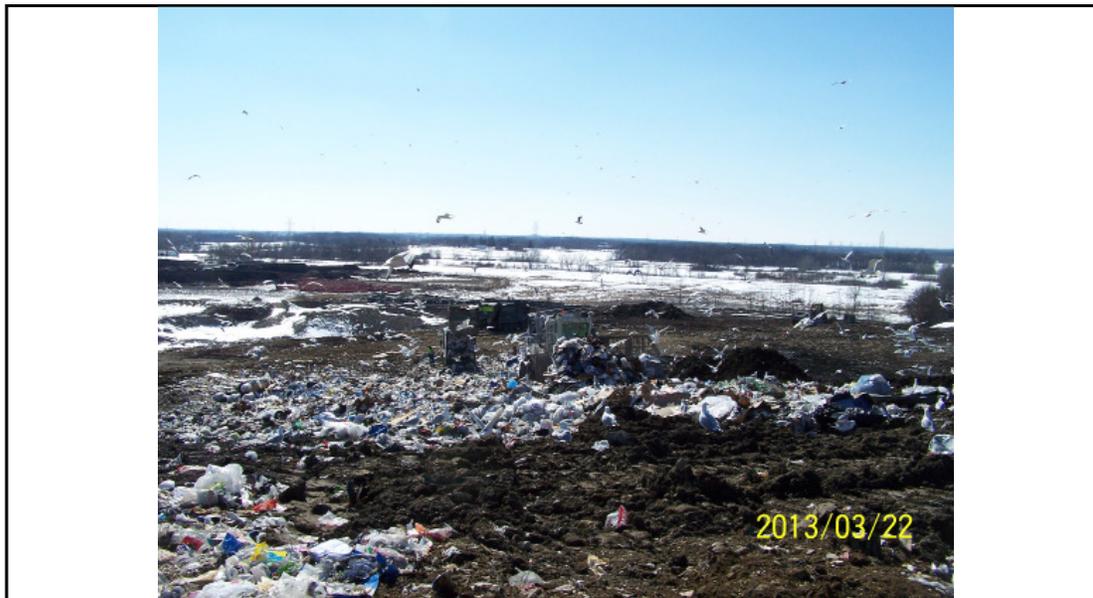
Working face viewed from access road (Northeast)

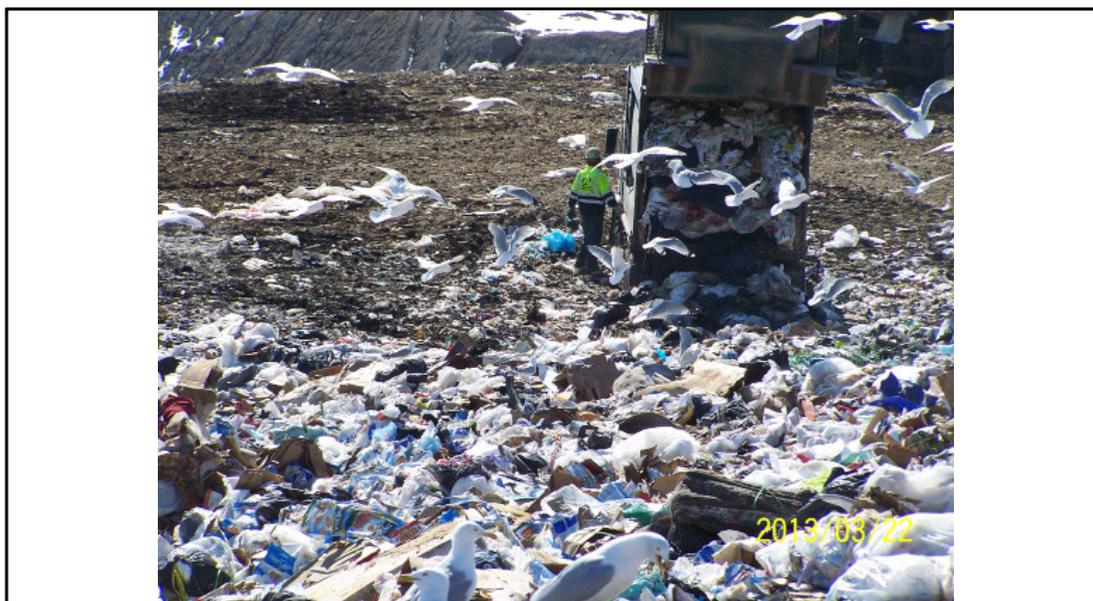
Truck tipping at working face

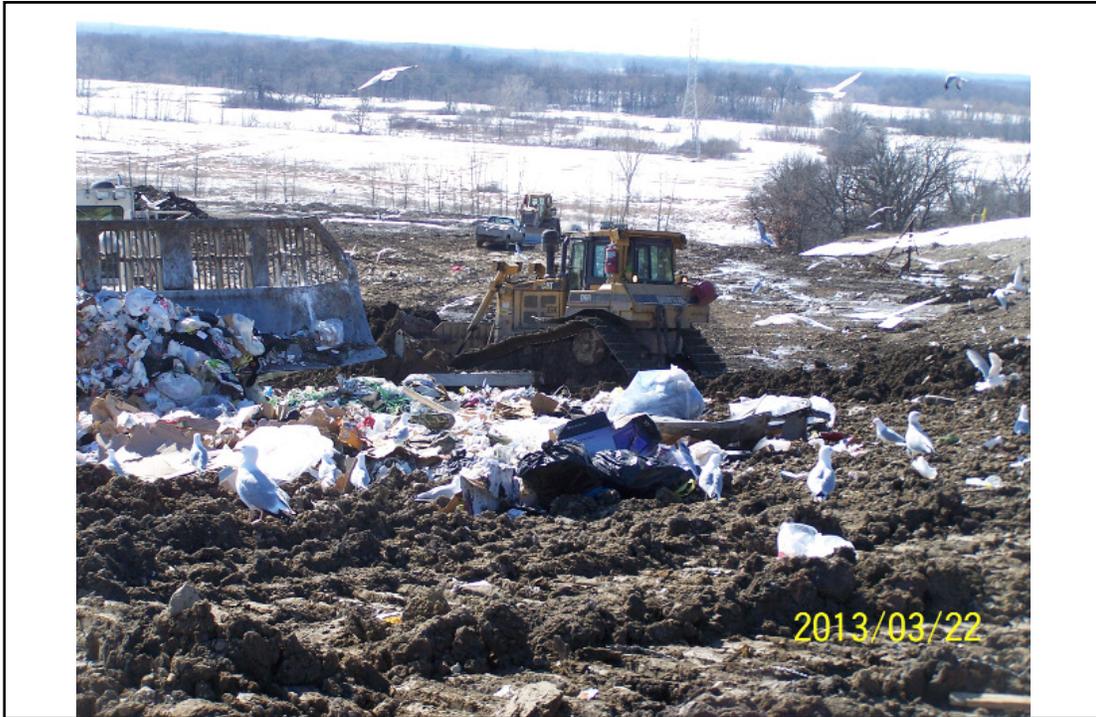
Dozer and compactor in working face

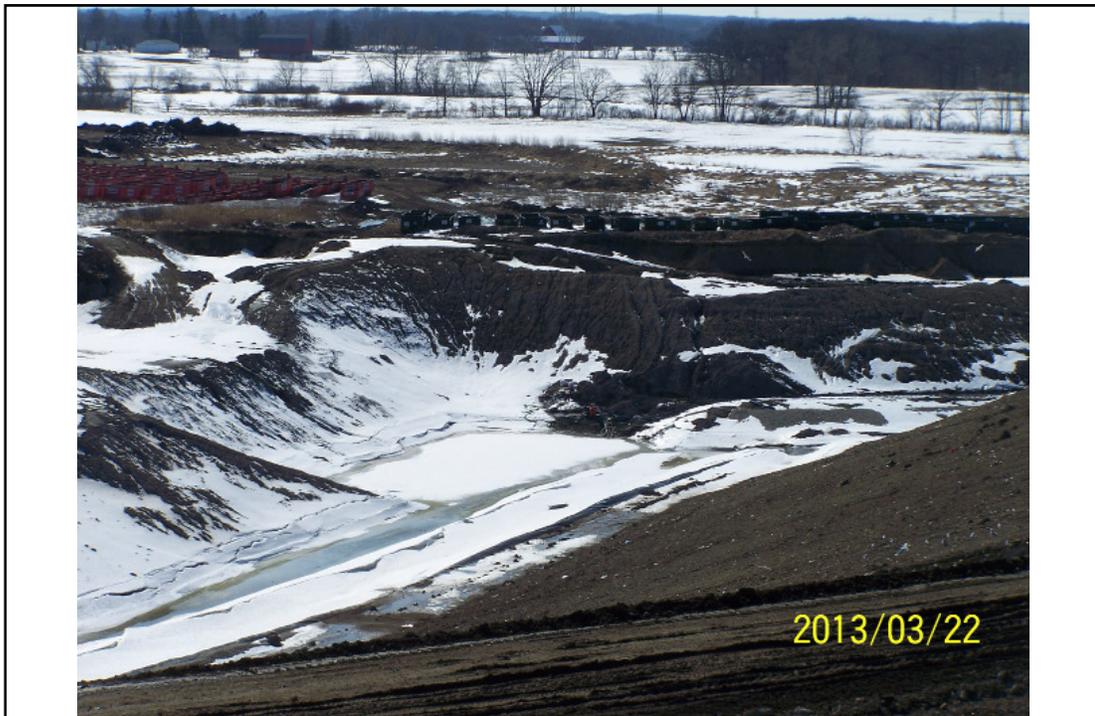
Basins frozen at top. Temp BASIN

Pumped down

Temp sed pond, draining by pump with ice covering

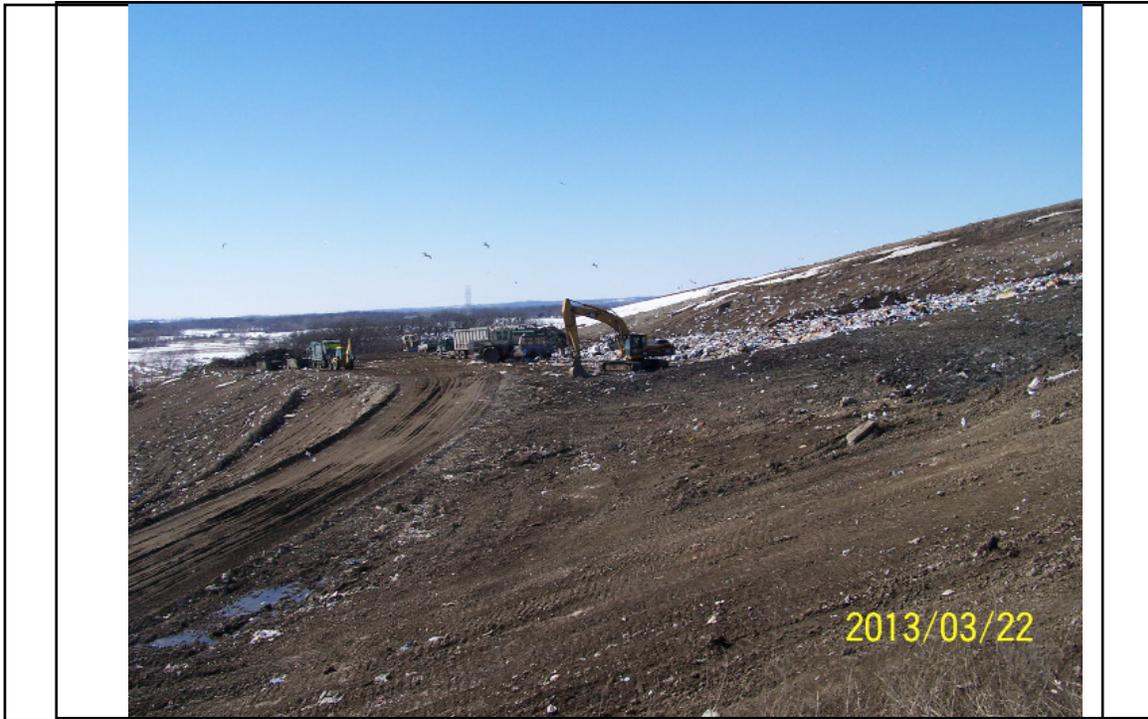
Working face and compactor for frozen loads

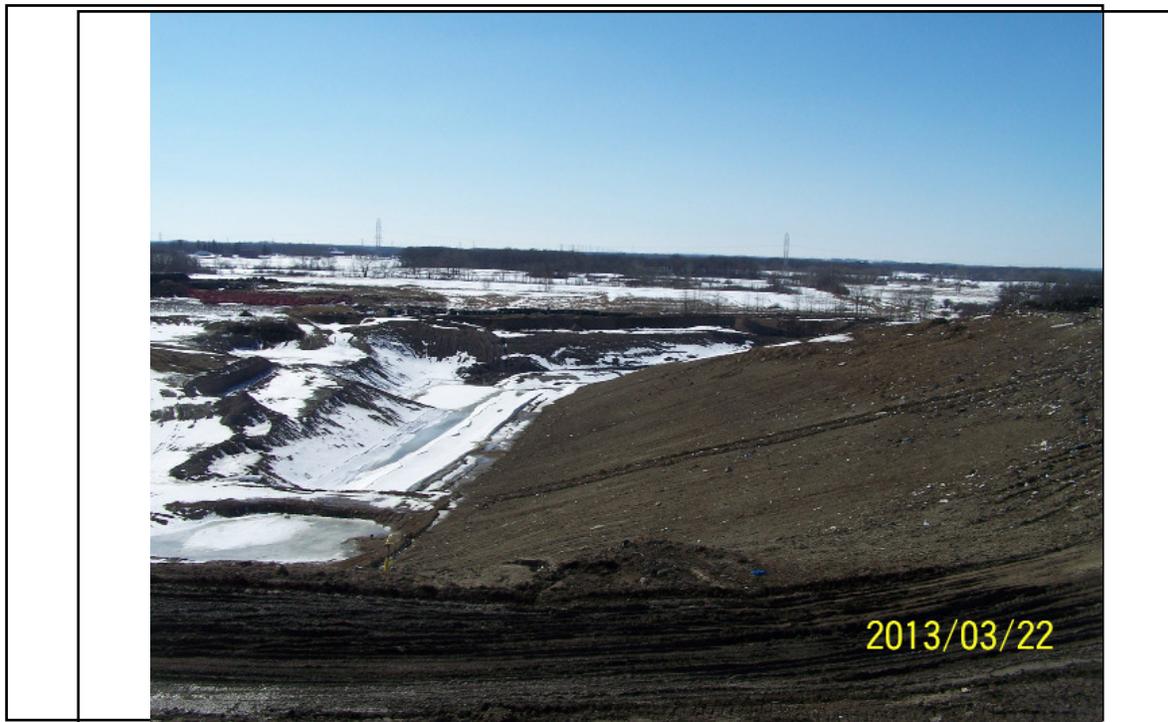
South slope of Phase 7 and temp sed basin
