VEOLIA Emerald Park Landfill Audit Summary

TO: Veolia Emerald Park Landfill Standing Committee, City of Muskego
FROM: Anna Krajcik
COPIES: File
DATE: 02/25/13
PROJECT NUMBER: 1012.10030

VEOLIA EMERALD PARK LANDFILL
LANDFILL OPERATIONS AUDIT FORM
CITY OF MUSKEGO

**VEOLIA EMERALD PARK LANDFILL
AUDIT PHOTOS
CITY OF MUSKEGO**

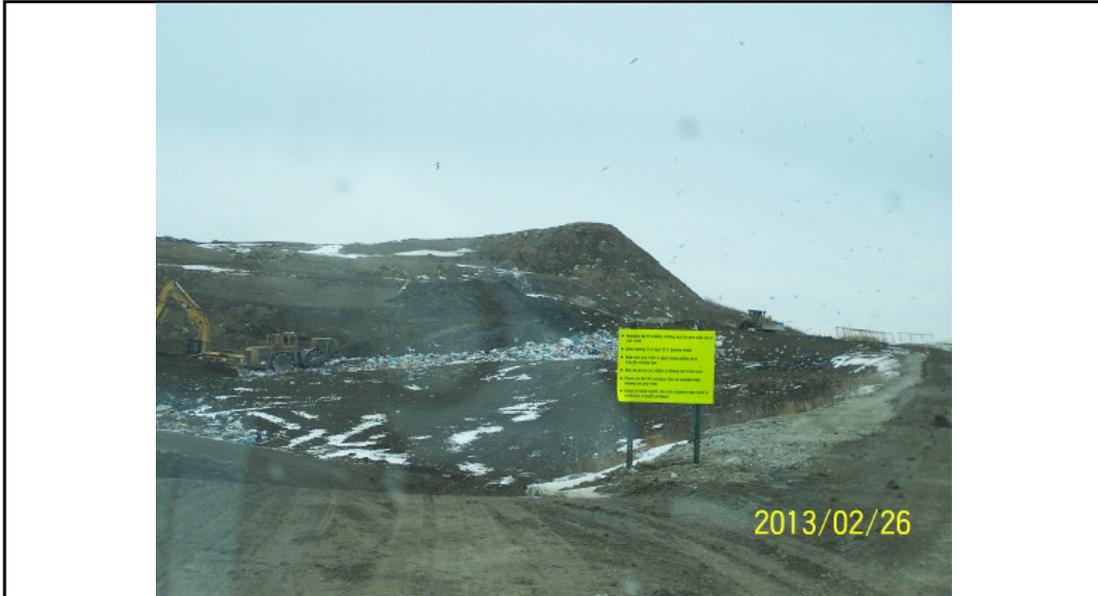
Working face viewed from the South

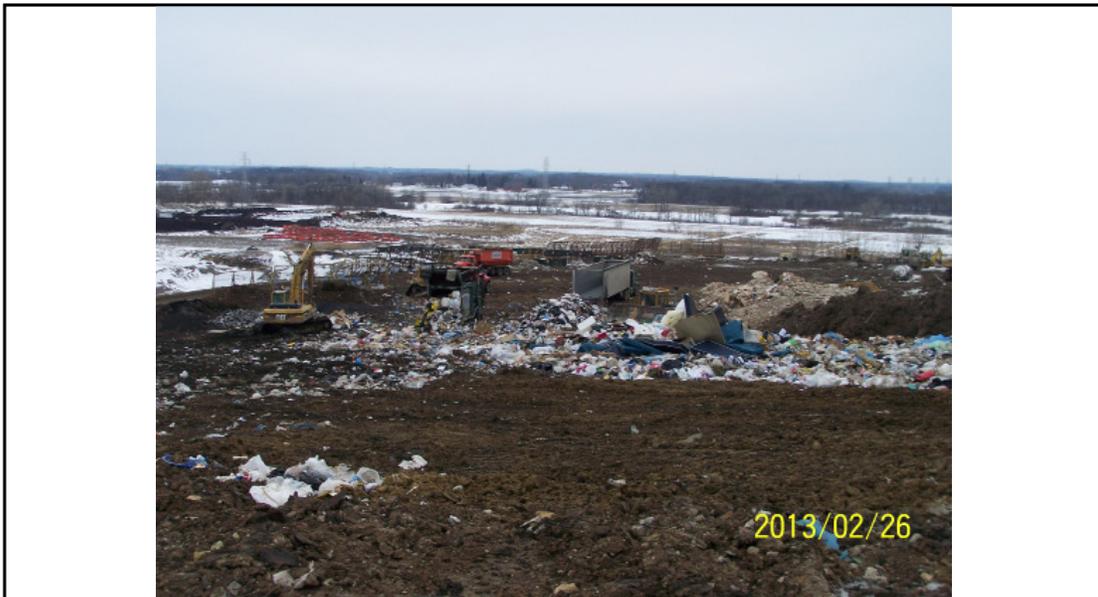
Working face viewed from East

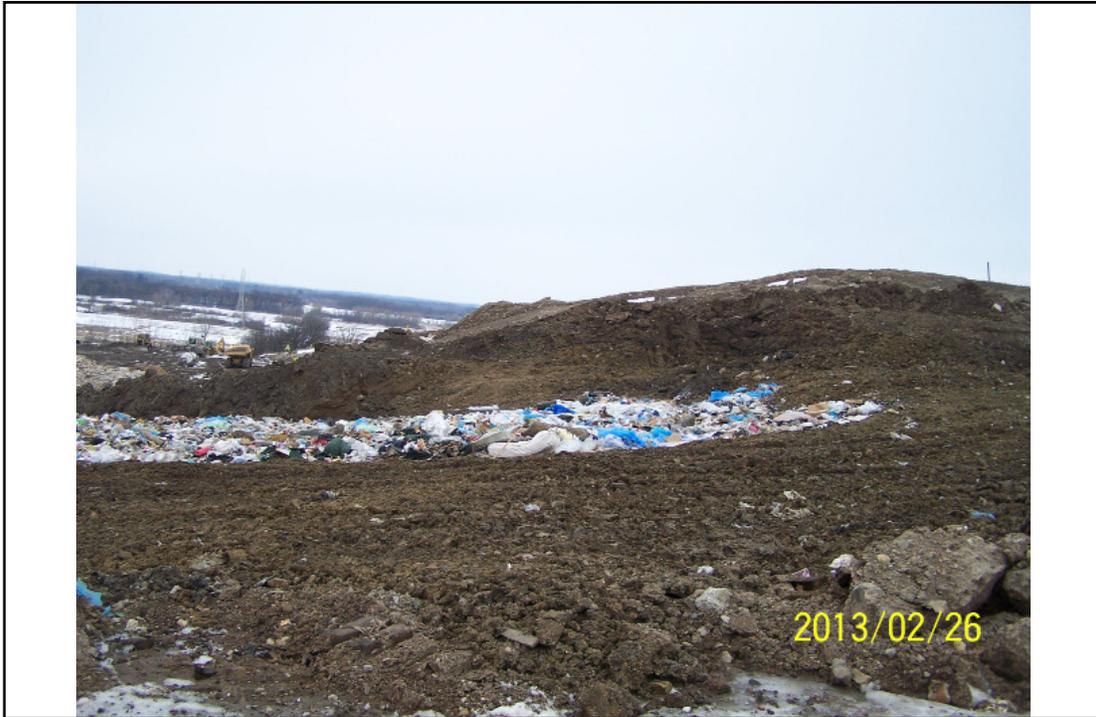
Working face

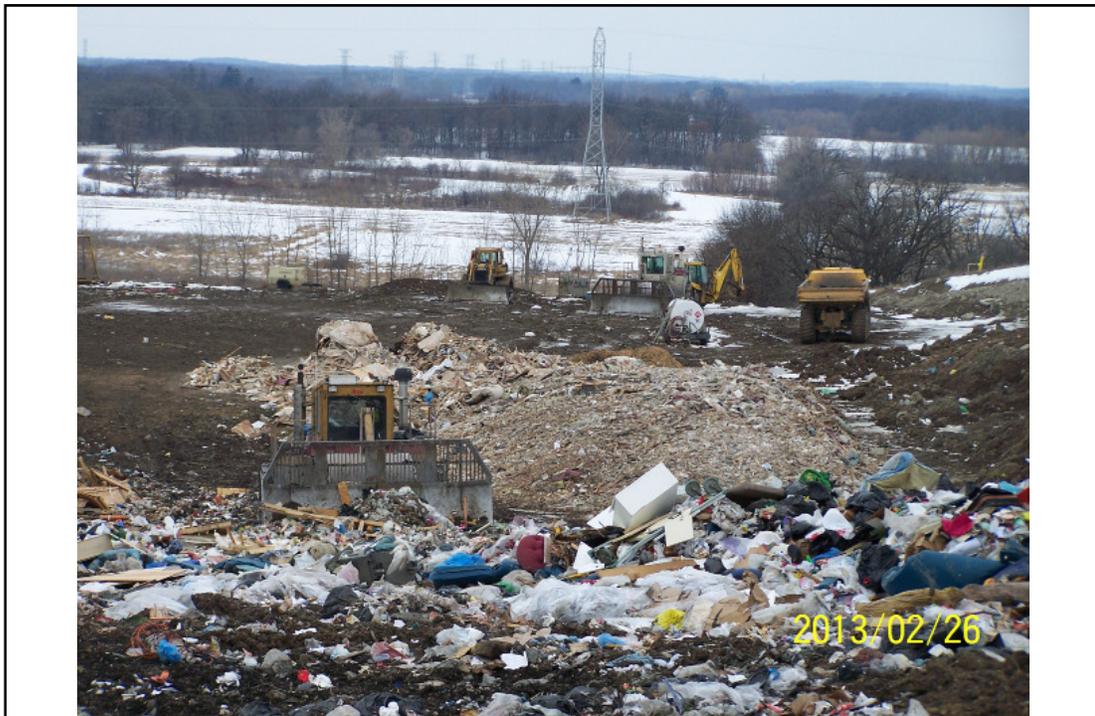
Working face with stockpiled C&D waste beyond

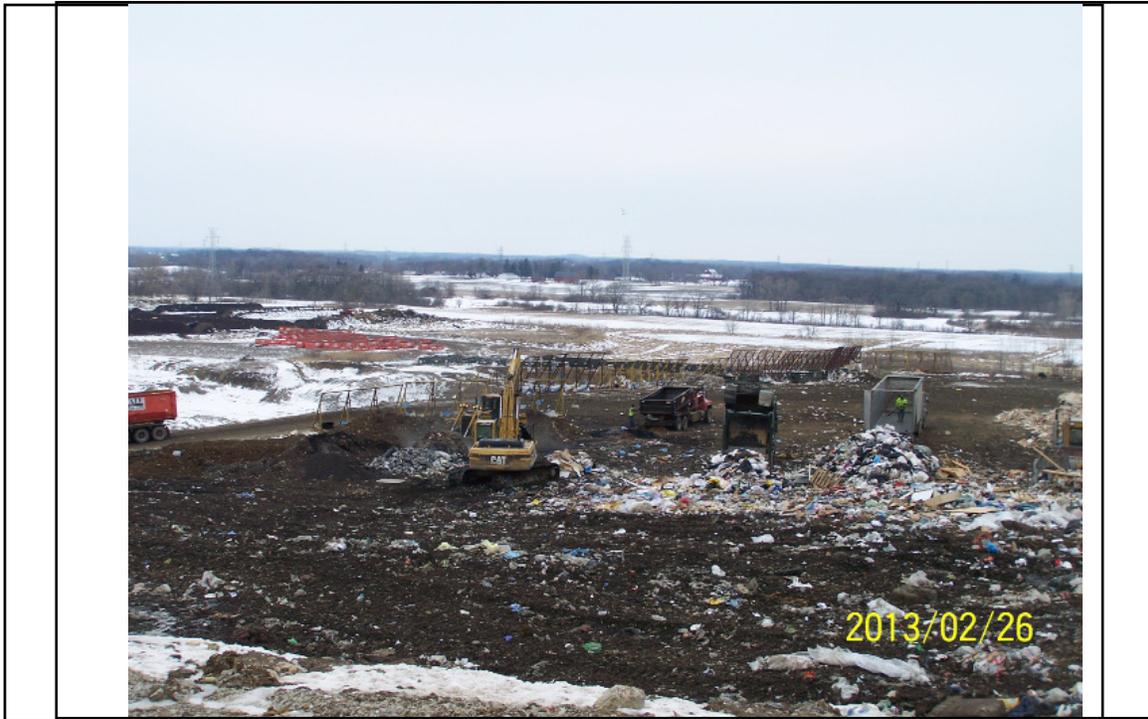
Active area

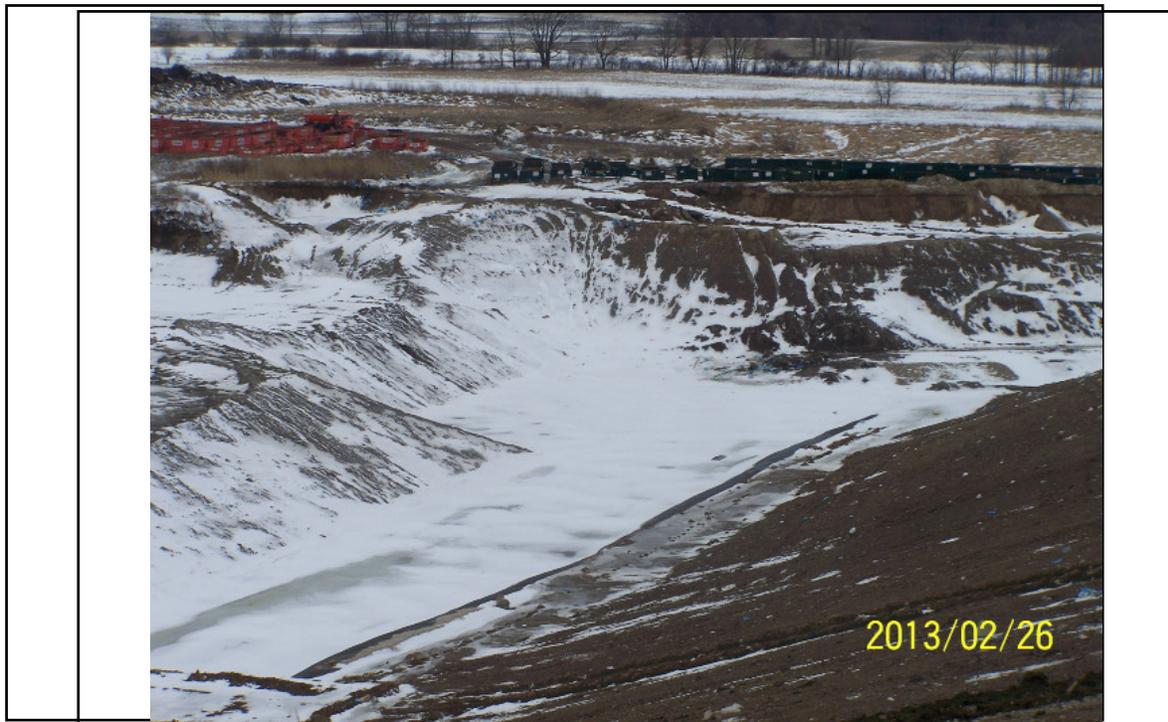
* Temp sed basins frozen, & frozen water
at base of Phase 6

Temp Sed Basin
