# VEOLIA Emerald Park Landfill Audit Summary

**TO:** Veolia Emerald Park Landfill Standing Committee, City of Muskego  
**FROM:** Anna Krajcik  
**COPIES:** File  
**DATE:** 02/25/13  
**PROJECT NUMBER:** 1012.10030

VEOLIA EMERALD PARK LANDFILL  
LANDFILL OPERATIONS AUDIT FORM  
CITY OF MUSKEGO

**VEOLIA EMERALD PARK LANDFILL  
AUDIT PHOTOS  
CITY OF MUSKEGO**

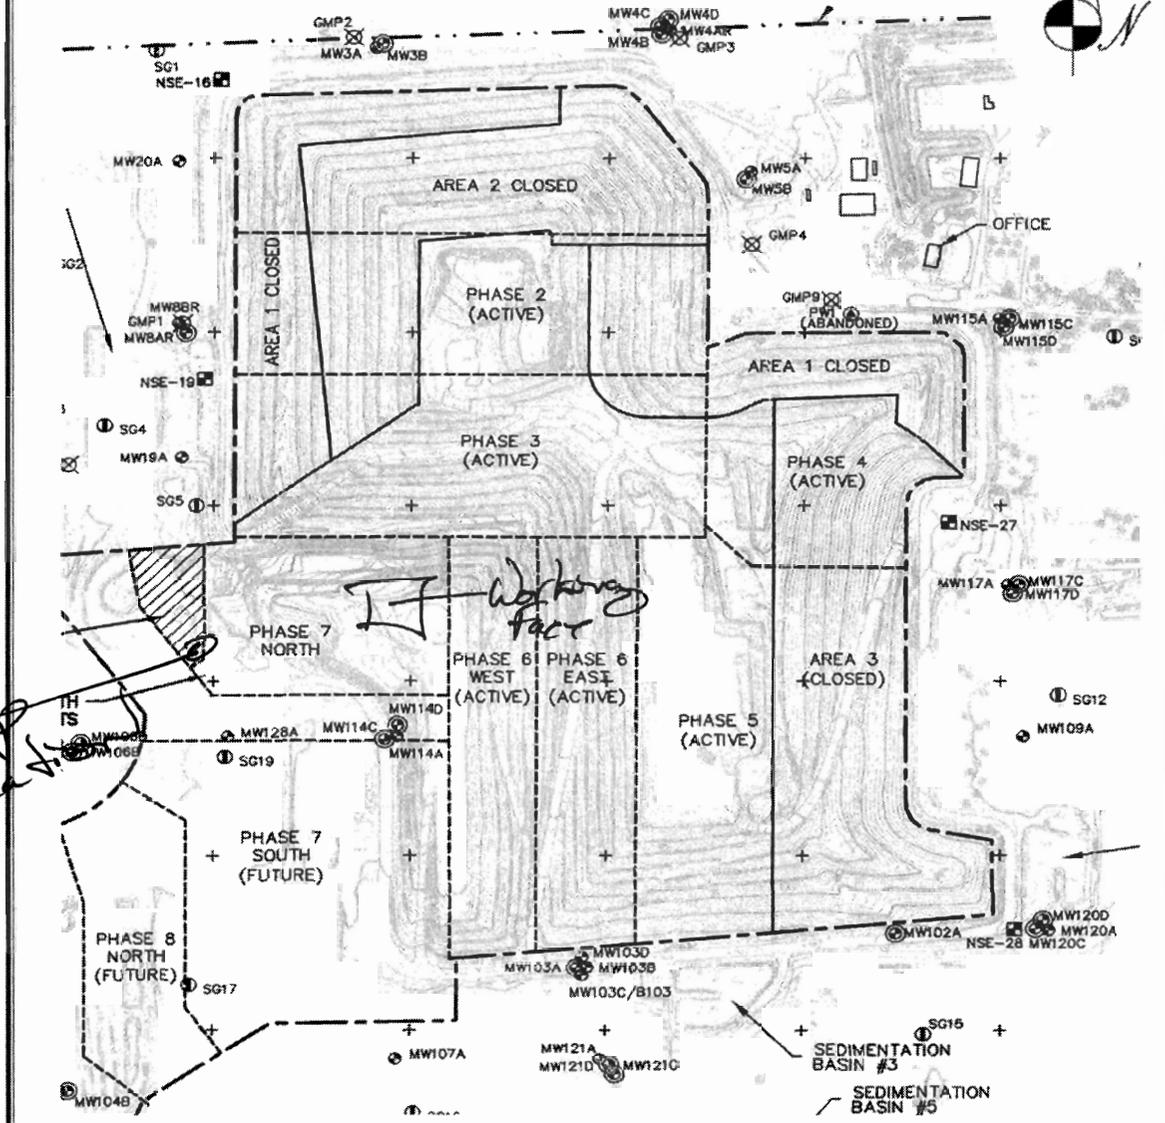
LANDFILL AUDIT MAP

*Handwritten notes:*  
 Pump location (with arrow pointing to MW100A)  
 Working Face (with arrow pointing to the boundary between Phase 6 and Phase 7)

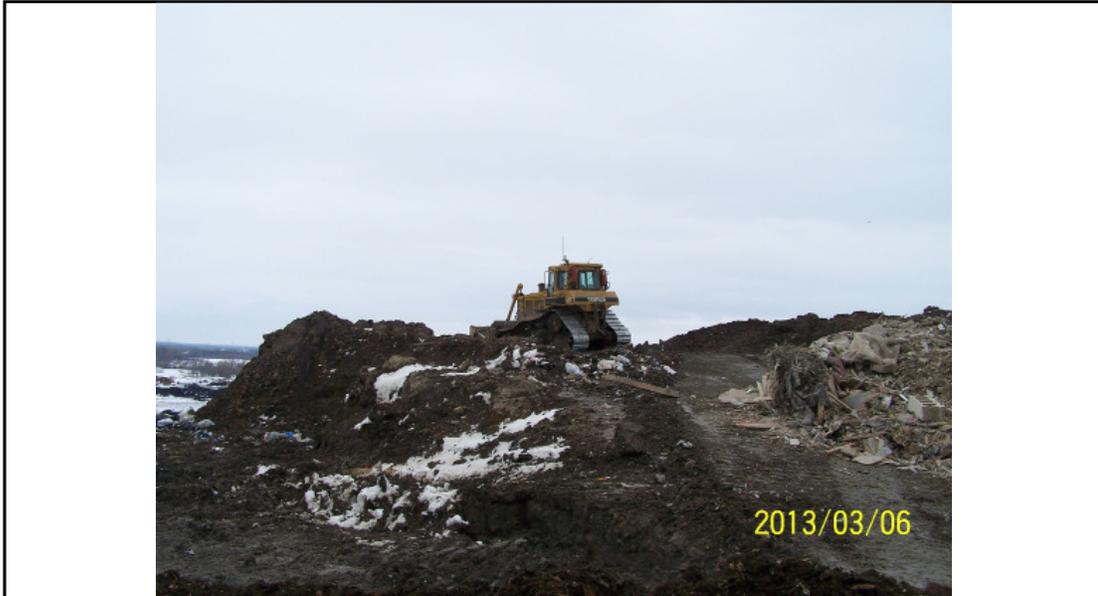
Cuts in soil placement for previous cover

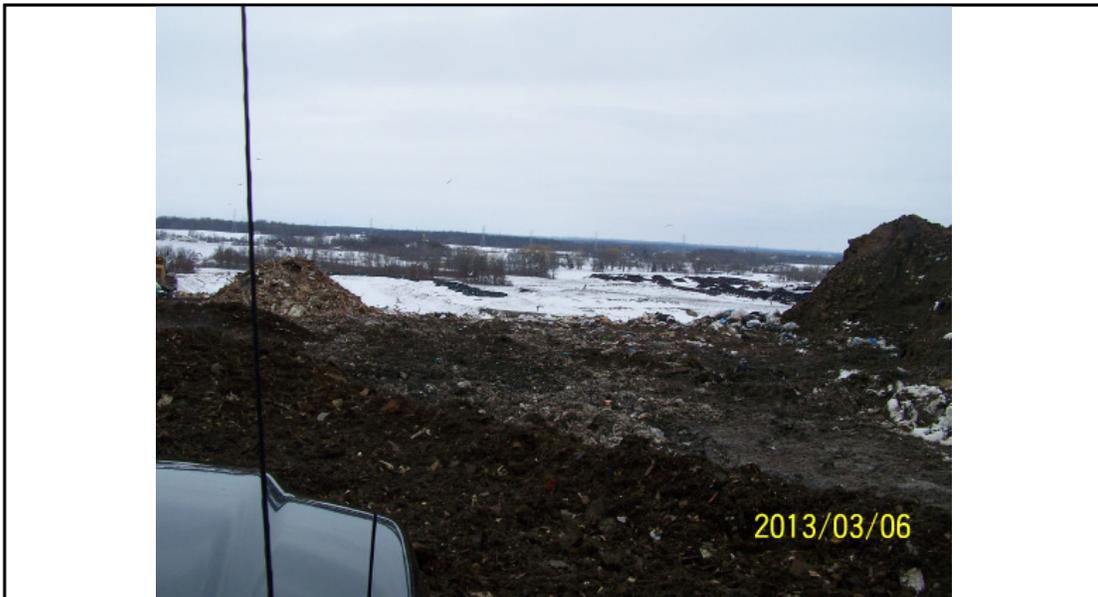
previously covered working face

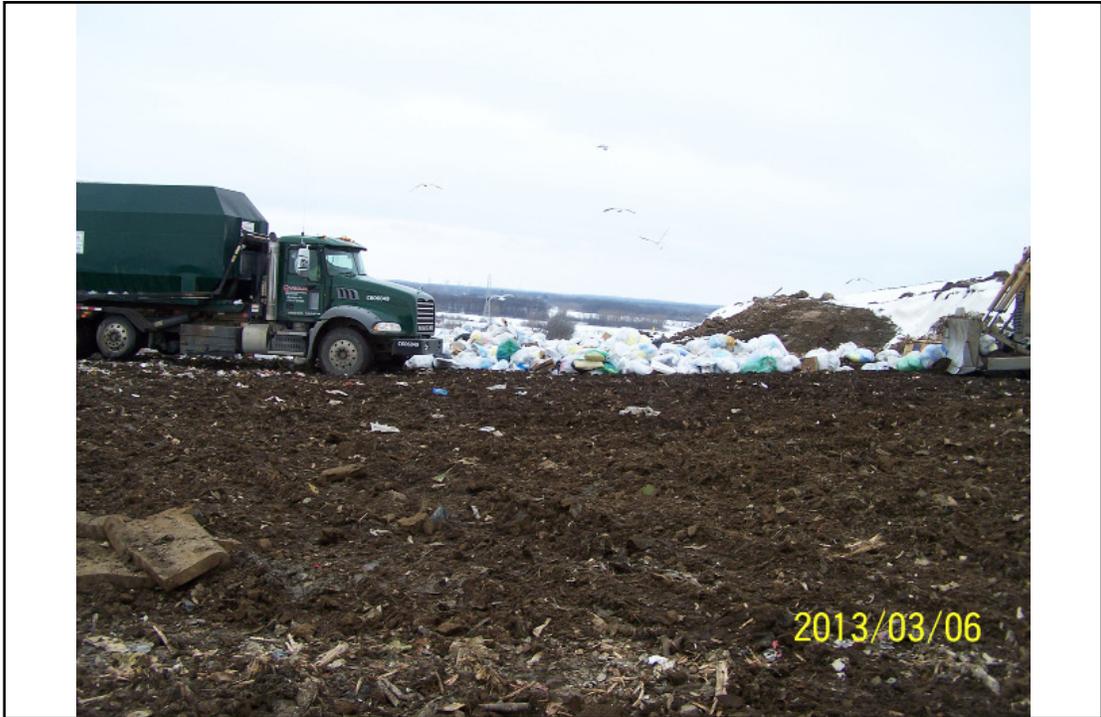
Working face created to access road in Northeast corner of Phase 7. Demolition being combined for access for future days use. No soils or other working faces.

Working face viewed from North

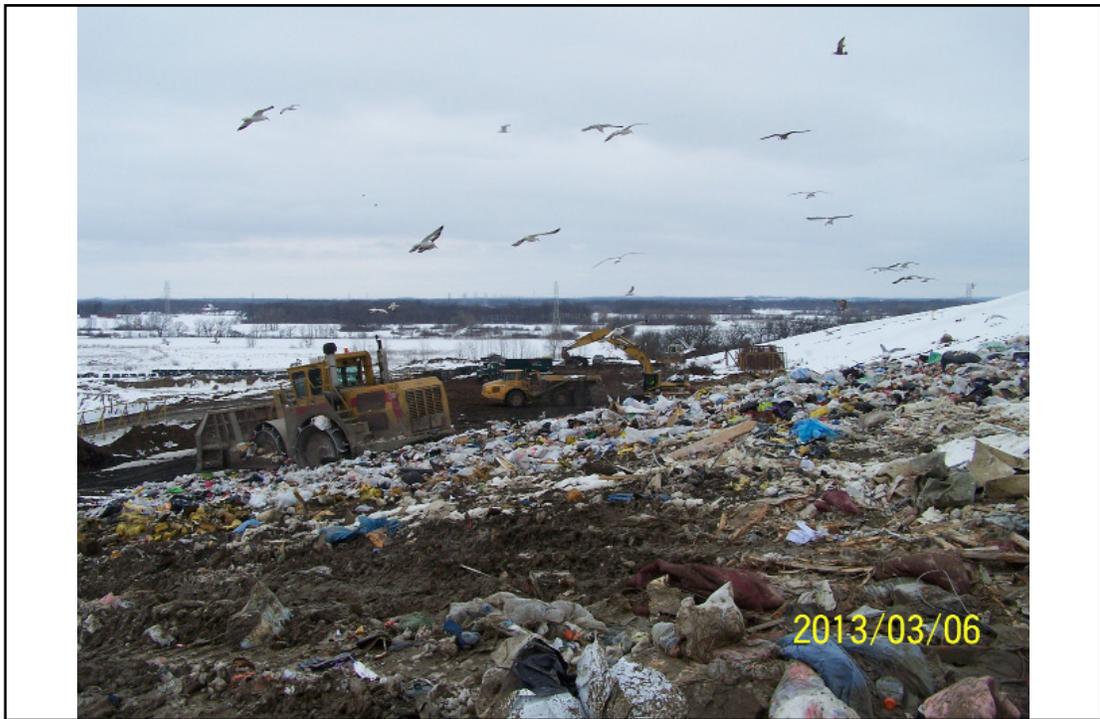
Working face, viewed from Northeast

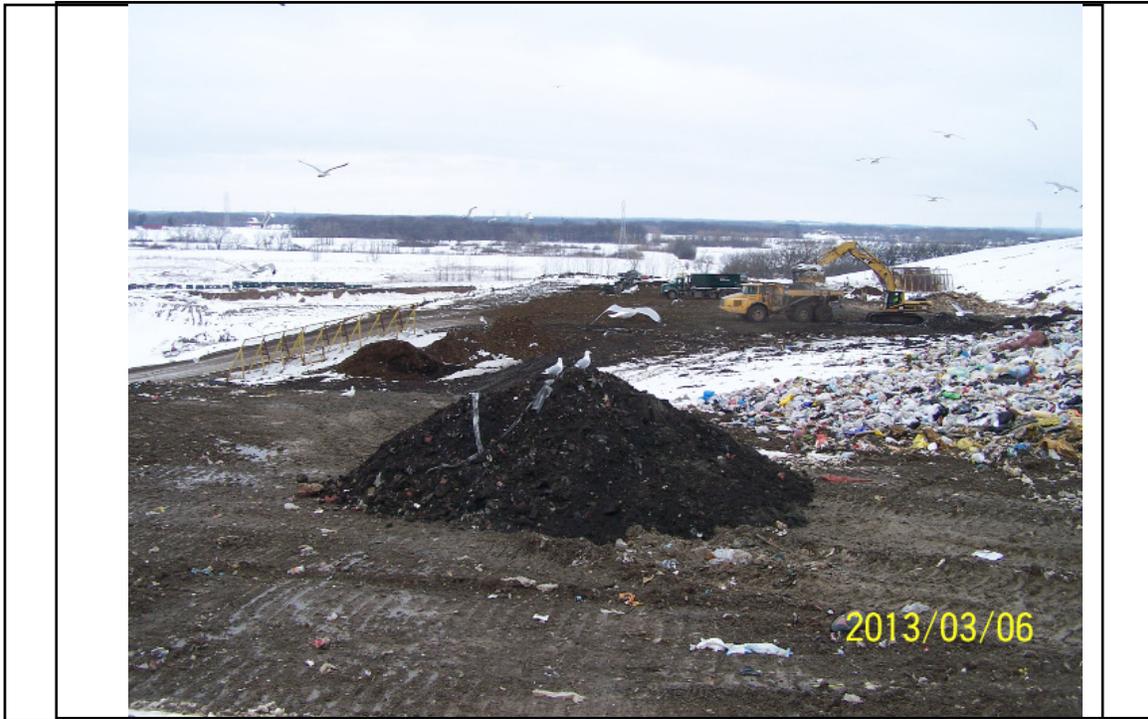
Foundry sands & Autopluff for cover

Foundry sand moved from stockpile to location for cover placement

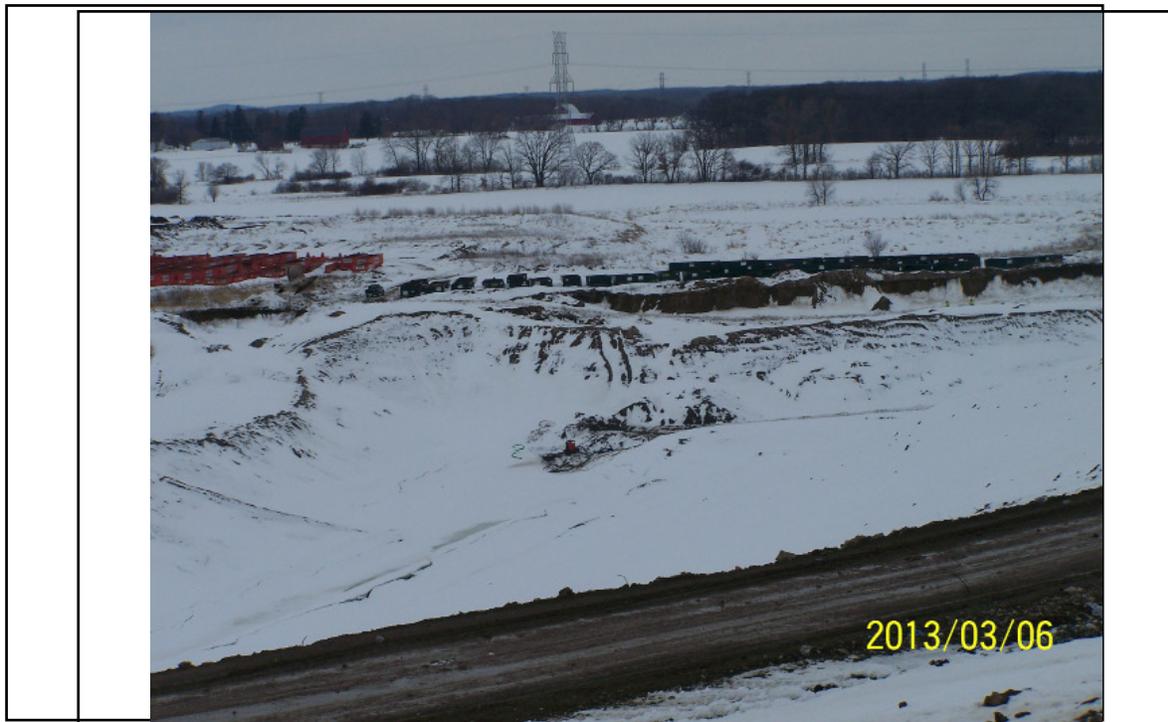
\* Grinch pump repaired and in use  
for draining Temp Sed Basins. Basins  
appeared drained during Audits  
\* Foundry sand stock piled for cover

Temp Sed Basin
