VEOLIA Emerald Park Landfill Audit Summary

TO: Veolia Emerald Park Landfill Standing Committee, City of Muskego
FROM: Anna Krajcik
COPIES: File
DATE: 02/25/13
PROJECT NUMBER: 1012.10030

VEOLIA EMERALD PARK LANDFILL
LANDFILL OPERATIONS AUDIT FORM
CITY OF MUSKEGO

VEOLIA EMERALD PARK LANDFILL AUDIT PHOTOS CITY OF MUSKEGO

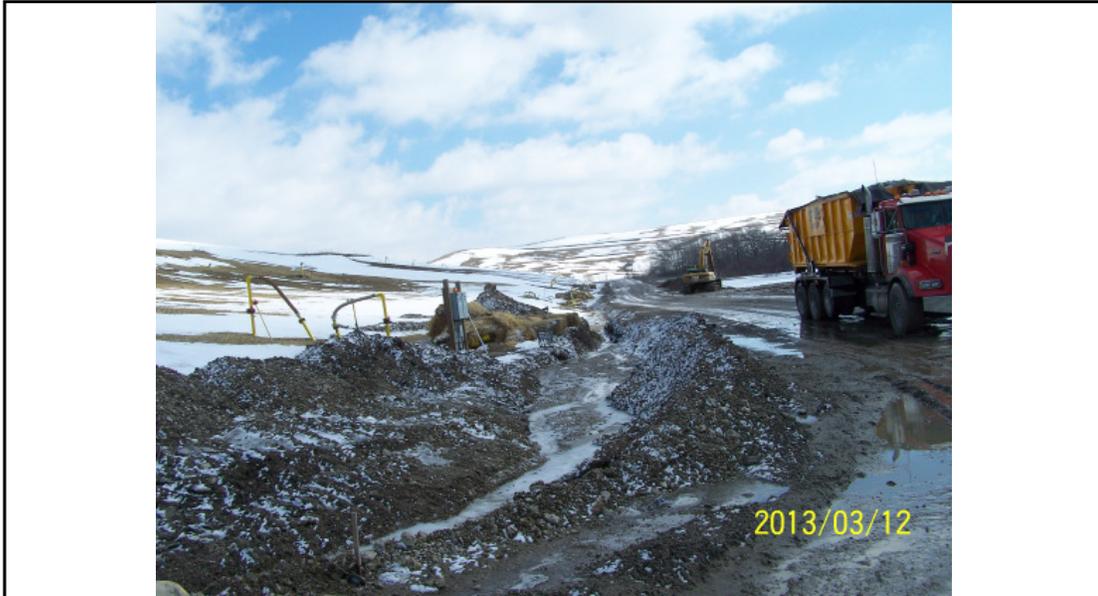
Drainage ways being cleaned on South edge of Phase 5 & 6

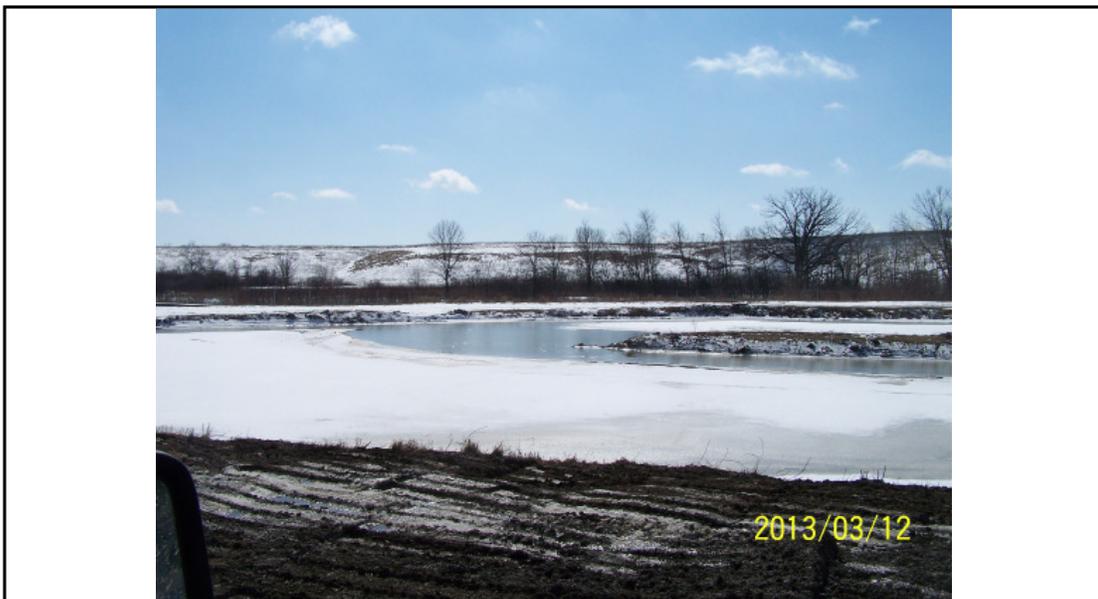
Snow & Rainfall since last audit, sunny conditions
causing melt. Basins have at least 1' of freeboard.

Basin with capacity, but elevations are up

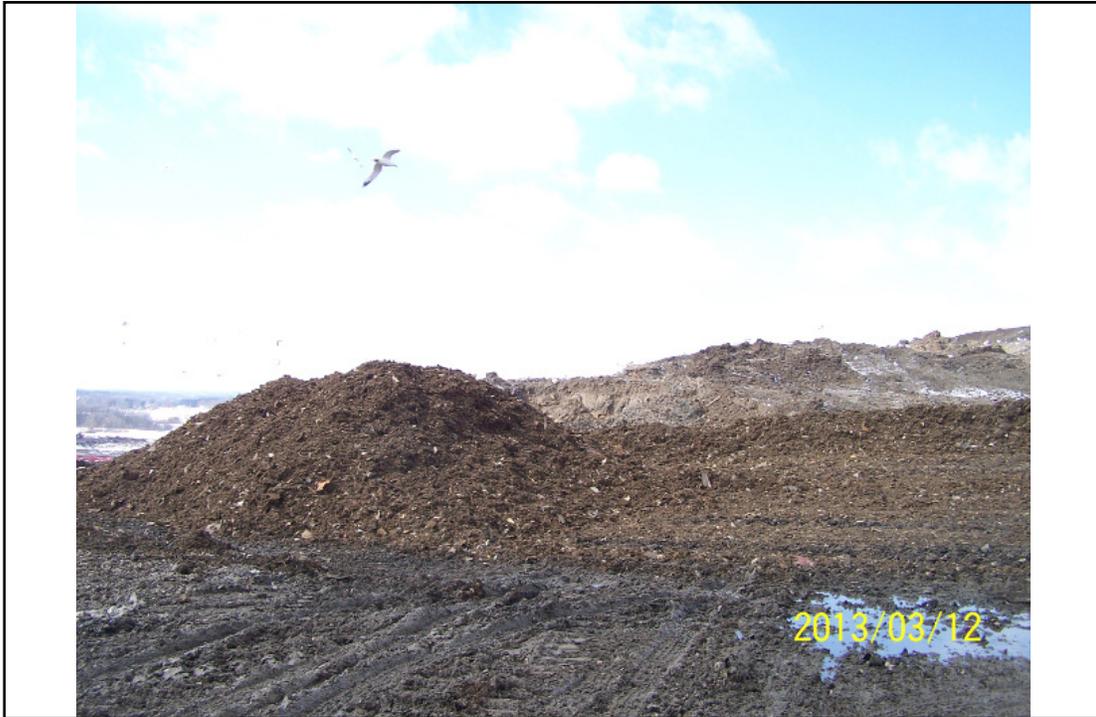
Foundry sands & Soils to date Autofluff picking
back up

Autofluff stockpiled above - North of Phase 7

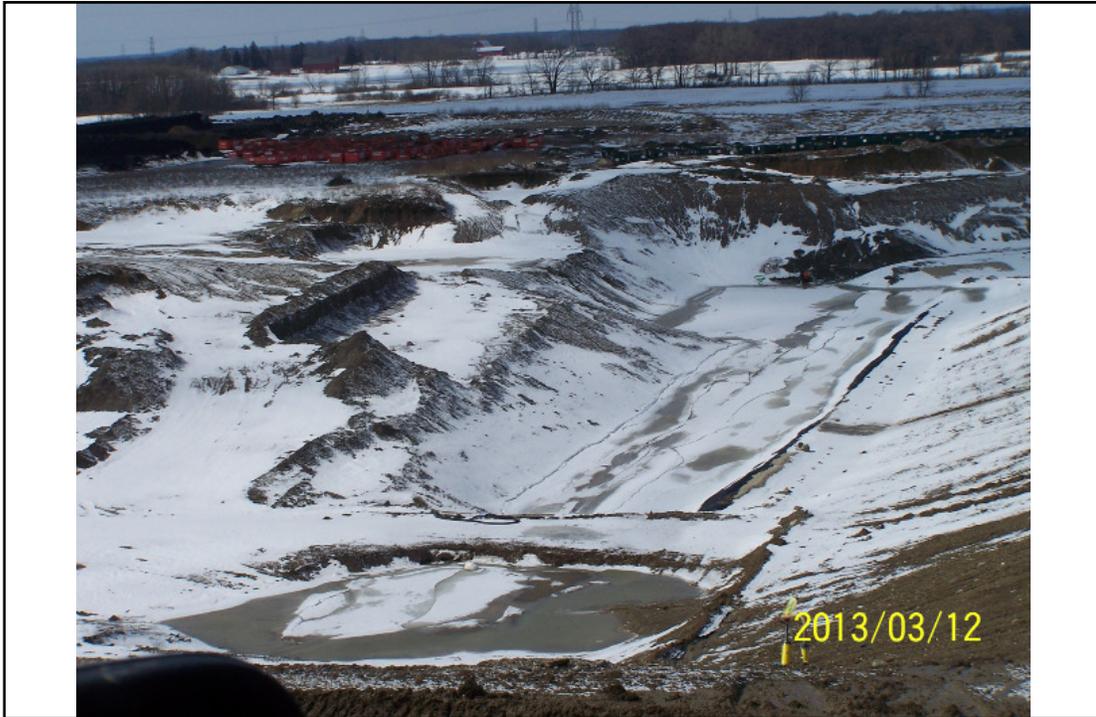
Temp sed basins

* Basins Volumes up with rainwater, Temp Basin
however drained by pumps.
* Access roads to working face being changed
ramps being removed & added.

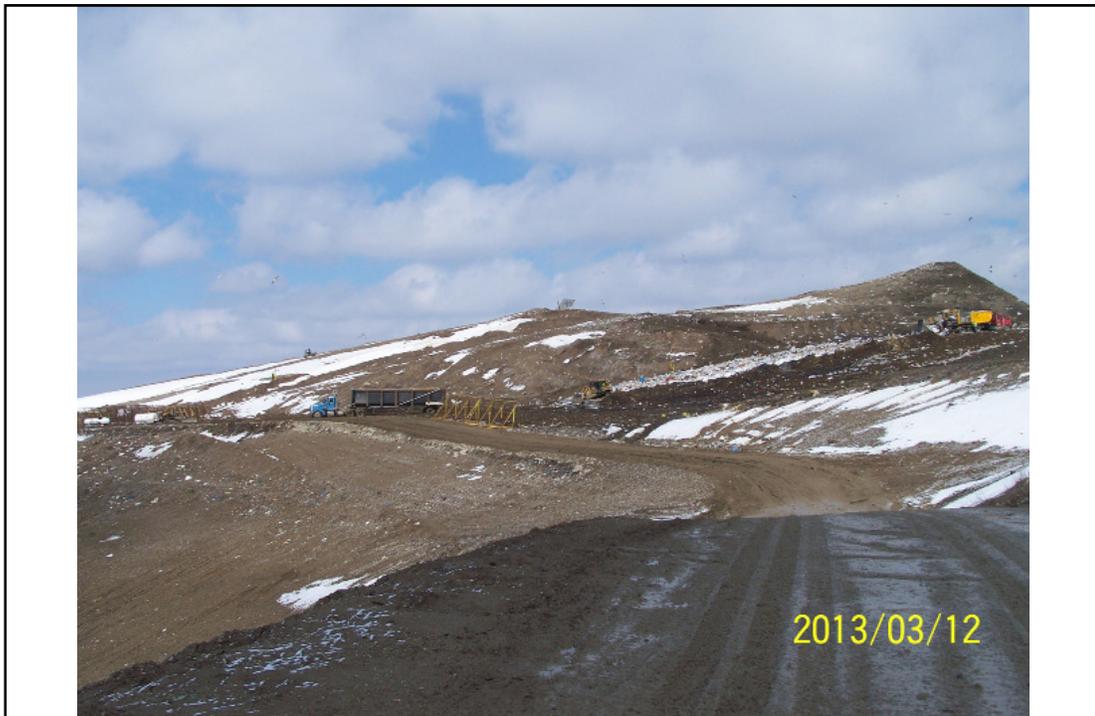
Working face in Northeast corner of Phase 7
at top of access road. Conditions too wet
to come in from below. No soils or
other working faces

Working face, viewed from South

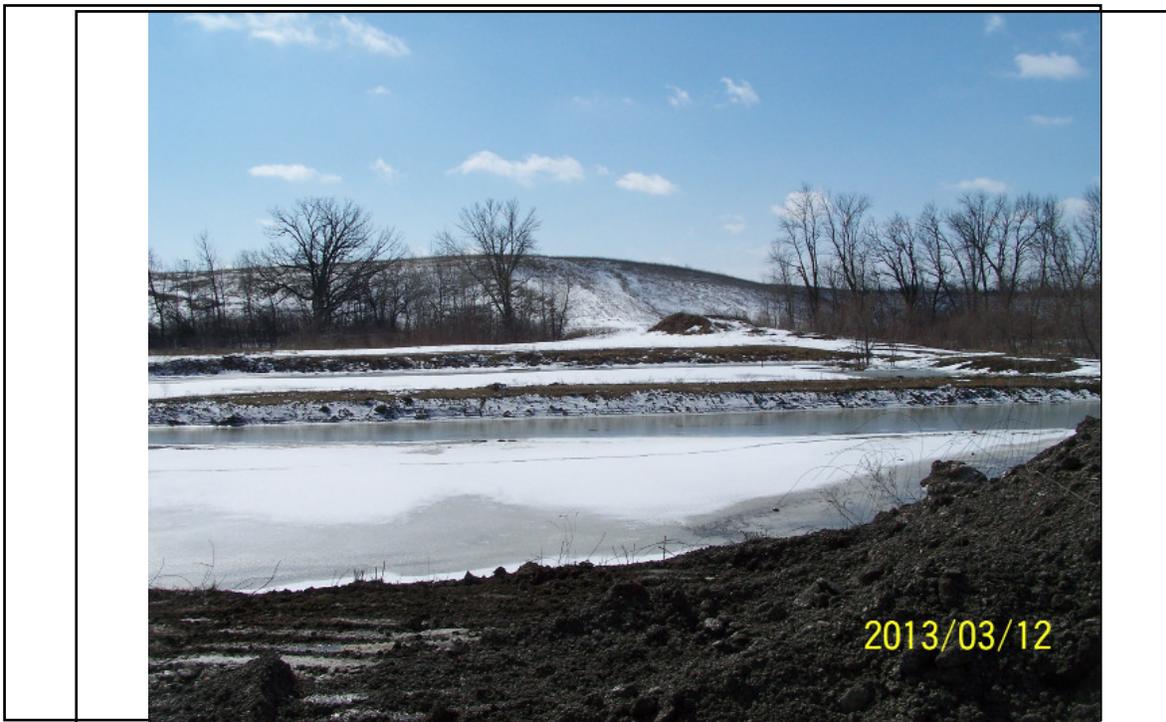
Drainage basin, top frozen only, receiving melt water
