VEOLIA Emerald Park Landfill Audit Summary

TO: Veolia Emerald Park Landfill Standing Committee, City of Muskego
FROM: Anna Krajcik
COPIES: File
DATE: 04/03/13
PROJECT NUMBER: 1012.10030

ADVANCED DISPOSAL SERVICES EMERALD PARK LANDFILL
 LANDFILL OPERATIONS AUDIT FORM
 CITY OF MUSKEGO

**ADVANCED DISPOSAL SERVICES
EMERALD PARK LANDFILL
AUDIT PHOTOS
CITY OF MUSKEGO**

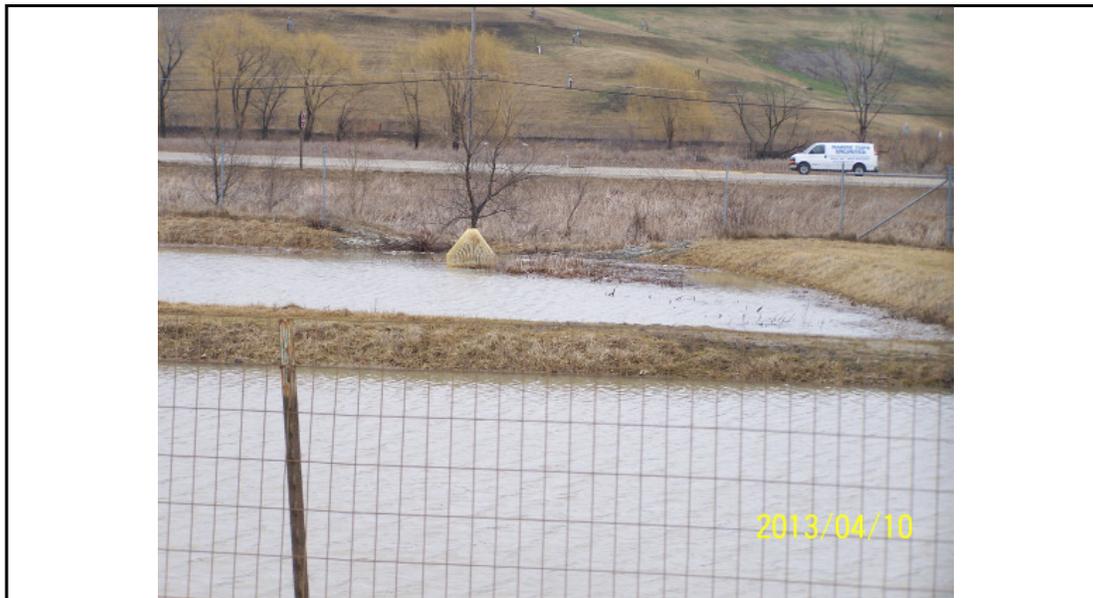
Basin 3

Basins nearly full, erosion damage present

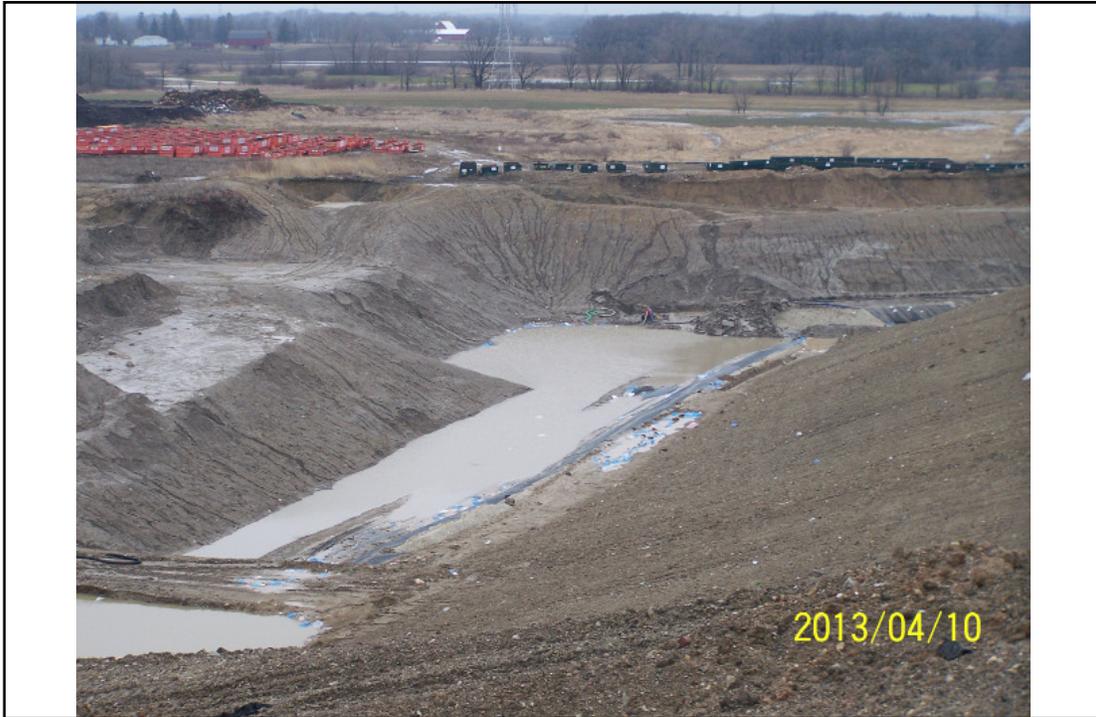
Temp sed basin, pumped down between storm events

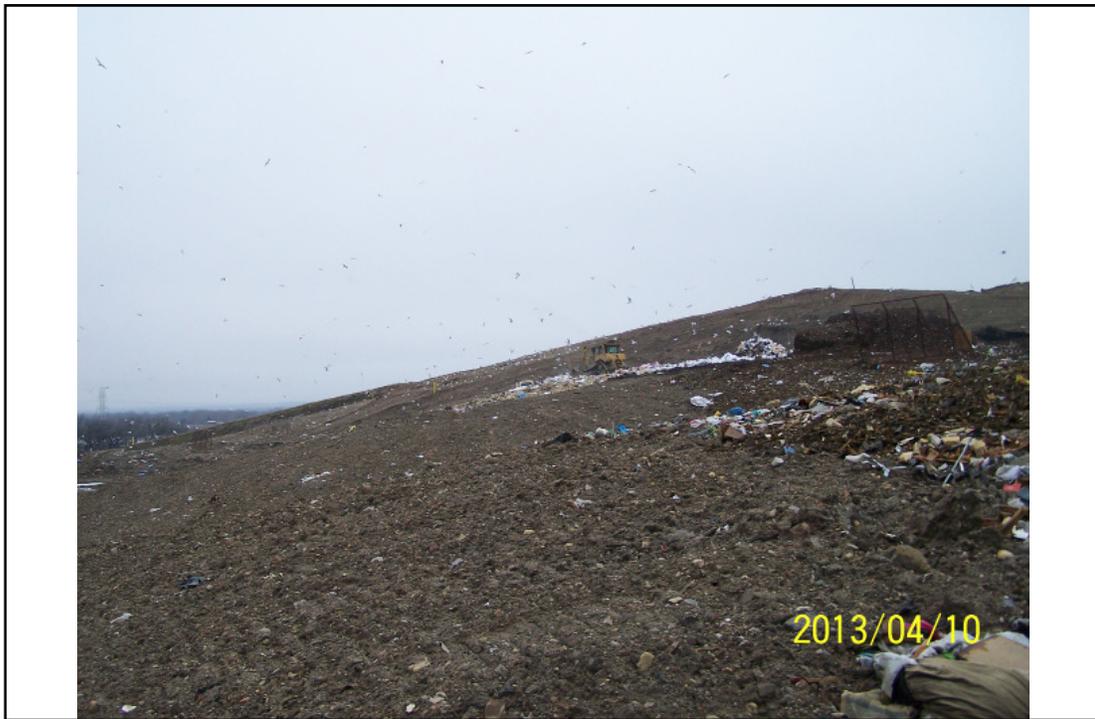
Previous area of road and ramp

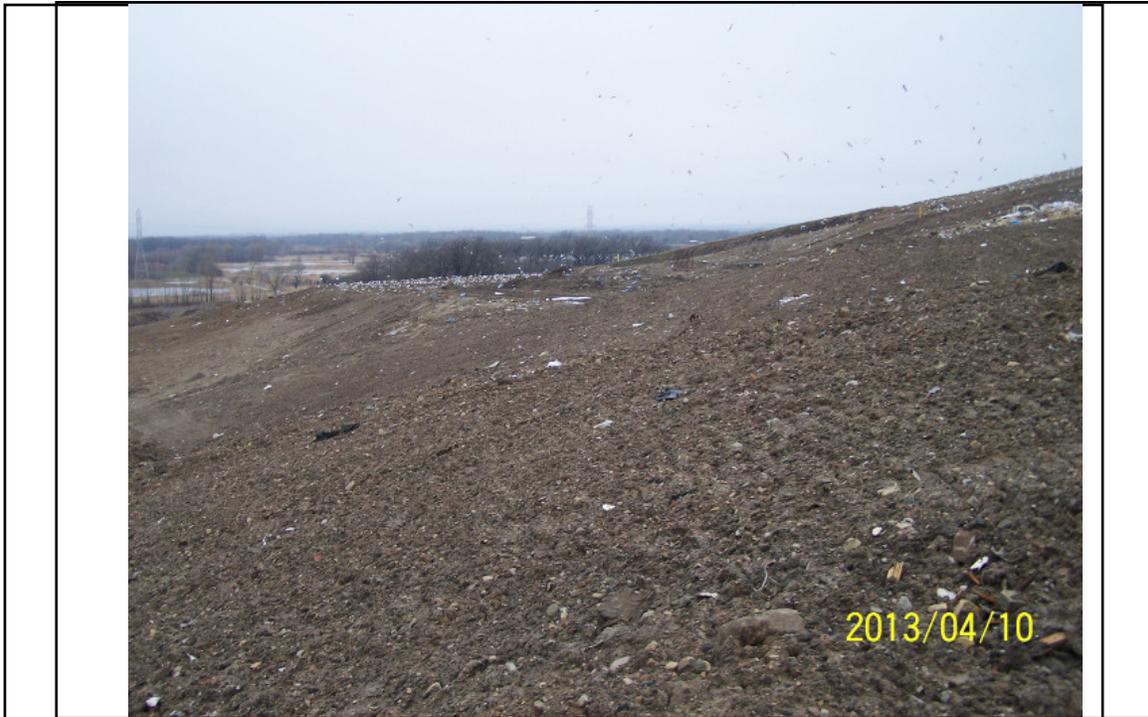
South slope of Phase 7 in good condition after rain fall

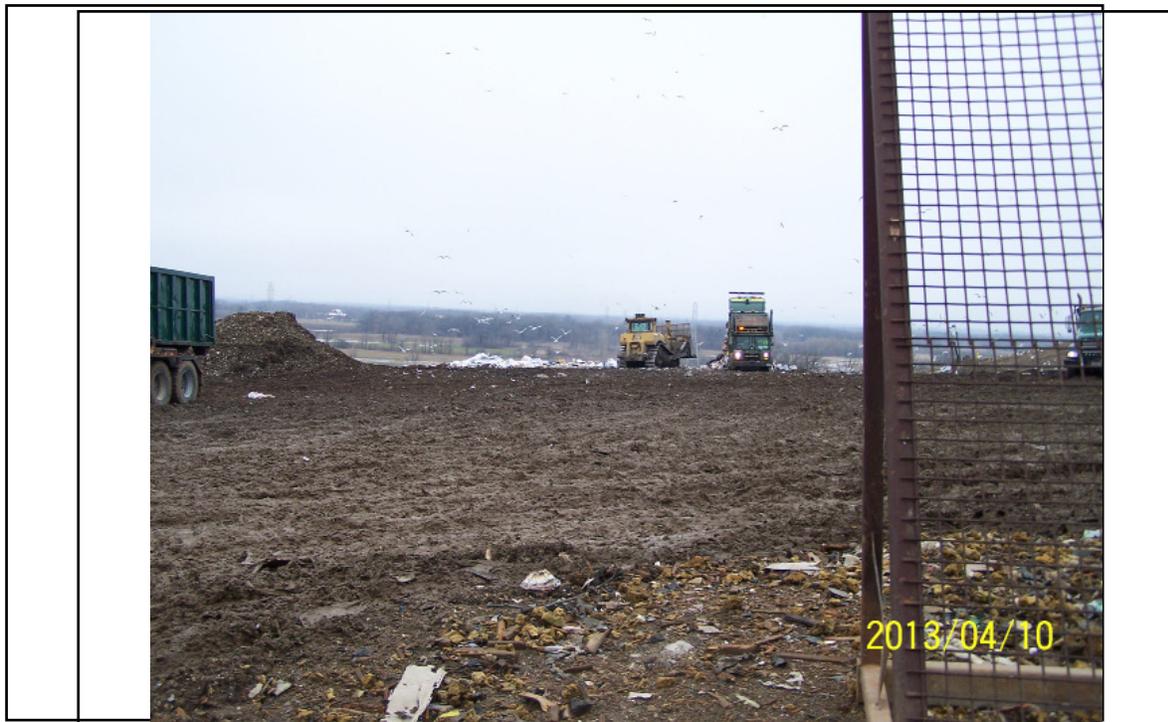
Working face moving West across Phase 7
