### Advanced Disposal Services Emerald Park Landfill Audit Summary

**TO:** ADSEPL Standing Committee, City of Muskego  
**FROM:** Anna Krajcik  
**COPIES:** File  
**DATE:** 04/03/13  
**PROJECT NUMBER:** 1012.10030

ADVANCED DISPOSAL SERVICES EMERALD PARK LANDFILL  
 LANDFILL OPERATIONS AUDIT FORM  
 CITY OF MUSKEGO

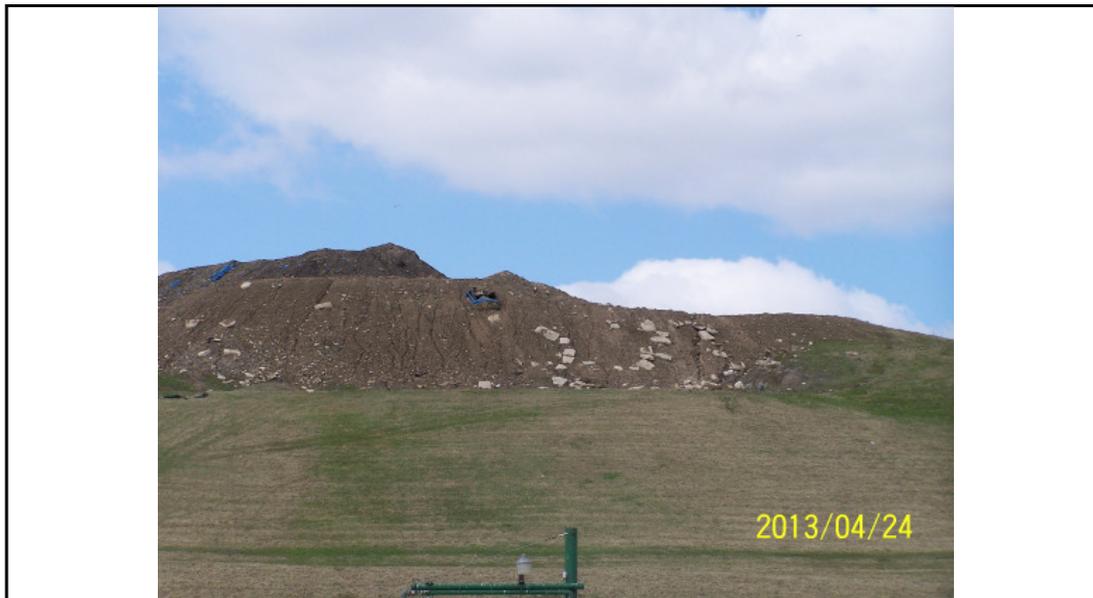
Landfill direct soil stock pile, concrete exposed by rain

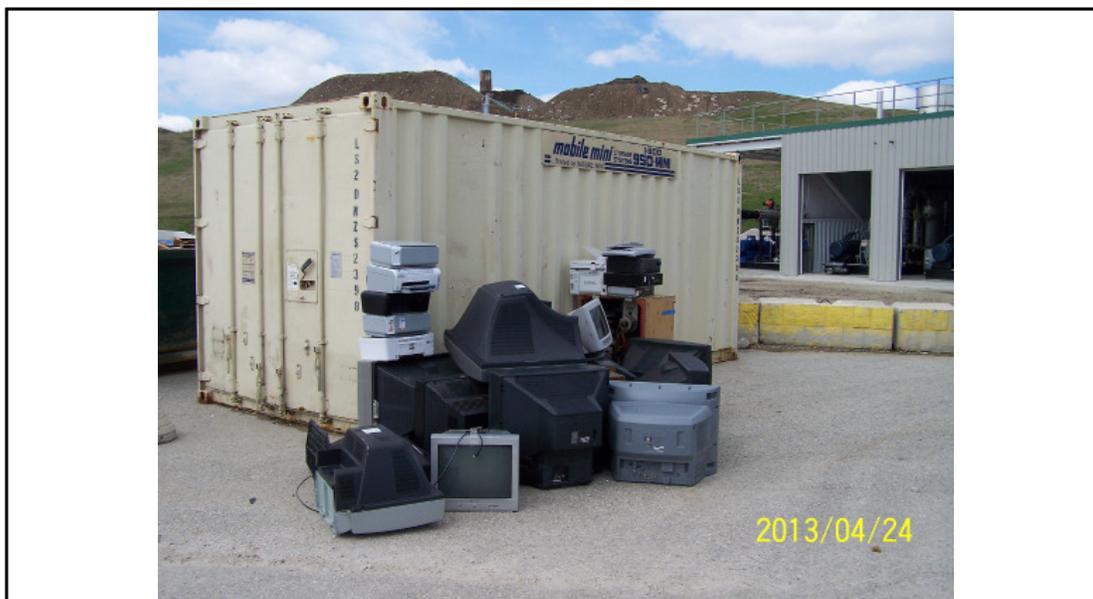
E-Waste container over-flowing

E-Cycling stock pile outside of collection box

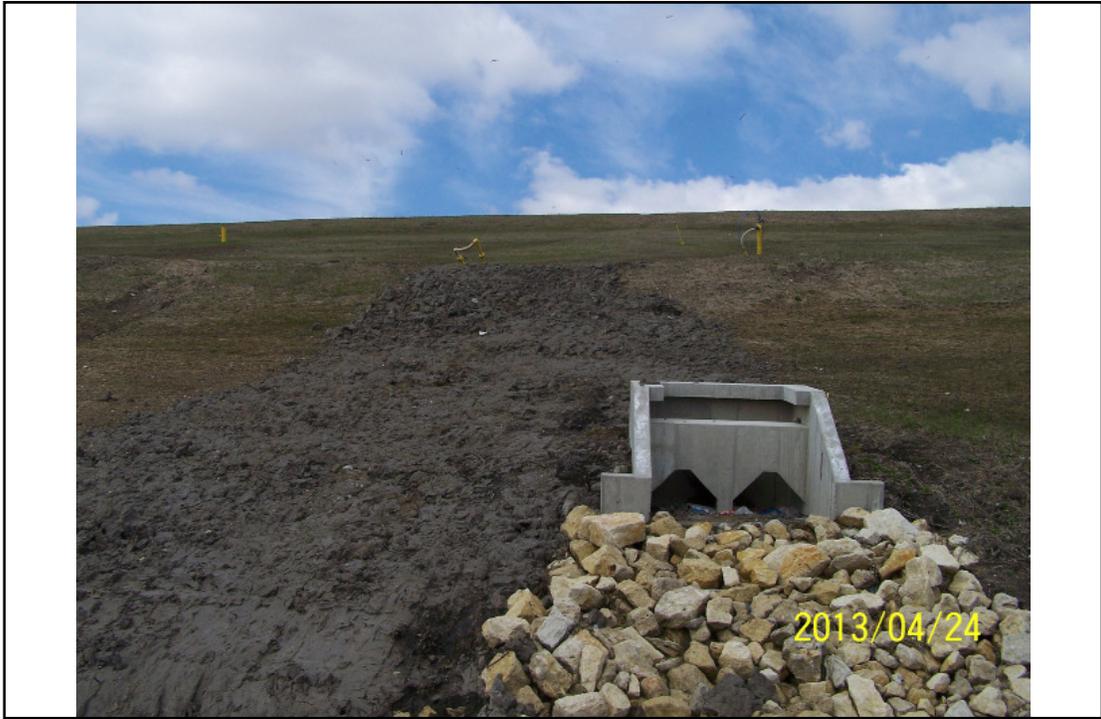
Closure Area III repairs

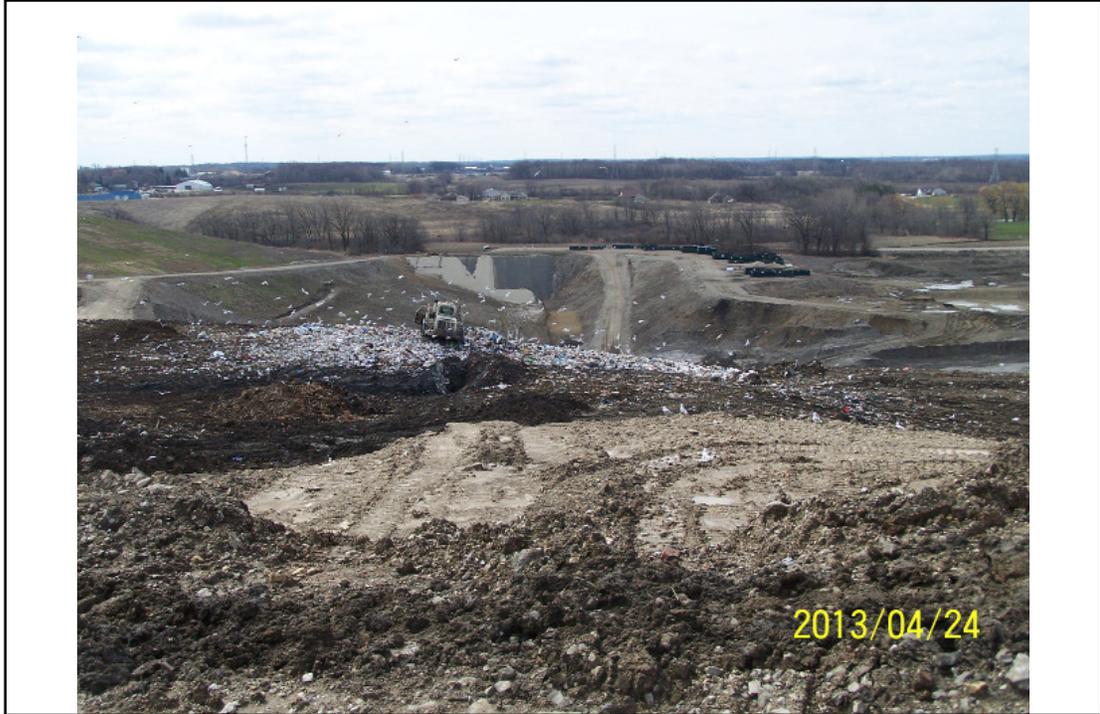
Compactor active in working face

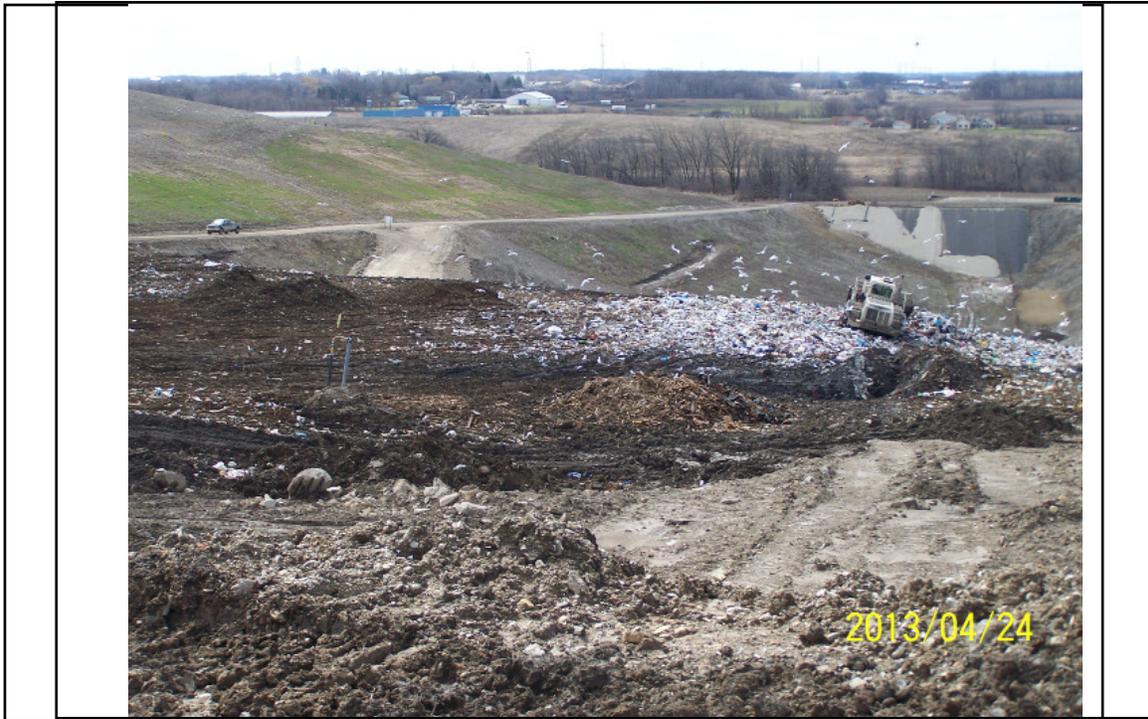
Active area, tipping location

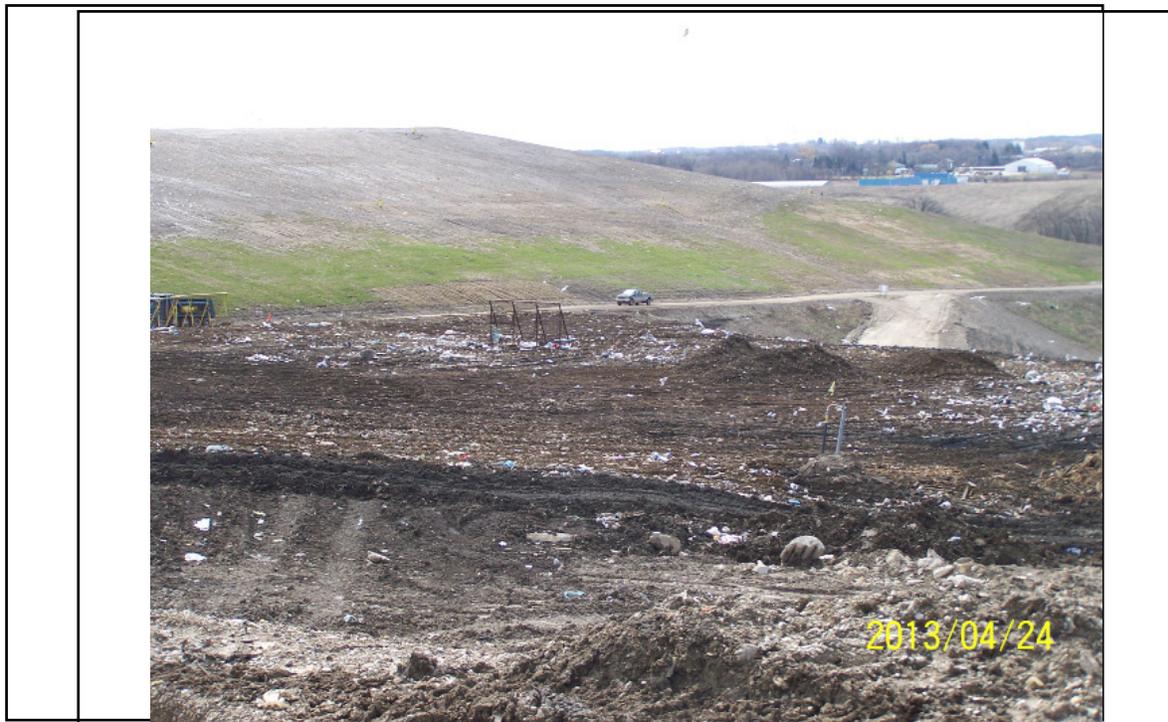
Active area viewed from Phase 3

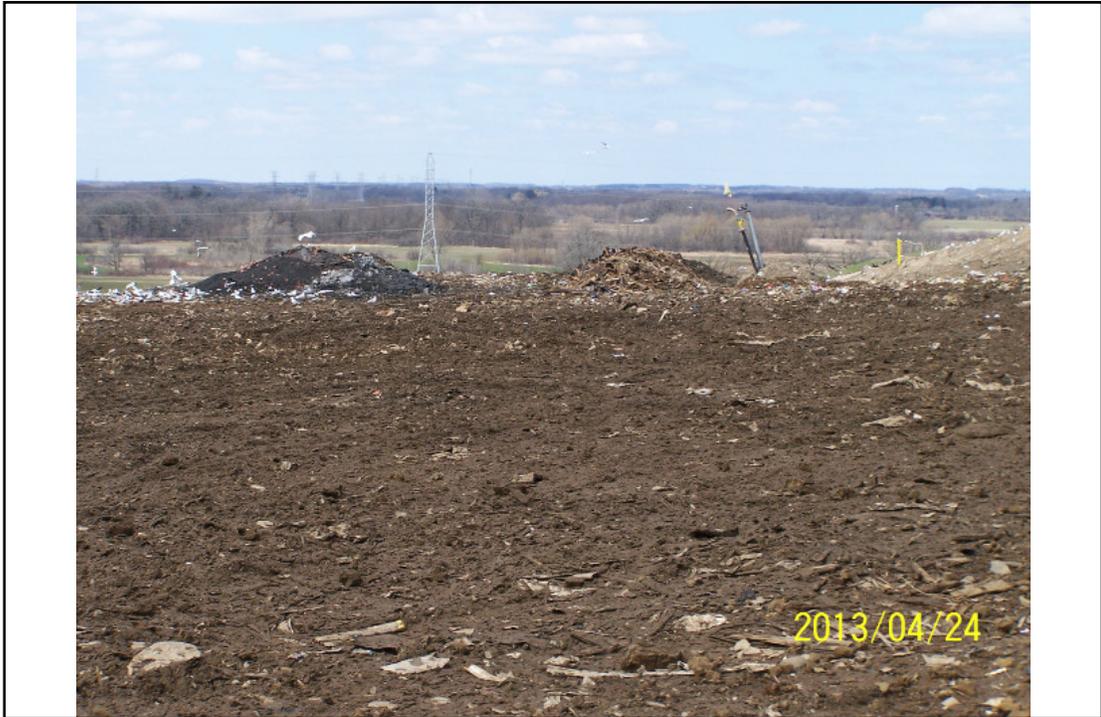
Active area

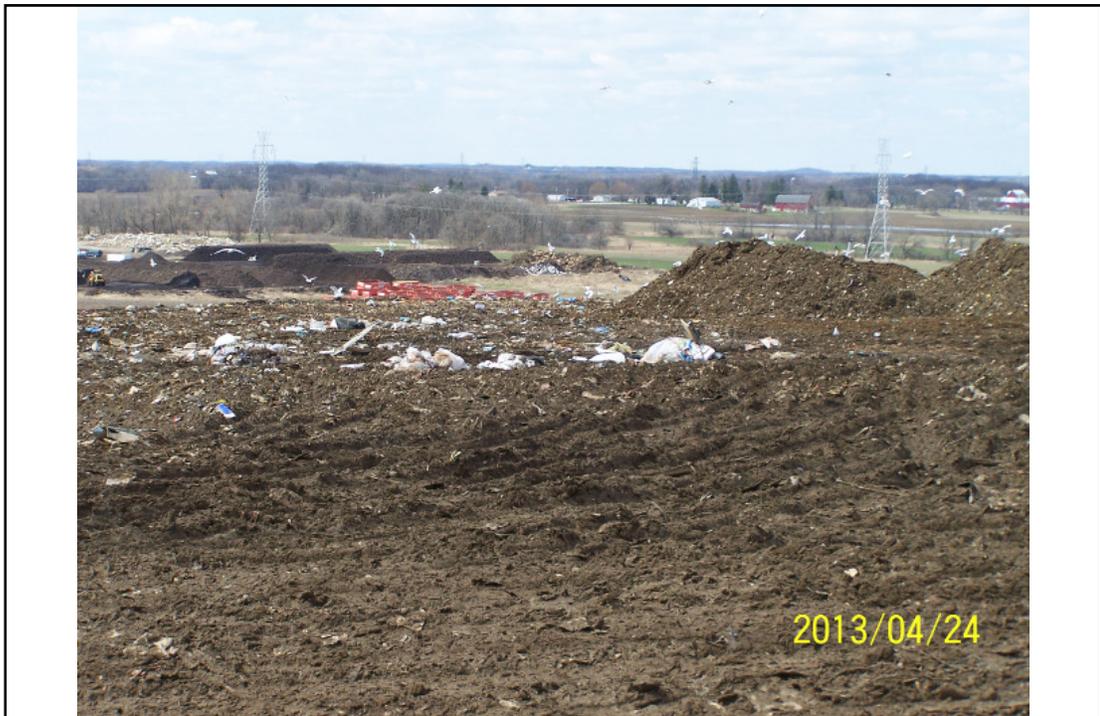
Cover conditions

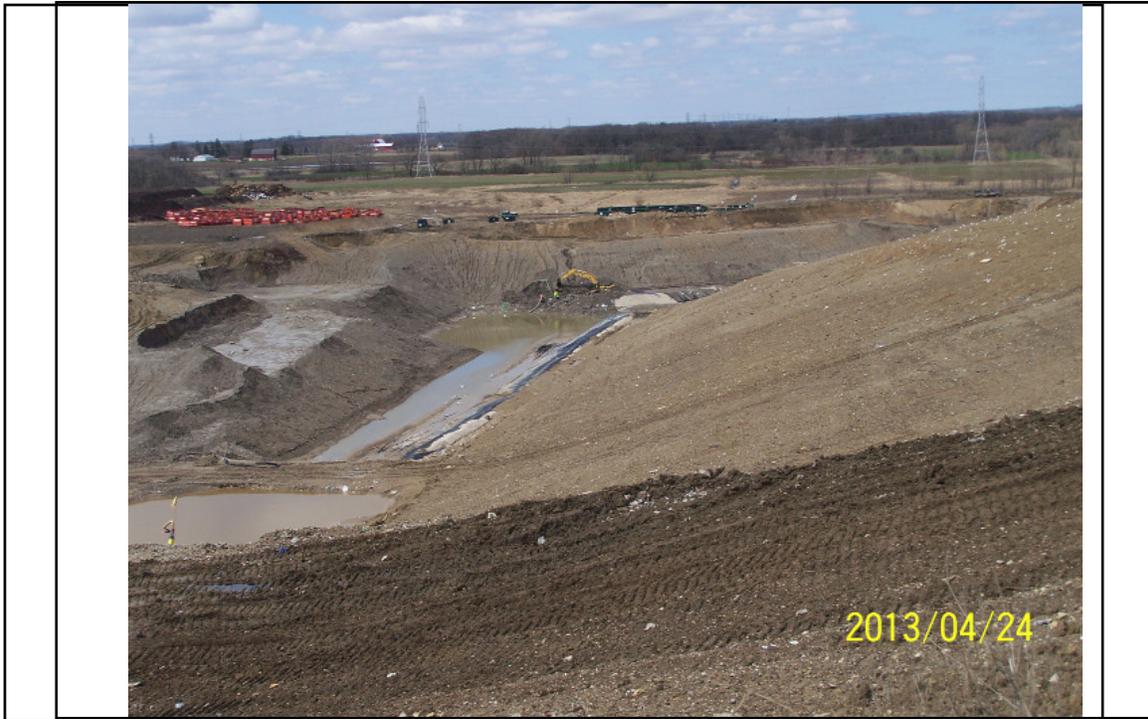
Side slope conditions of Phase 7

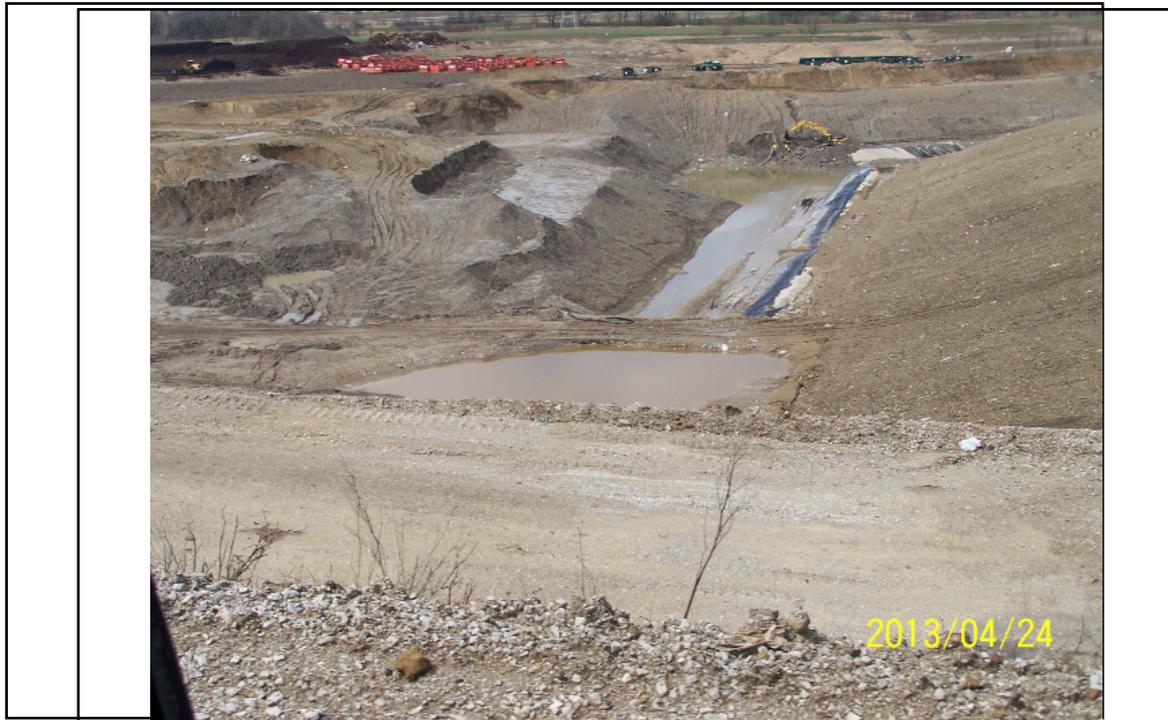
Both temp sed basin

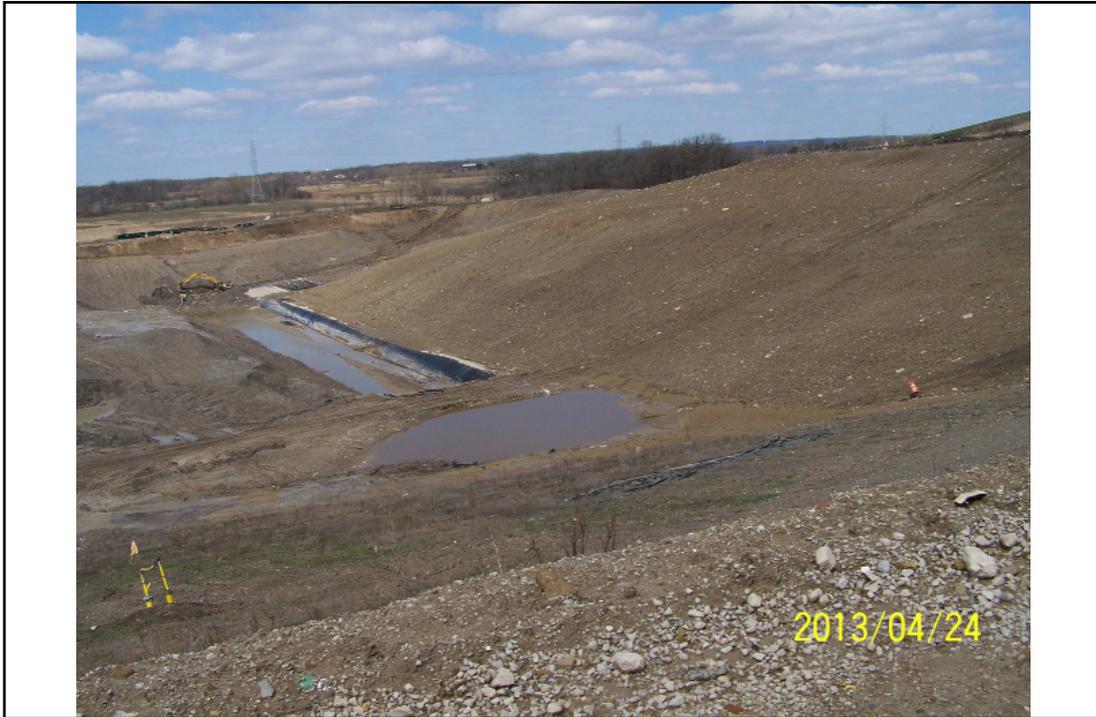
Eastern temp sed basin awaiting pumping

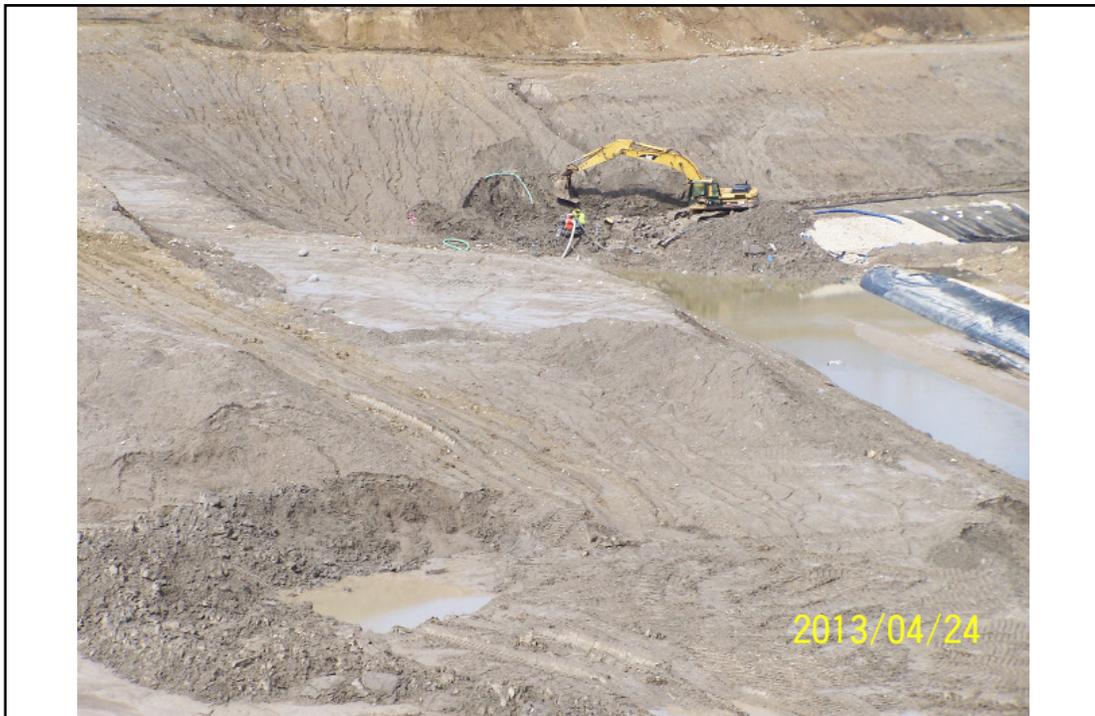
Repairs to the suction pipe for Temp Sed Basin pump.

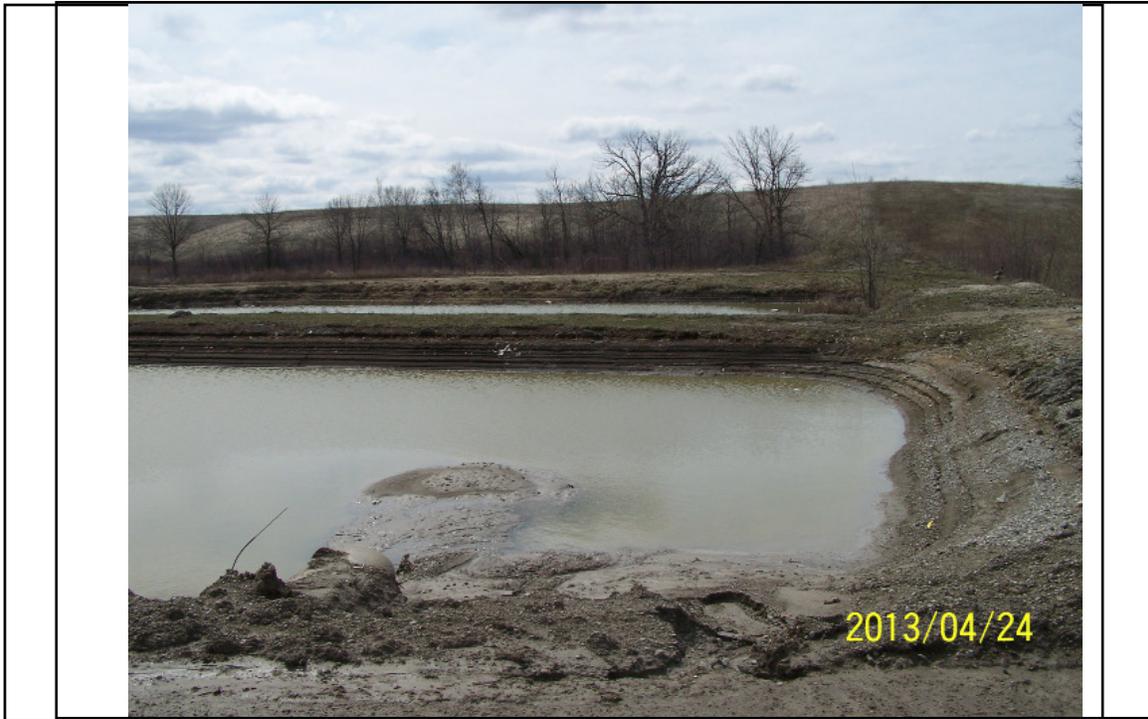
Basin #2, draining well, though a great deal of sediment has been trapped in the basin for future cleaning

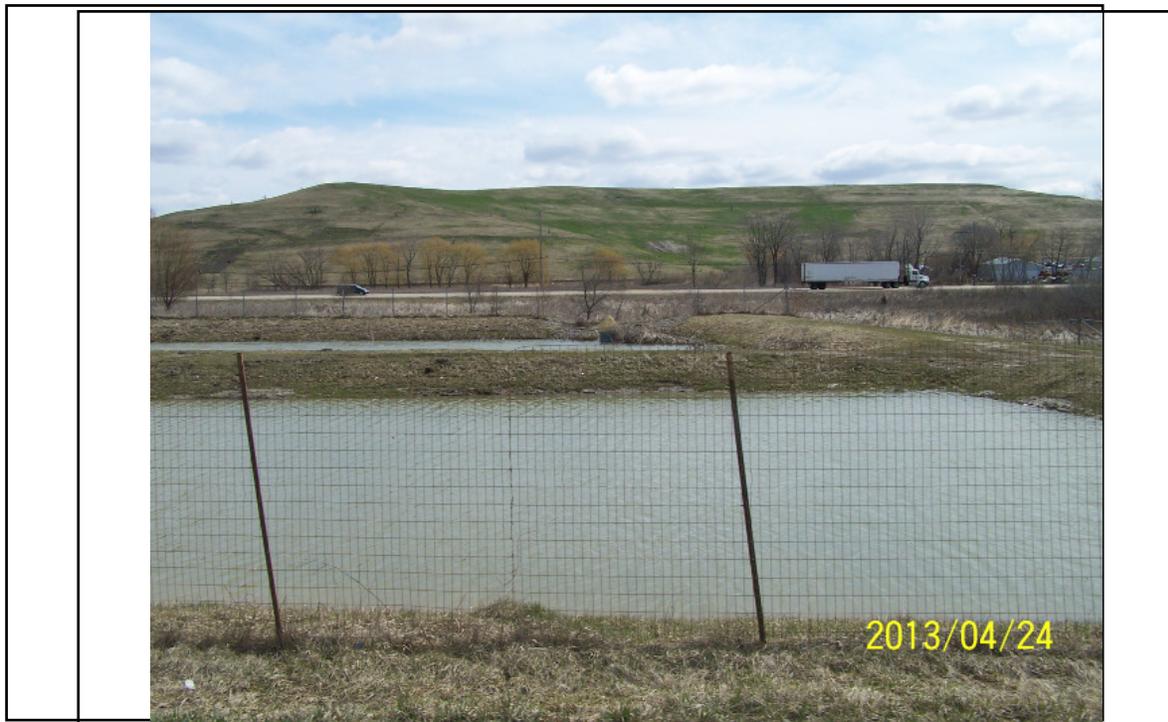
Basins partially drained. Basin 2 draining slower due to stuck gate.

Basin #3 draining slowly due to a stuck gate
