Advanced Disposal Services Emerald Park Landfill Audit Summary

To: ADSEPL Standing Committee, City of Muskego
FROM: Anna Krajcik
COPIES: File
DATE: 04/03/13
PROJECT NUMBER: 1012.10030

ADVANCED DISPOSAL SERVICES EMERALD PARK LANDFILL
 LANDFILL OPERATIONS AUDIT FORM
 CITY OF MUSKEGO

**ADVANCED DISPOSAL SERVICES
EMERALD PARK LANDFILL
AUDIT PHOTOS
CITY OF MUSKEGO**

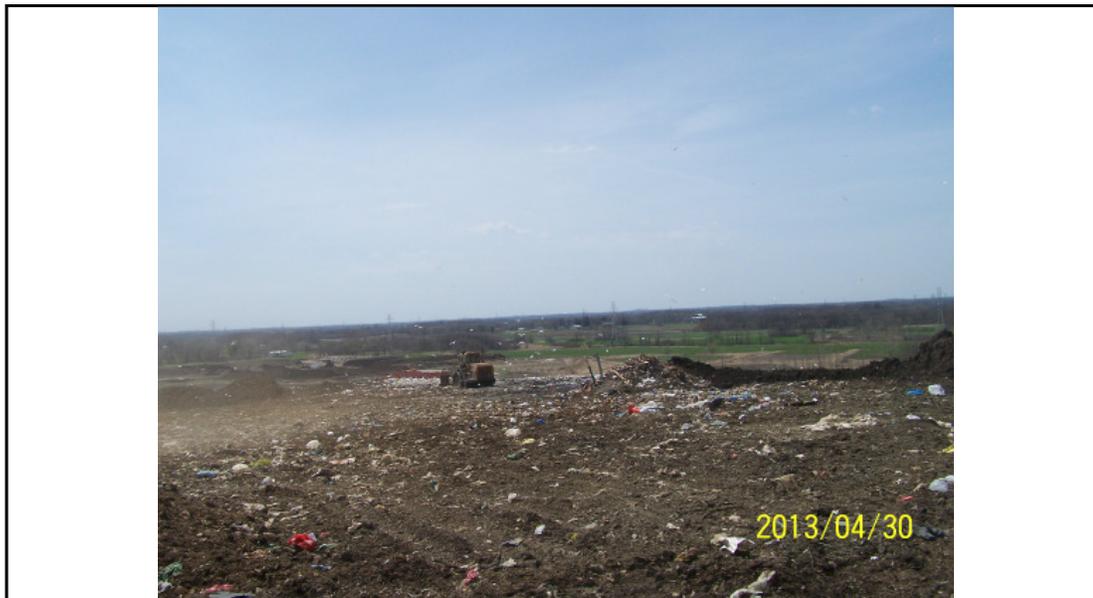
Active area out to working face

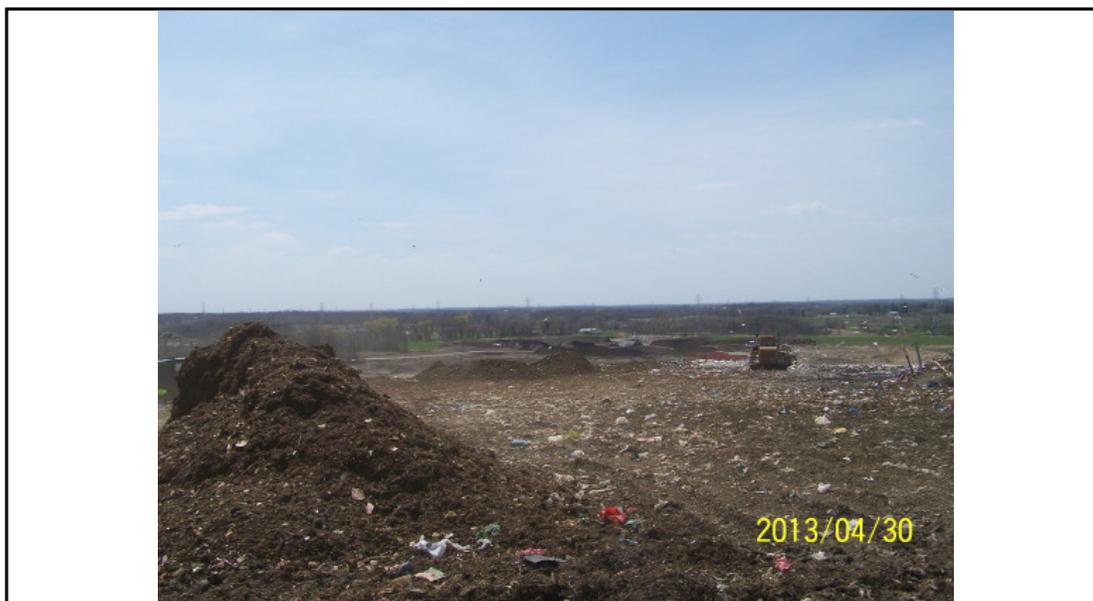
Active area

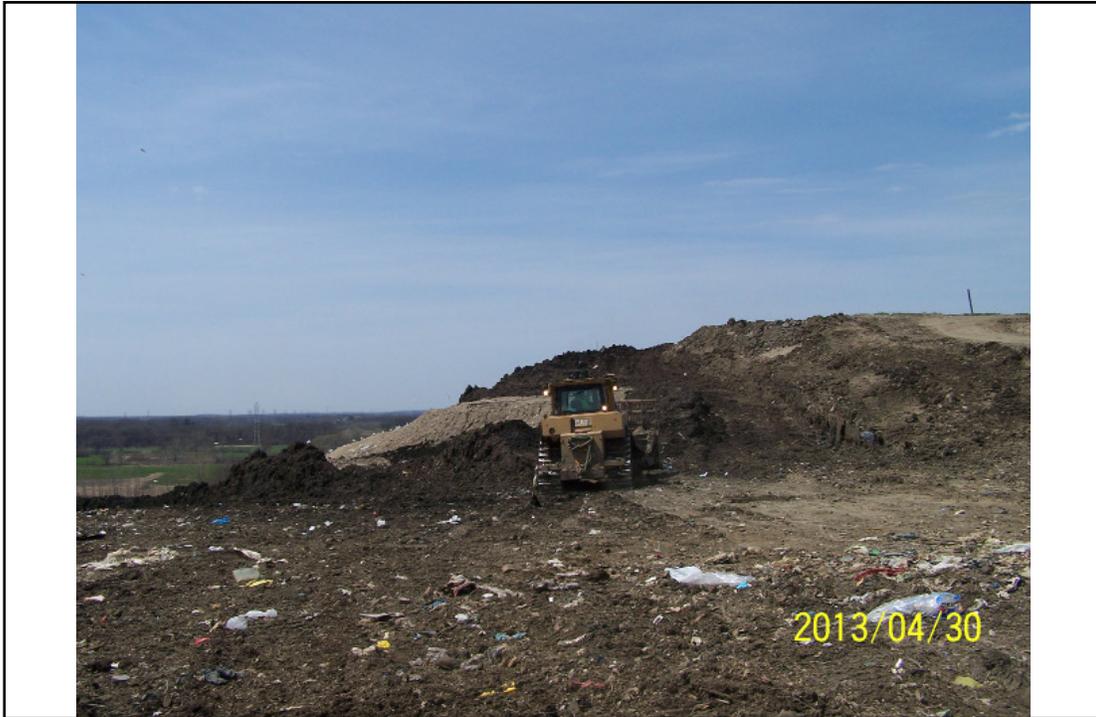
Soils being relocated for cover and disposal

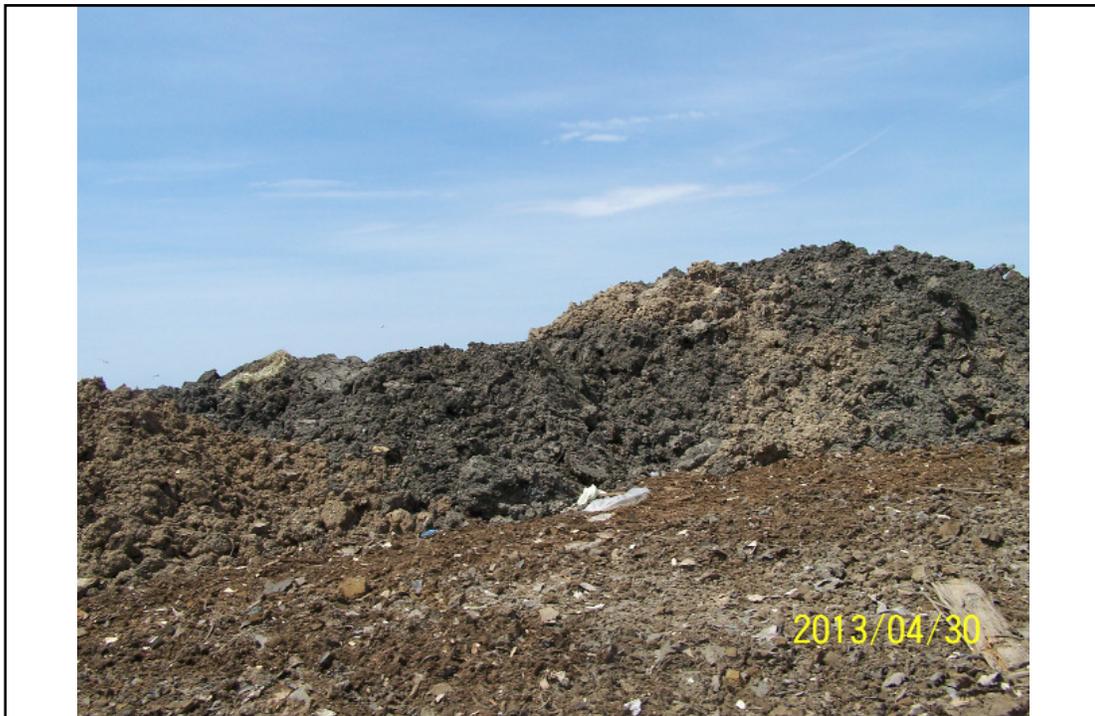
- Working face moving westward along south edge of Phase 7 at top of slope. Working face at approximately ½ the distance between North and South end.
 - Wet soils tipped at southeast corner of Phase 7 will be relocated when it dries out

Soils drying for future placement

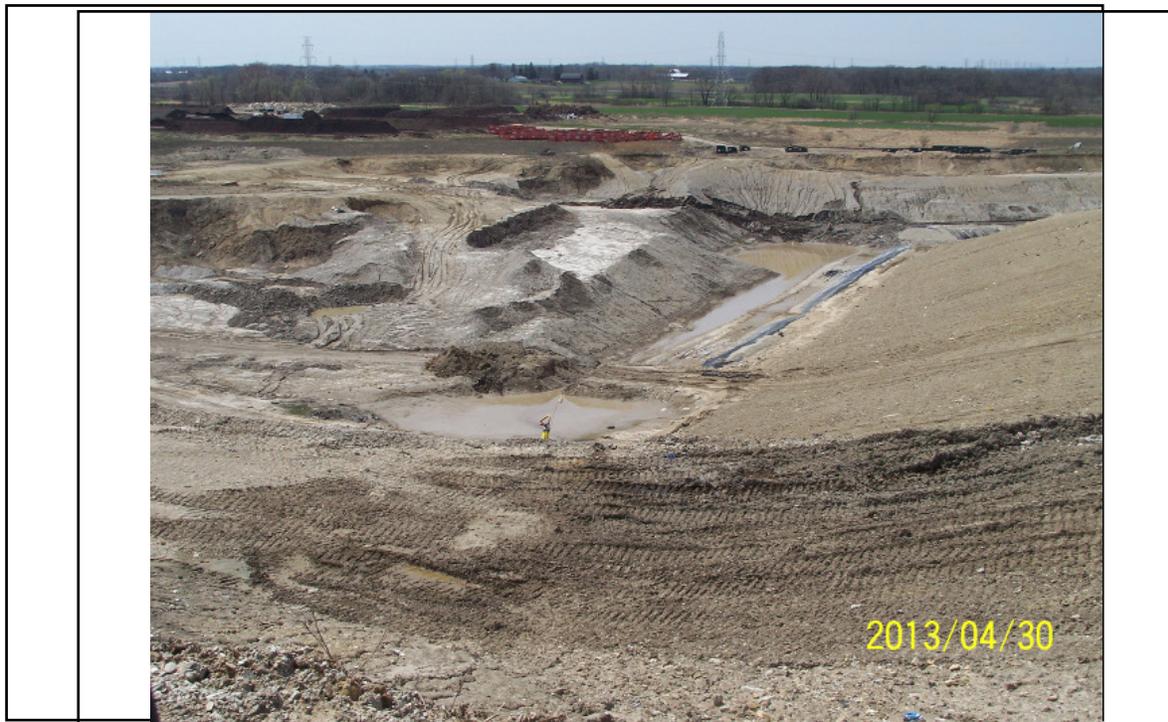
* Temp sed basins still pumping down for next rain events

South temp sed basins, Western most drained, Eastern awaiting pump relocation

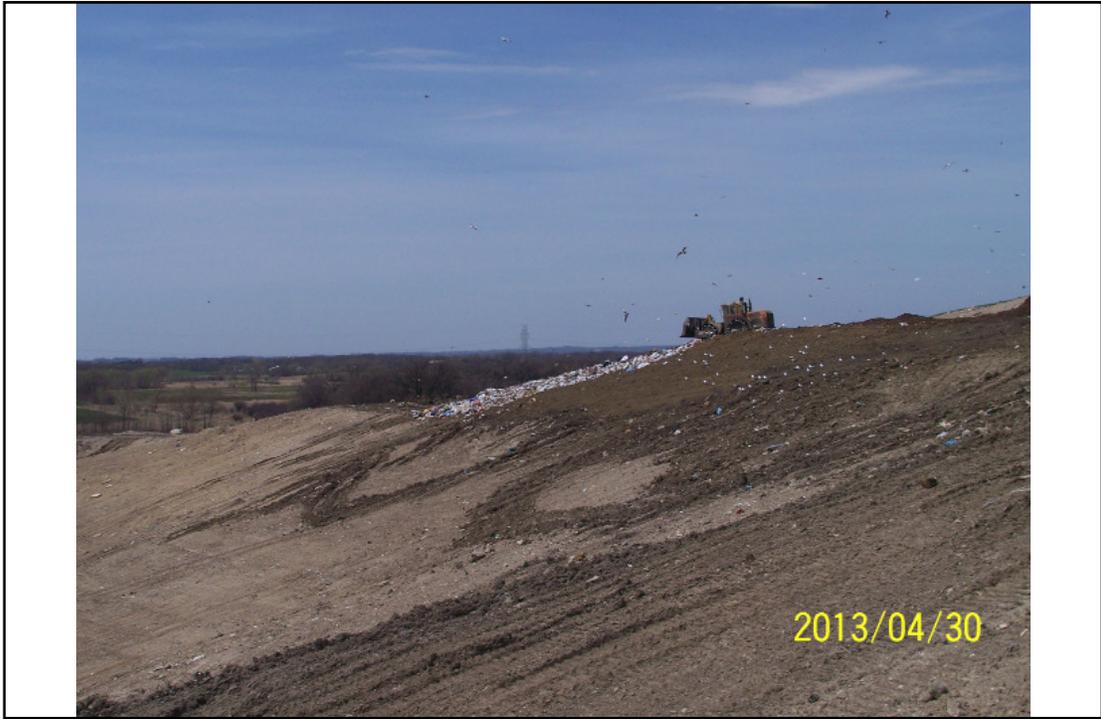
Previously covered areas on South slope of Phase 7

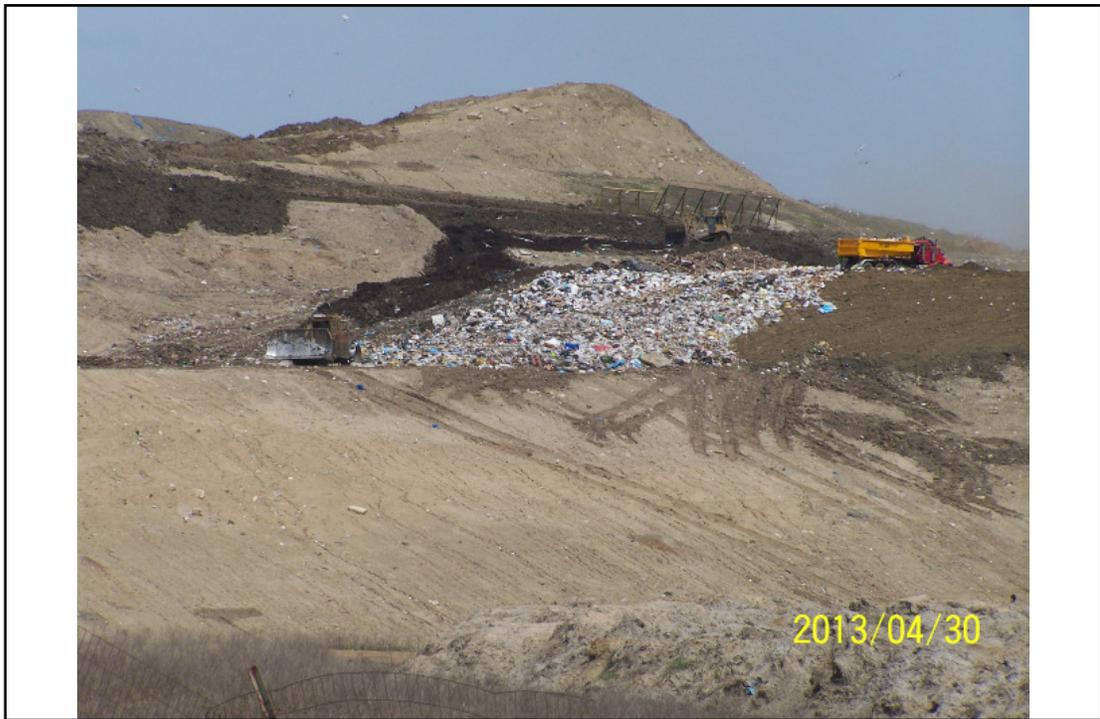
Working face

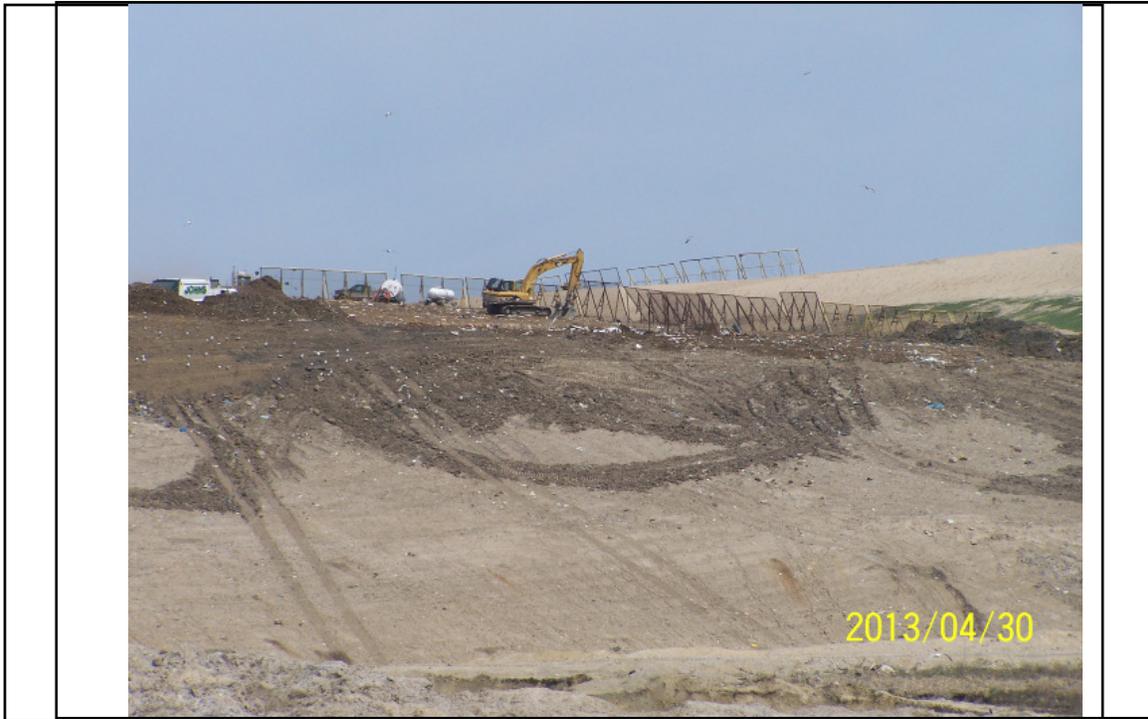
Active Area viewed from the South

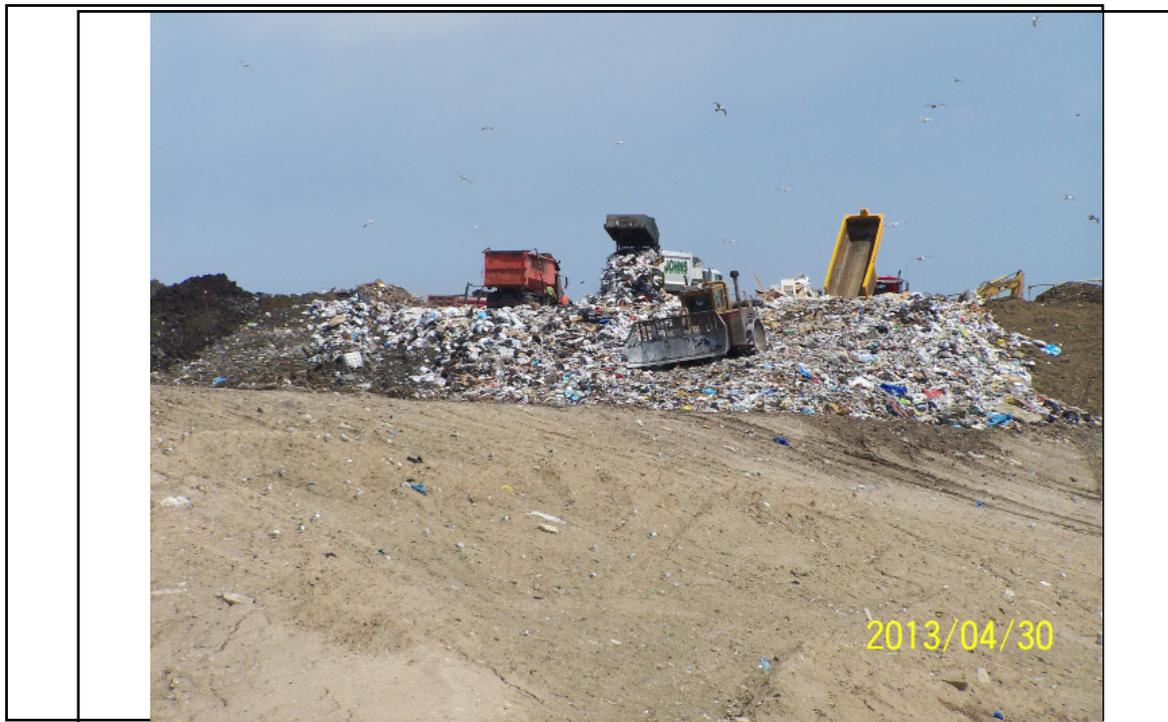
Working face viewed from the Southwest
