VEOLIA Emerald Park Landfill Audit Summary

TO: Veolia Emerald Park Landfill Standing Committee, City of Muskego
FROM: Anna Krajcik
COPIES: File
DATE: 05/30/13
PROJECT NUMBER: 1012.10030

Attached is the audit report for activities at the Veolia Emerald Park Landfill for the week of May 20, 2013. The audit was performed at 12:00 pm on **May 22, 2013** by Jo Spear Jr. in the presence of David Geier.

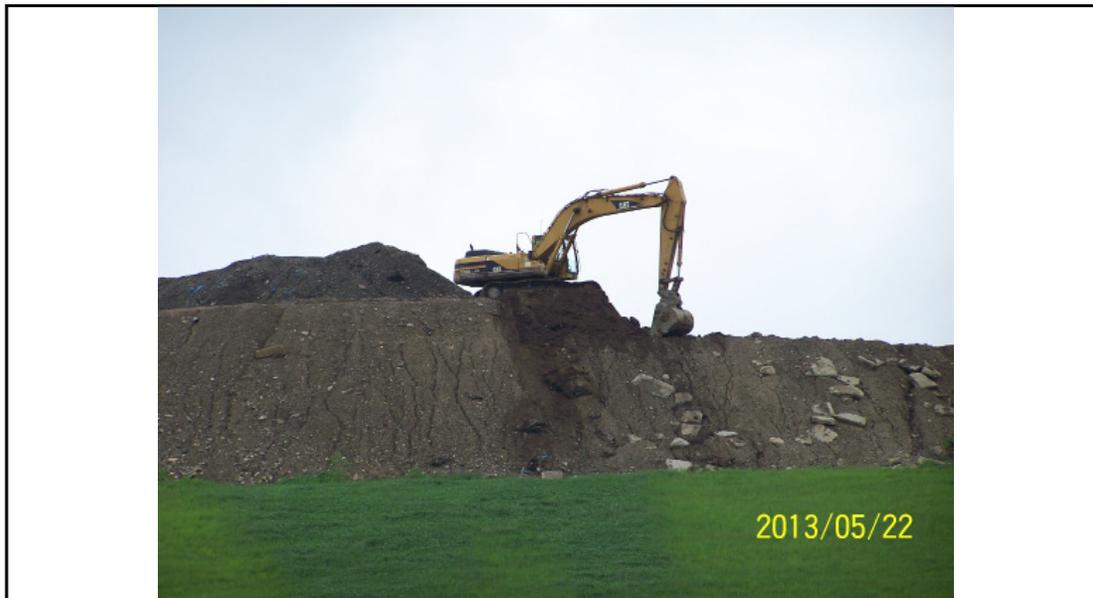
Landfill direct soils being excavated for use

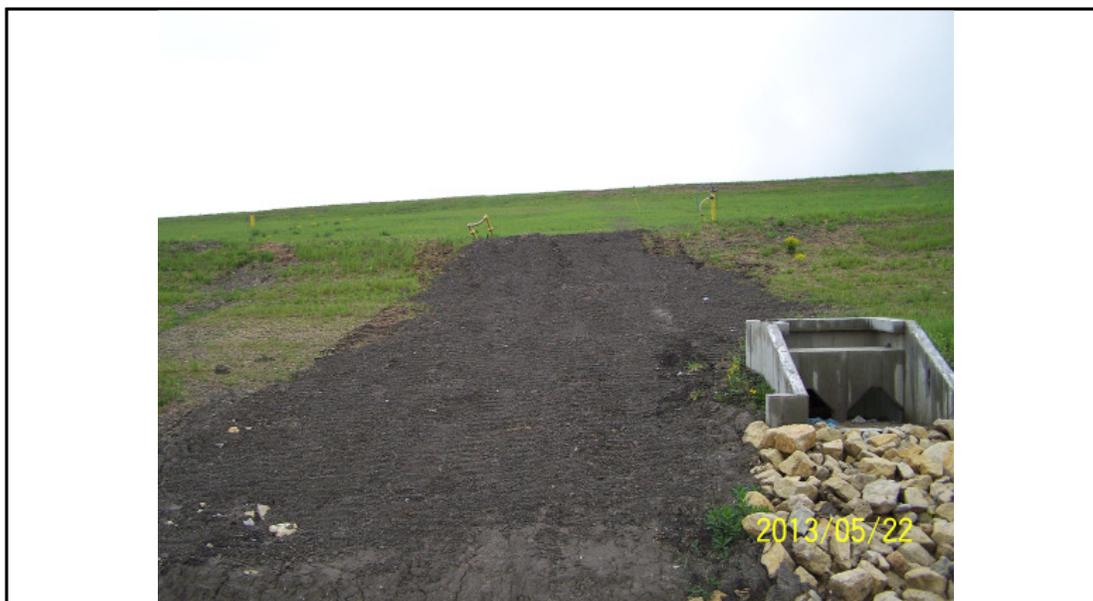
Erosion repair in Closure Area III

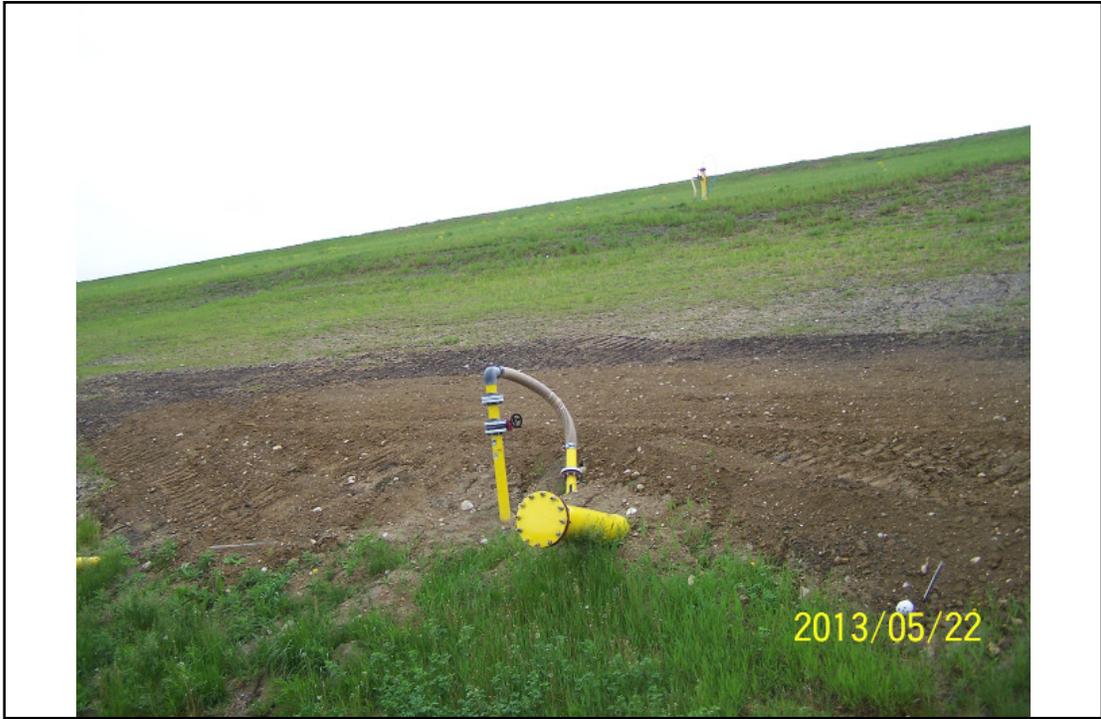
Erosion repair in Closure Area III

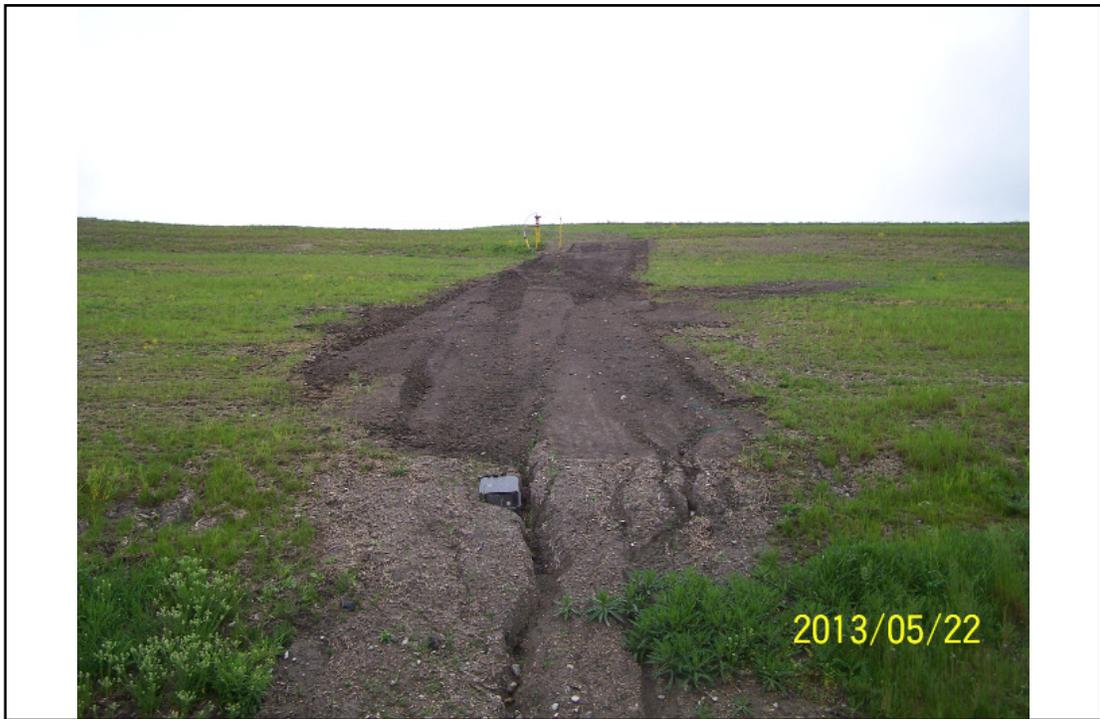
Erosion repair in Closure Area III

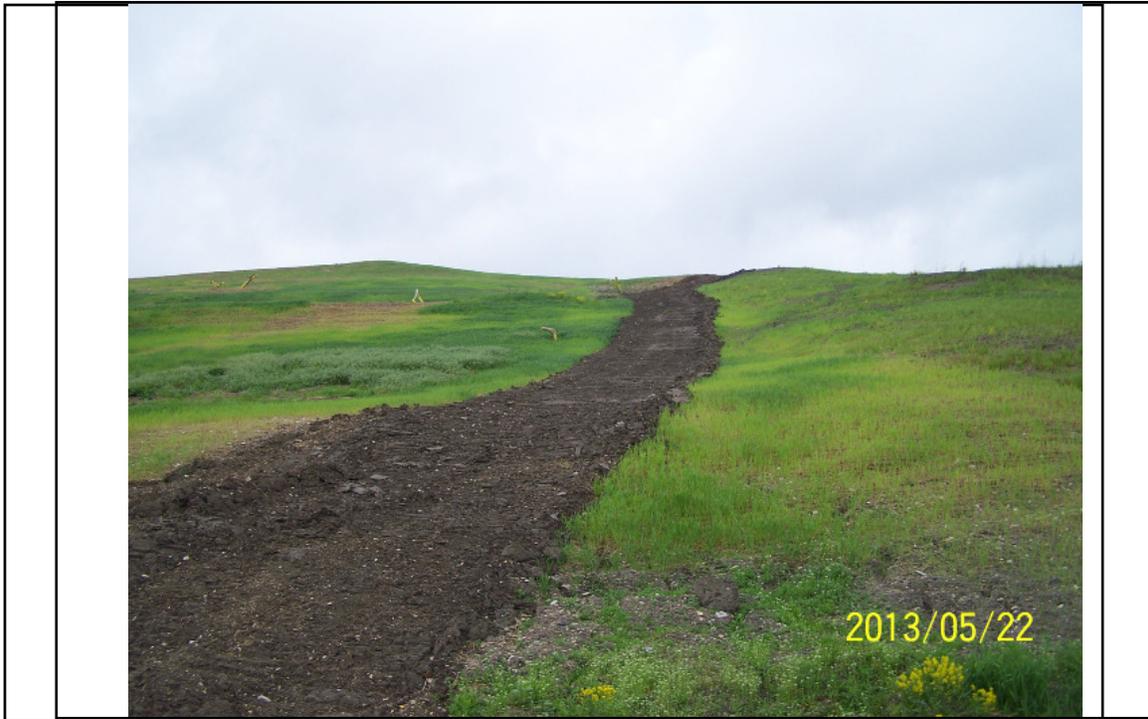
Erosion repair over pneumatic line installation

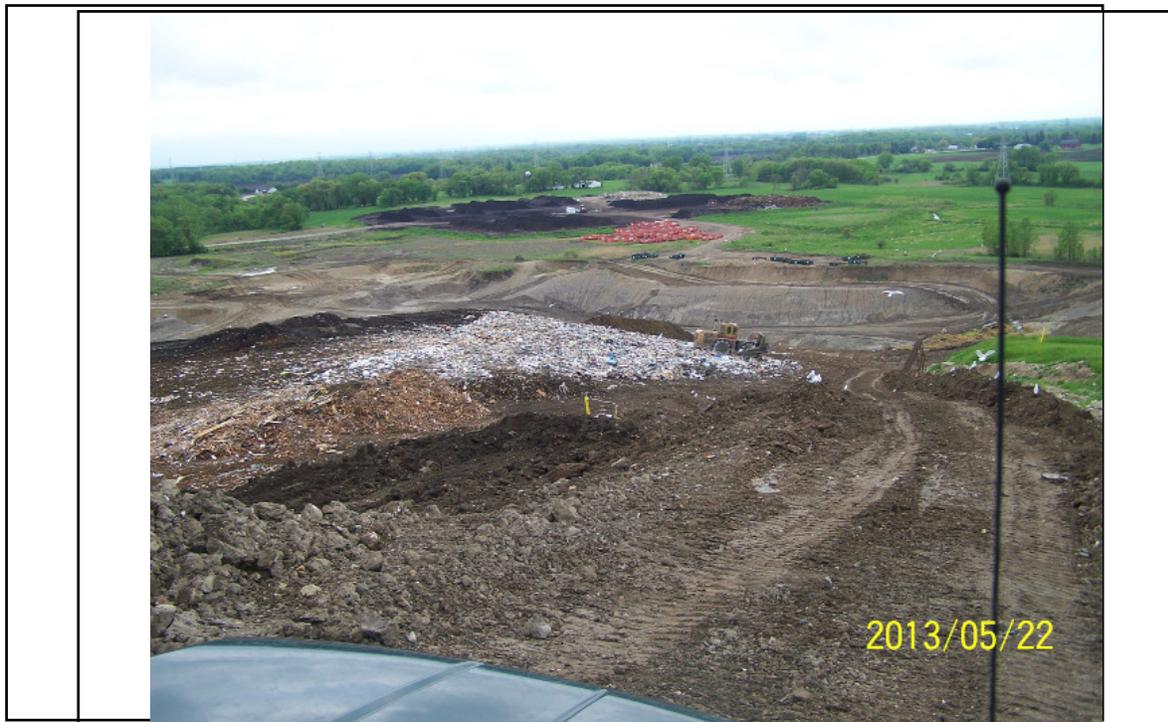
Elevation above Phase 7, viewed down on working face

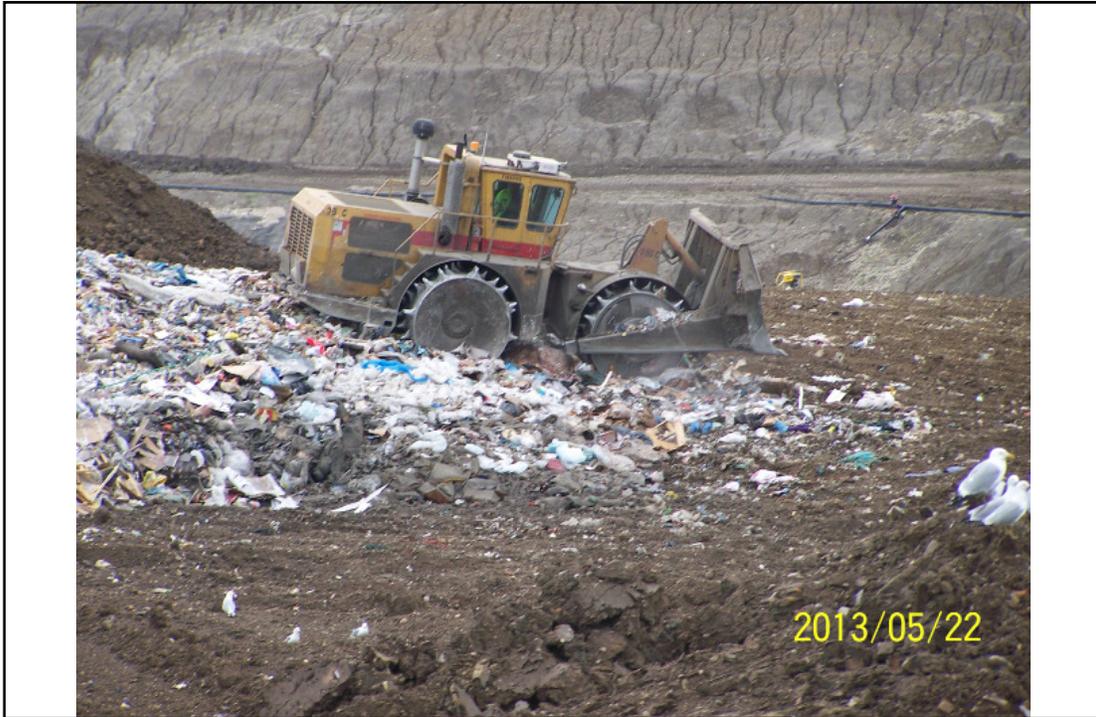
Active compactor

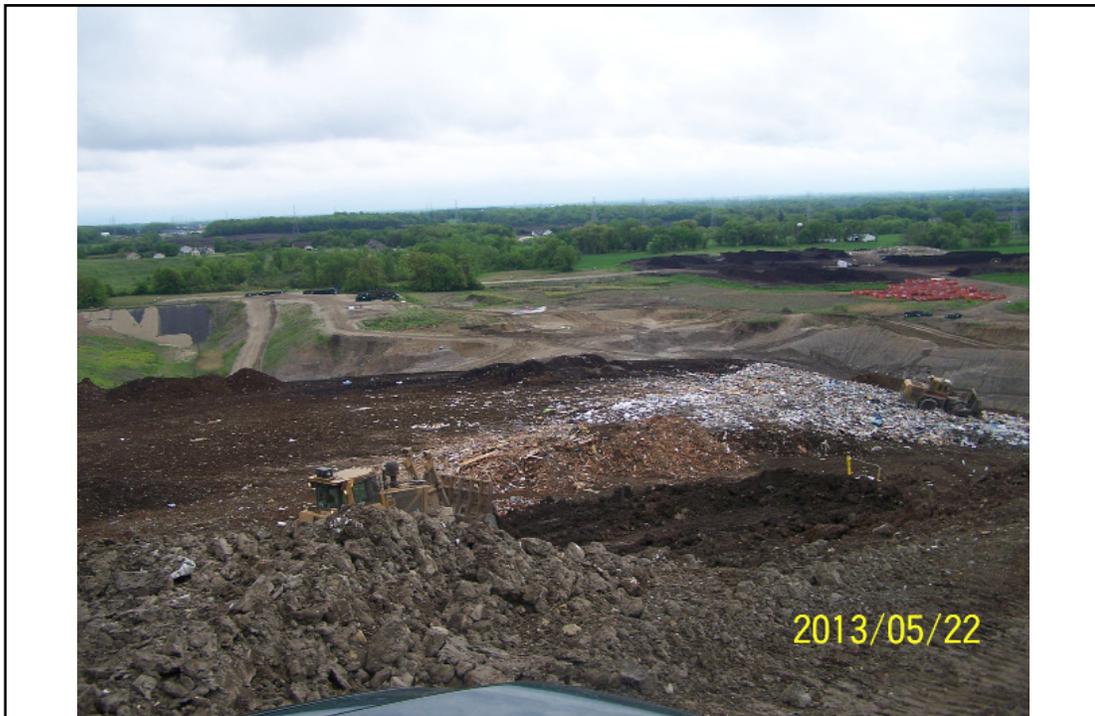
Working face at West edge of Phase 7 receiving
M.S.W. & some contaminated concrete. Soils
(small volume) being tipped in Phase 2 & 3.

Working face on Western most edge of Phase 7

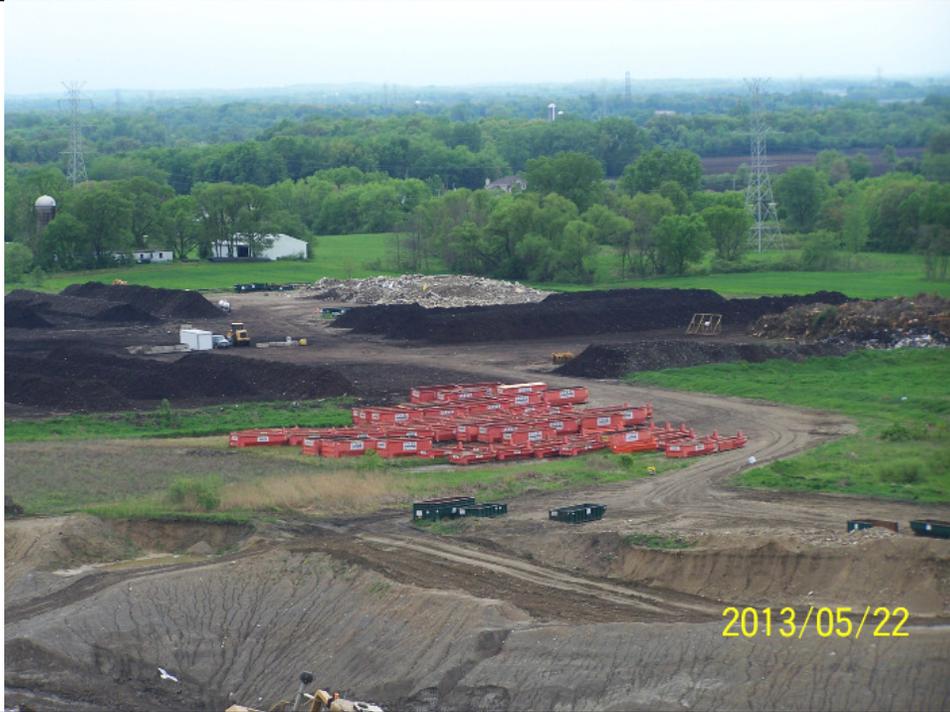
Compost area and roll off storage

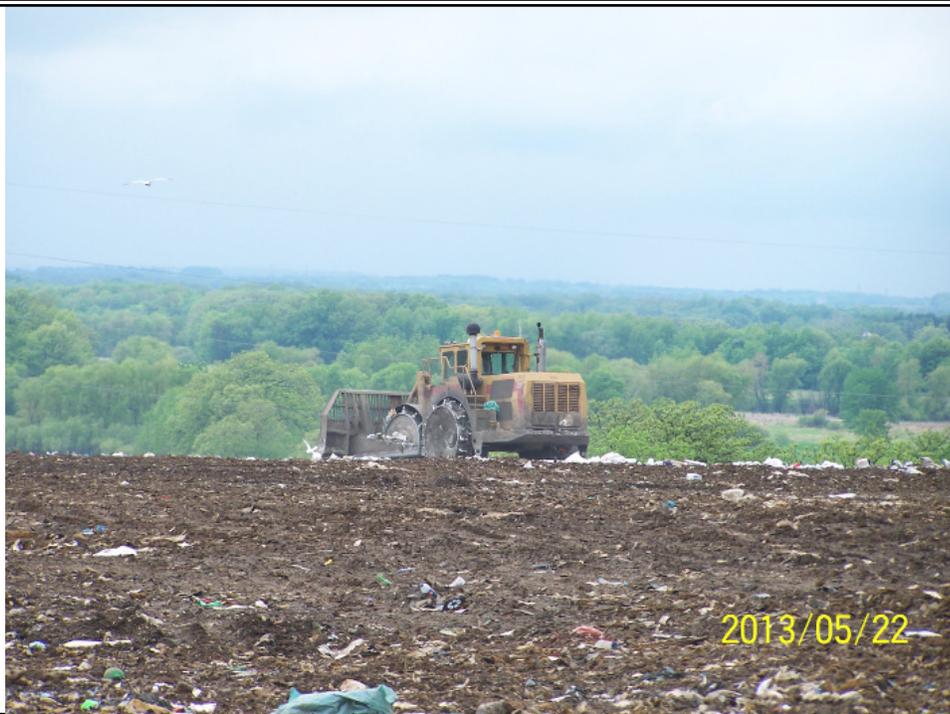
Compactor at top of slope above working face

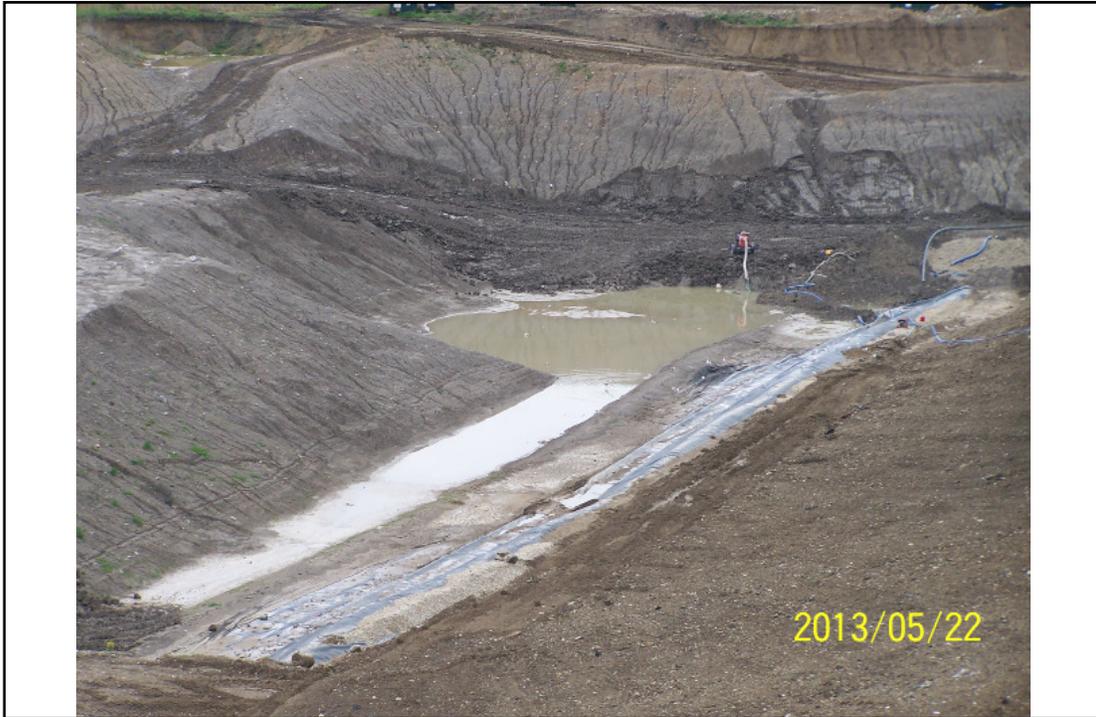
Temp sed basin to the West

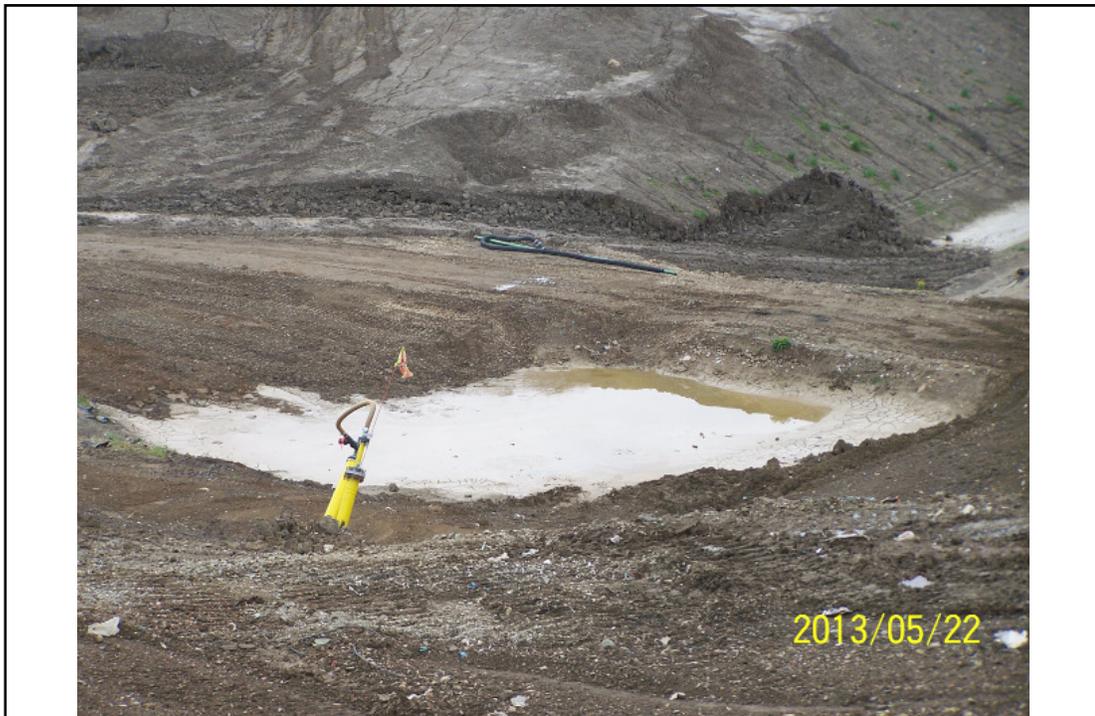
Temp sed basin, to the East
