MEMORANDUM

VEOLIA Emerald Park Landfill Audit Summary

TO: Veolia Emerald Park Landfill Standing Committee, City of Muskego
FROM: Anna Krajcik
COPIES: File
DATE: 05/30/13
PROJECT NUMBER: 1012.10030

ADVANCED DISPOSAL SERVICES EMERALD PARK LANDFILL
 LANDFILL OPERATIONS AUDIT FORM
 CITY OF MUSKEGO

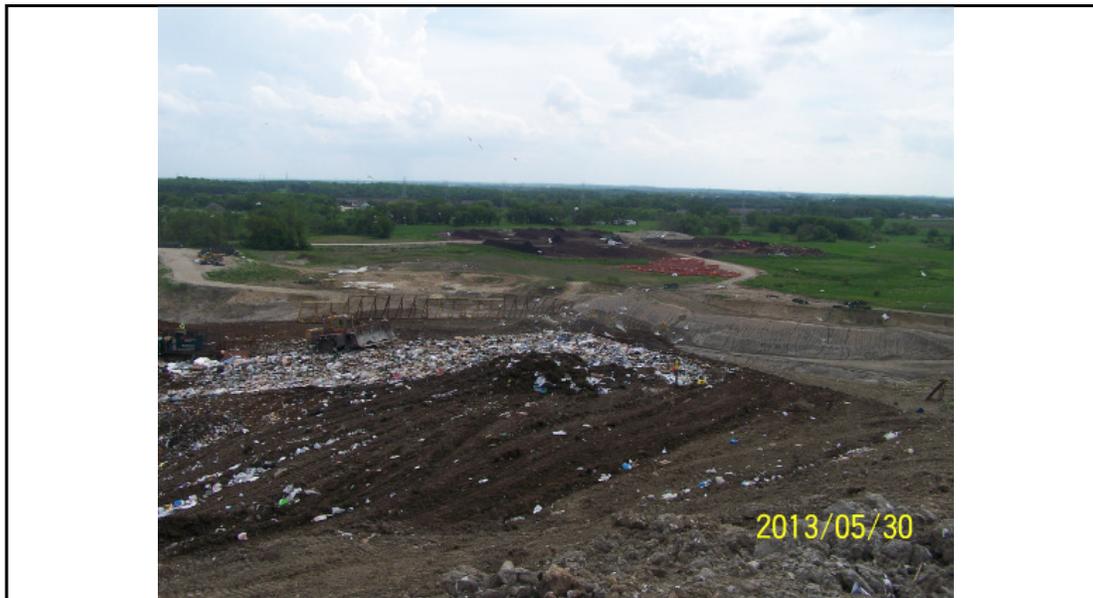
Working face viewed from above

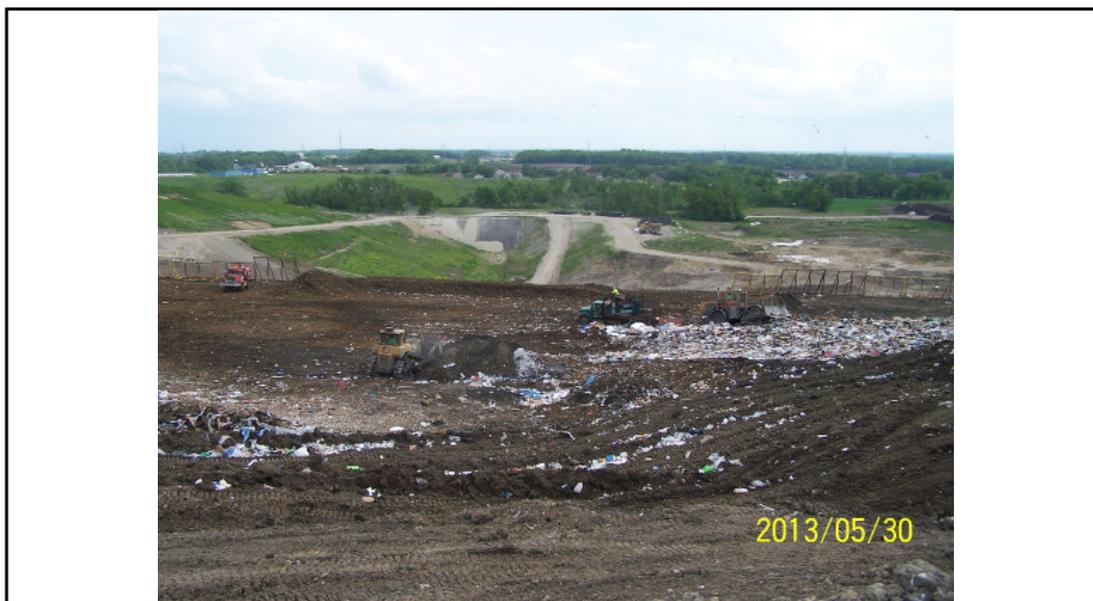
Active area

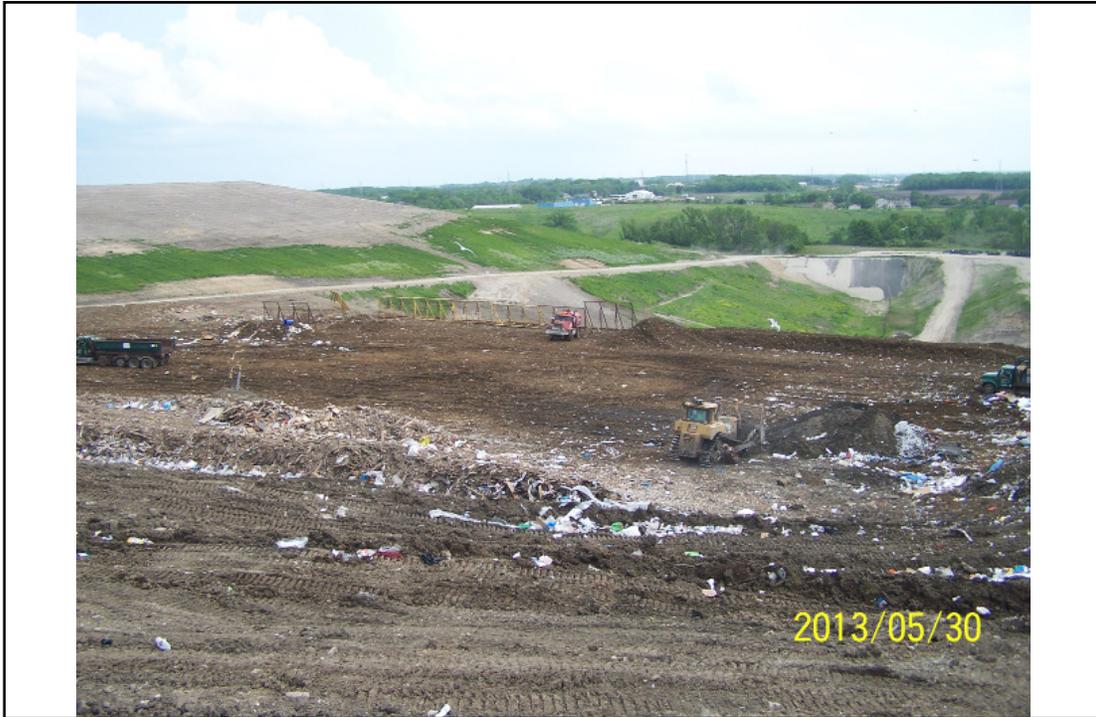
Active area viewed from North

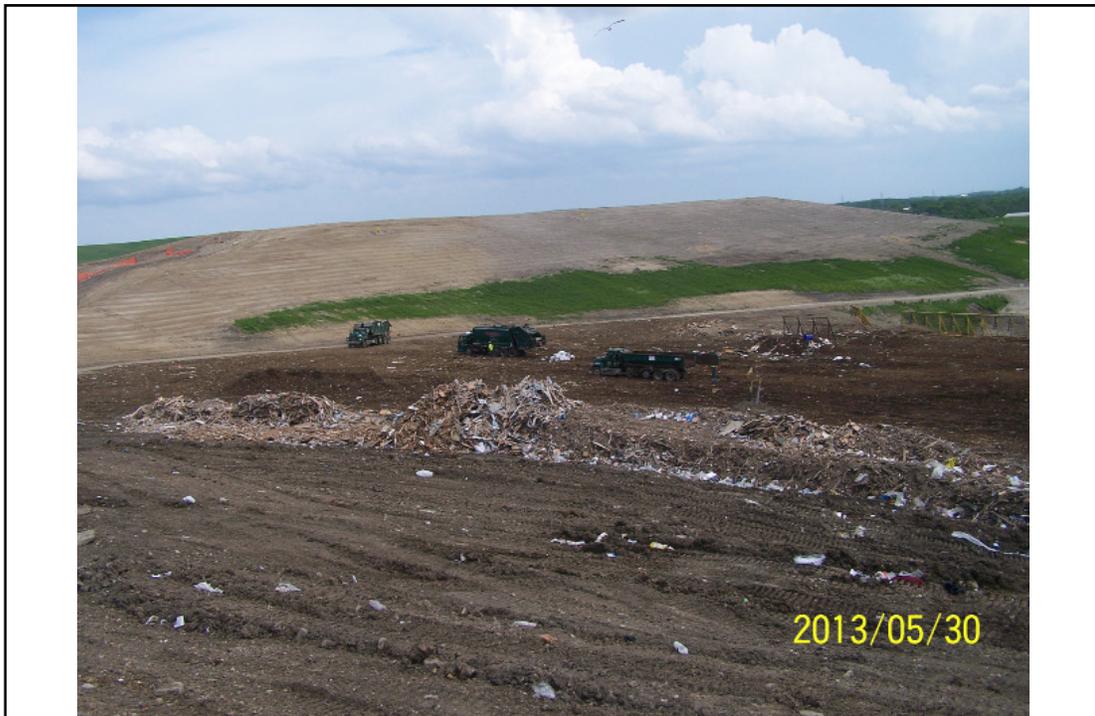
Active area with C&D stock piled

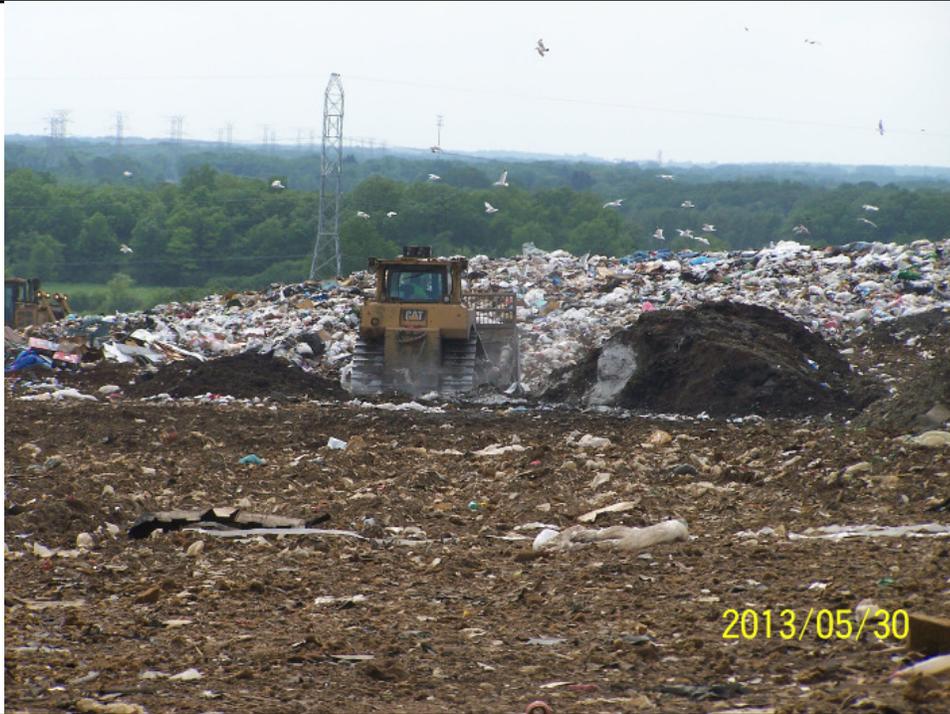
Working face viewed from East

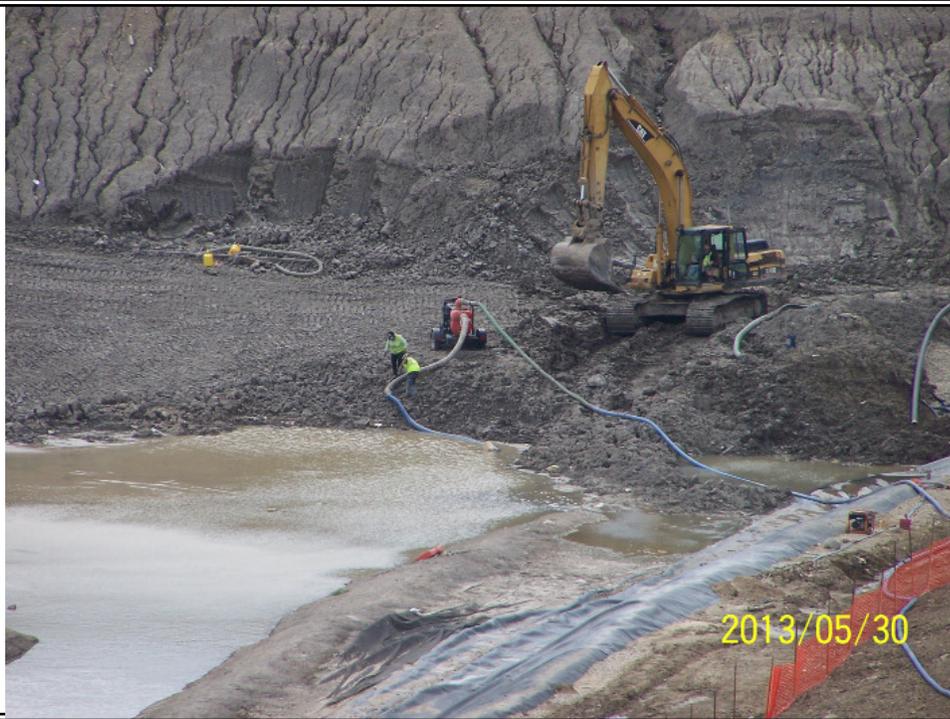
Activities at temp sed basin

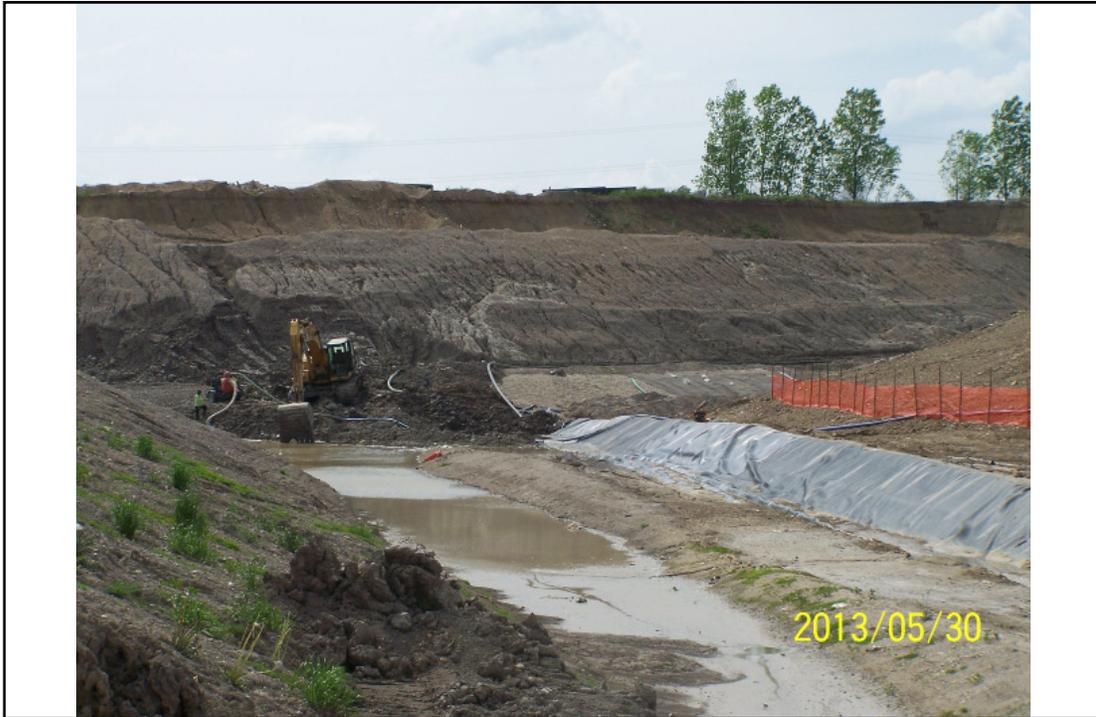
Temp sed basin

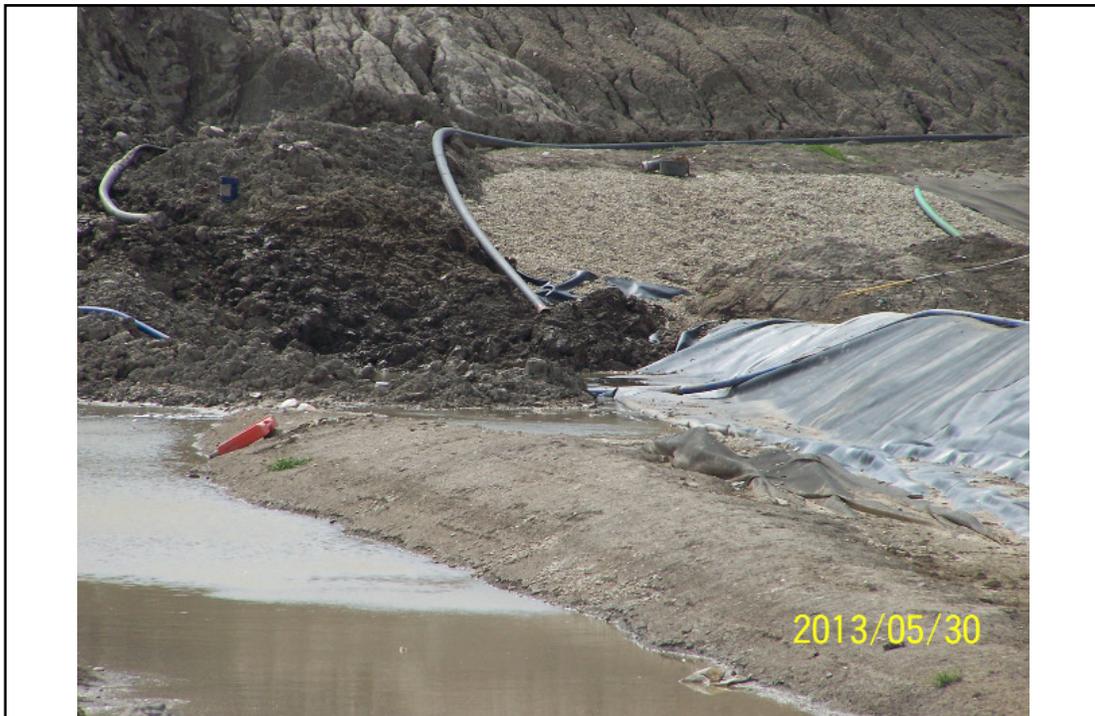
- Tipping scale camera and equipment operators inspecting waste
 - Random load inspection date not noted ~3500 tpd
 - Soils recieved
- Dave working with liner crew to patch seep in pump location. Phase 7 liner requires patching and extrusions welds to complete. Liner/rain flap cut to drain and will be repaired when leachate removed

Item Number	DATE month/date/year	Condition Description	Permit or Contract Reference	Initial Schedule for Completion	Observed Completion Date	Elapsed Time (Days)	Notes
1	5/09/2013	Seep in Rainflap, Southwest corner of Phase 7		ASAP			All contact water is being treated as leachate and pumped back into Phase 7.

Location of seep and rain flap damage. Too much liquid is behind the flap to patch during audit

* Dave Working with liner crew to patch seep
at pump location. Three liner requires
patching & extrusion welds to complete.
~~Two~~ Liner/vent flap out to drain and
will be repaired when leachate cured
* Construction equipment Mobilization
started

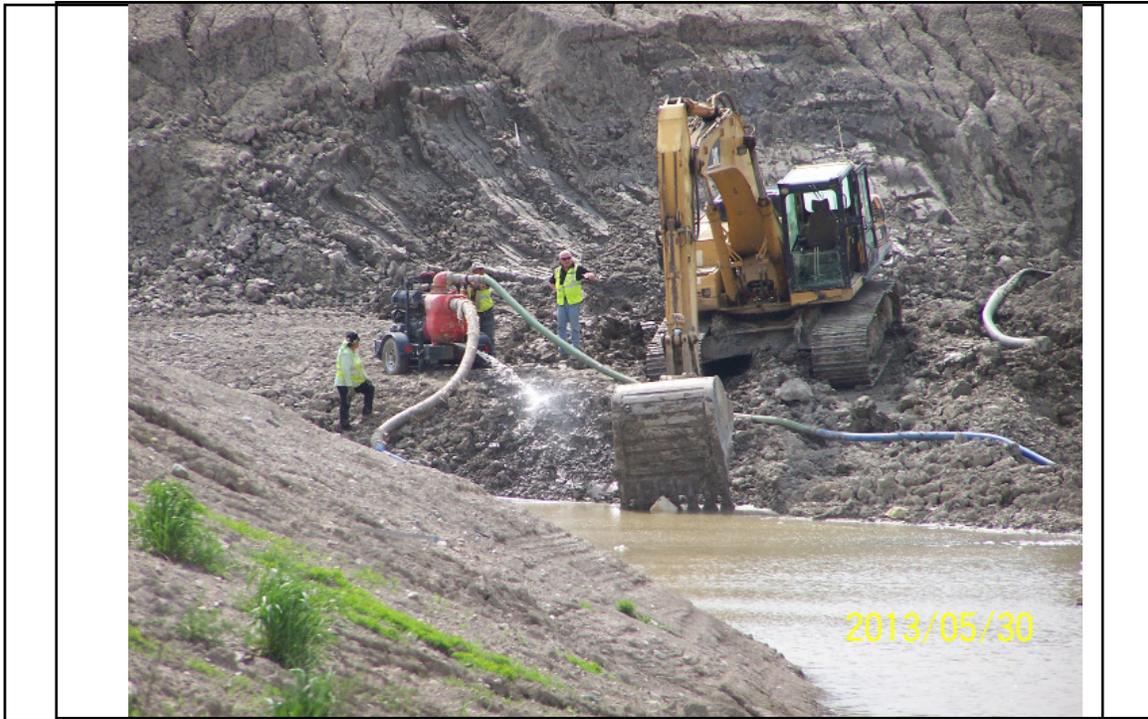
Excavator used to manage sump in Temp Sed Basin
