ADS Emerald Park Landfill Audit Summary

TO: ADS Emerald Park Landfill Standing Committee, City of Muskego
FROM: Anna Krajcik
COPIES: File
DATE: 06/28/13
PROJECT NUMBER: 1012.10030

ADVANCED DISPOSAL SERVICES EMERALD PARK LANDFILL
 LANDFILL OPERATIONS AUDIT FORM
 CITY OF MUSKEGO

**ADVANCED DISPOSAL SERVICES
EMERALD PARK LANDFILL / CITY OF MUSKEGO
AUDIT PHOTOS**

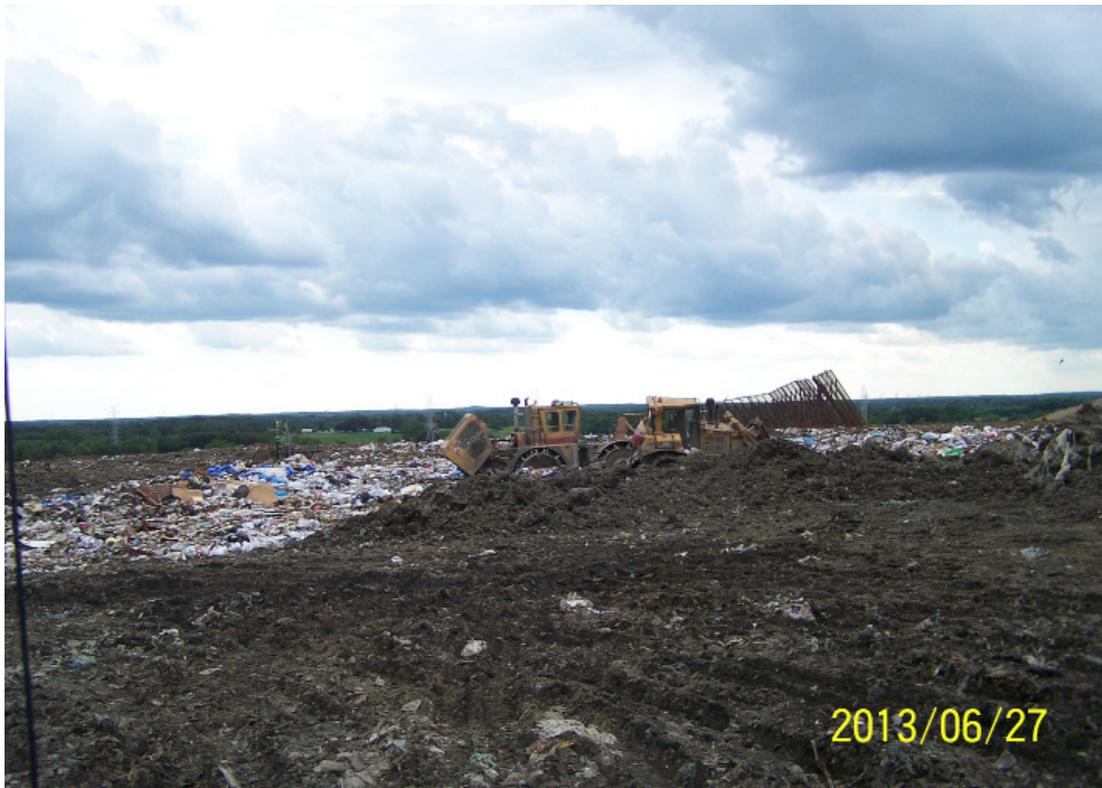
Working face, D5 Dozer moving waste, Compactor shut down.

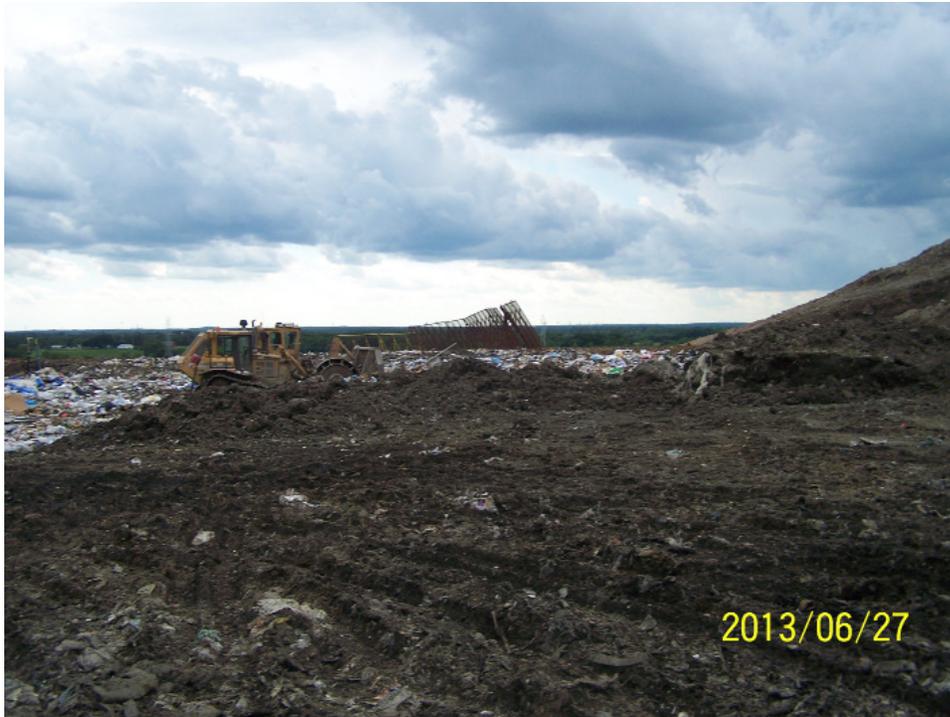
- D6, D8, Dozer and Compactor down for repairs, D8 & D6 up and running during audit
- Temp sediment basin at capacity, pump under repairs

Compactor broken down in working face

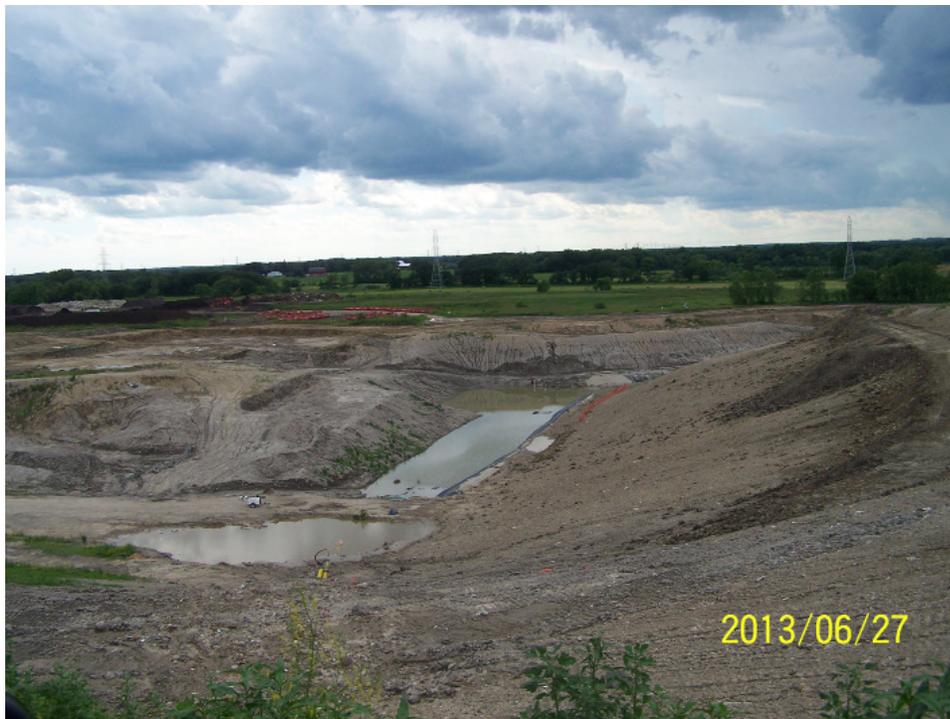
- * No construction Activities due to heavy rains ~ Possible new start tomorrow
- * D6, D8 Dozer, & Compactor down for repairs, D8 & D6 Dozer up and running during audit
- * Temp sed basin at capacity pump under repairs.

Temp sed basin over banks, pump under repair.

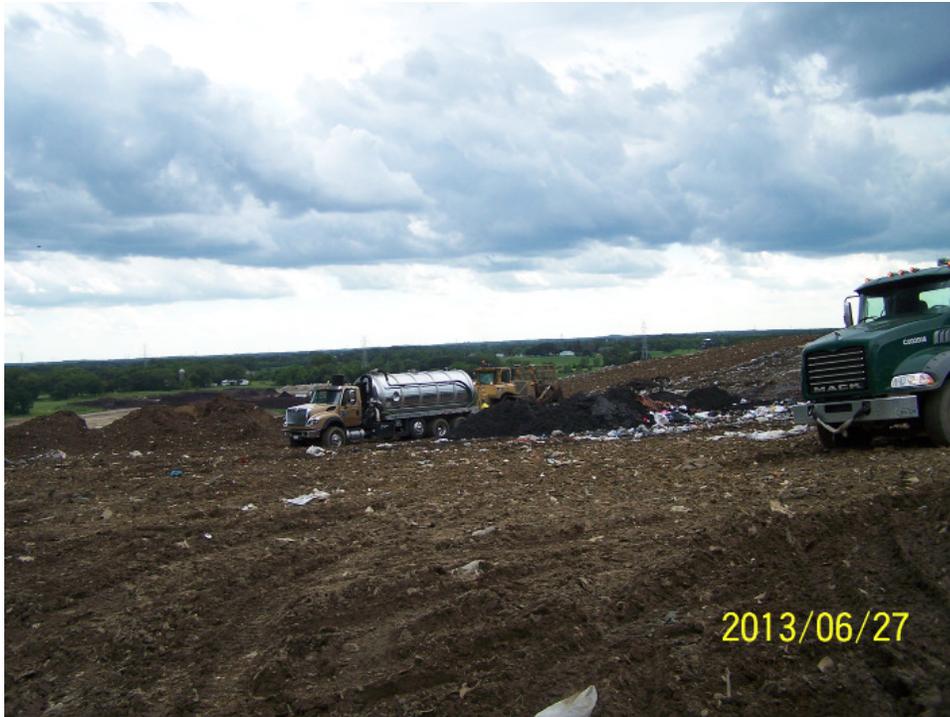
Active area, receiving liquid load

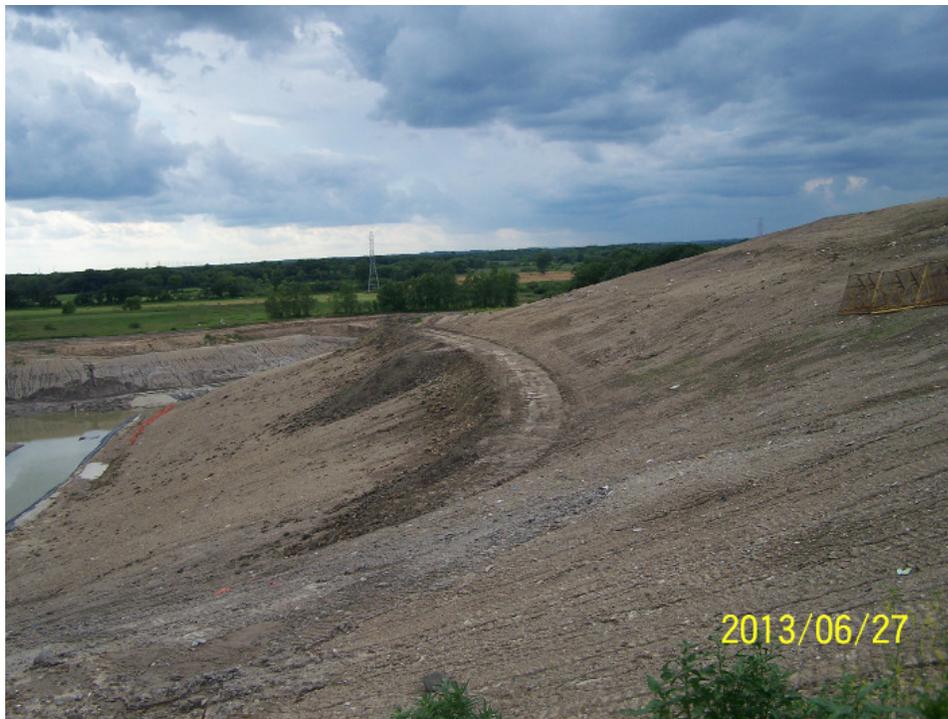
South slope of Phase 7, bench created by contractors for future soil placement

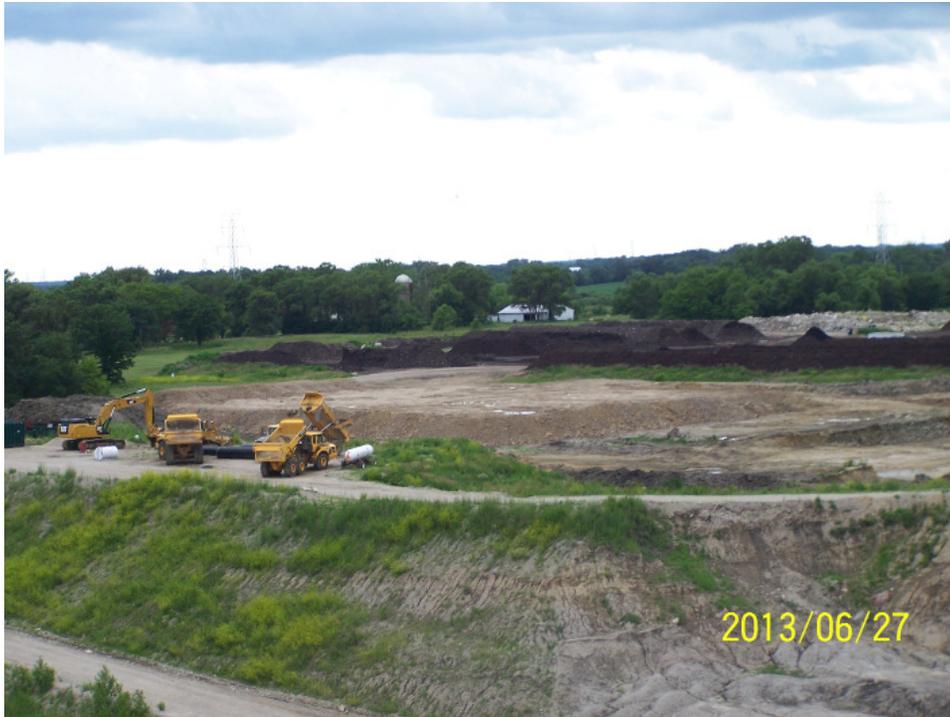
Excavation halted by rain events, stockpile still developing

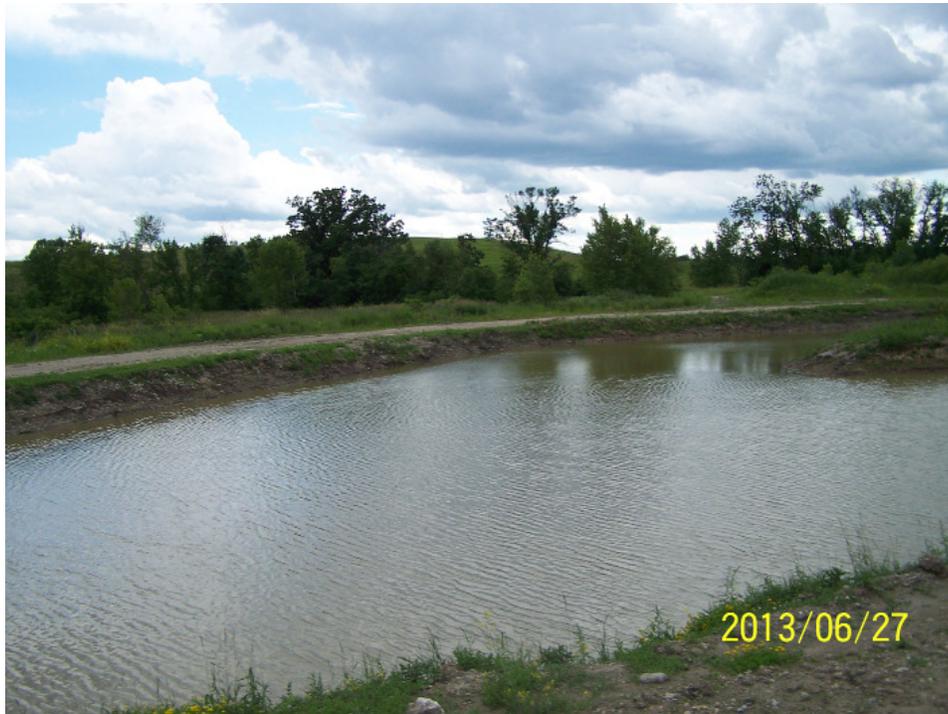
Basin #2, still with freeboard
