MEMORANDUM

ADS Emerald Park Landfill Audit Summary

TO: ADS Emerald Park Landfill Standing Committee, City of Muskego
FROM: Faith F. Spear
COPIES: File
DATE: 07/08/13
PROJECT NUMBER: 1012.10030

**ADVANCED DISPOSAL SERVICES
EMERALD PARK LANDFILL / CITY OF MUSKEGO
AUDIT PHOTOS**

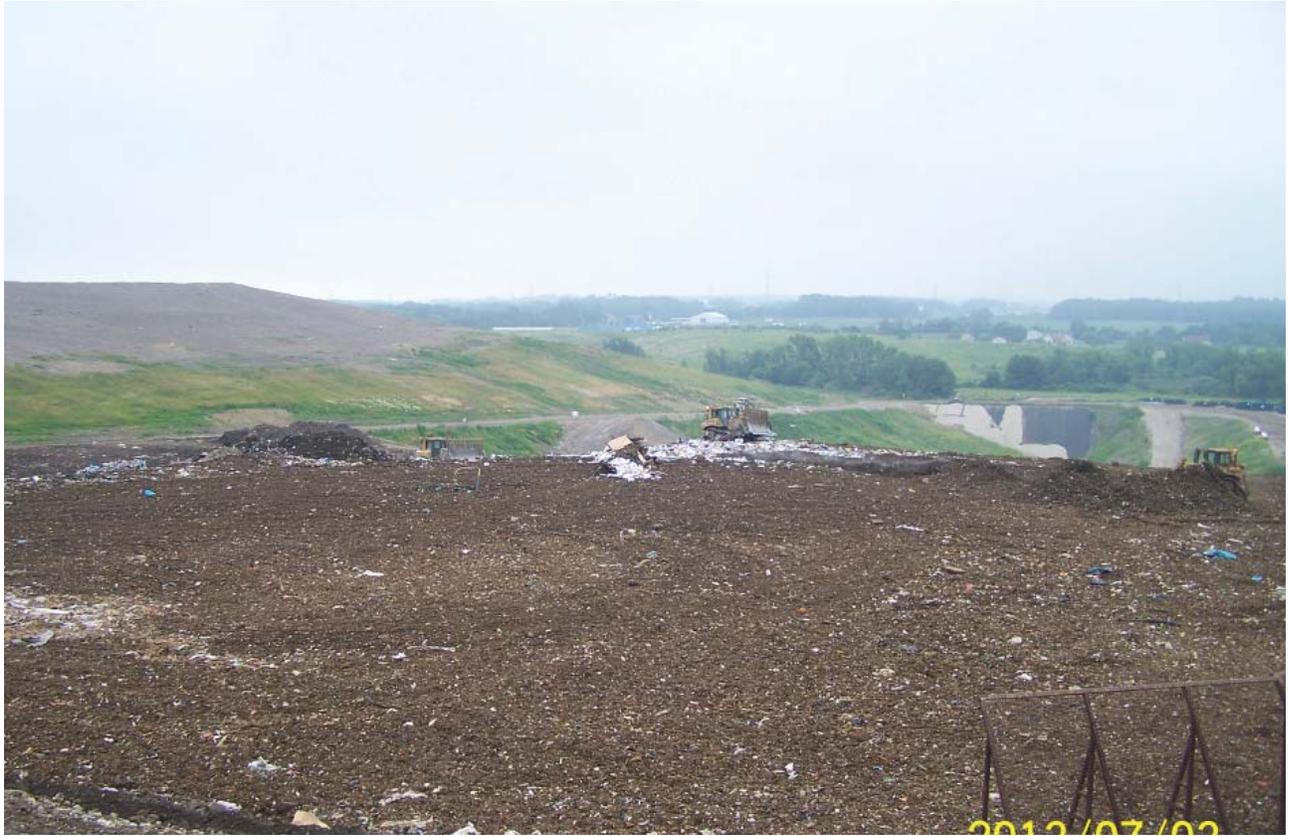
Active area with working face in center of photo

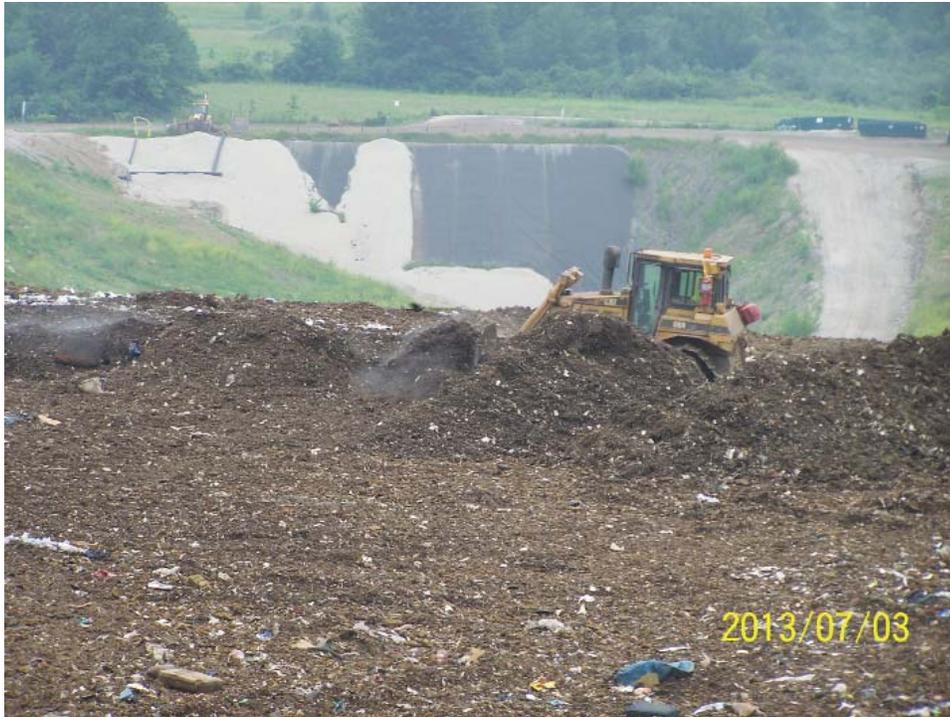
D6 Dozer spreading cover

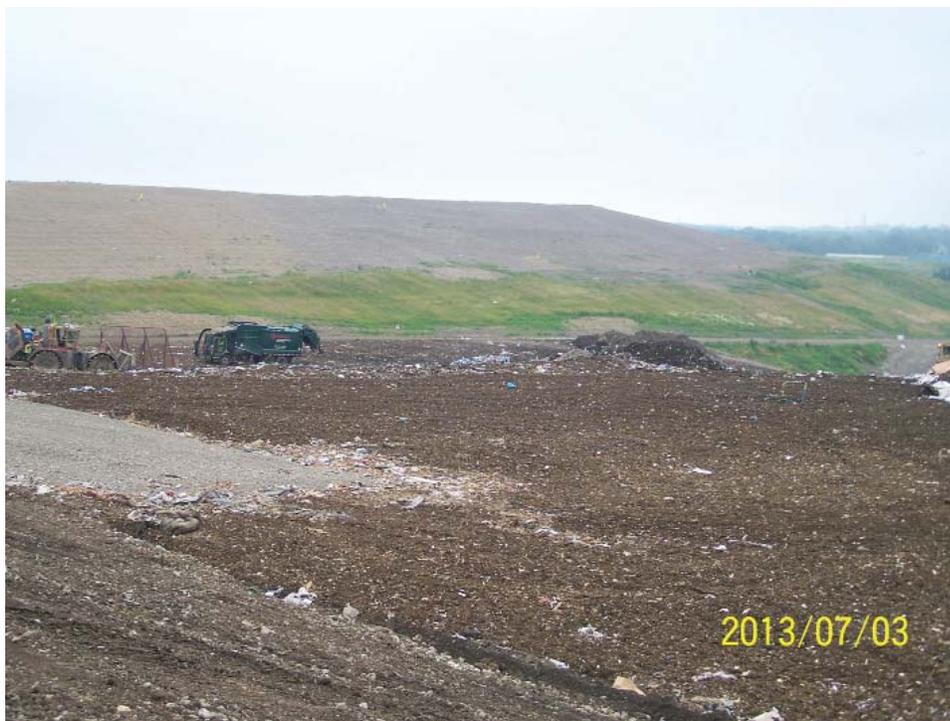
Active area

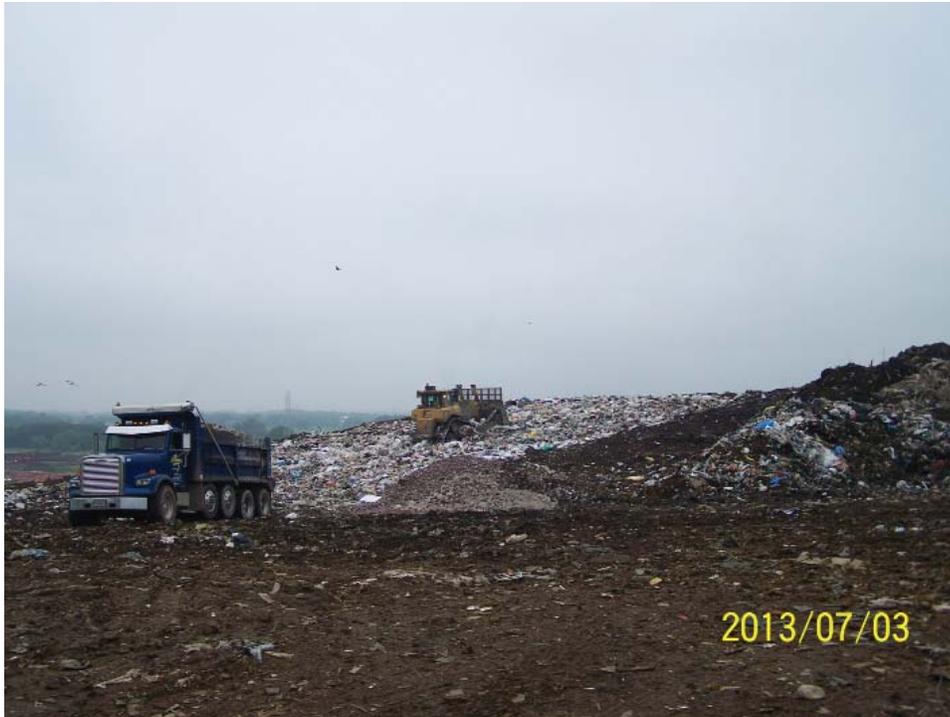
* Compactor down due to power issues, DB
dozer compacting waste D6 & D7 managing
cover and pushing waste for compaction

D8 Dozer compacting waste

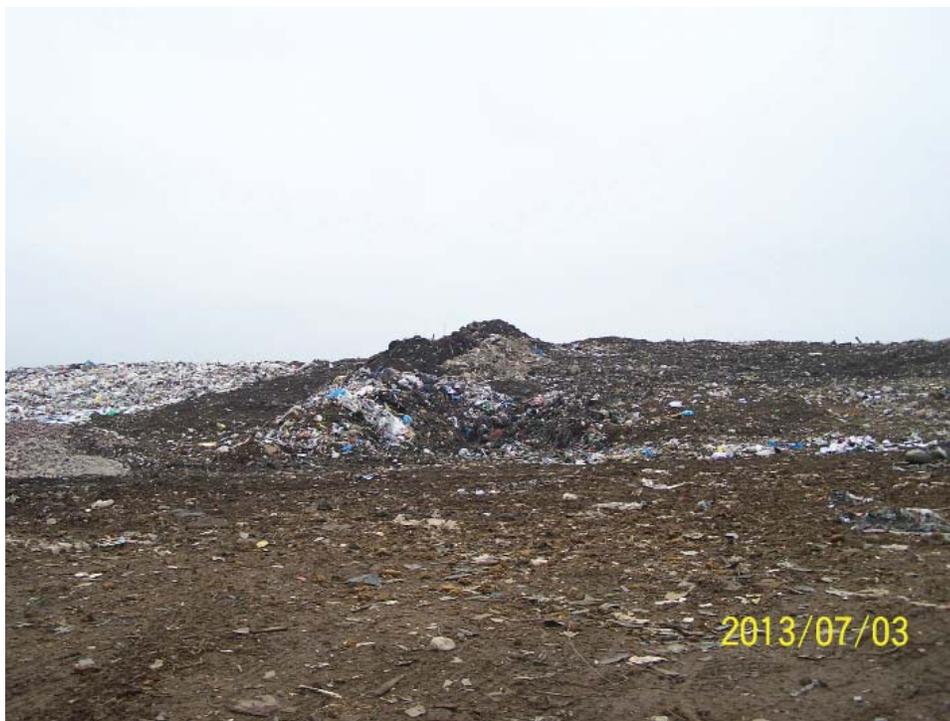
Working face

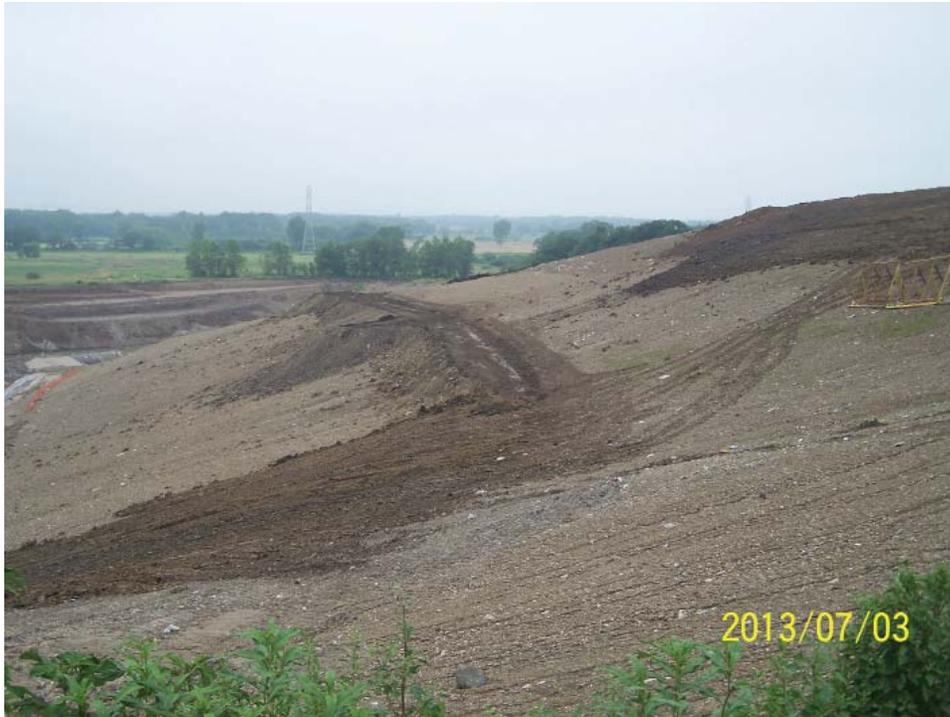
Access road for slope work, cover placement, by contractor

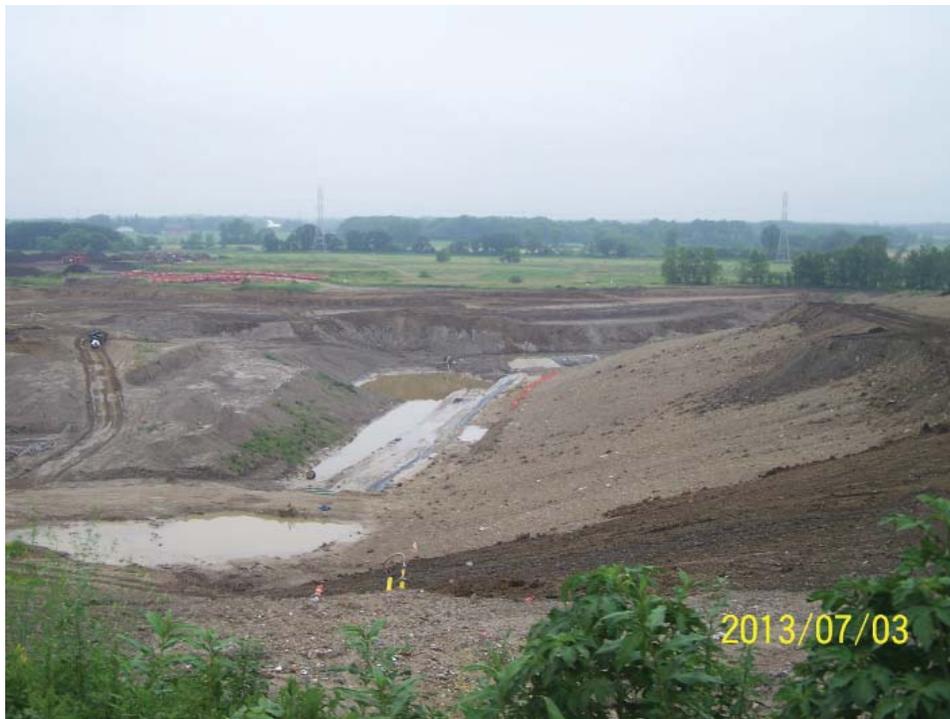
* Temp Sed pond pumping down

Temp sed basins

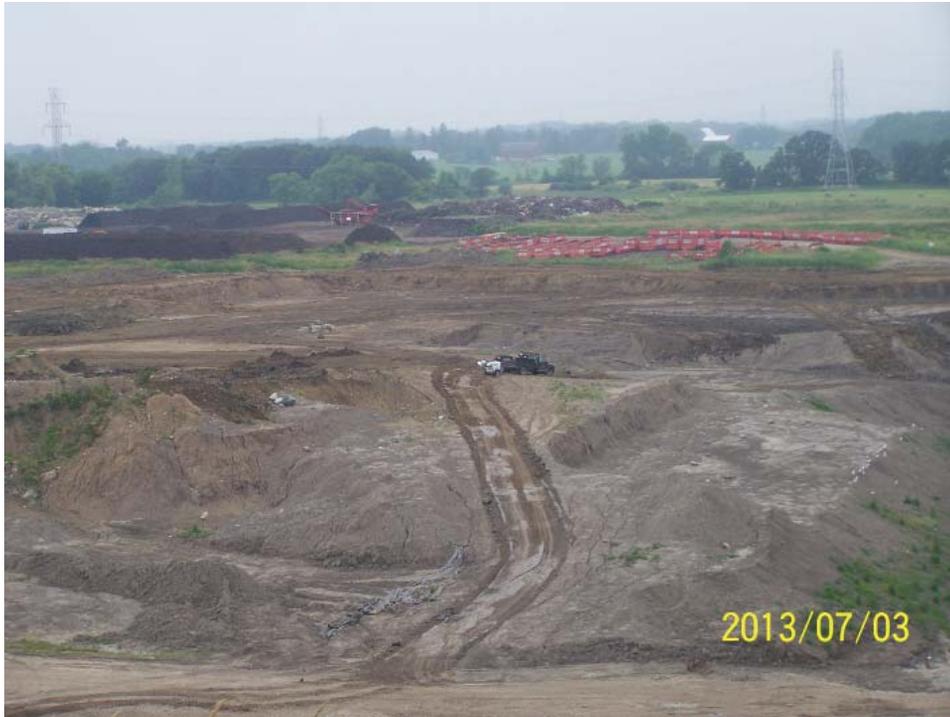
Excavation area

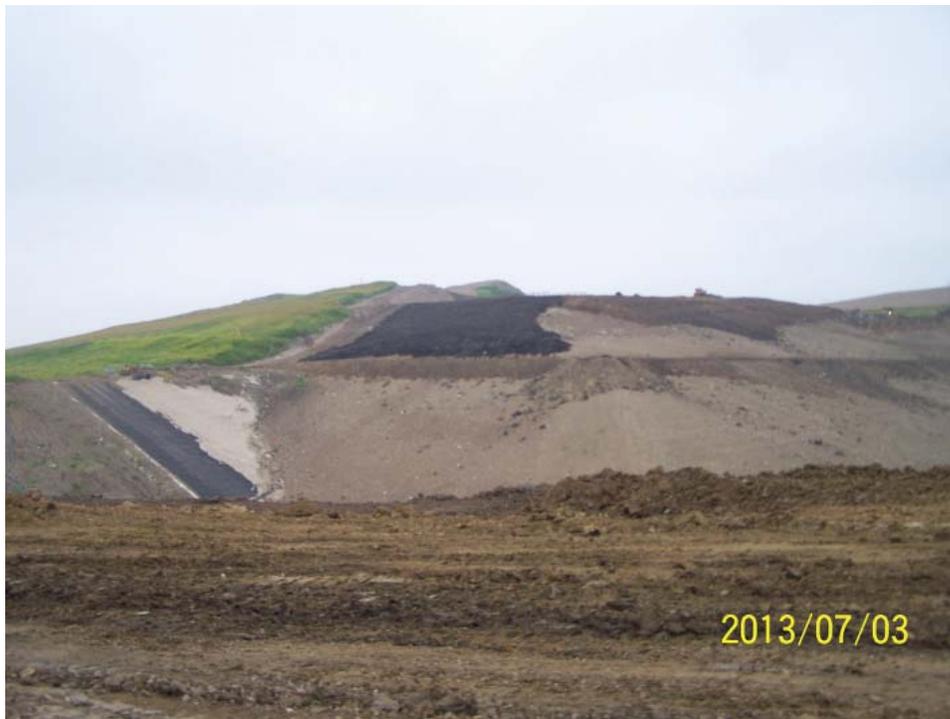
* Contractor preparing West Slope of Phase 7
for seeding

West side of Phase 7, areas to be seeded after construction

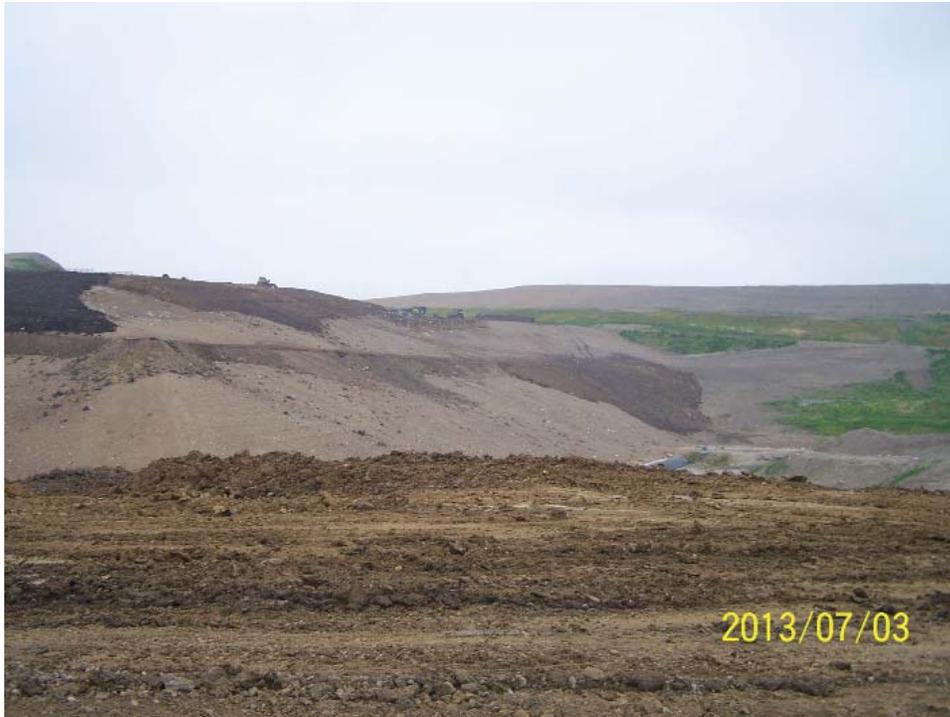
Phase 7 viewed from the Southwest, South outboard slope
