ADS Emerald Park Landfill Audit Summary

To: ADS Emerald Park Landfill Standing Committee, City of Muskego
FROM: Jo-Walter Spear, Jr. P.E.
COPIES: File
DATE: 08/09/13
PROJECT NUMBER: 1012.10030

ADVANCED DISPOSAL SERVICES EMERALD PARK LANDFILL
 LANDFILL OPERATIONS AUDIT FORM
 CITY OF MUSKEGO

**ADVANCED DISPOSAL SERVICES
EMERALD PARK LANDFILL / CITY OF MUSKEGO
AUDIT PHOTOS**

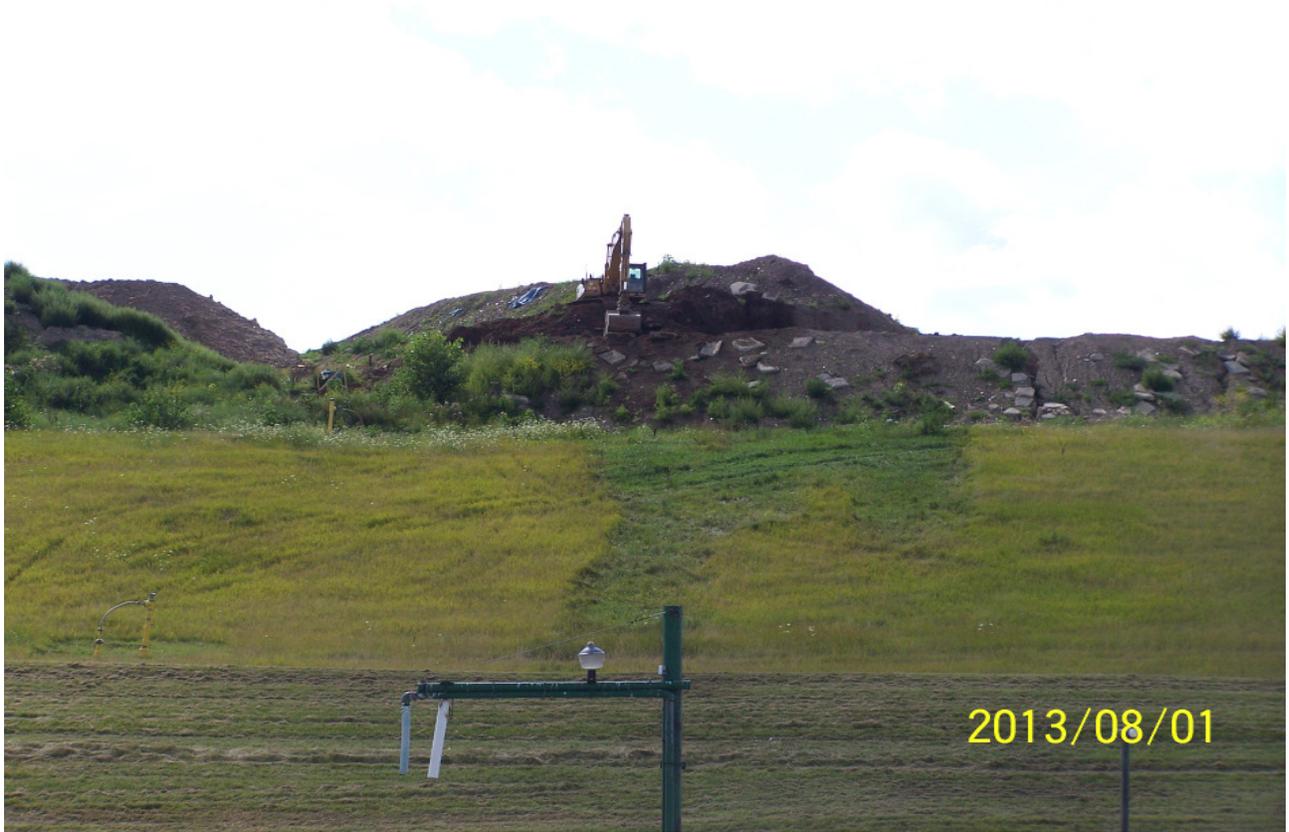
Harvesting of soils for use in daily and intermediate covers.

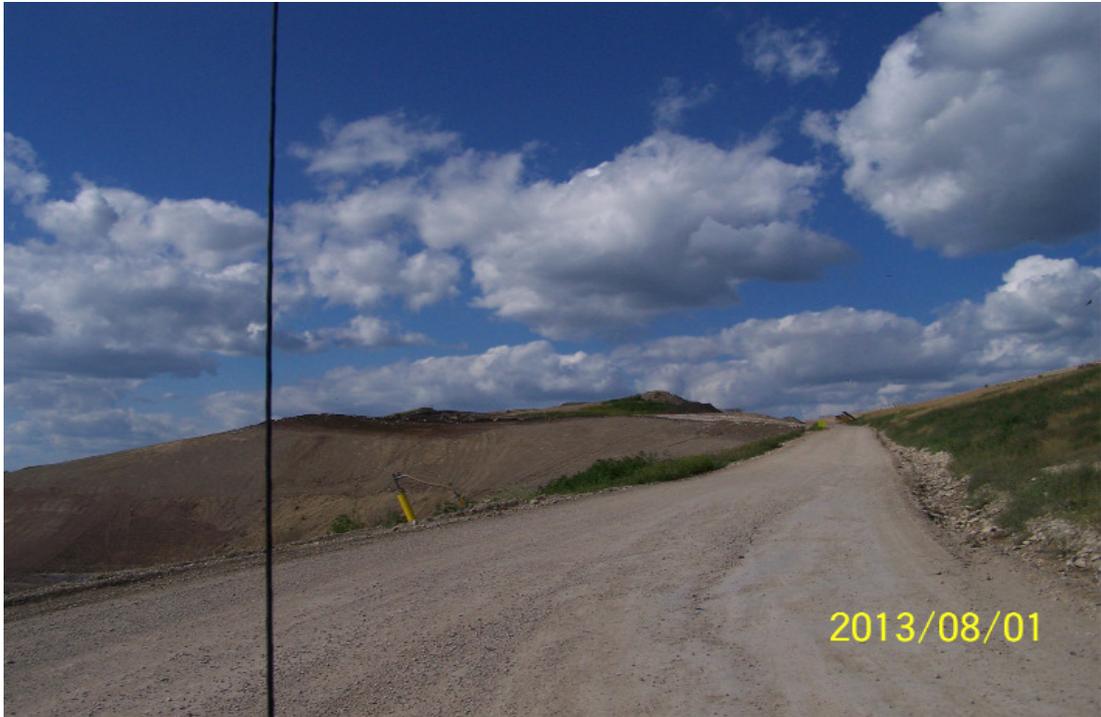
Active area viewed from the South

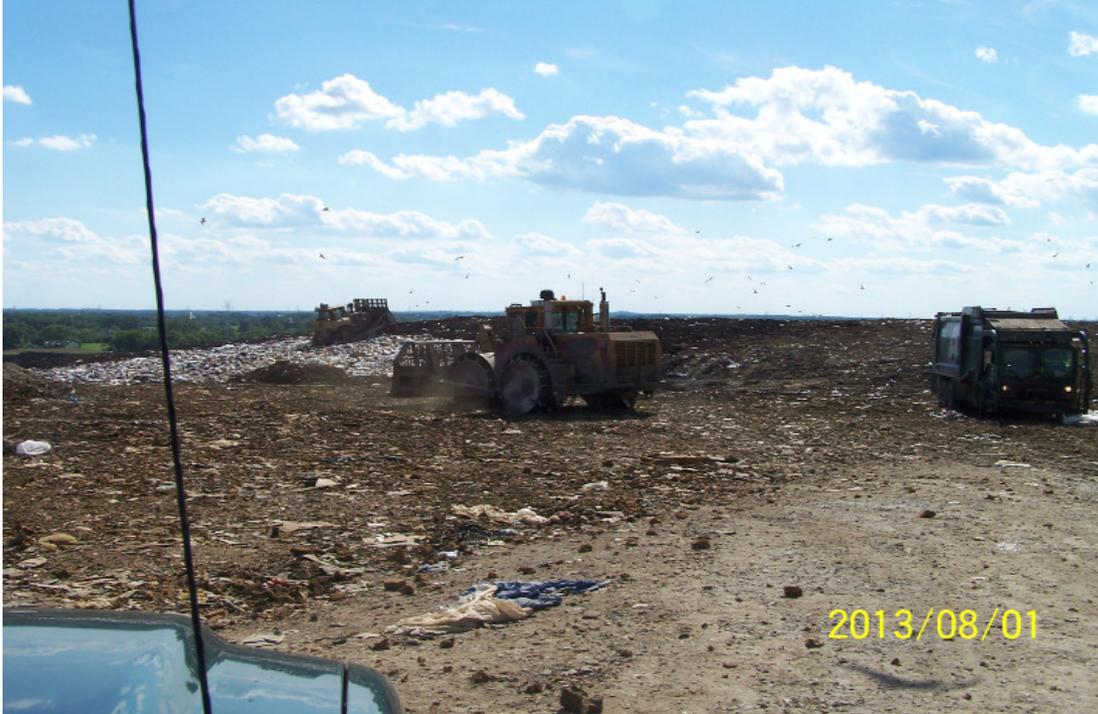
Active area, Phase 7

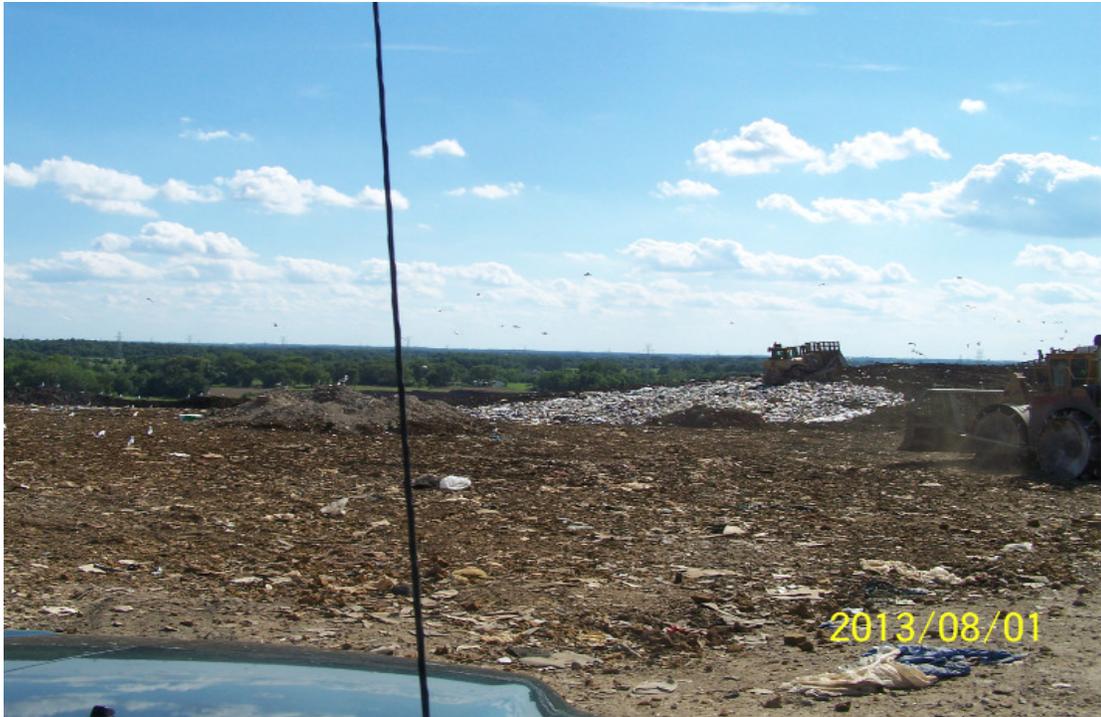
Dozer moving to begin cover placement

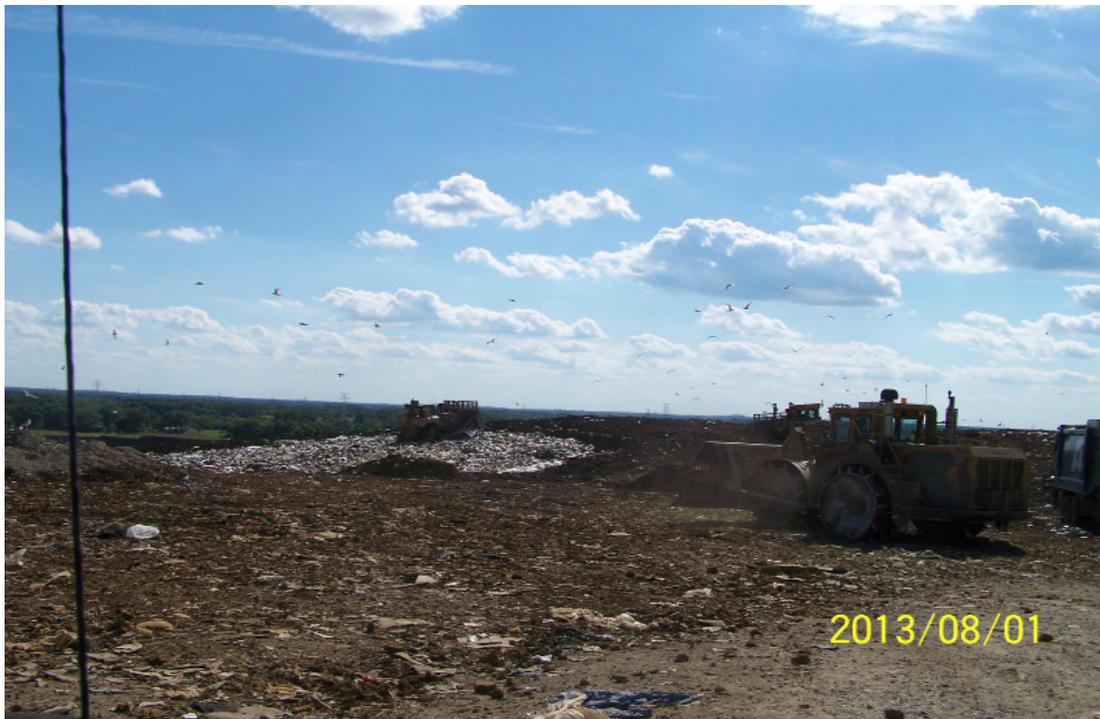
Active area, compactor withdrawing to allow cover placement

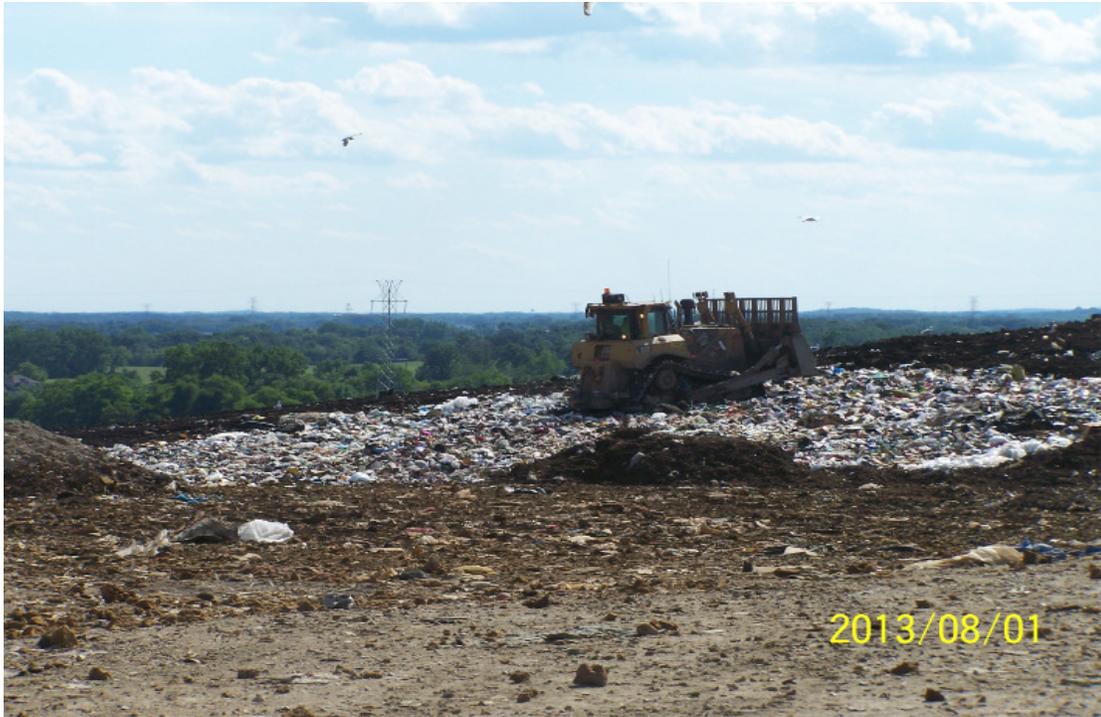
Working face with dozer preparing for cover placement

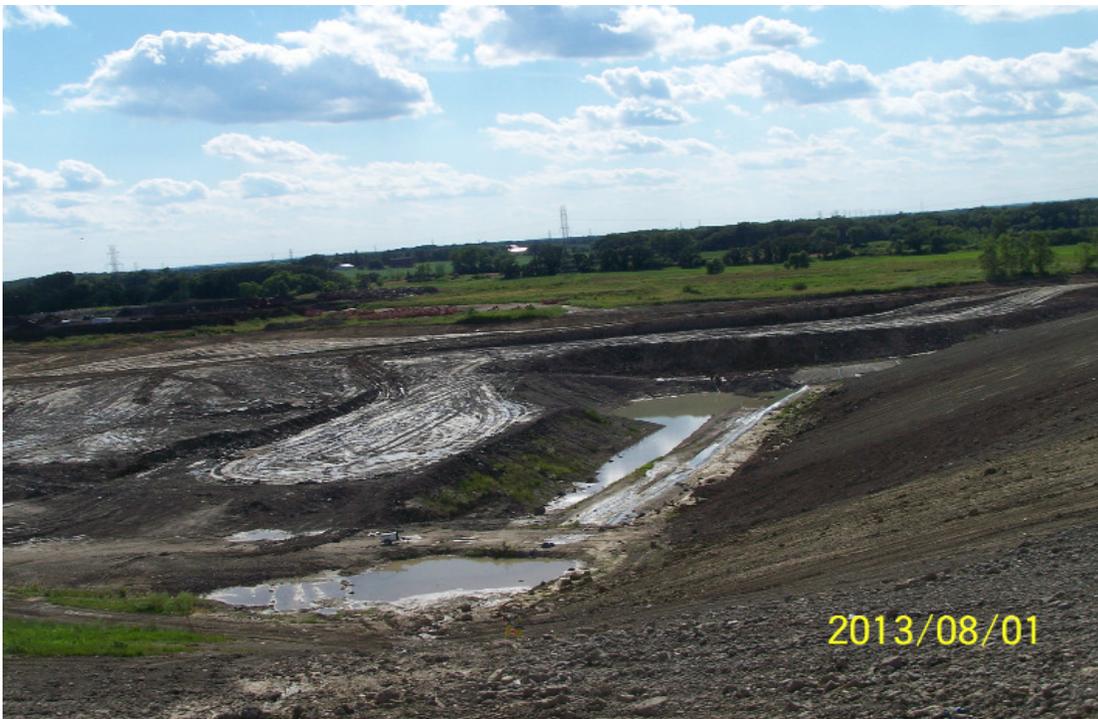
Excavation area and temp sed pond

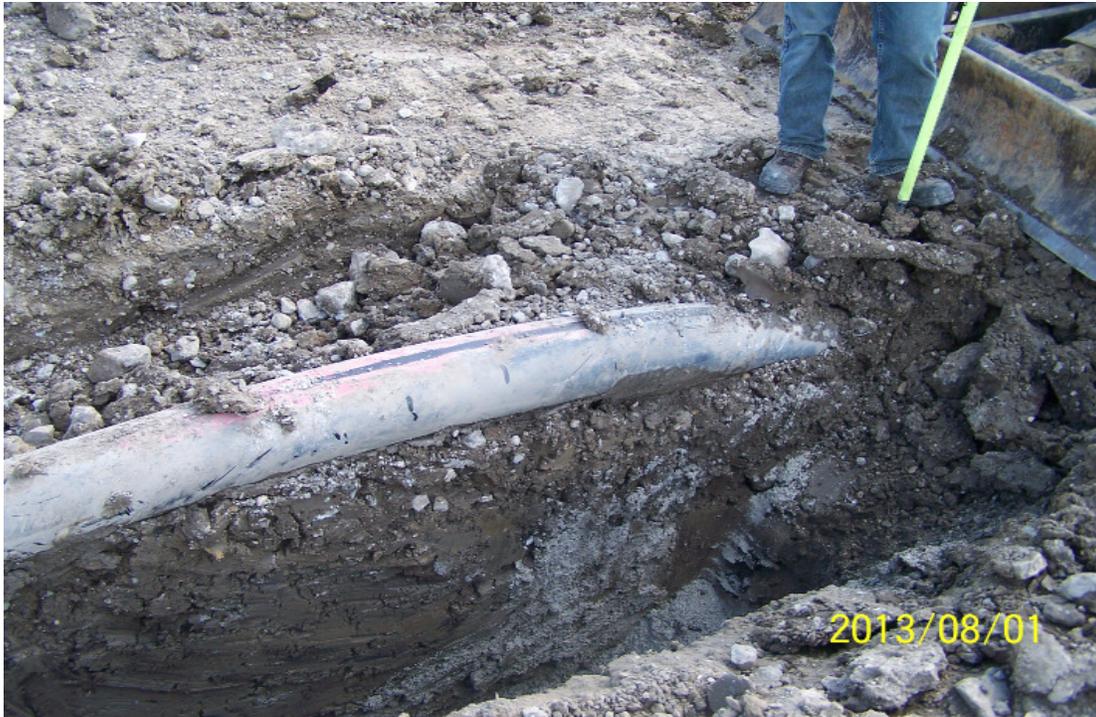
- Forcemain along North perimeter road has crested from the ground, contractors repairing during day activities and at time of audit
- Construction audit
- No construction activities due to wet conditions and repair of forcemain

Forcemain, forced to the surface, exposed for repairs.

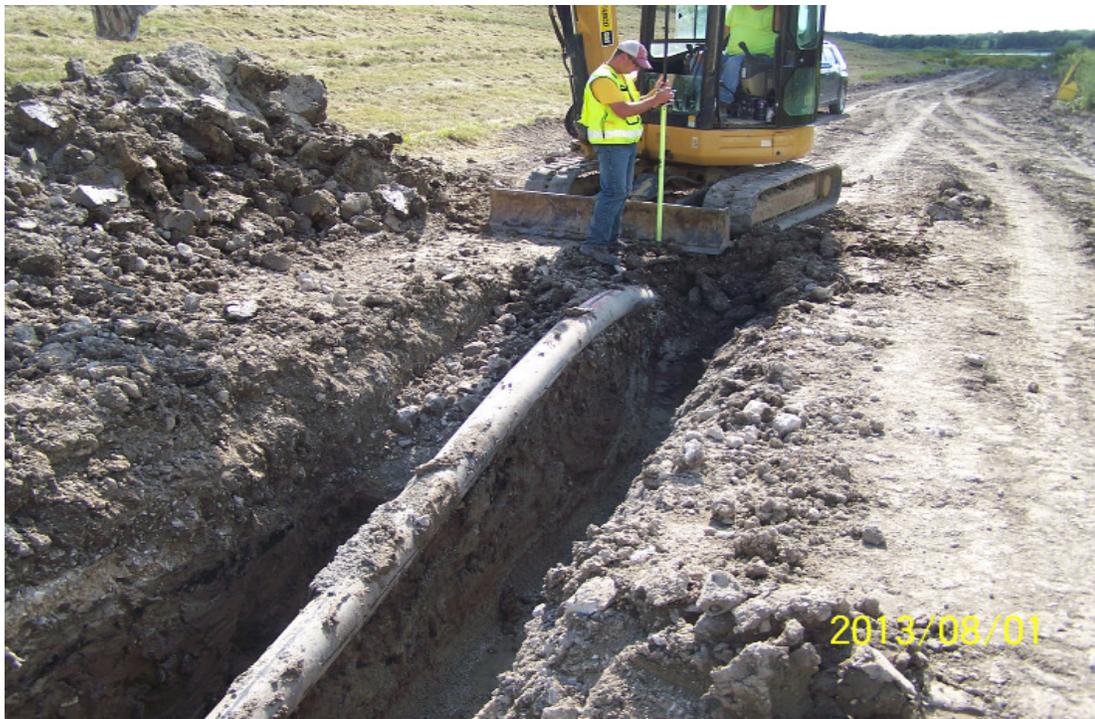
Raised and exposed forcemain
