MEMORANDUM

ADS Emerald Park Landfill Audit Summary

TO: ADS Emerald Park Landfill Standing Committee, City of Muskego
FROM: Jo-Walter Spear, Jr., P.E.
COPIES: File
DATE: 08/09/13
PROJECT NUMBER: 1012.10030

**ADVANCED DISPOSAL SERVICES
EMERALD PARK LANDFILL / CITY OF MUSKEGO
AUDIT PHOTOS**

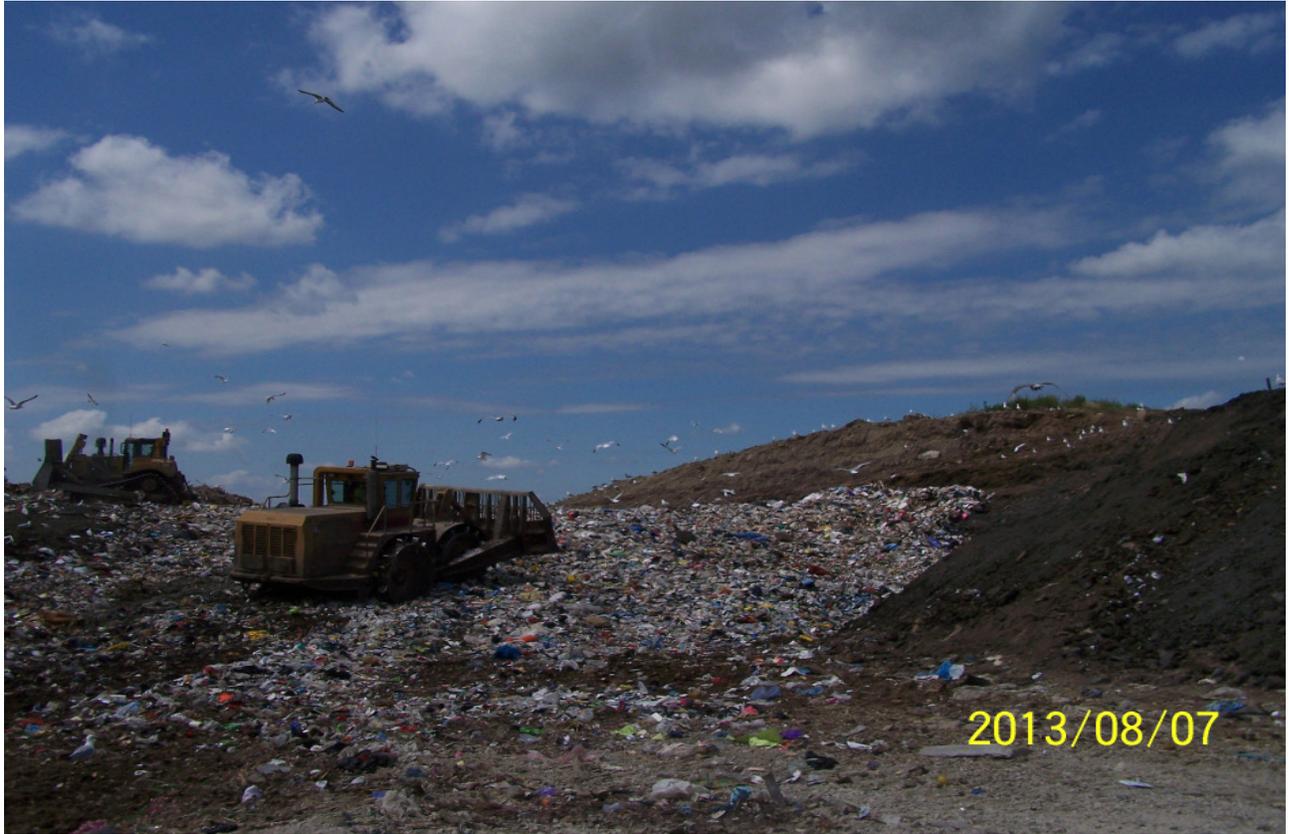
Working face

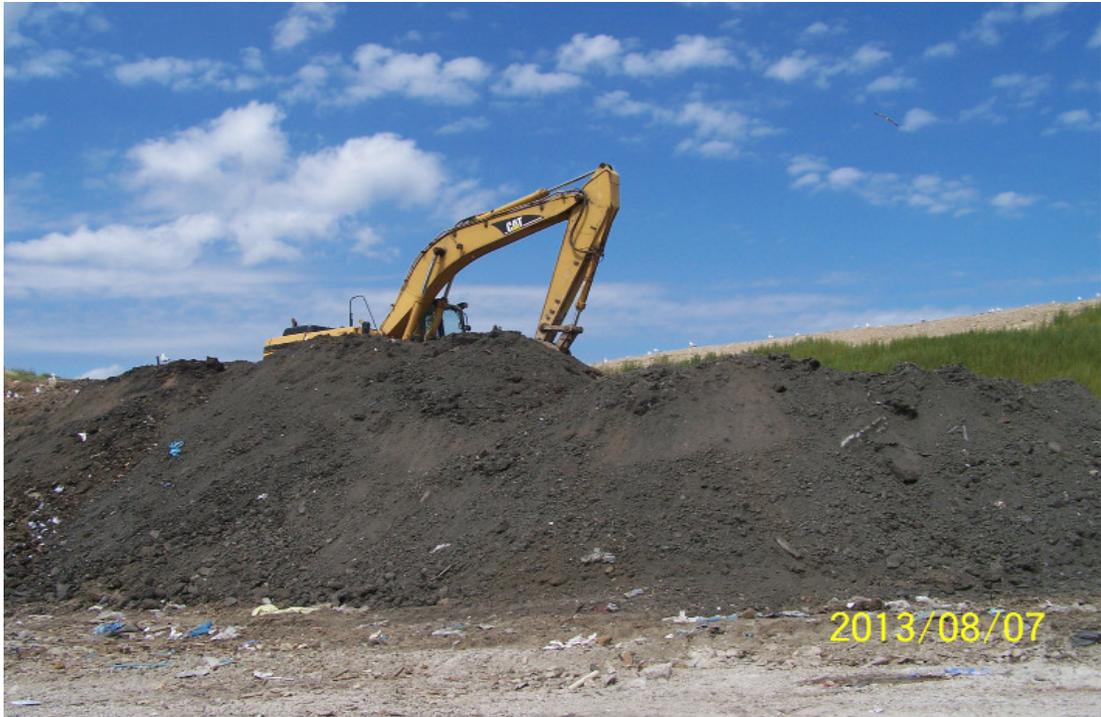
Stockpiled soils

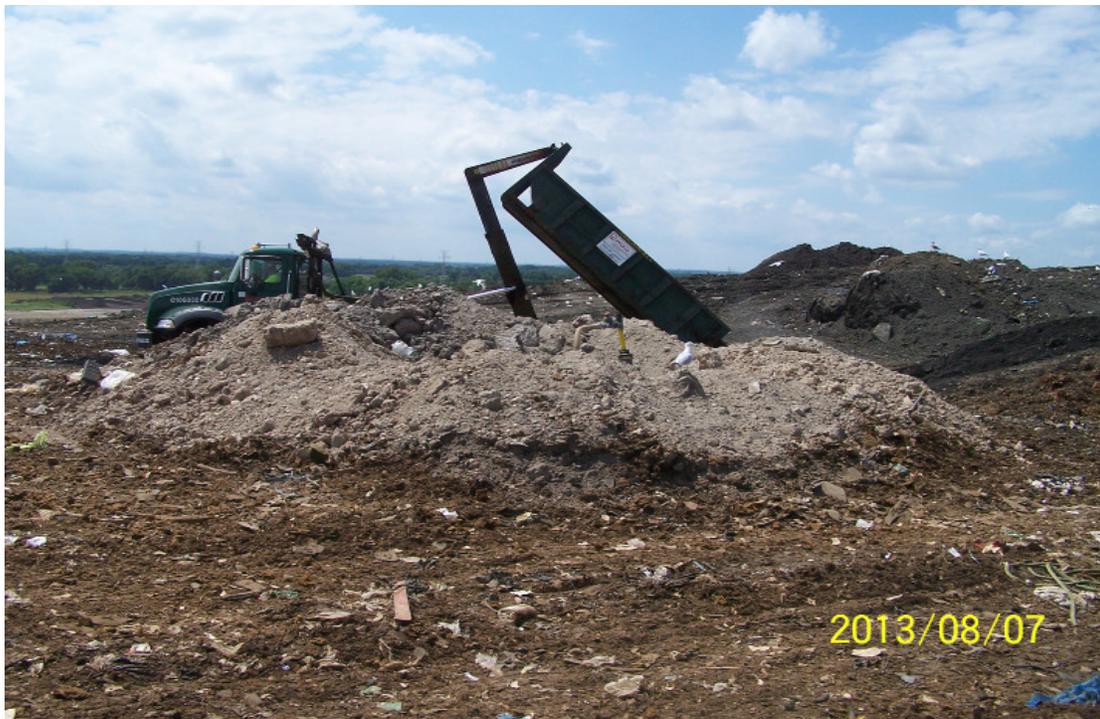
Infiltration trench for liquid loads

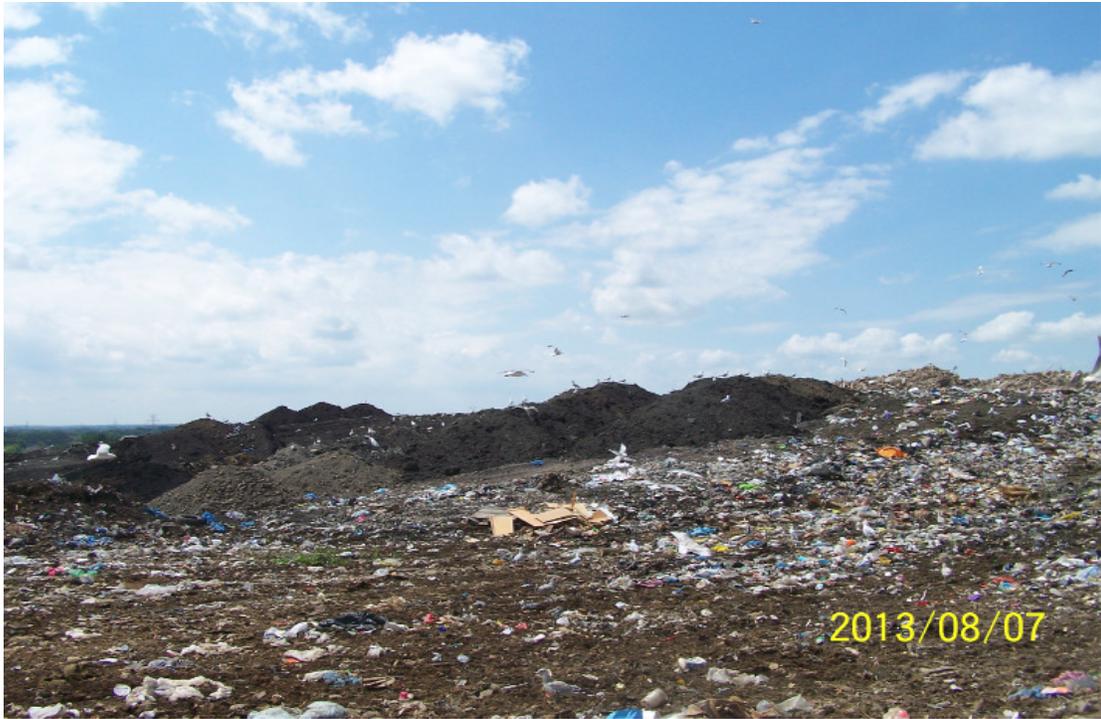
Working face

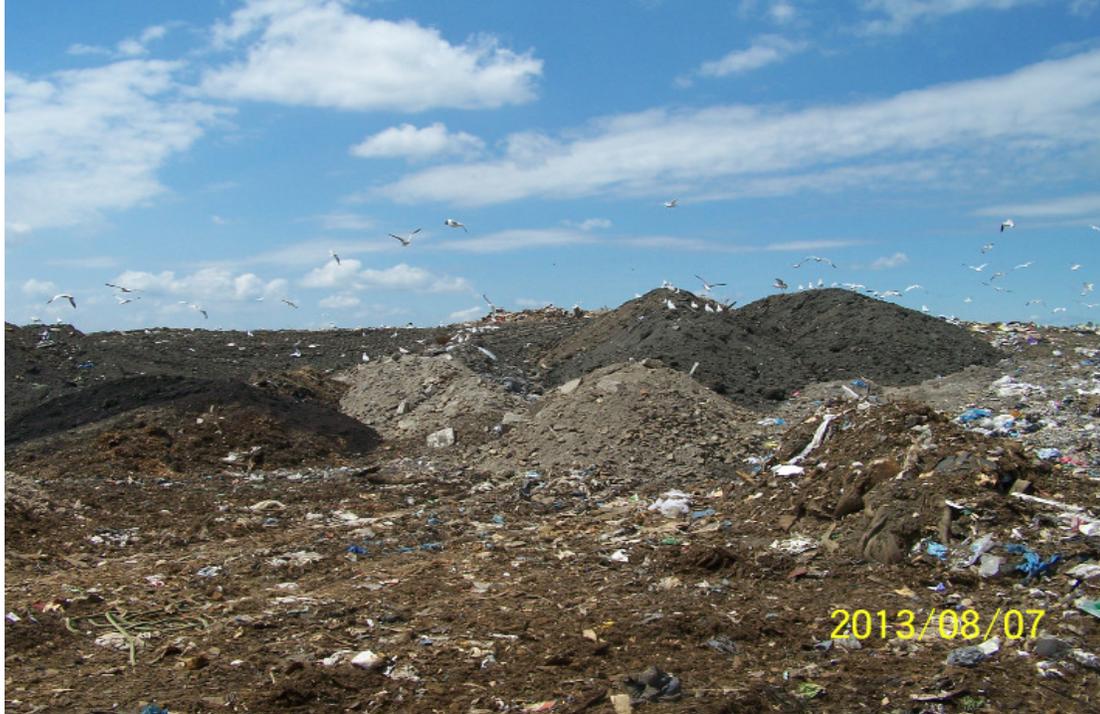
Soil stockpiles on active area

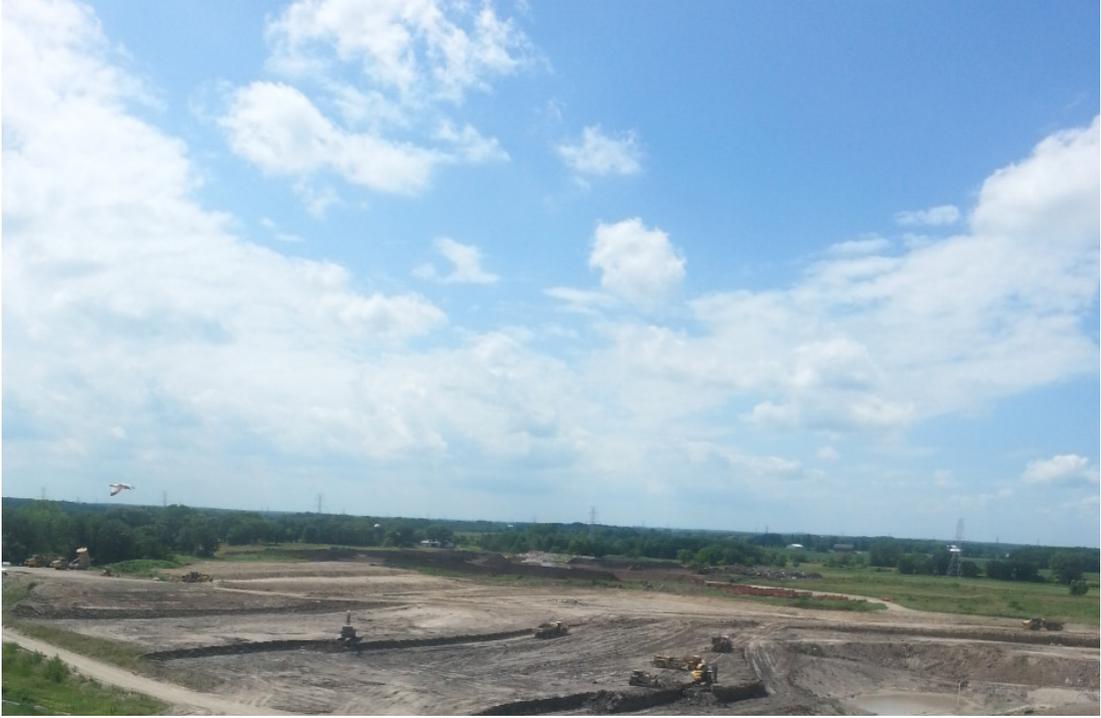
Excavation area

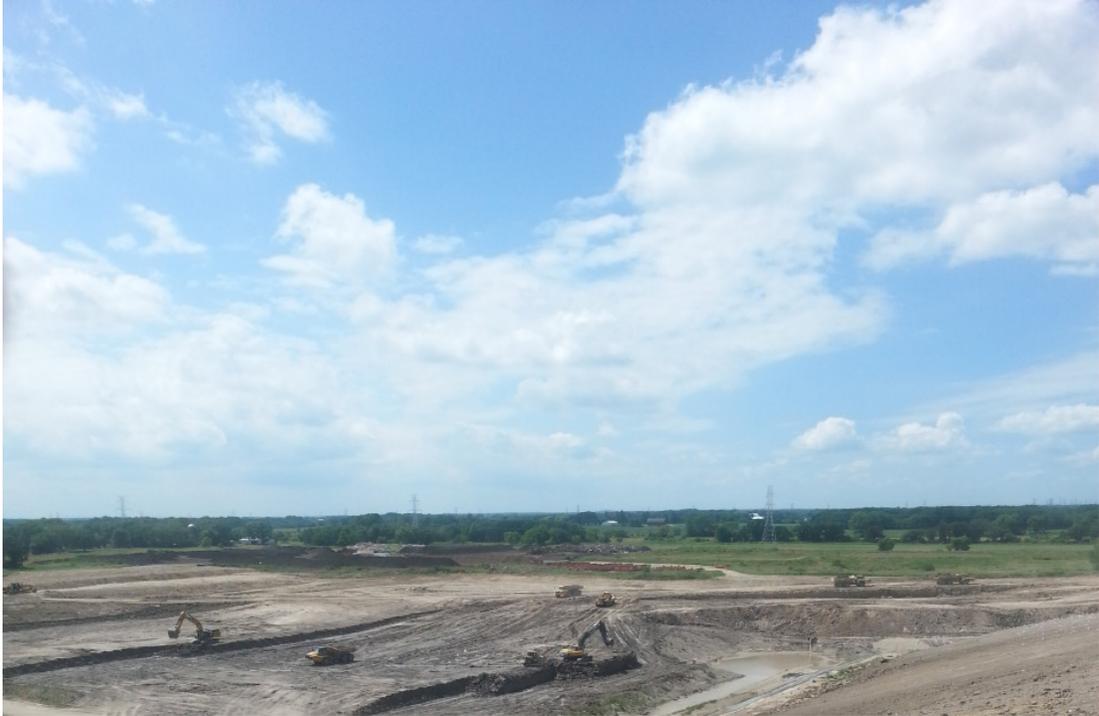
Excavation area

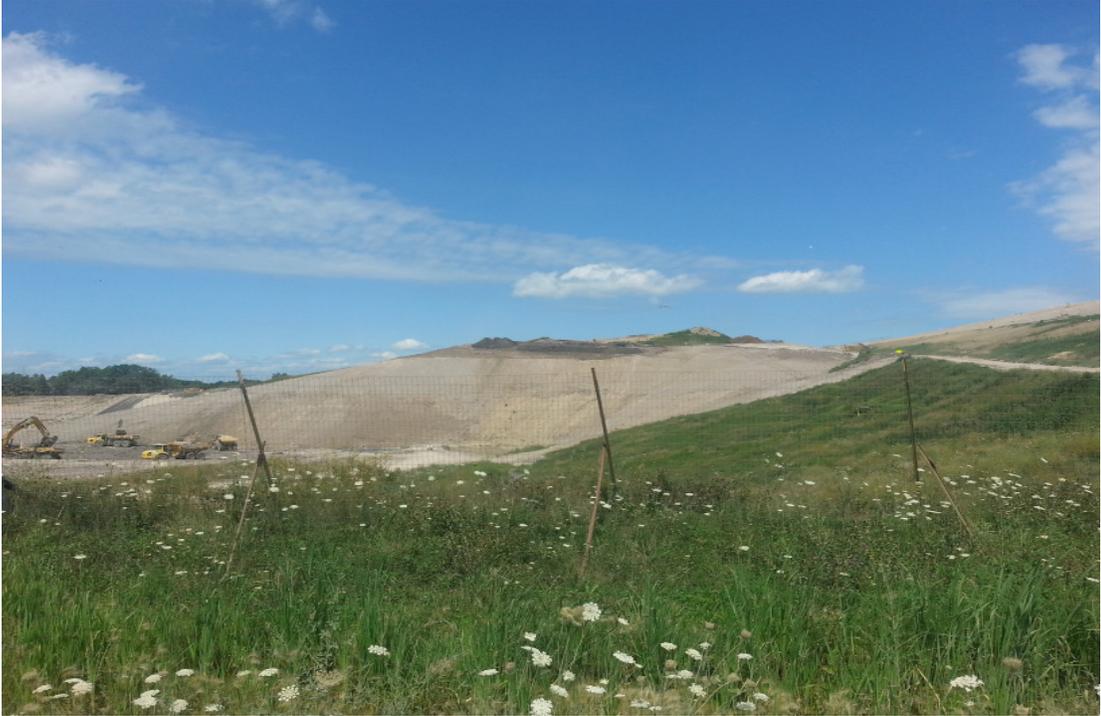
Phase 6 & 7 viewed from the South

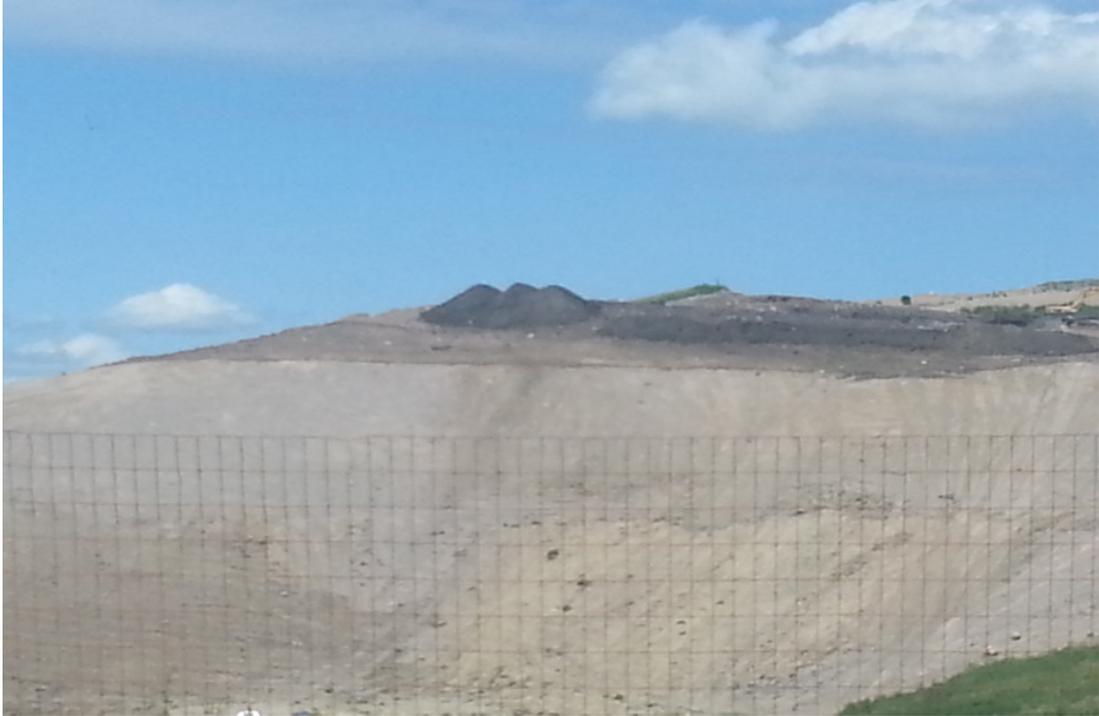
Active area, South slope of Phase 7
