MEMORANDUM

ADS Emerald Park Landfill Audit Summary

TO: ADS Emerald Park Landfill Standing Committee, City of Muskego
FROM: Jo-Walter Spear, Jr., P.E.
COPIES: File
DATE: 09/5/2013
PROJECT NUMBER: 1012.10030

**ADVANCED DISPOSAL SERVICES
EMERALD PARK LANDFILL / CITY OF MUSKEGO
AUDIT PHOTOS**

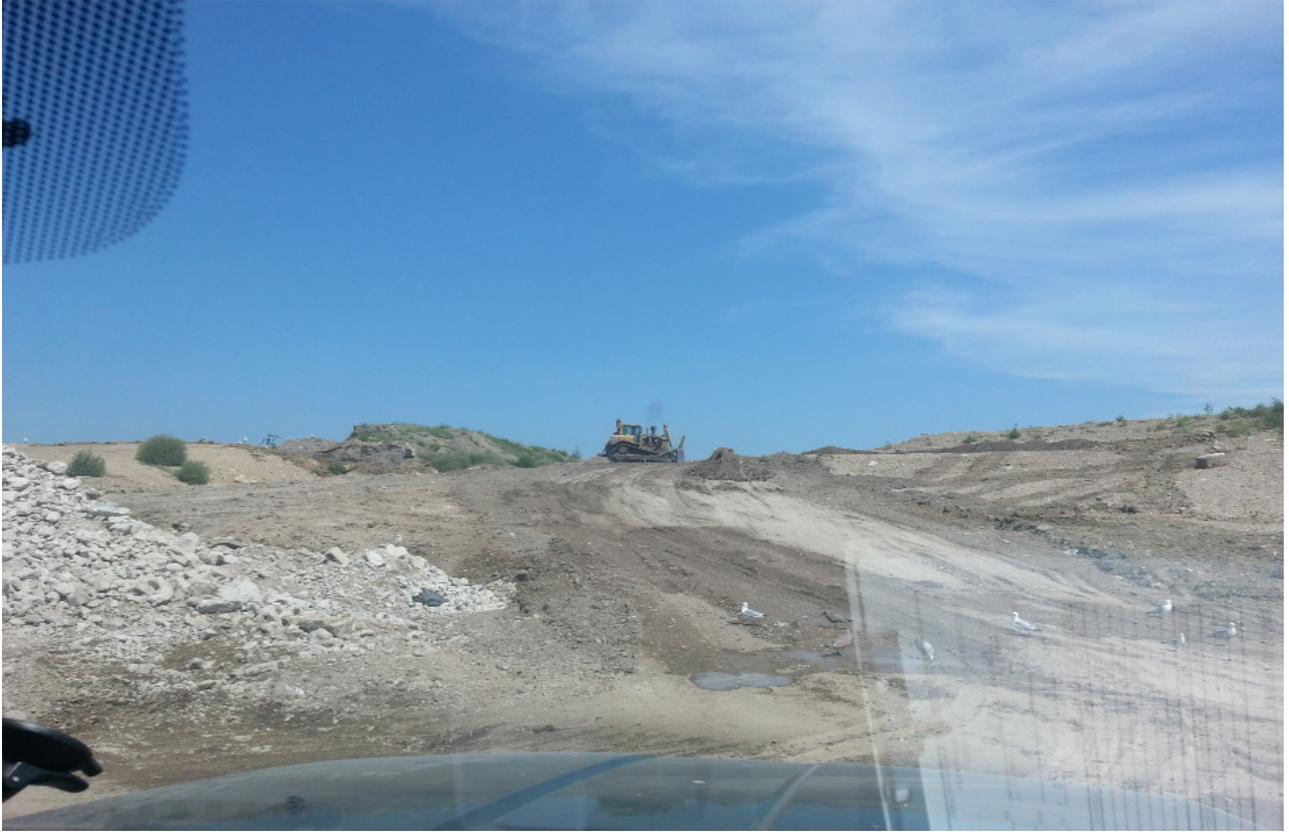
Bio soil management

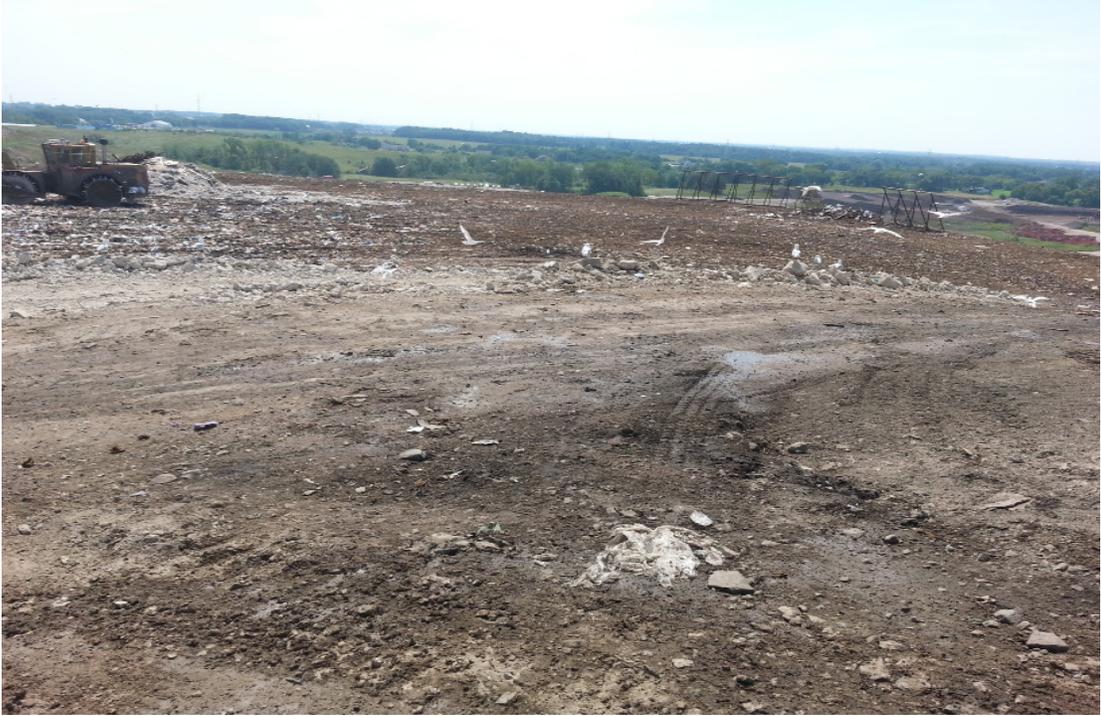
Active area covered

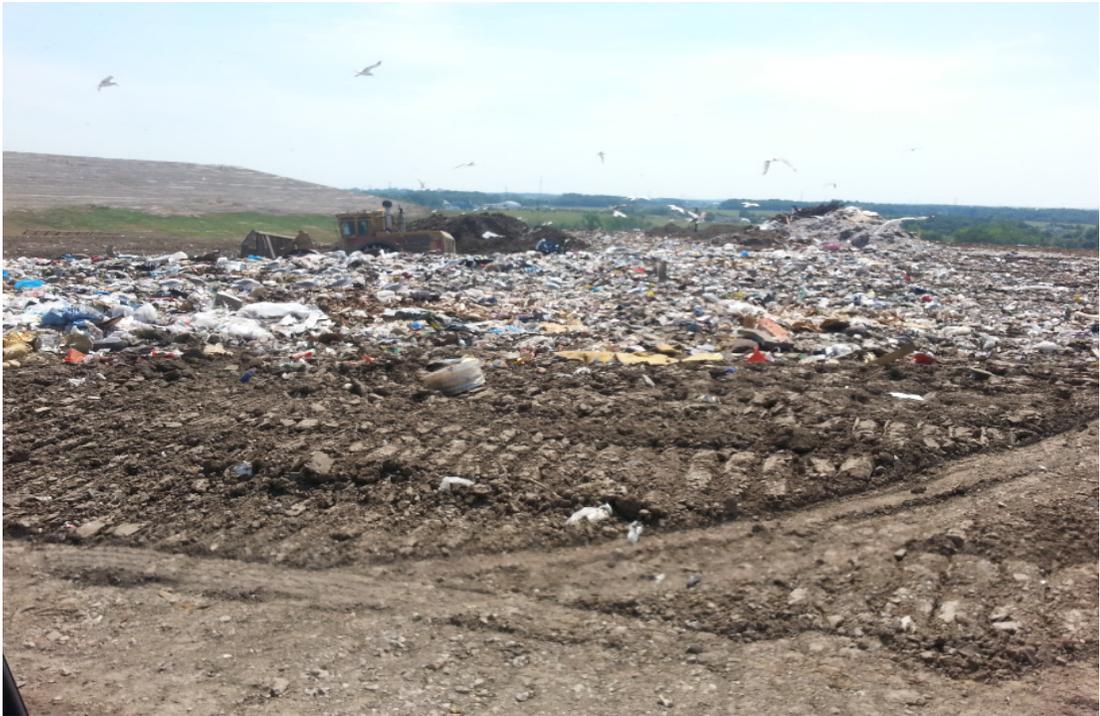
Working face

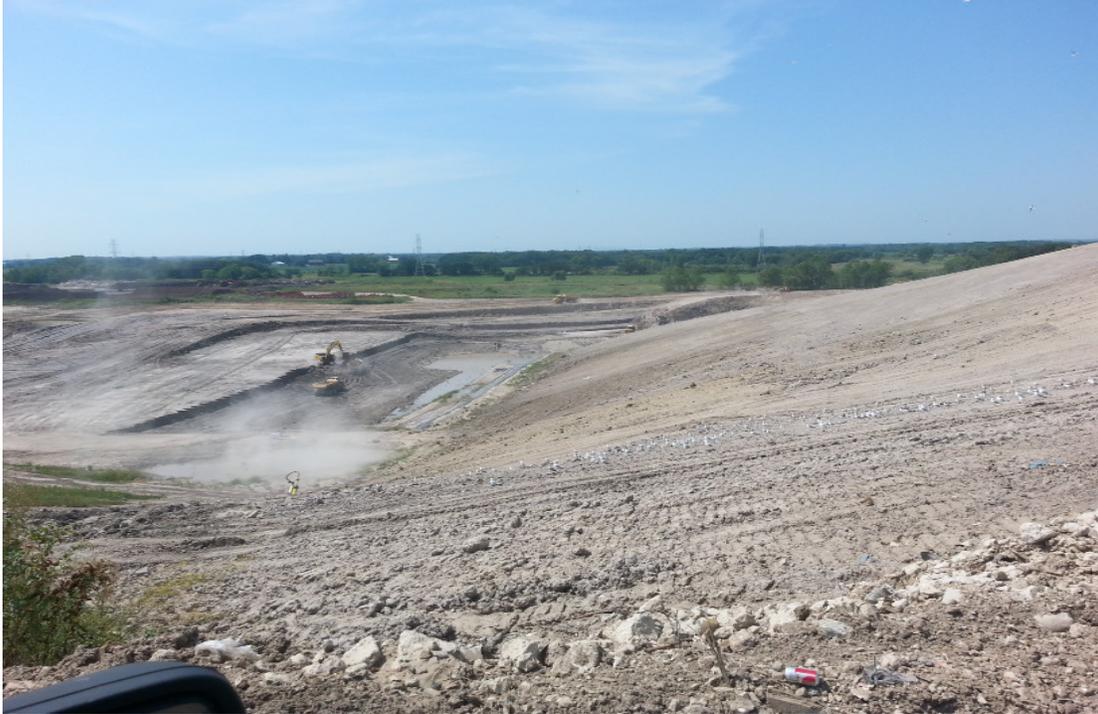
South slope of Phase 7, diversion berm construction will begin soon so that temp sed basin can be removed

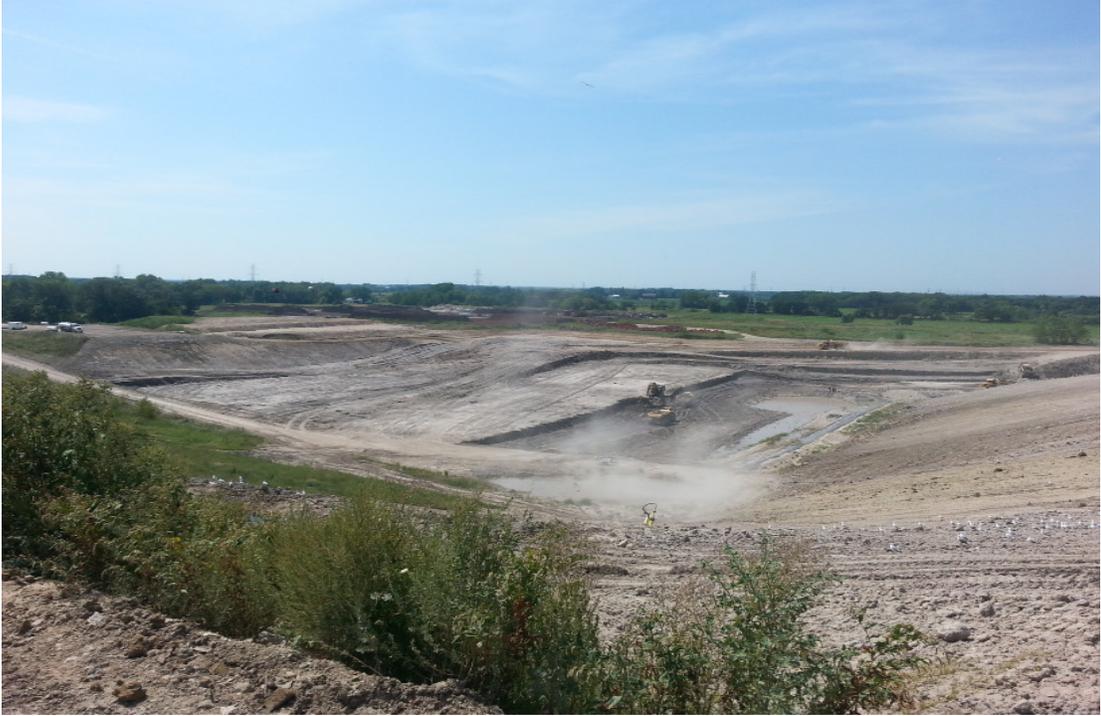
Excavation area

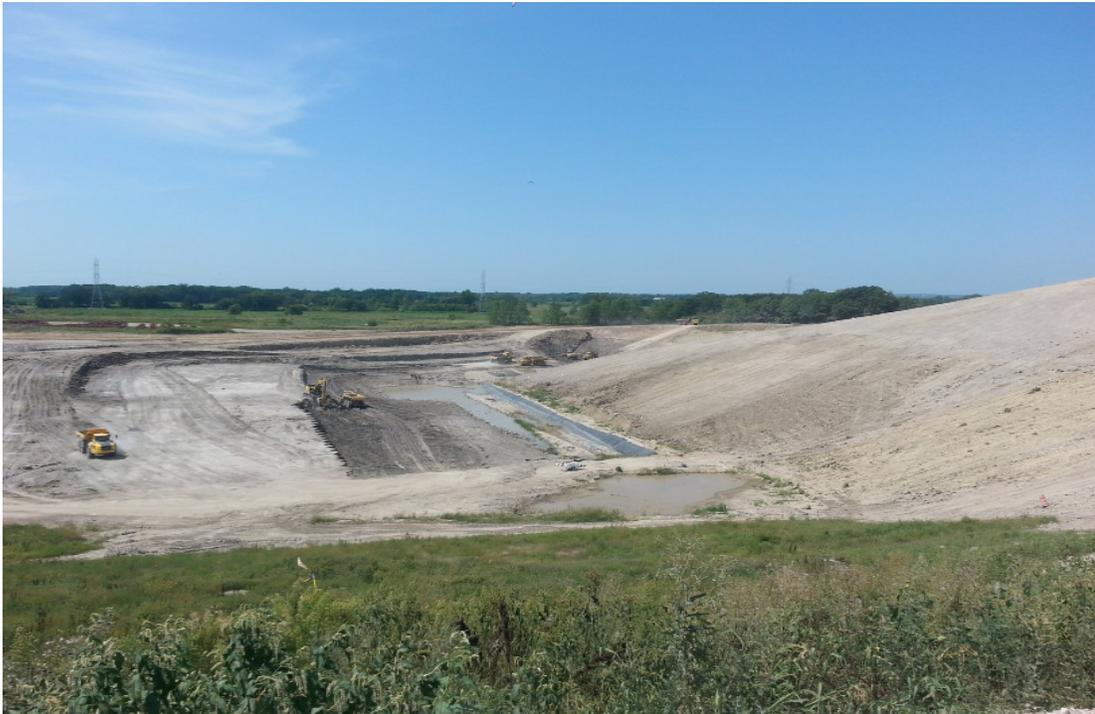
Excavation area, darker soils are nearing documentation point

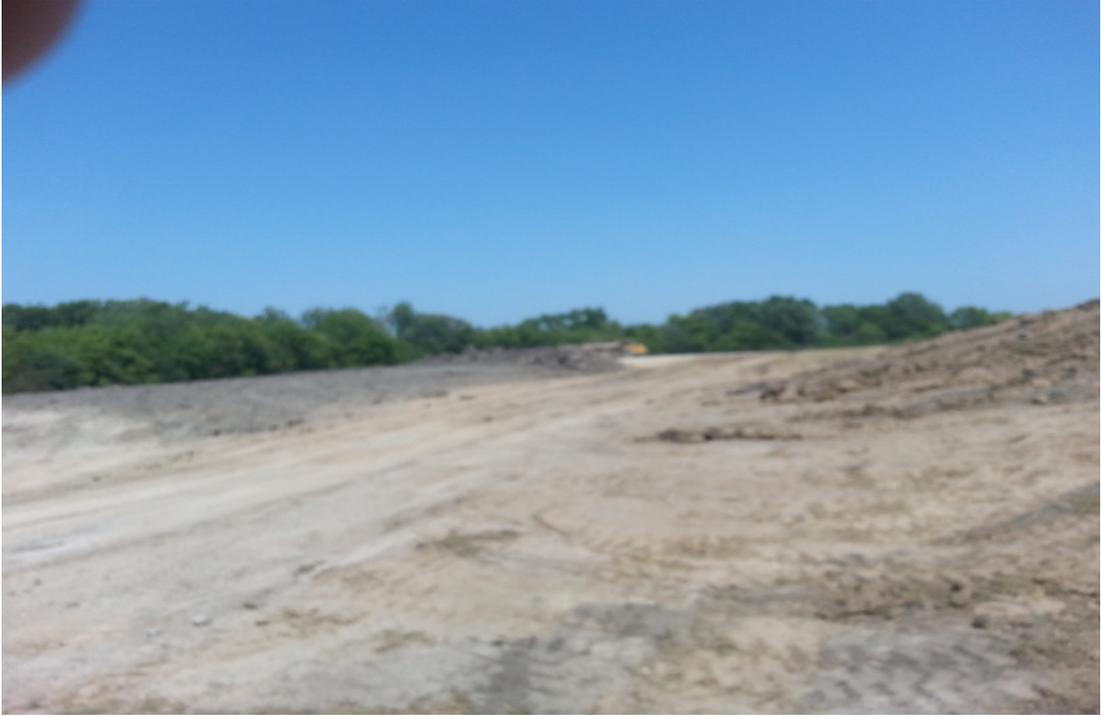
Cleared area before Western stockpile

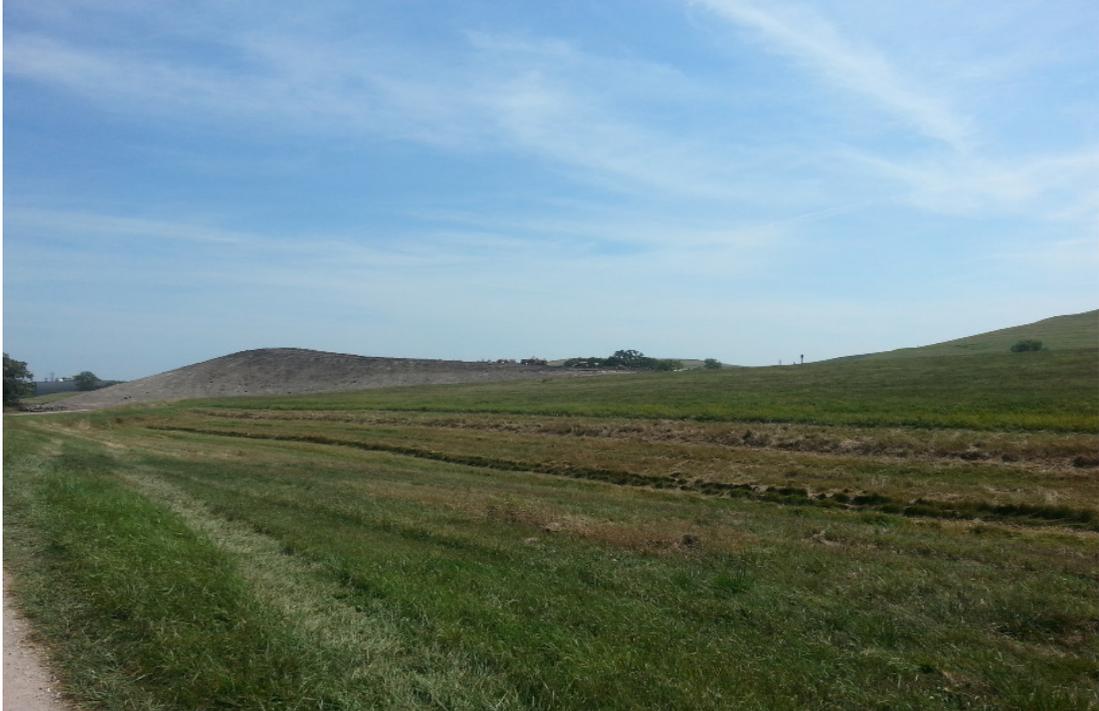
Eastern most stockpile in Future Parkland
