# ADS Emerald Park Landfill Audit Summary

**TO:** ADS Emerald Park Landfill Standing Committee, City of Muskego  
**FROM:** Jo-Walter Spear, Jr., P.E.  
**COPIES:** File  
**DATE:** 09/13/2013  
**PROJECT NUMBER:** 1012.10030

**ADVANCED DISPOSAL SERVICES  
EMERALD PARK LANDFILL / CITY OF MUSKEGO  
AUDIT PHOTOS**

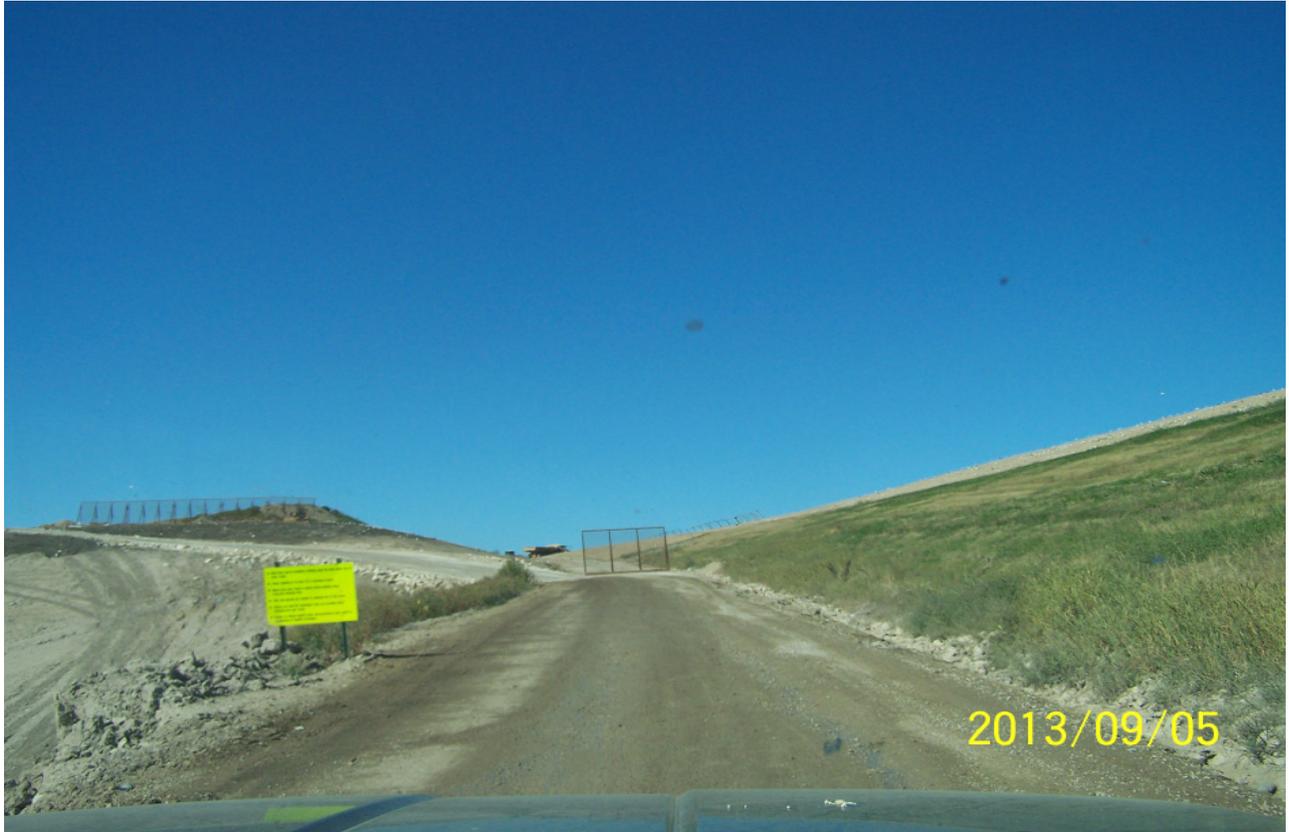
New ramp to left, old access straight ahead to be removed and filled with waste, lain over  
Phase 5/6

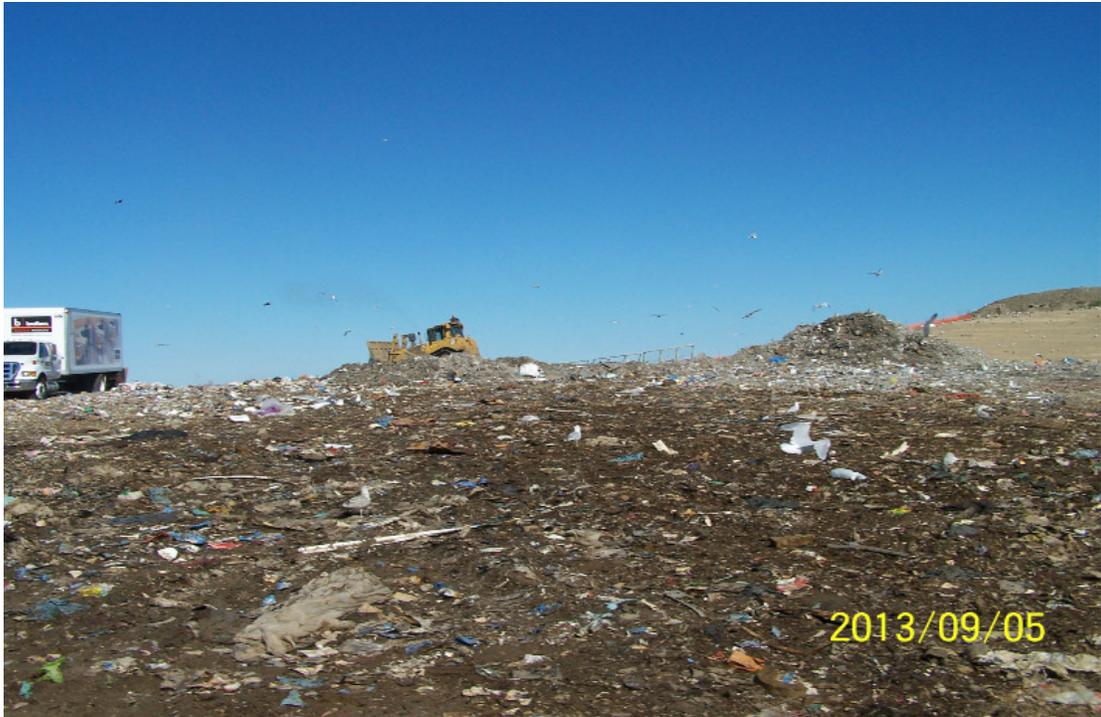
Dozer moving cover

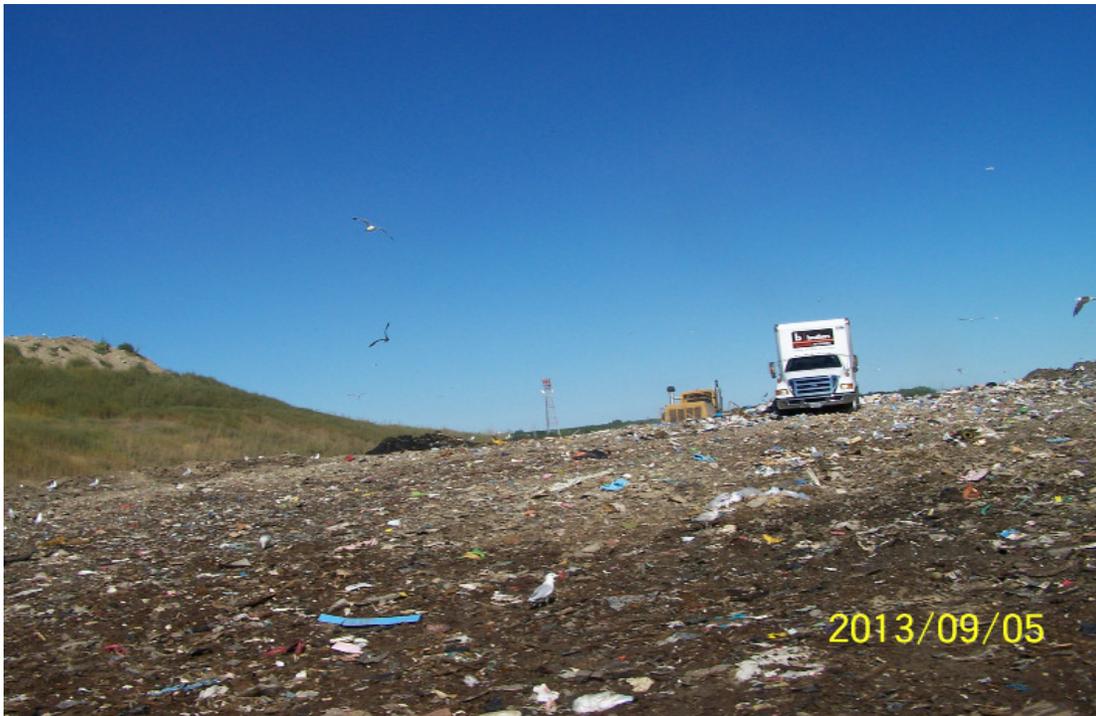
Working face

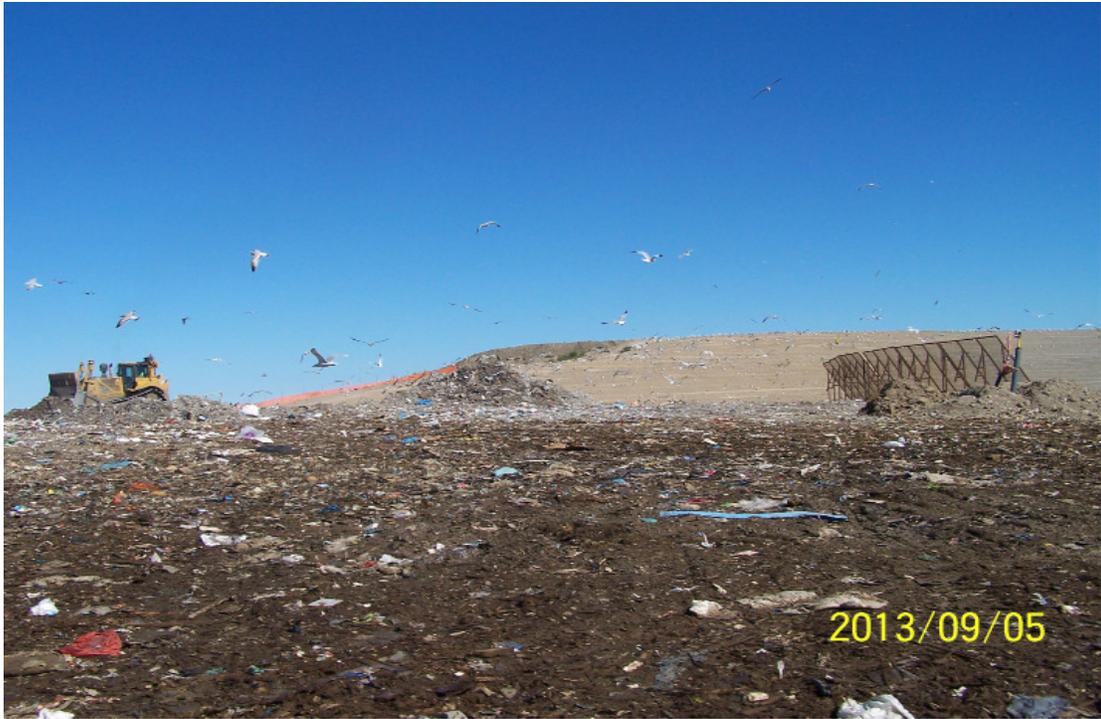
Active area

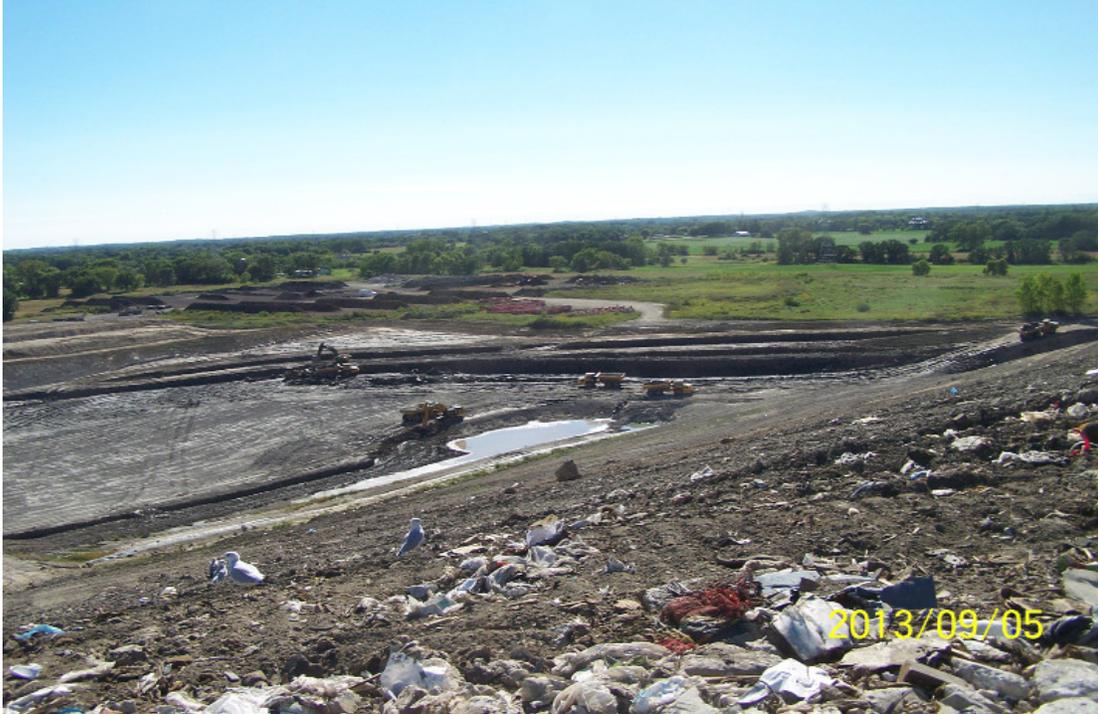
Temp sed basin nearly dry, no rain

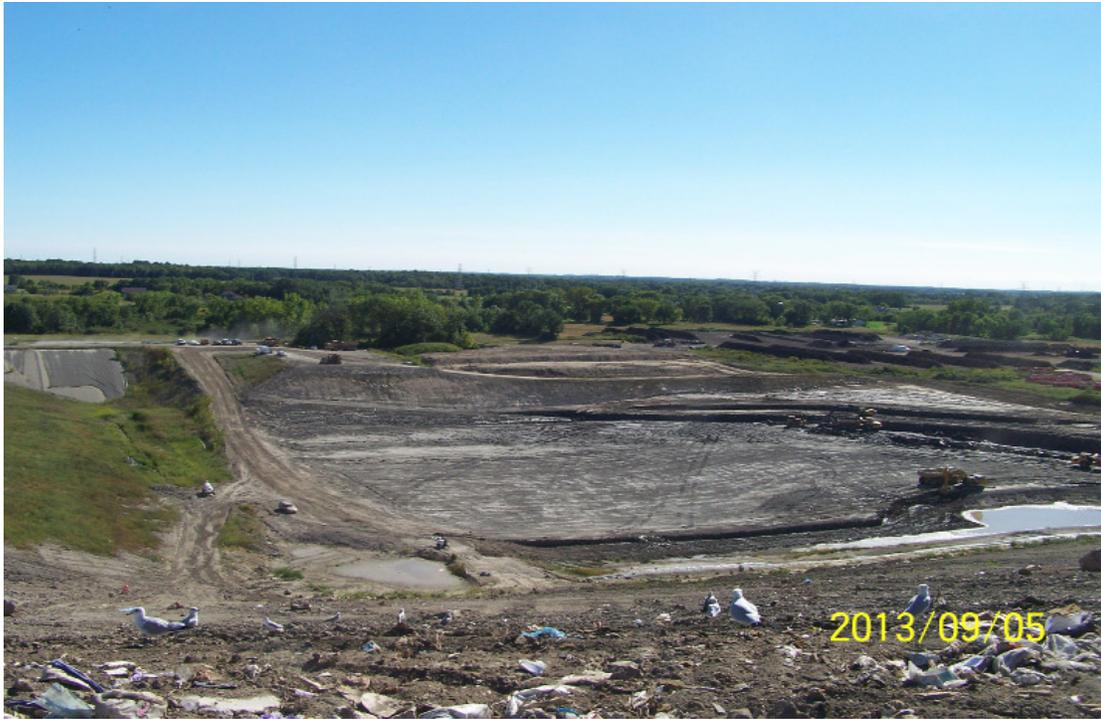
Excavation area

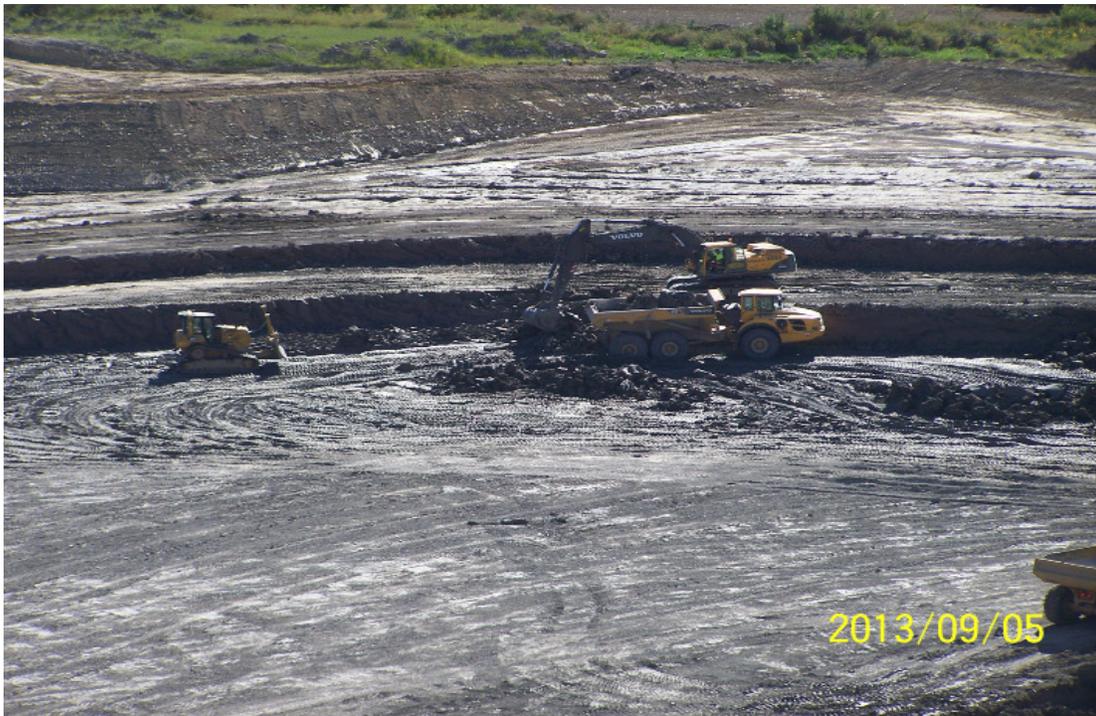
Outer edge of excavation

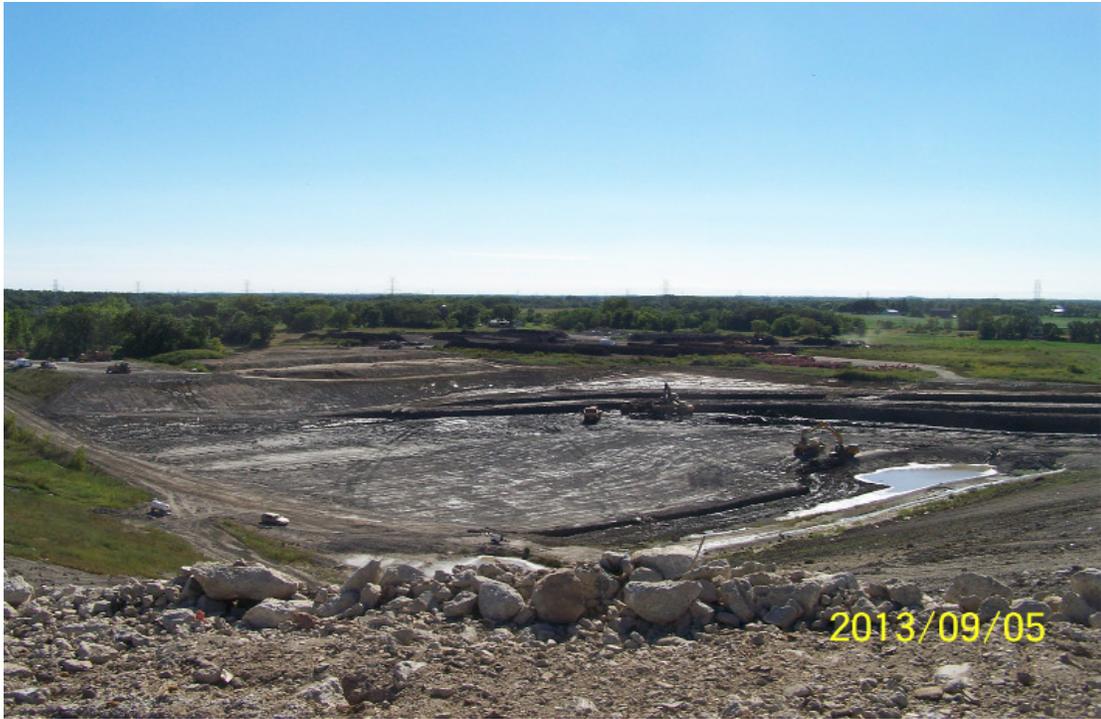
Clay excavation

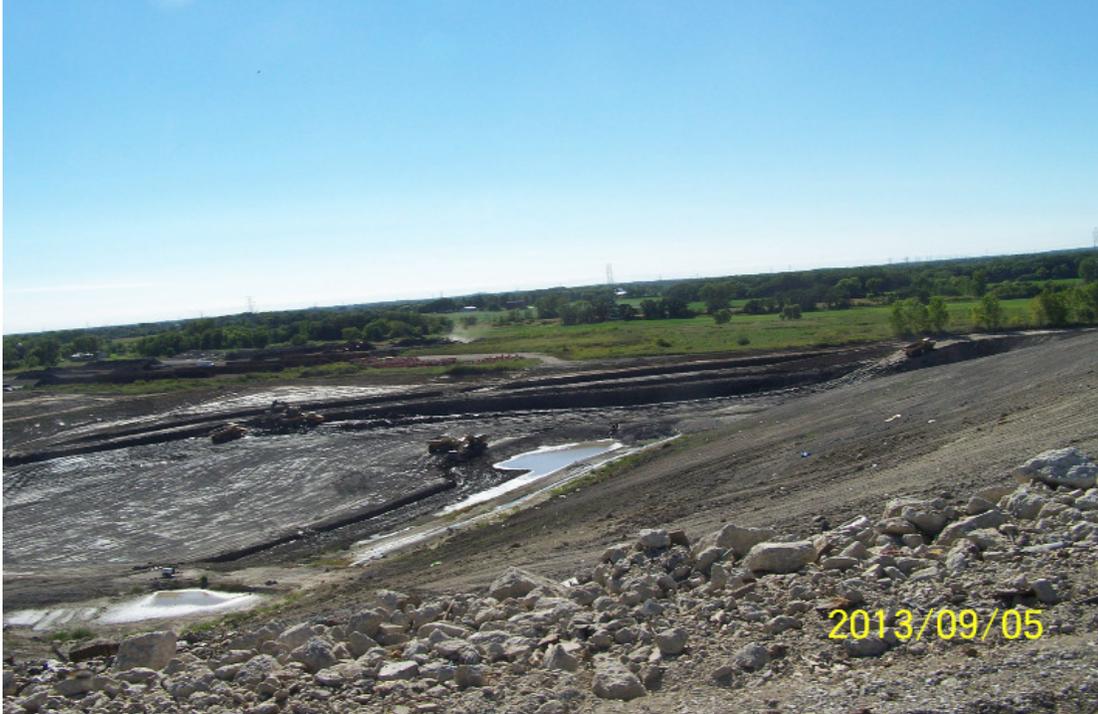
Excavation activities nearly at grad

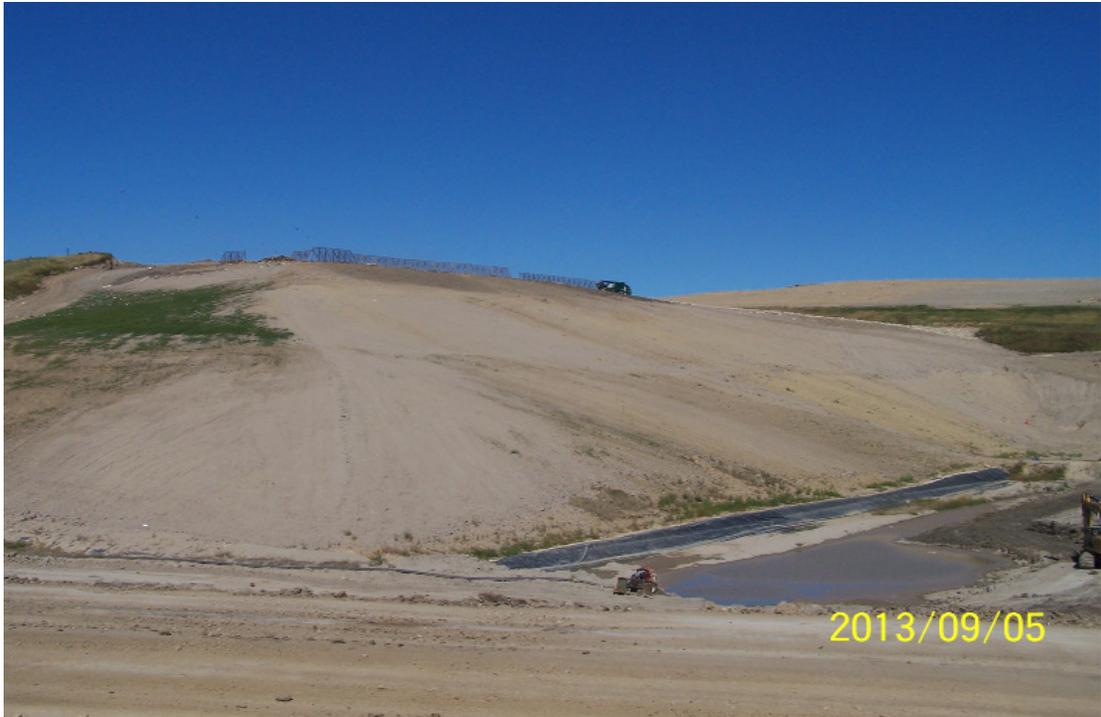
South and West slope of Phase 7

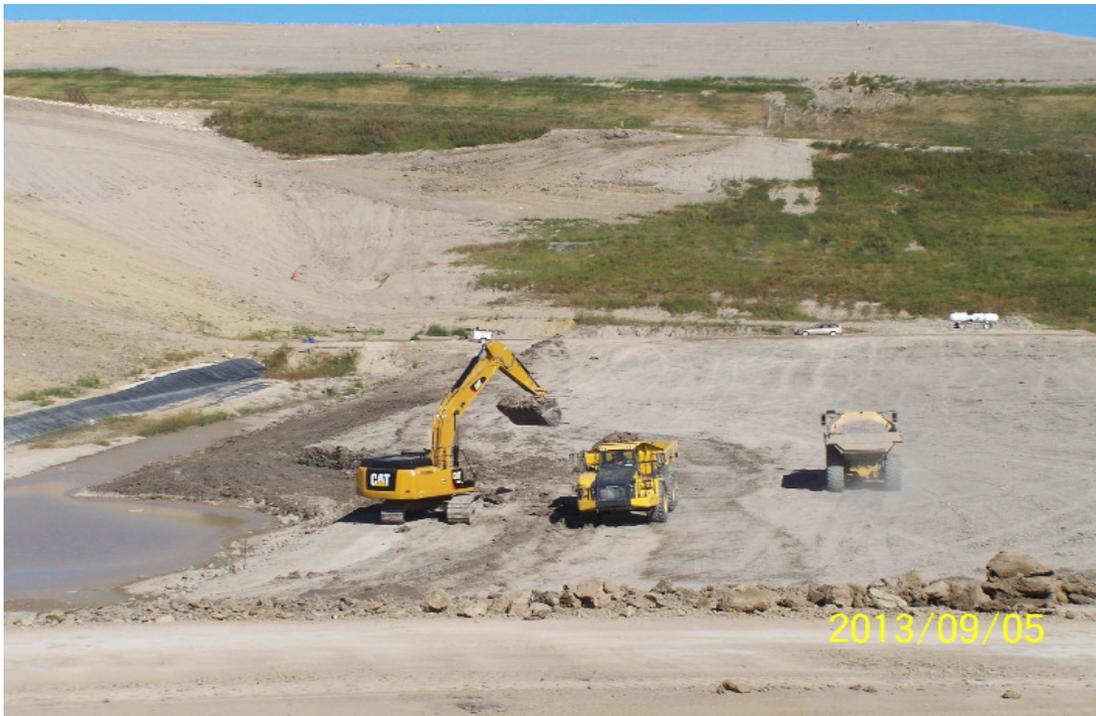
Excavation spreading out from temp sed basin grade

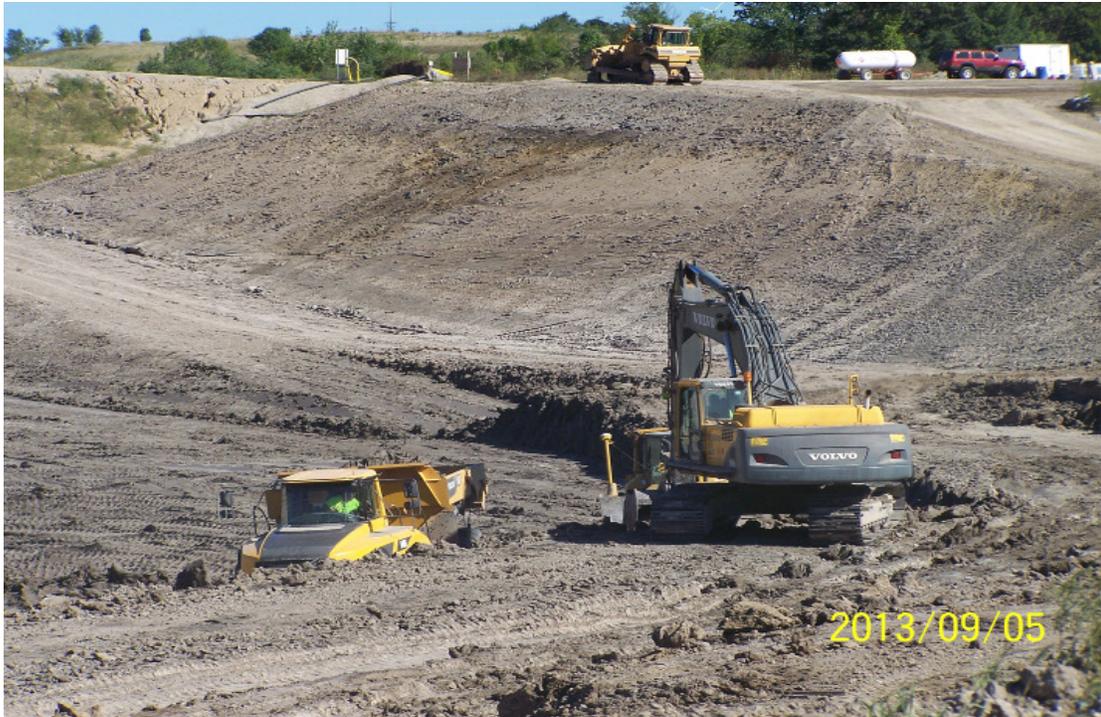
Excavation nearly at grade

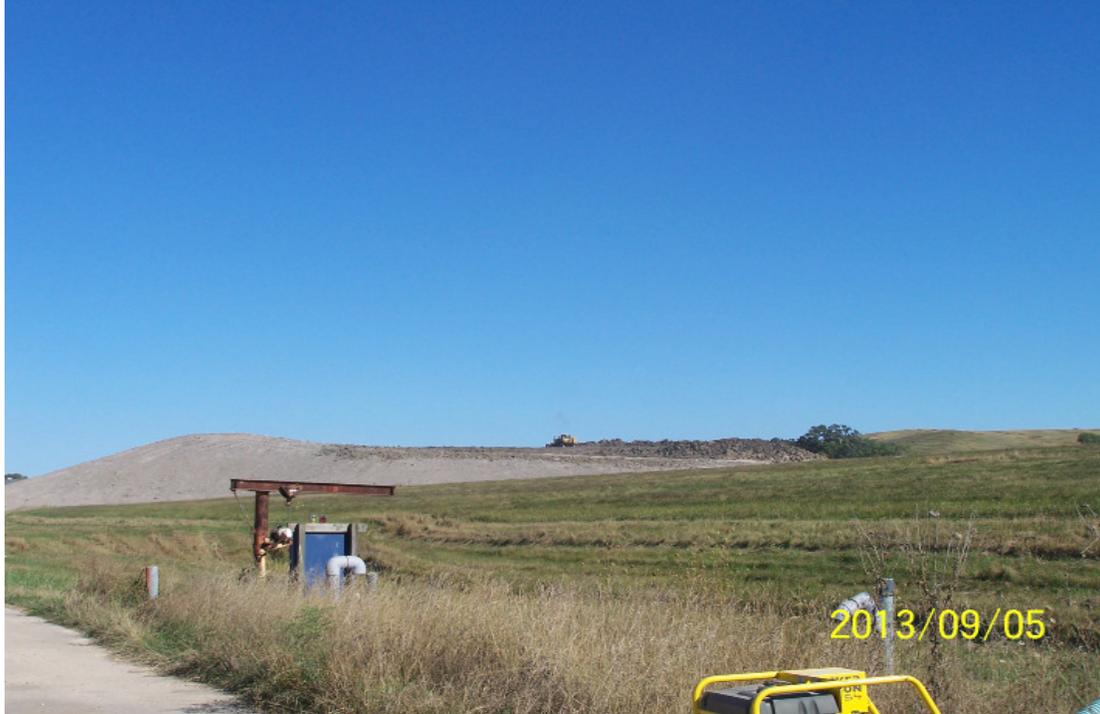
Eastern most stockpile in Future Parkland
