MEMORANDUM

ADS Emerald Park Landfill Audit Summary

TO: ADS Emerald Park Landfill Standing Committee, City of Muskego
FROM: Jo-Walter Spear, Jr., P.E.
COPIES: File
DATE: 09/19/2013
PROJECT NUMBER: 1012.10030

**ADVANCED DISPOSAL SERVICES
EMERALD PARK LANDFILL / CITY OF MUSKEGO
AUDIT PHOTOS**

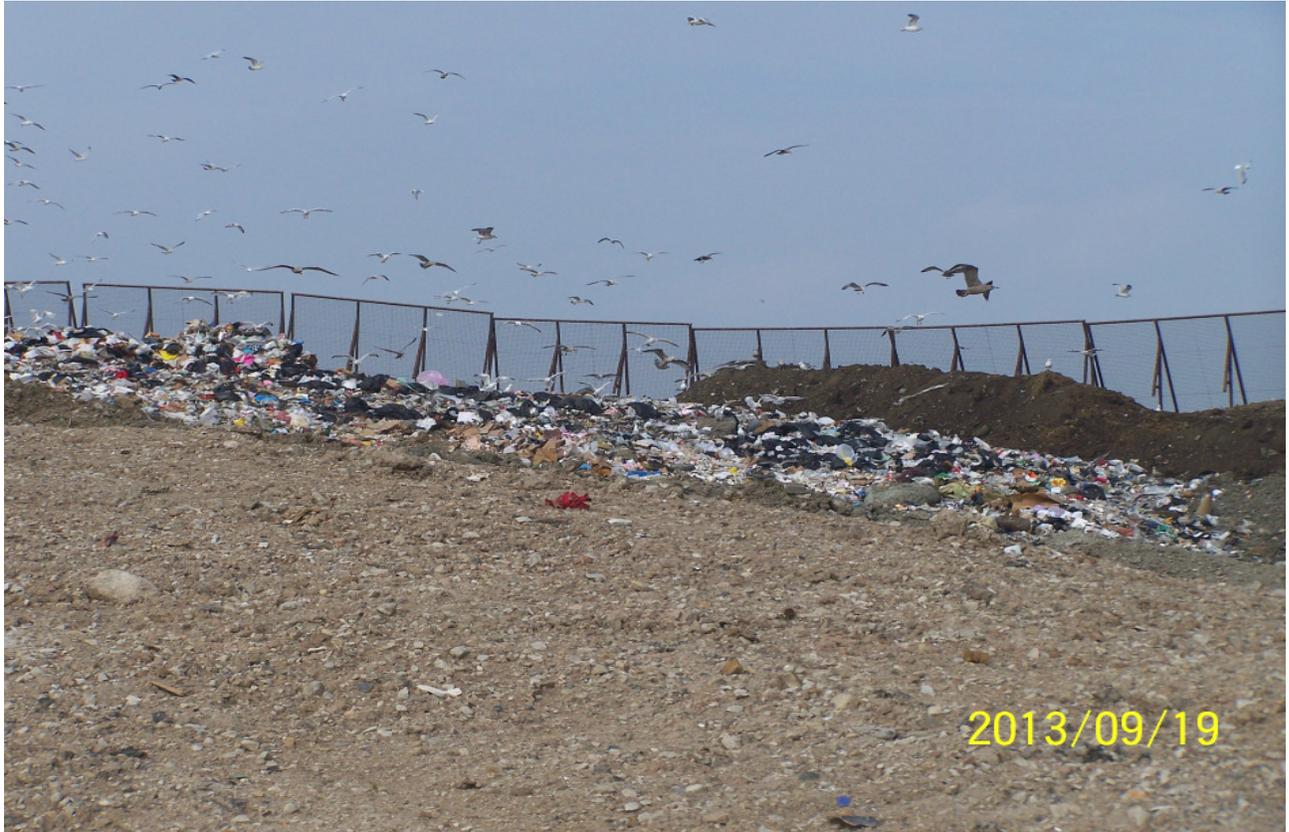
Minor litter about active area
Pickers combusting winds in Active Area

Windy day, litter filling fences in Active area

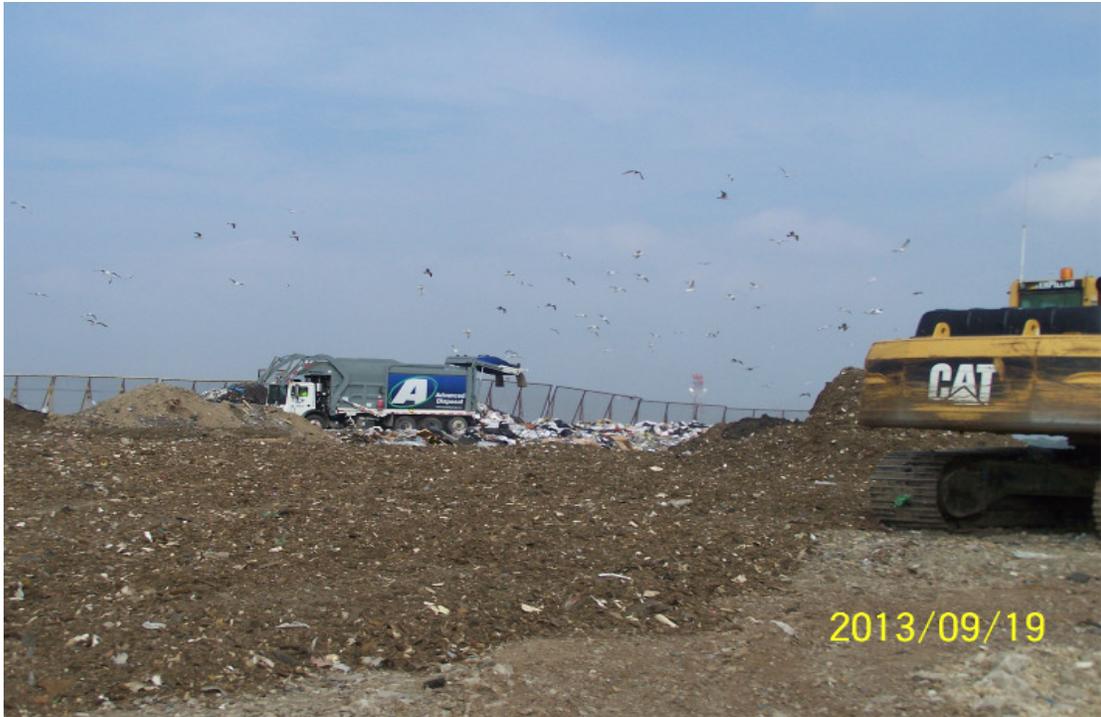
Working face

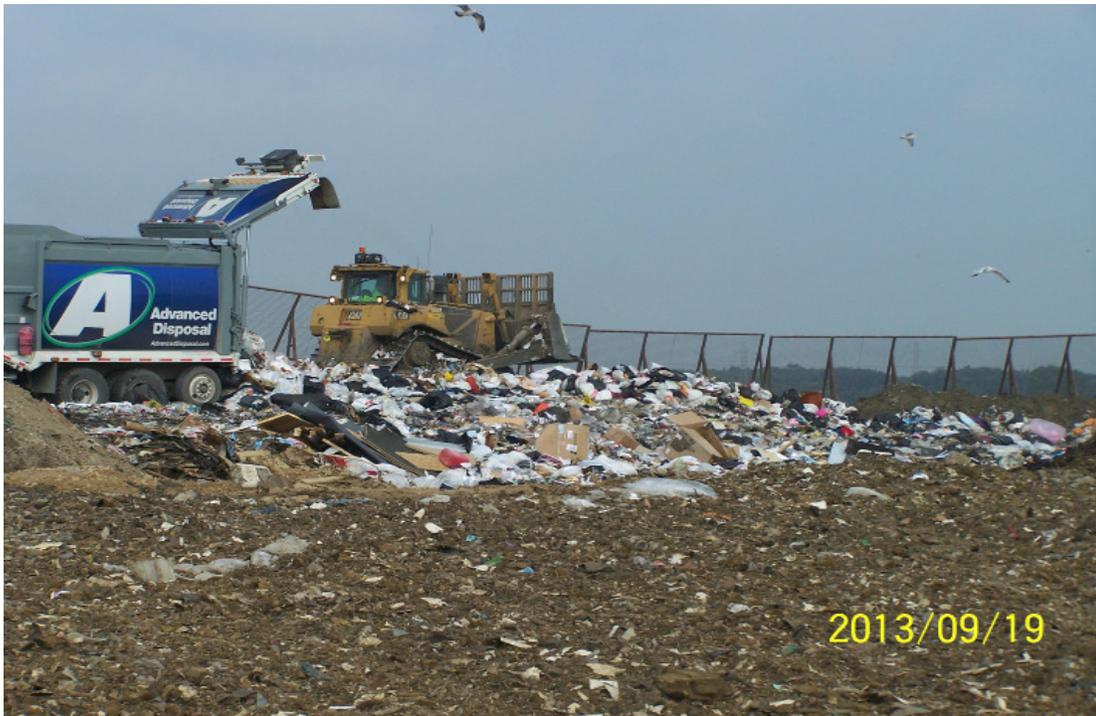
Working Face

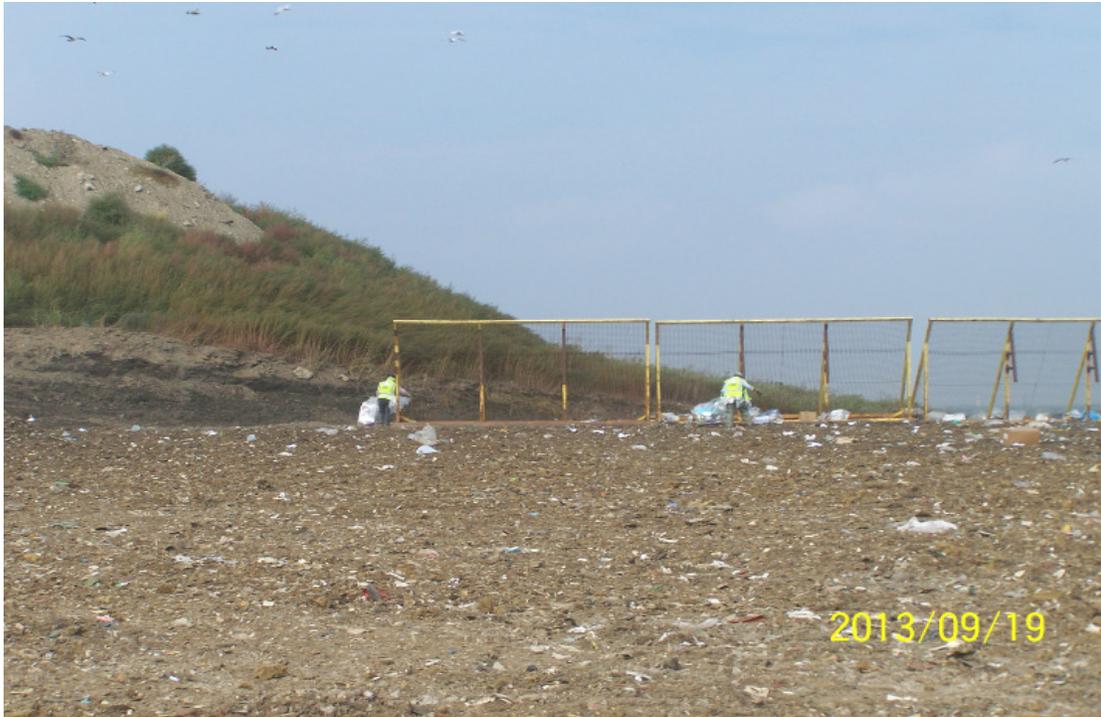
Transition point of Phases 3,4,5,6,& 7

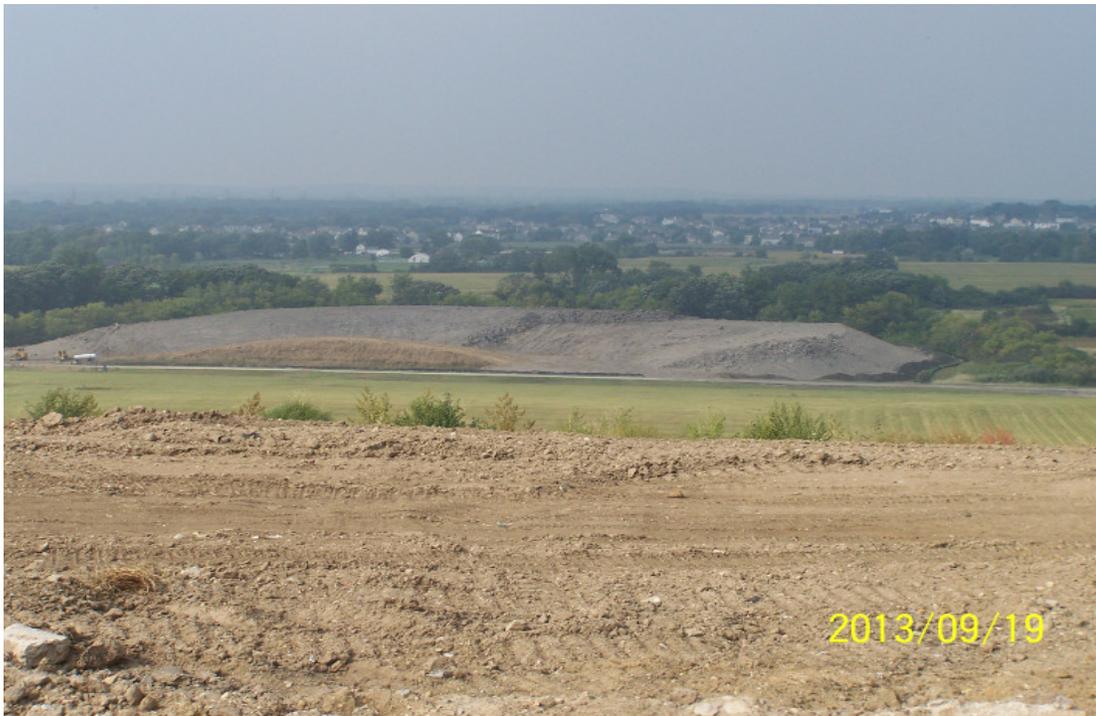
Western stockpile viewed from Emerald Park (South)

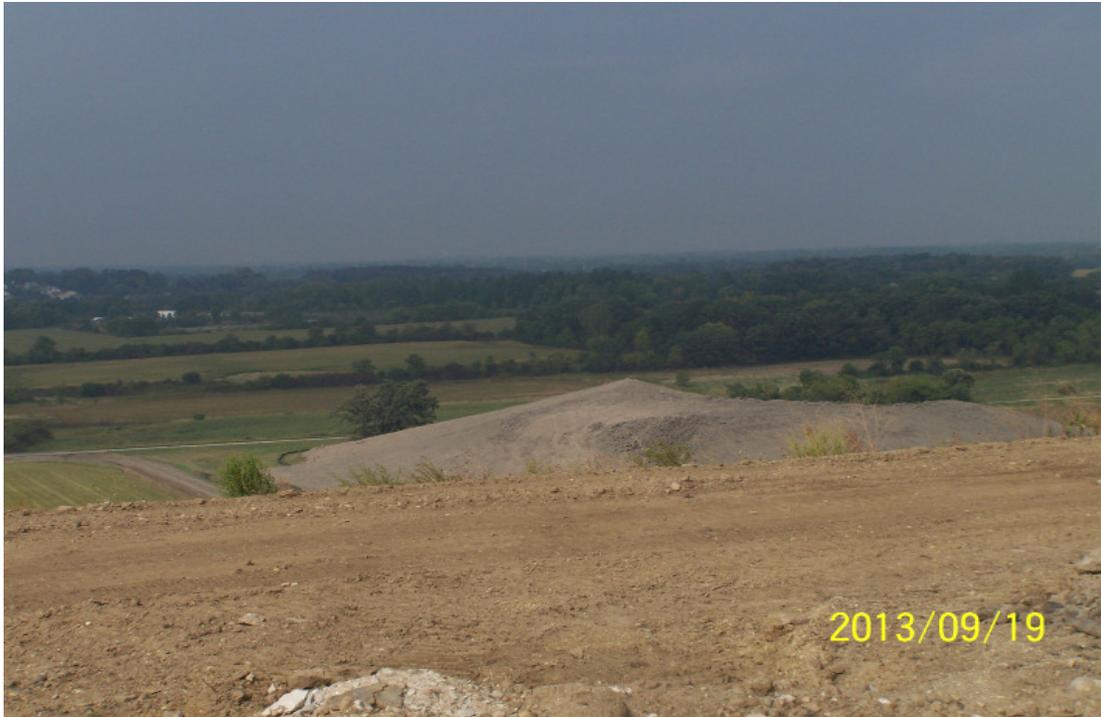
Eastern Stockpile viewed from Emerald Park (South)

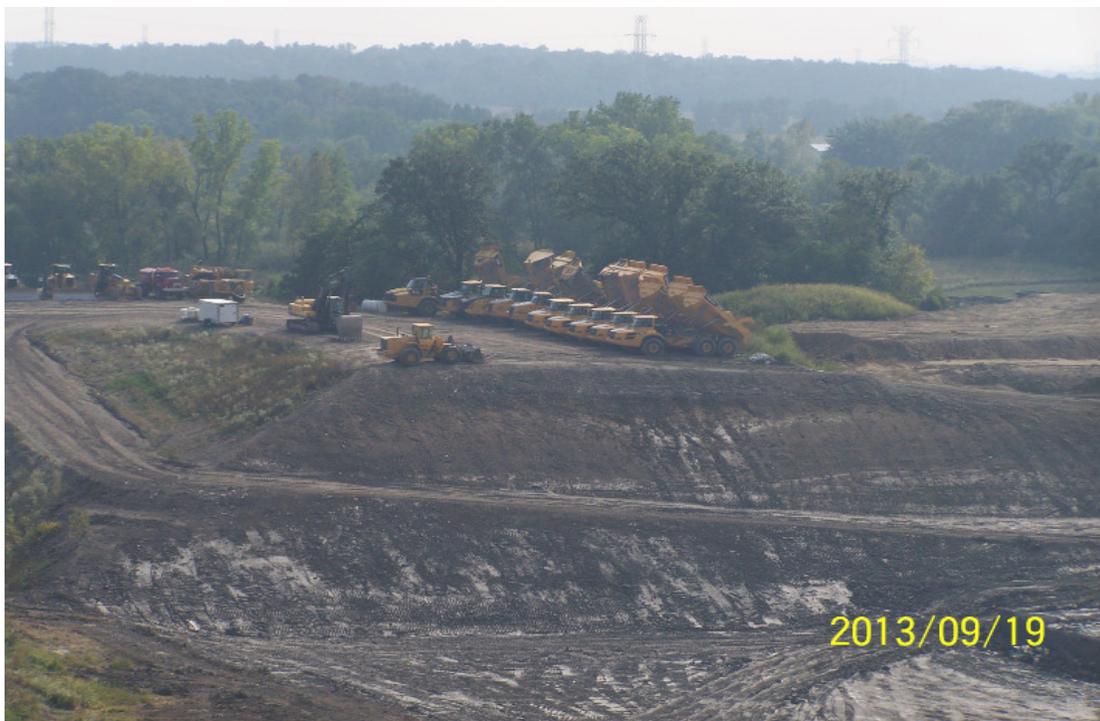
Equipment staged during bad weather
