MEMORANDUM

ADS Emerald Park Landfill Audit Summary

TO: ADS Emerald Park Landfill Standing Committee, City of Muskego
FROM: Jo-Walter Spear, Jr., P.E.
COPIES: File
DATE: 10/02/2013
PROJECT NUMBER: 1012.10030

Attached is the audit report for activities at the ADS Emerald Park Landfill for the week of September 30, 2013. The audit was performed at 2:15 PM on **October 2, 2013** by Jo Spear, Jr. in the presence of David Geier.

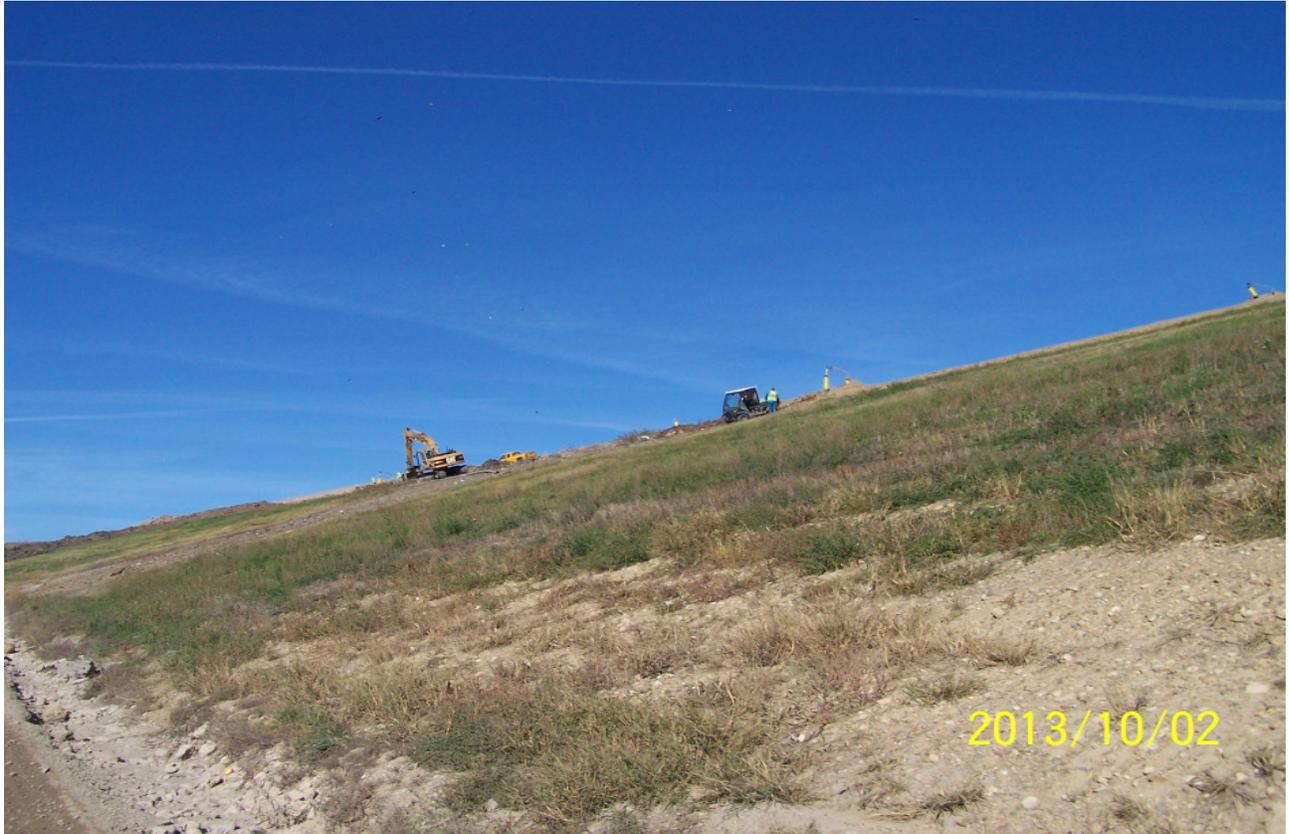
Phase 6, West slope, dressed with brown clay and under going gas field repairs.

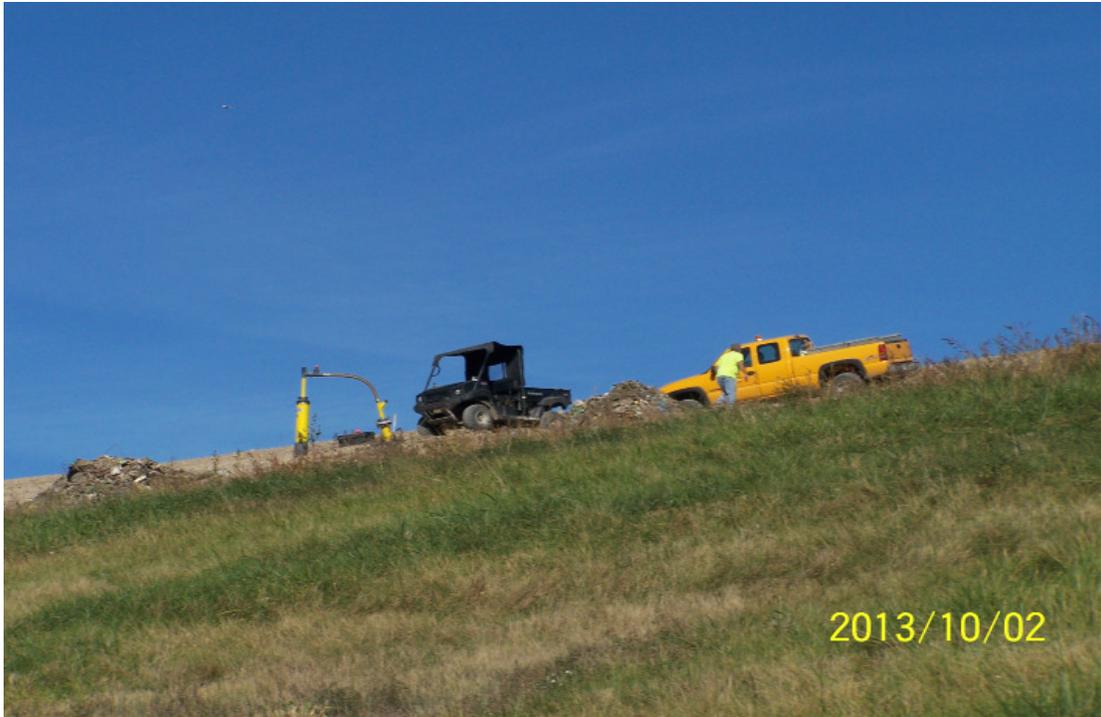
Contractor and site gas tech repairing lines

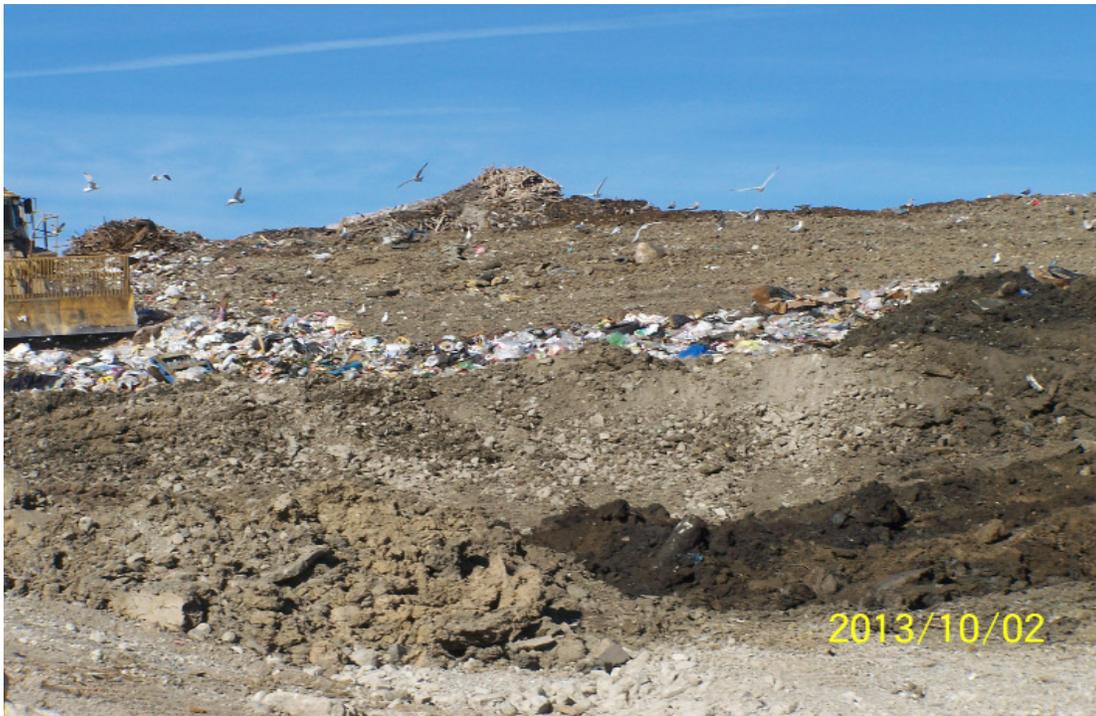
Working Face

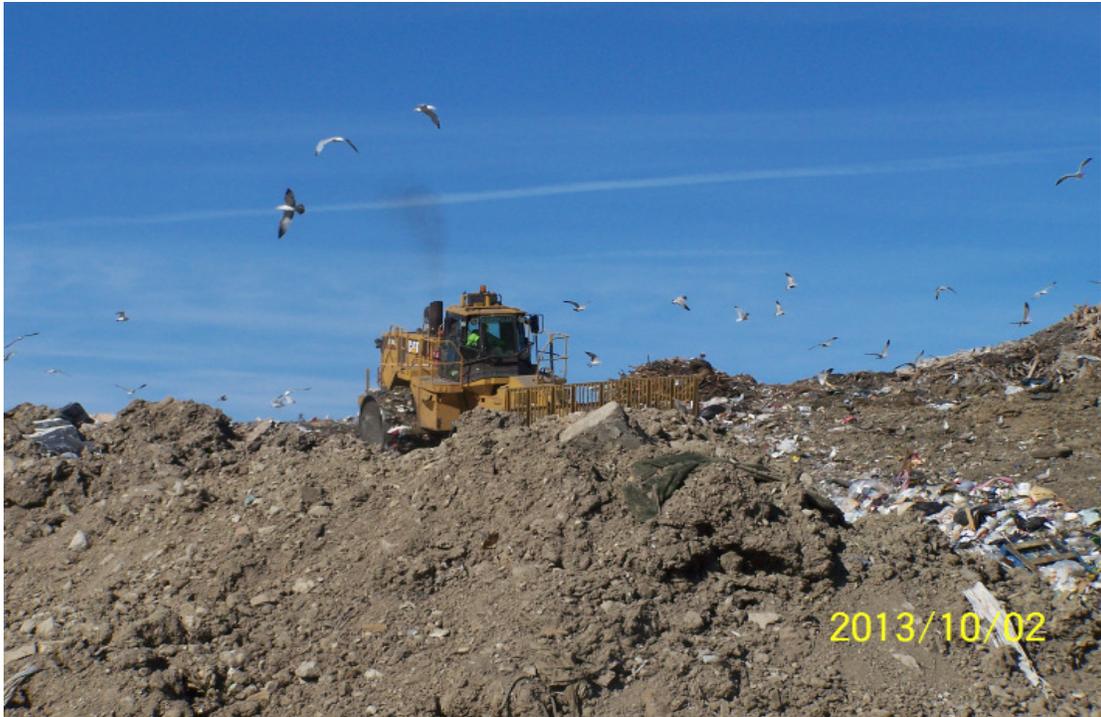
Compactor placing and compacting waste

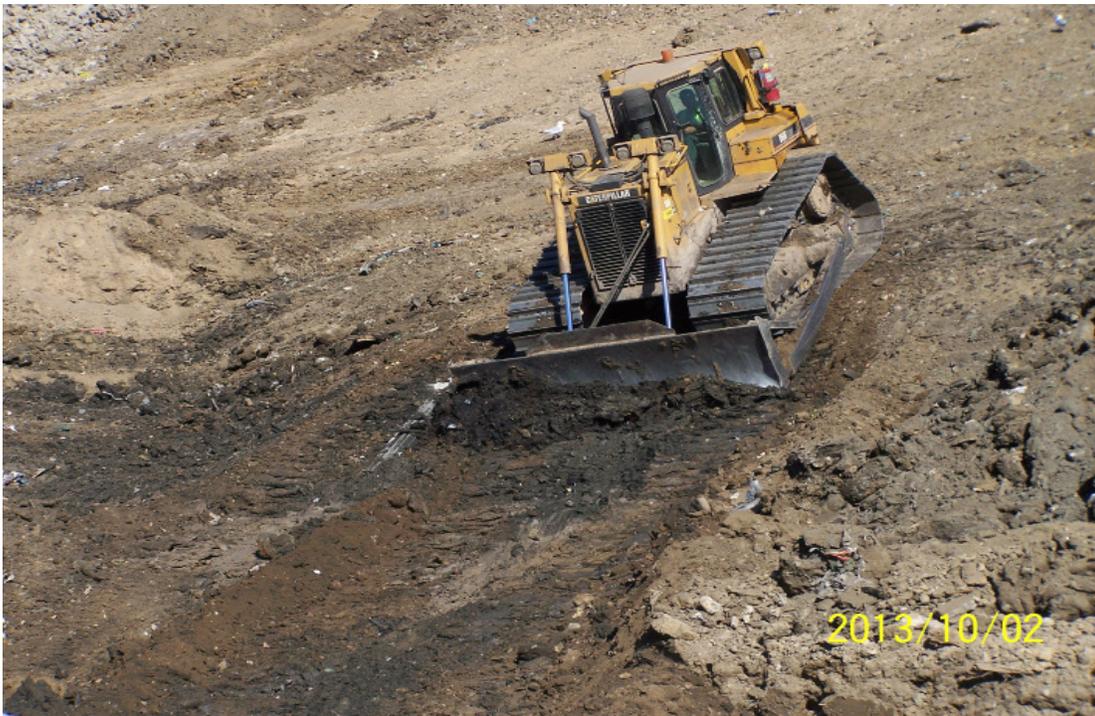
Dozer cleaning up limits of today's waste placement

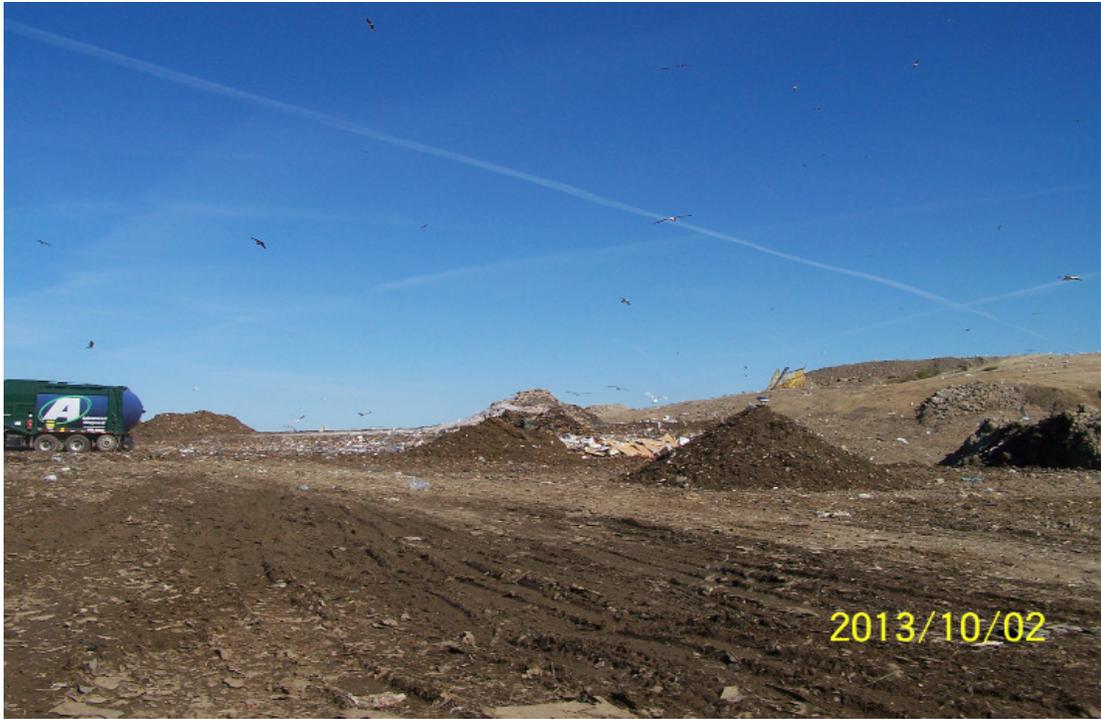
Active area

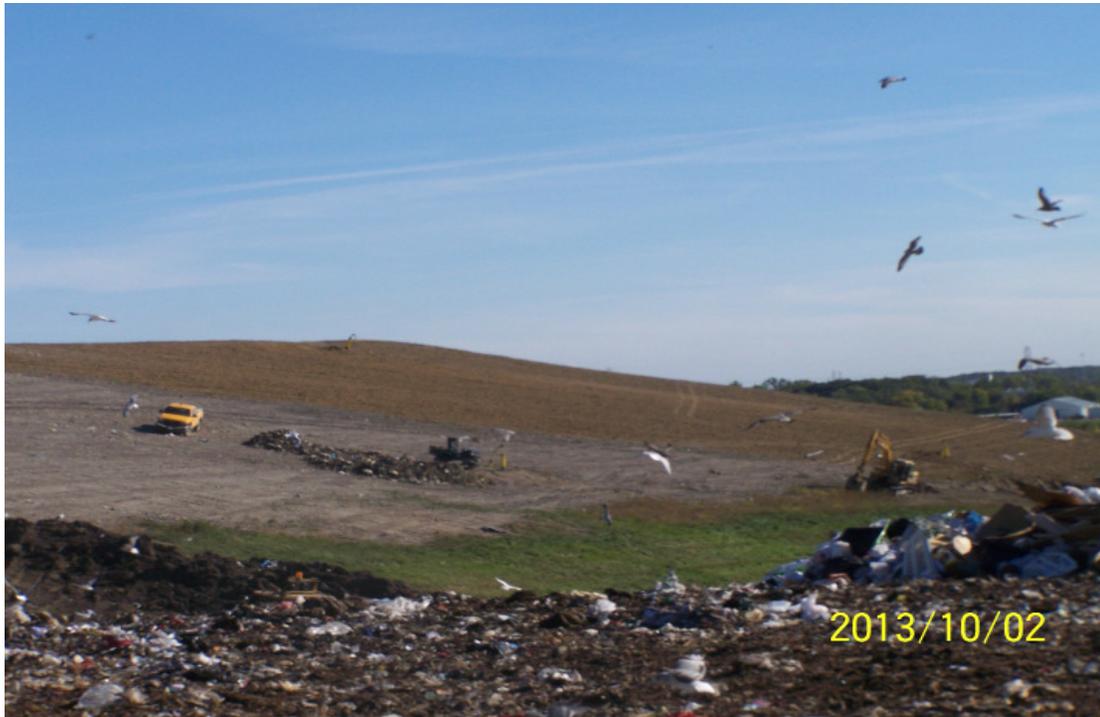
Repairs on gas lines in Phase 6

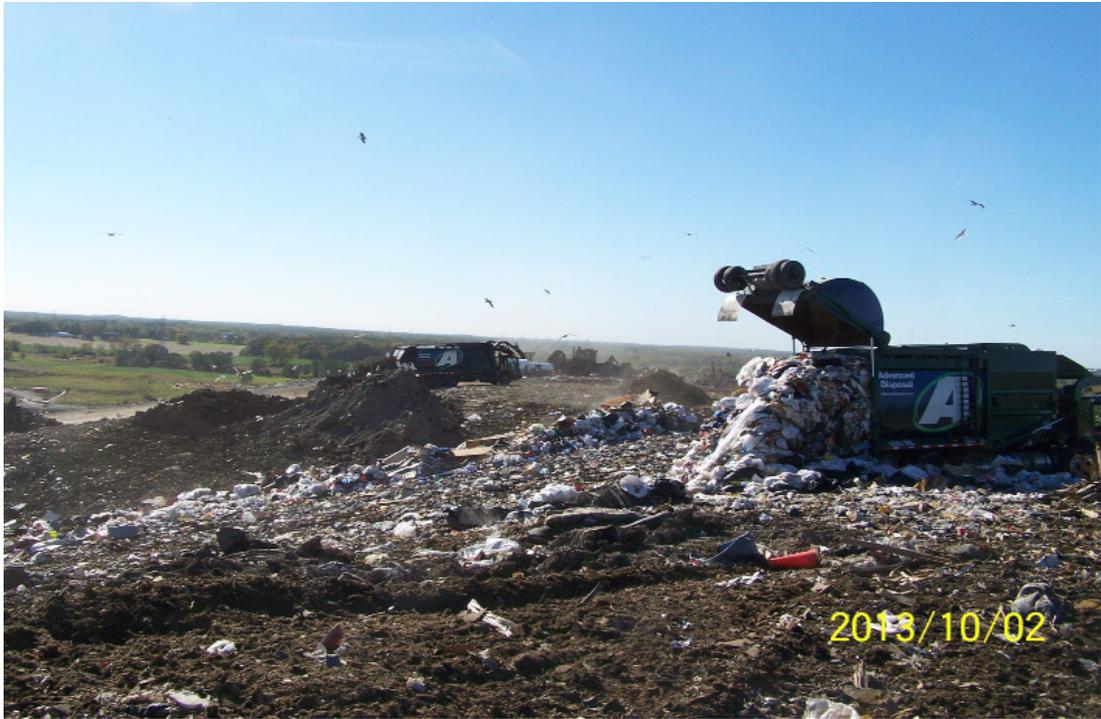
Tipping trucks in working face

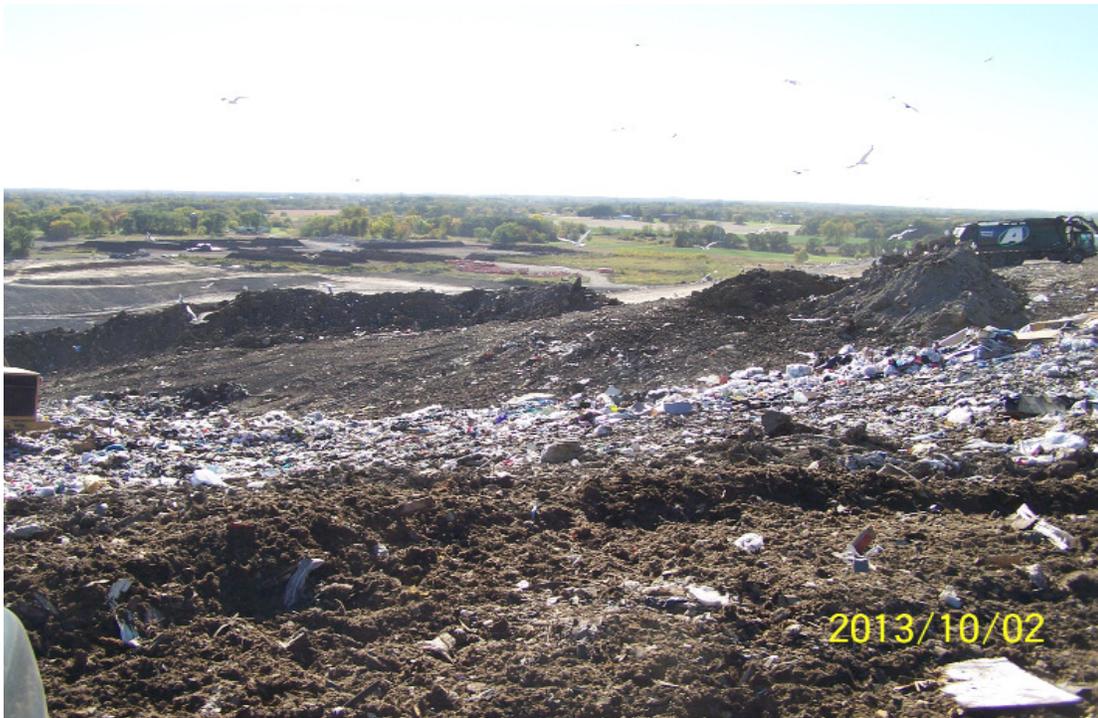
Working face

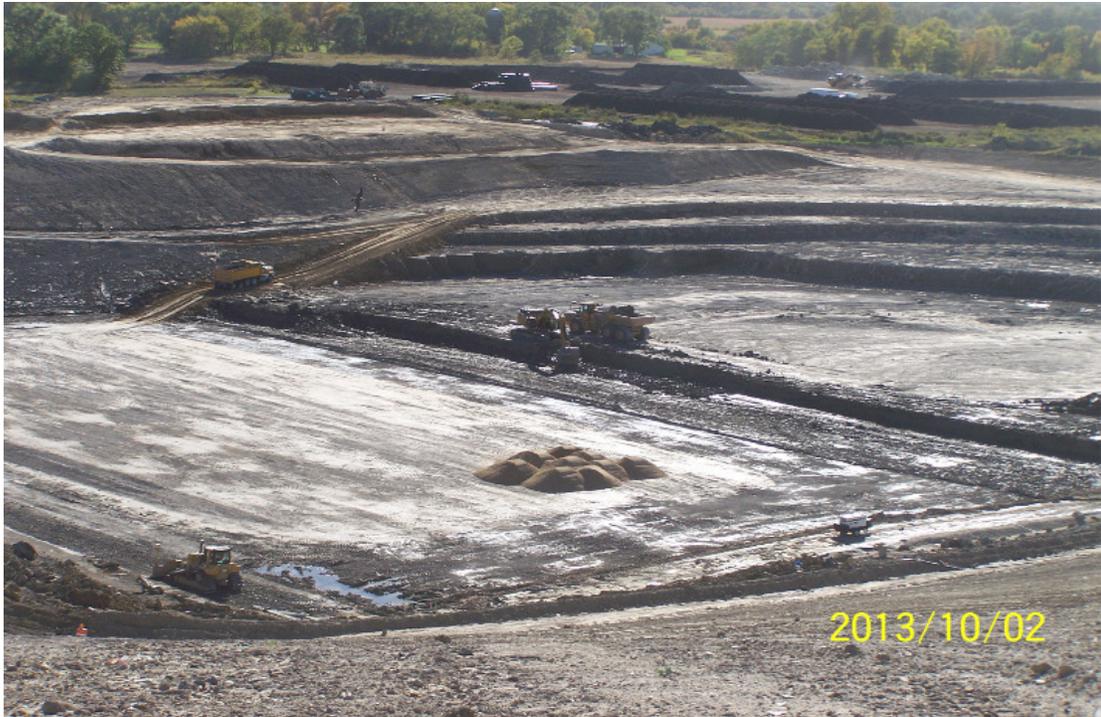
Excavation receiving sand for gradient layer

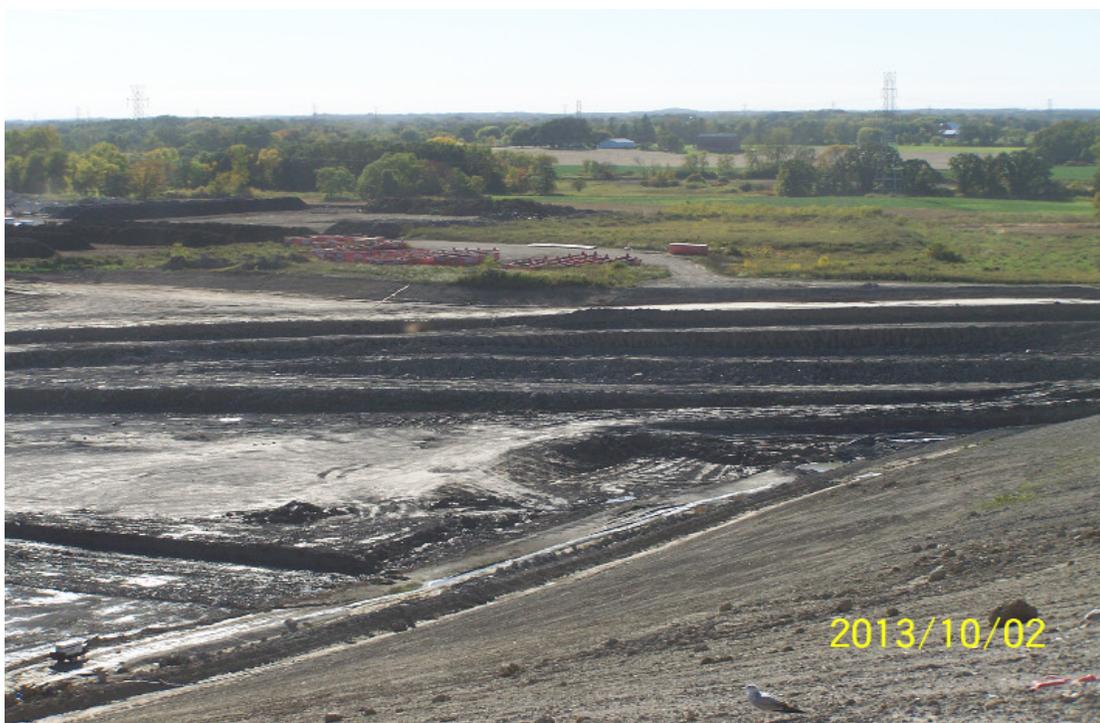
West extreme of excavation

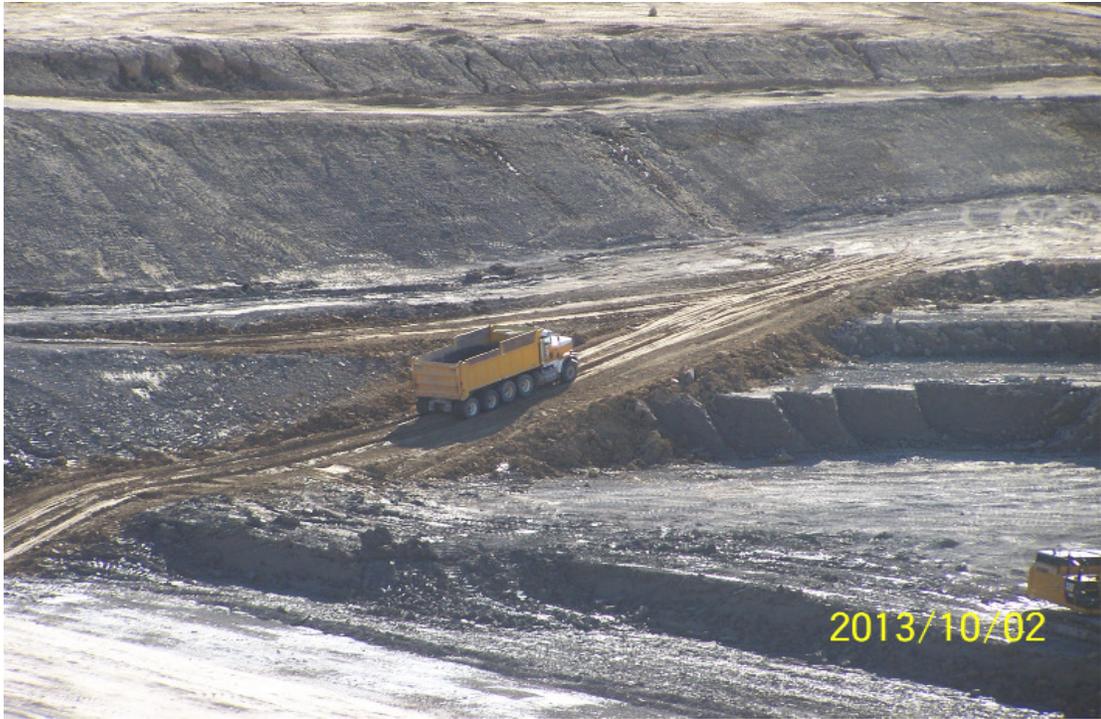
Sand delivery

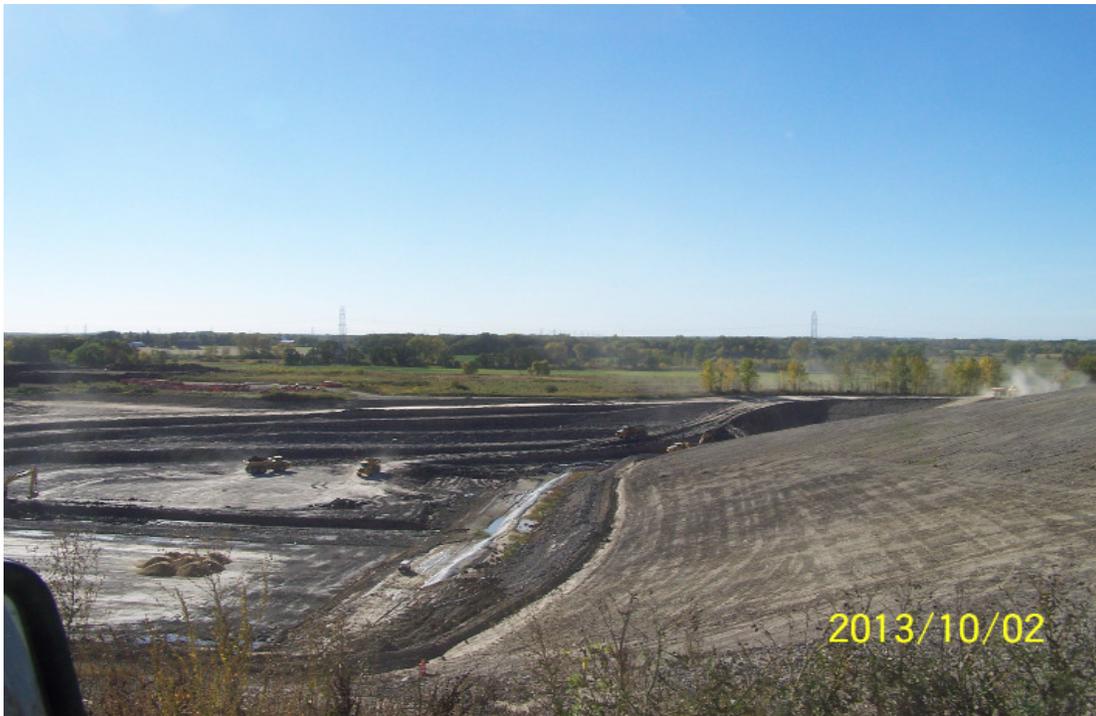
Northern portion of excavation

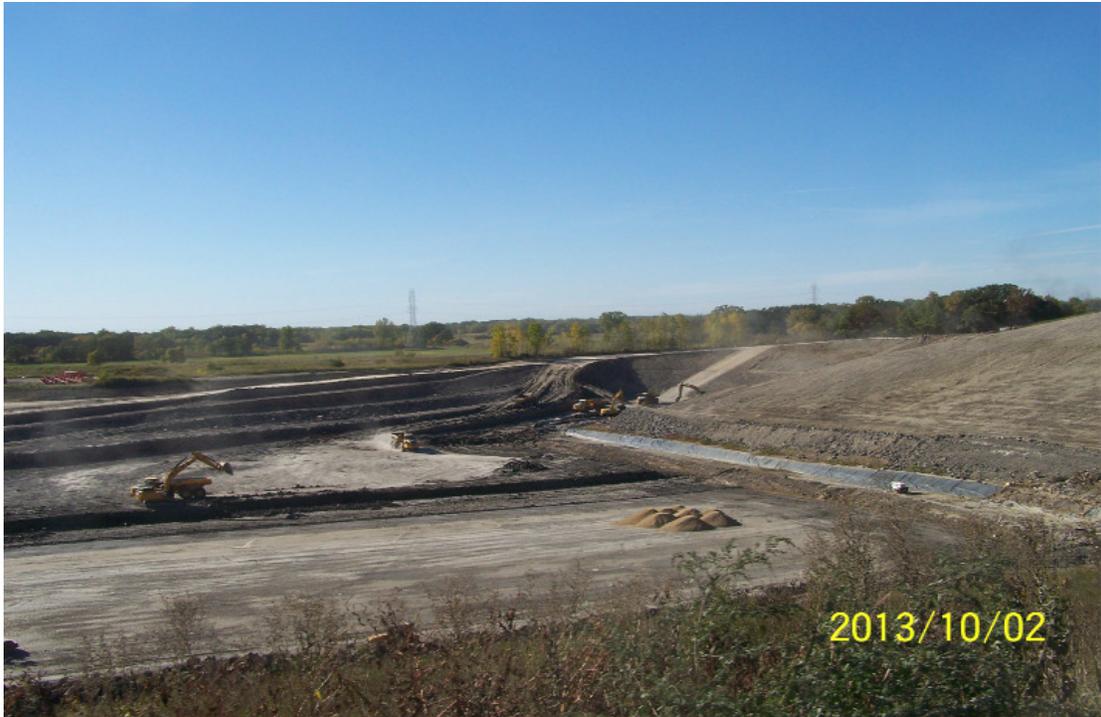
Excavation half completed and sand loads for gradient layer are being delivered

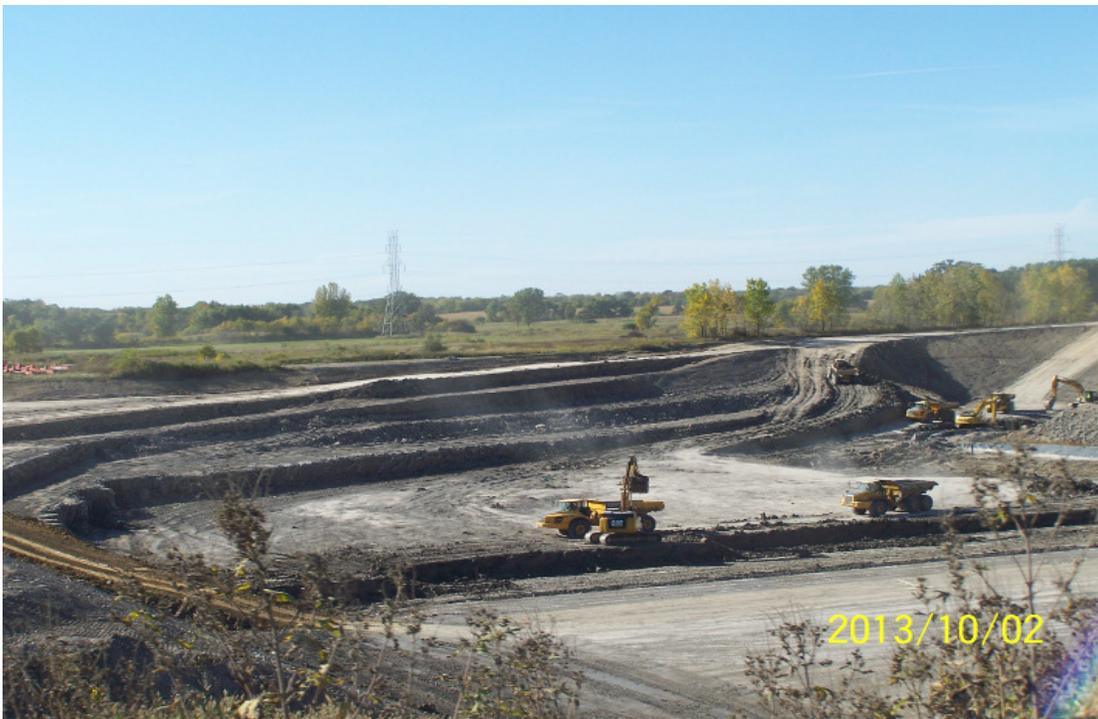
West half of excavation being excavated along with side slopes

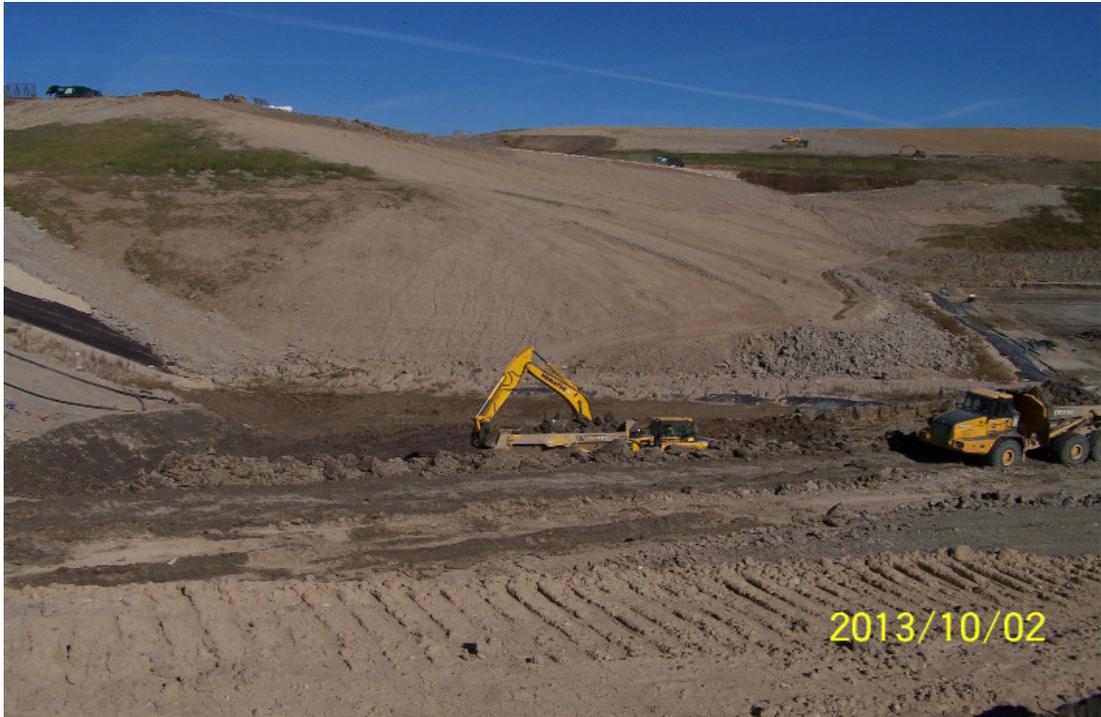
Sump excavation

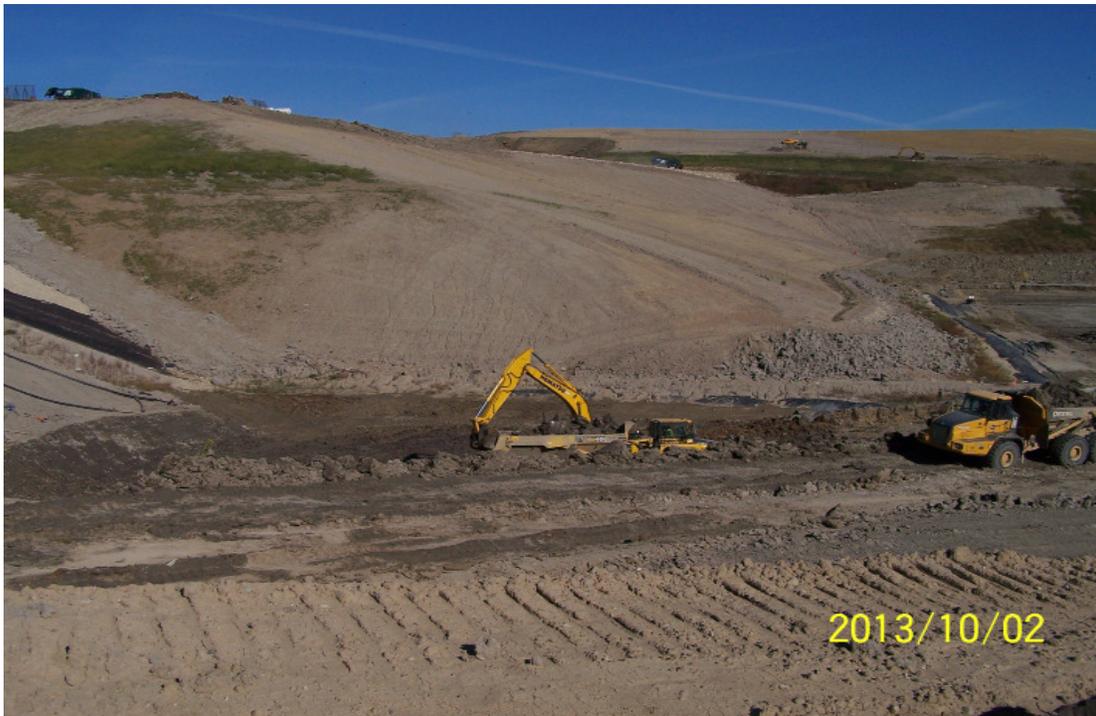
Sump at base of Phase 7 & 8, will be expanded to act as a temp sed basin.

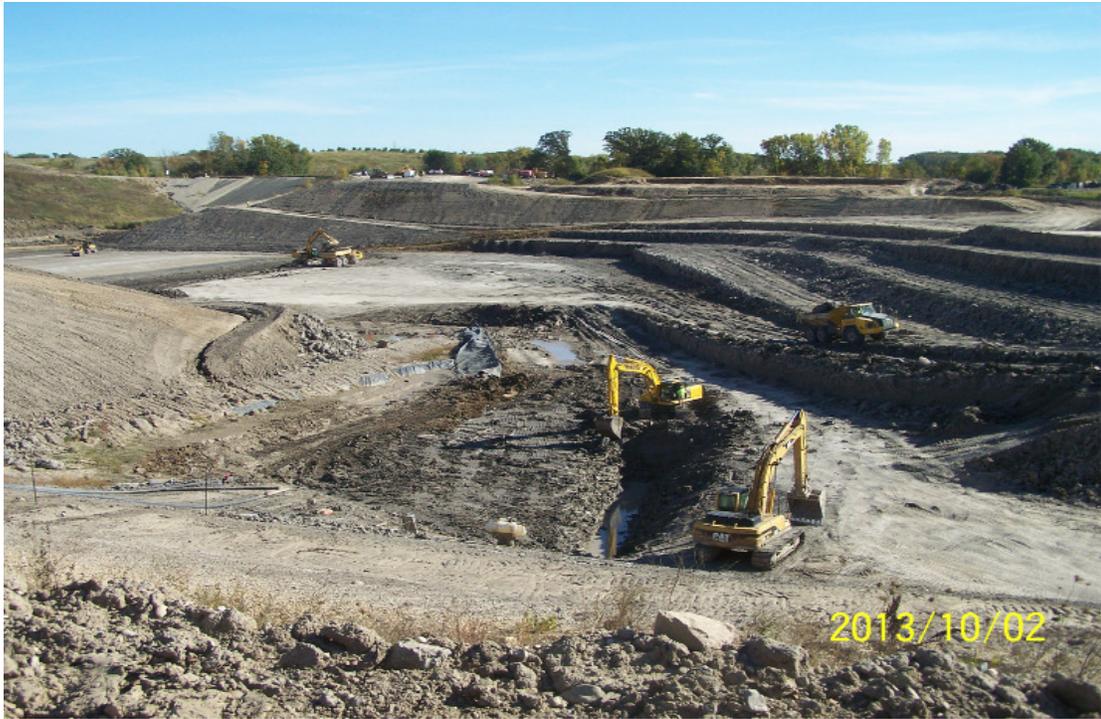
Excavation of sump

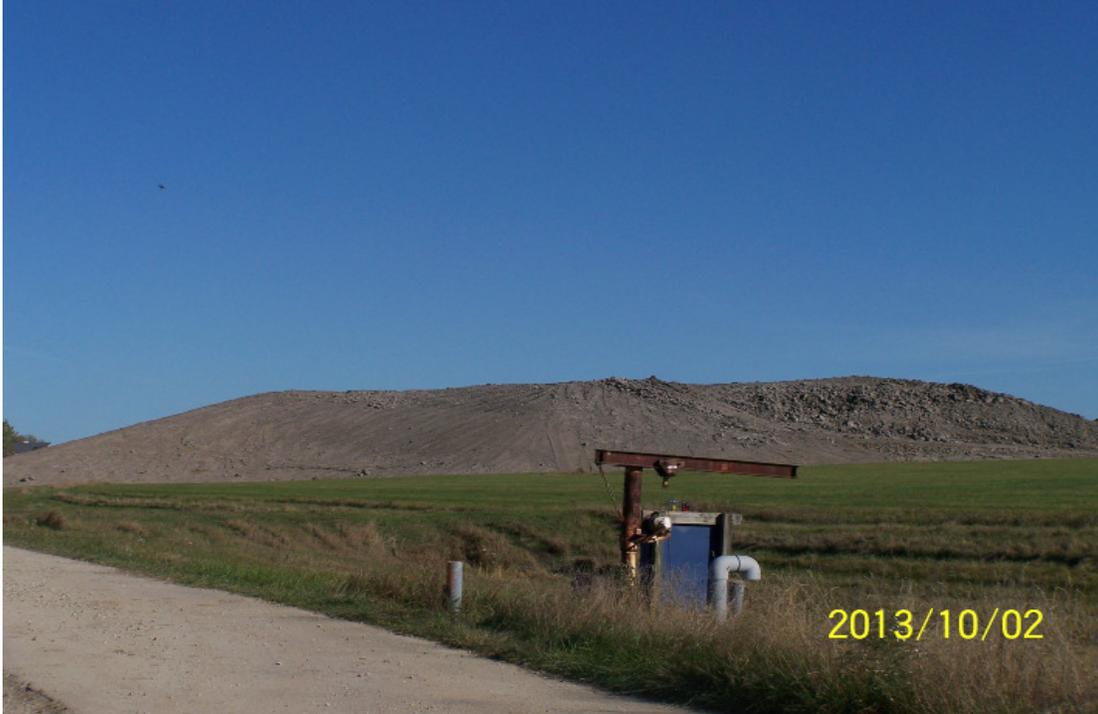
Eastern stock pile

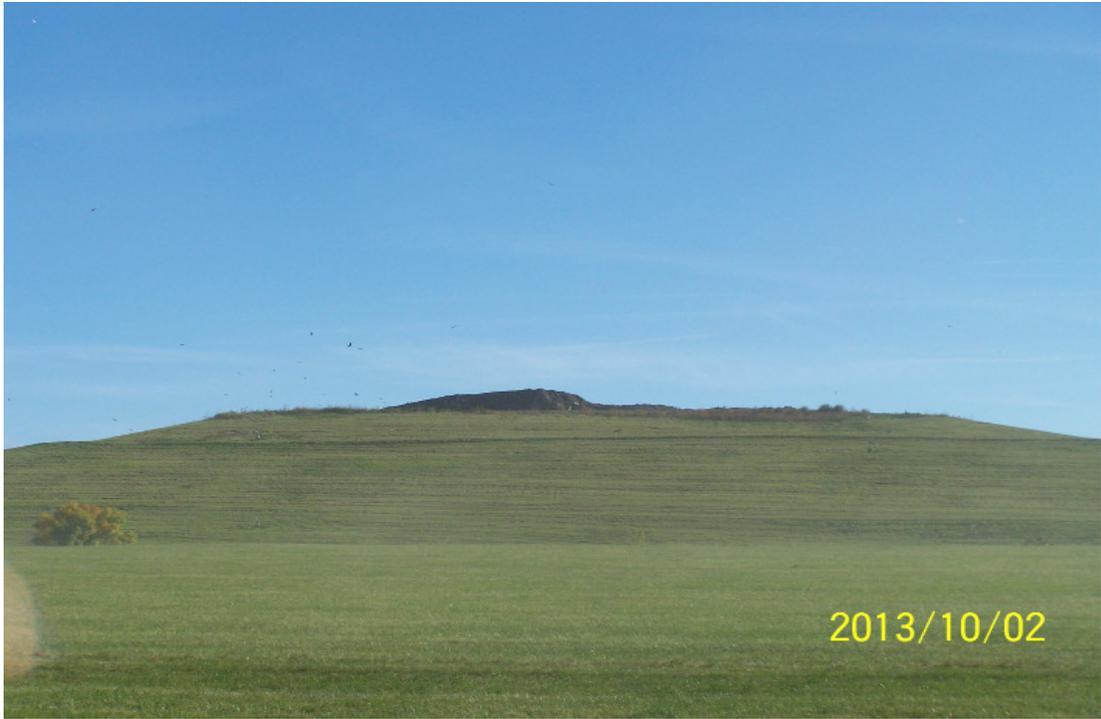
View of Phase 1, Closure Area 1, from North
