ADS Emerald Park Landfill Audit Summary

TO: ADS Emerald Park Landfill Standing Committee, City of Muskego
FROM: Jo-Walter Spear, Jr., P.E.
COPIES: File
DATE: 10/17/13
PROJECT NUMBER: 1012.10030

**ADVANCED DISPOSAL SERVICES
EMERALD PARK LANDFILL / CITY OF MUSKEGO
AUDIT PHOTOS**

PROJECT NO. 1012.10030

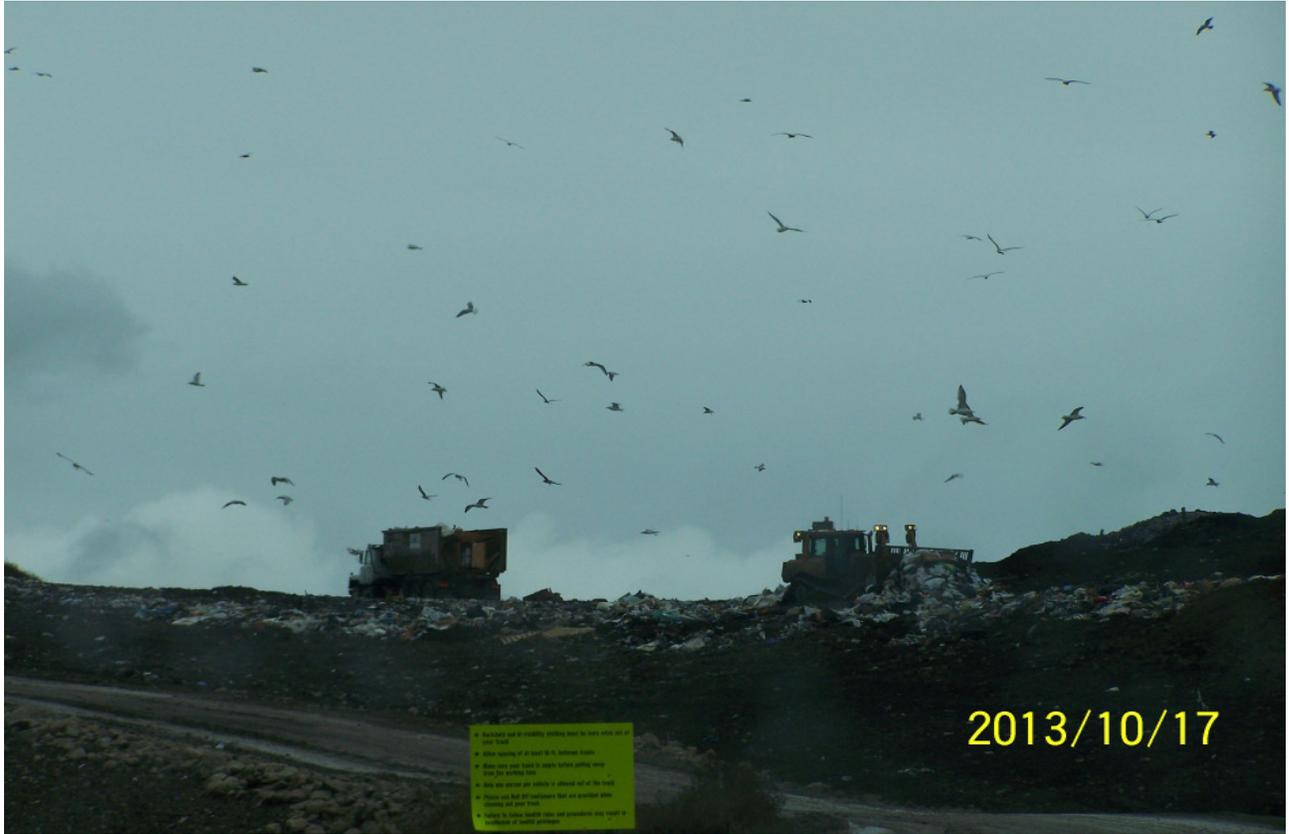
Active area

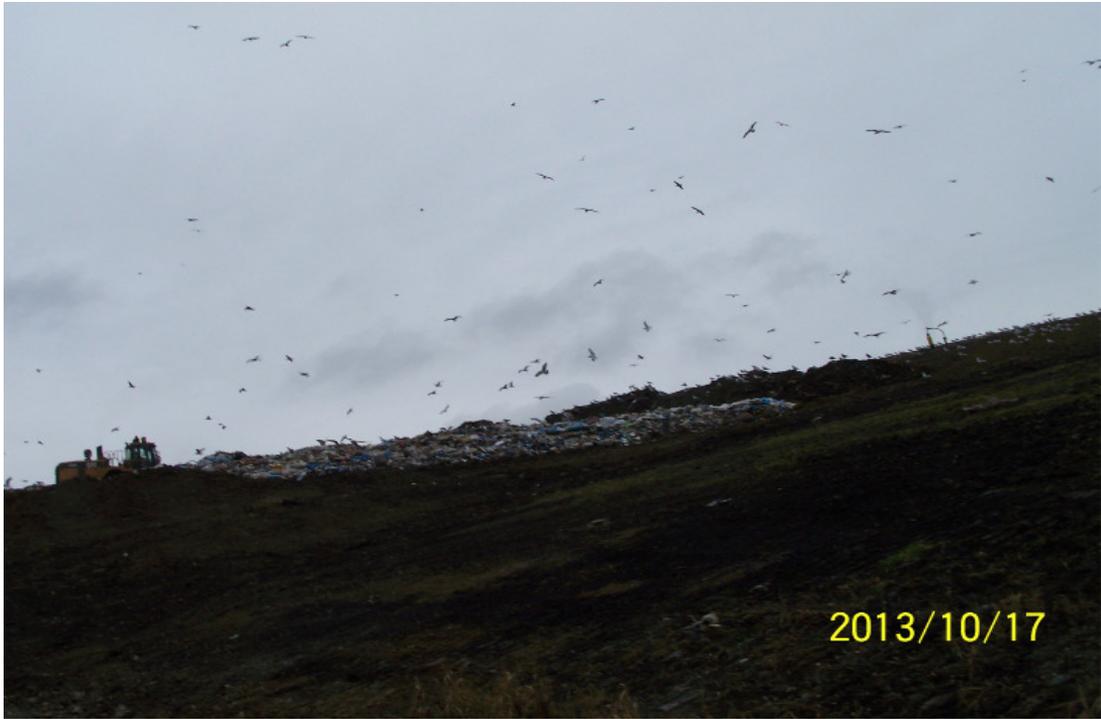
Working face

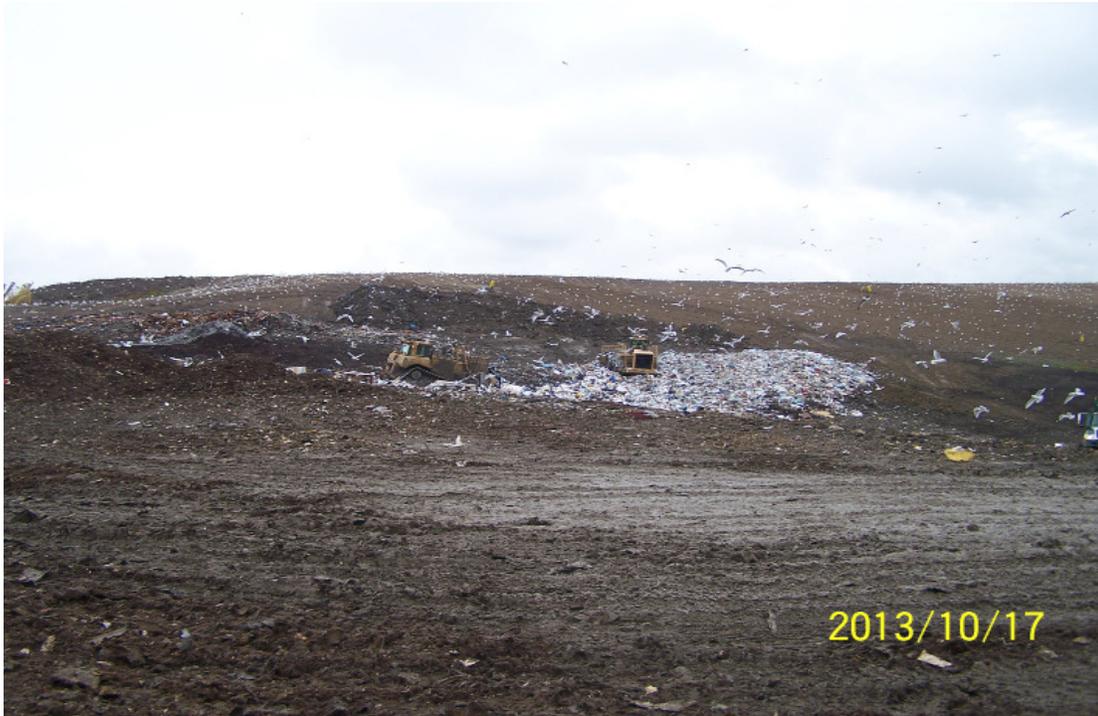
Working Face

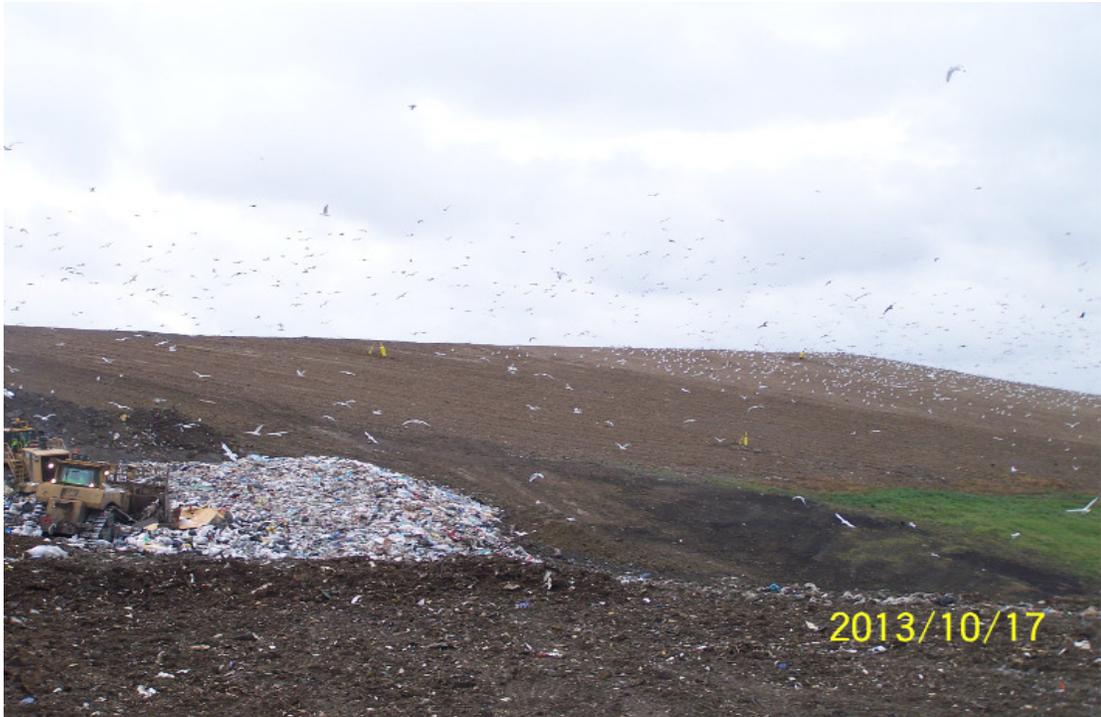
Working face finishing up filling of access road. Oddly shaped & to finish lift and will eventually start back westward Phase 6 & 7.

Working face finishing road fill in

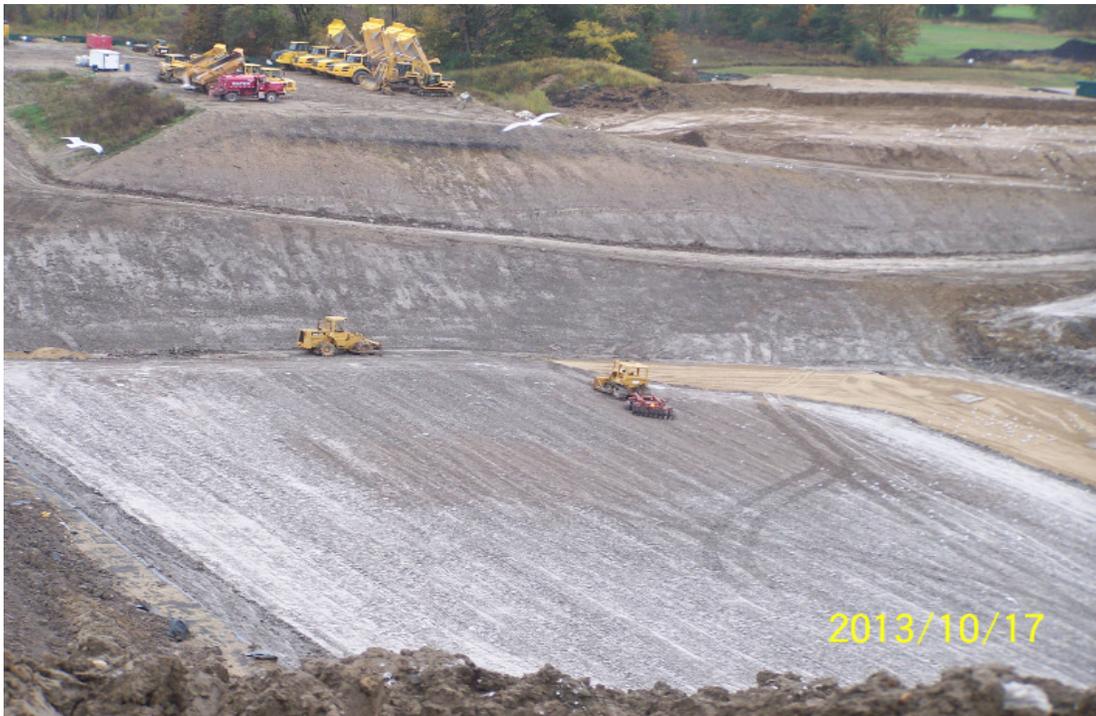
Clay placed over gradient layer prior to liner placement

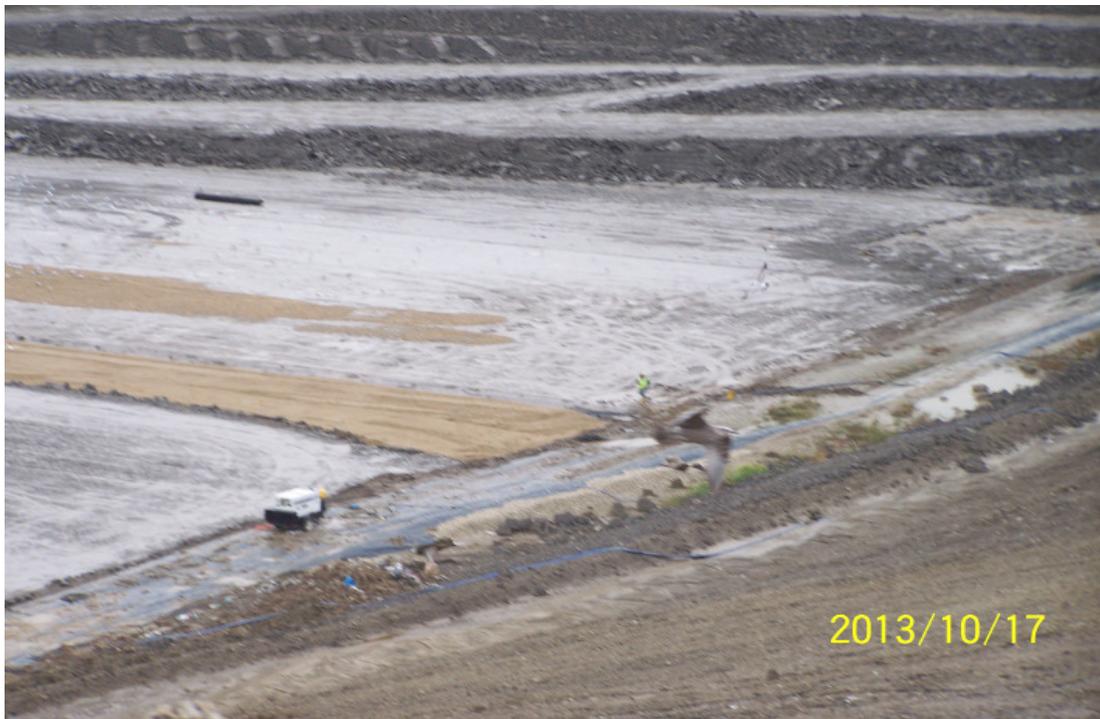
Remaining clay lifts to be removed prior to placement of gradient layer
