MEMORANDUM

ADS Emerald Park Landfill Audit Summary

TO: ADS Emerald Park Landfill Standing Committee, City of Muskego
FROM: Jo-Walter Spear, Jr., P.E.
COPIES: File
DATE: 10/25/13
PROJECT NUMBER: 1012.10030

Attached is the audit report for activities at the ADS Emerald Park Landfill for the week of October 21, 2013. The audit was performed at 1:30 PM on **October 25, 2013** by Jo Spear, Jr. in the presence of David Geier.

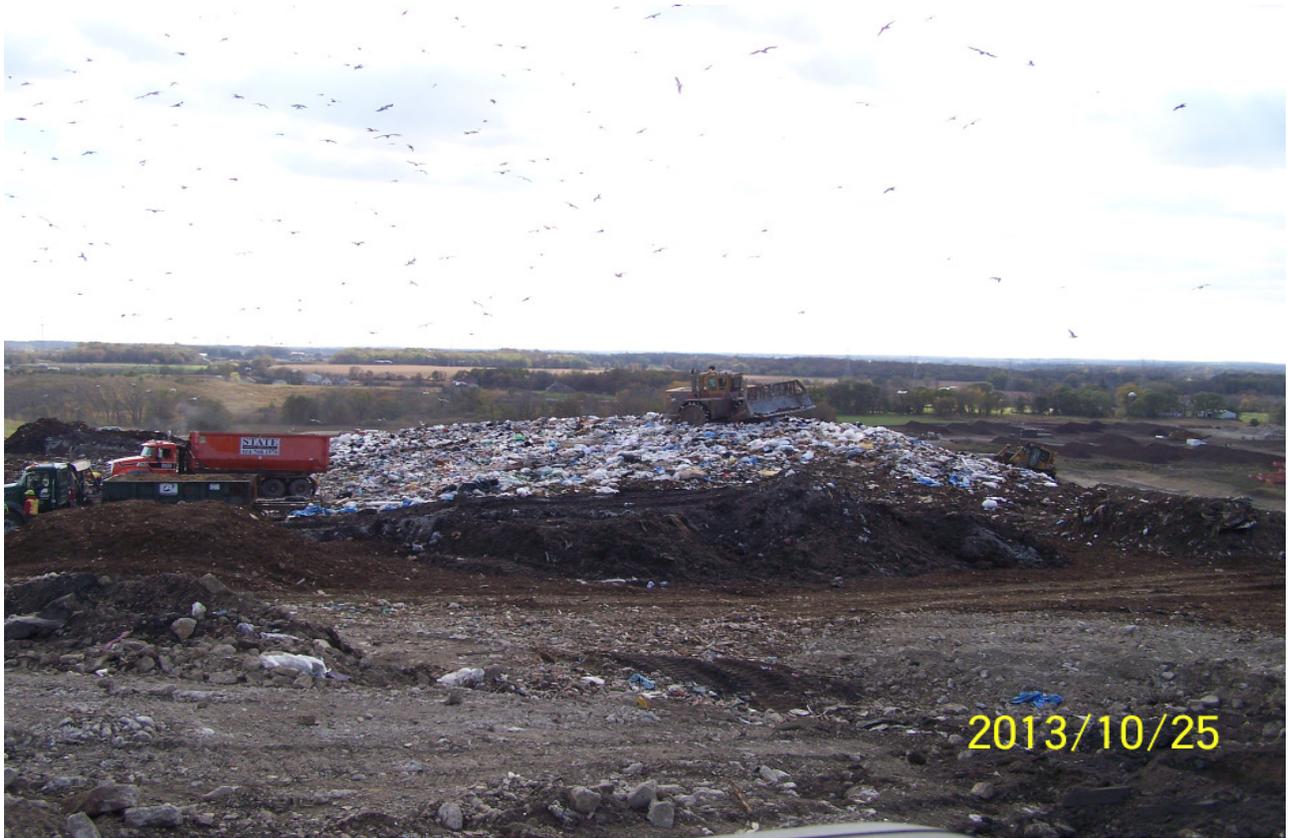
Working face at Southwest corner of Phase 7

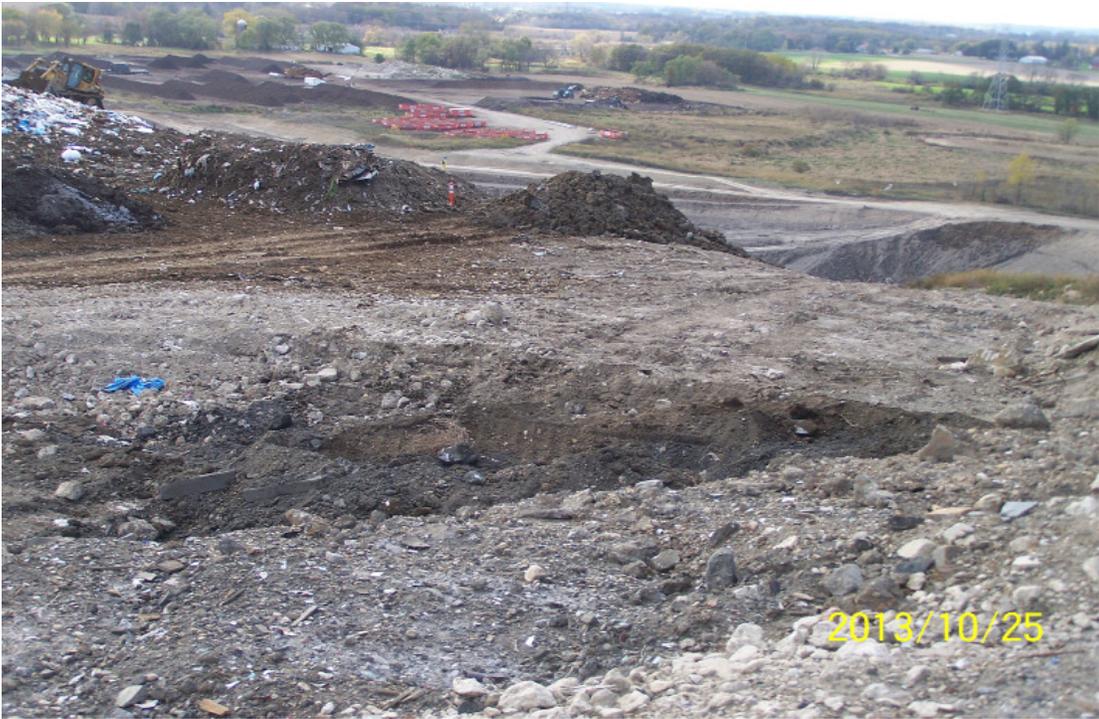
Test pit for soil depths in Active area

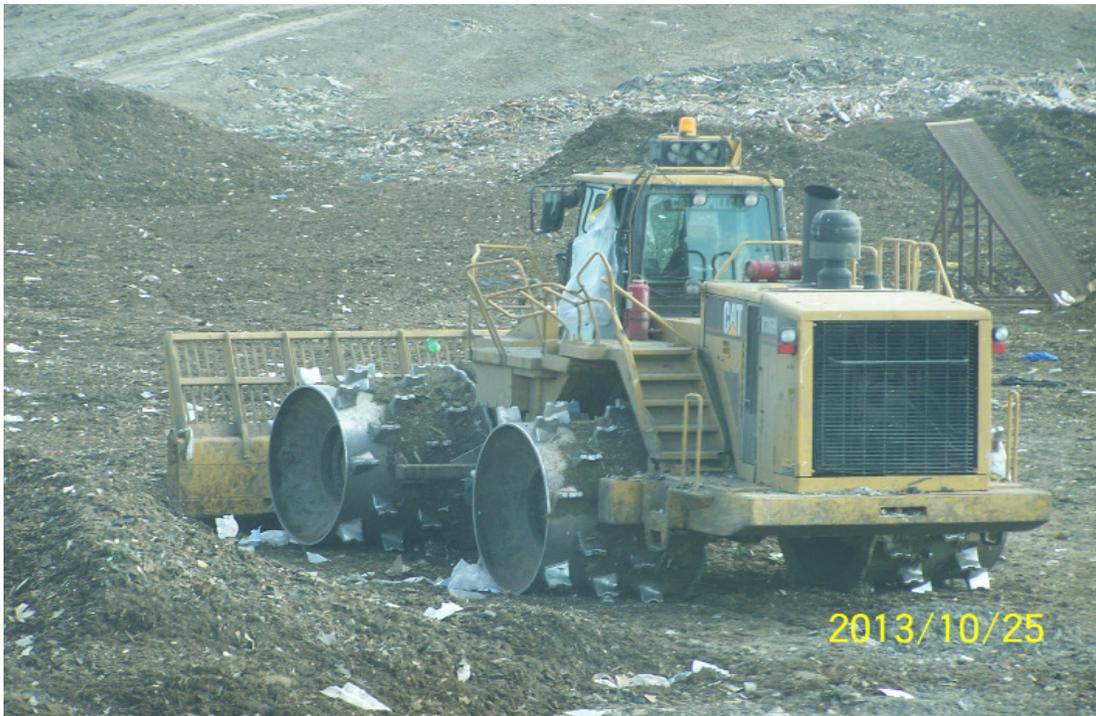
Compactor damage in minor accident

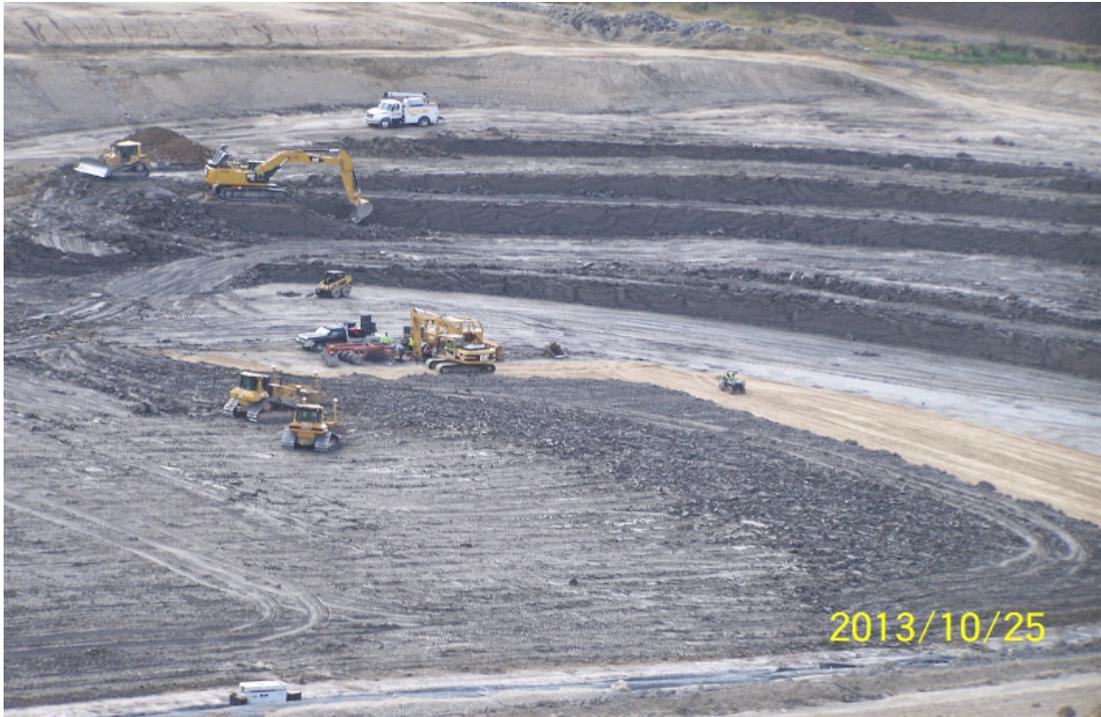
Sand placement nearly finished and clay flipped over it. When clay is finished and documented the liner can be deployed.

Clay being flipped onto gradient layer

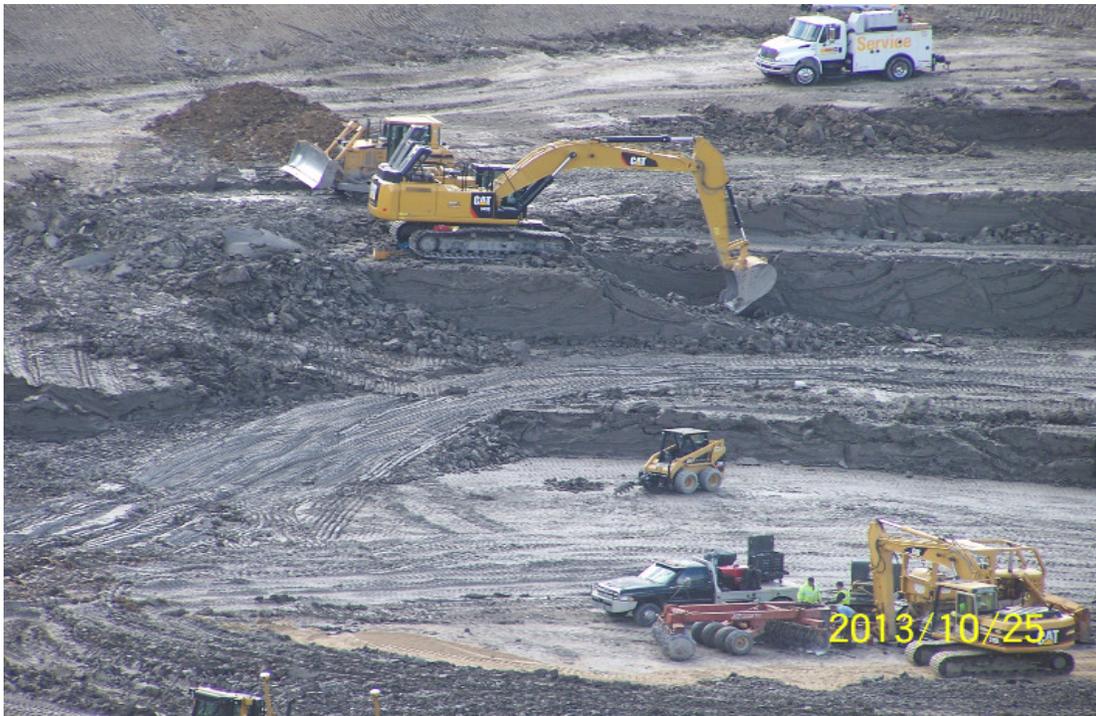
Nearly Completed

South end of Phase 8, excavation ongoing

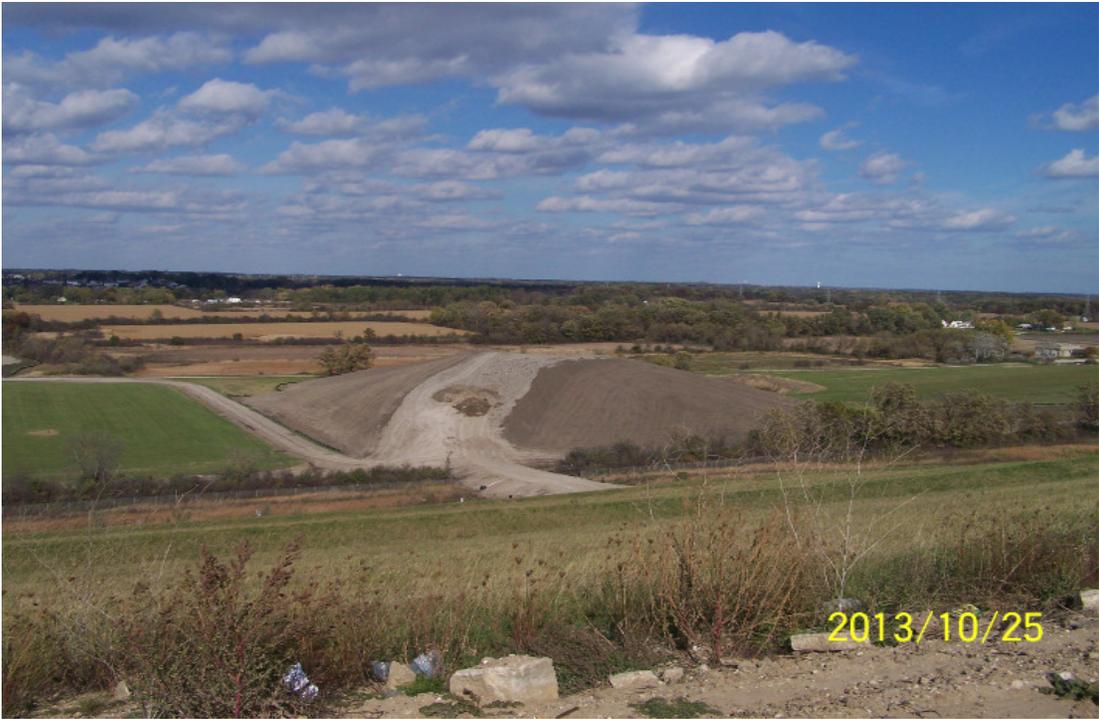
Stockpile most Eastward has been seeded

Eastern stockpile covered with topsoil and seeded.

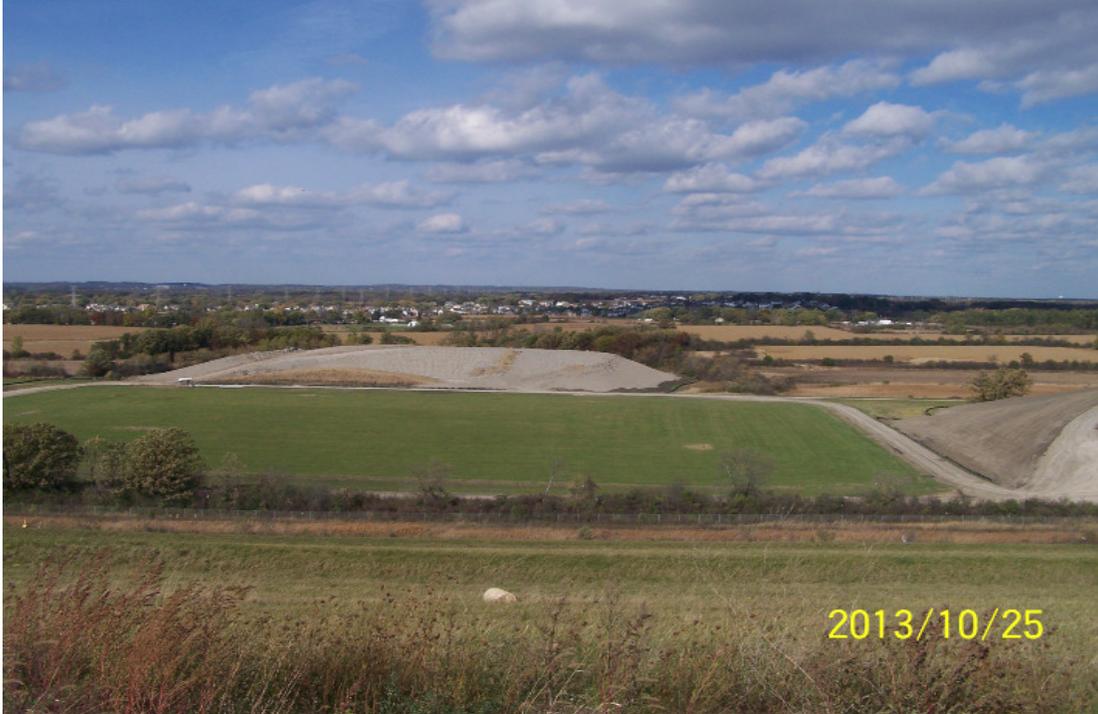
Western stockpile
