MEMORANDUM

ADS Emerald Park Landfill Audit Summary

DATE: 11/7/13

PROJECT NUMBER: 1012.10030

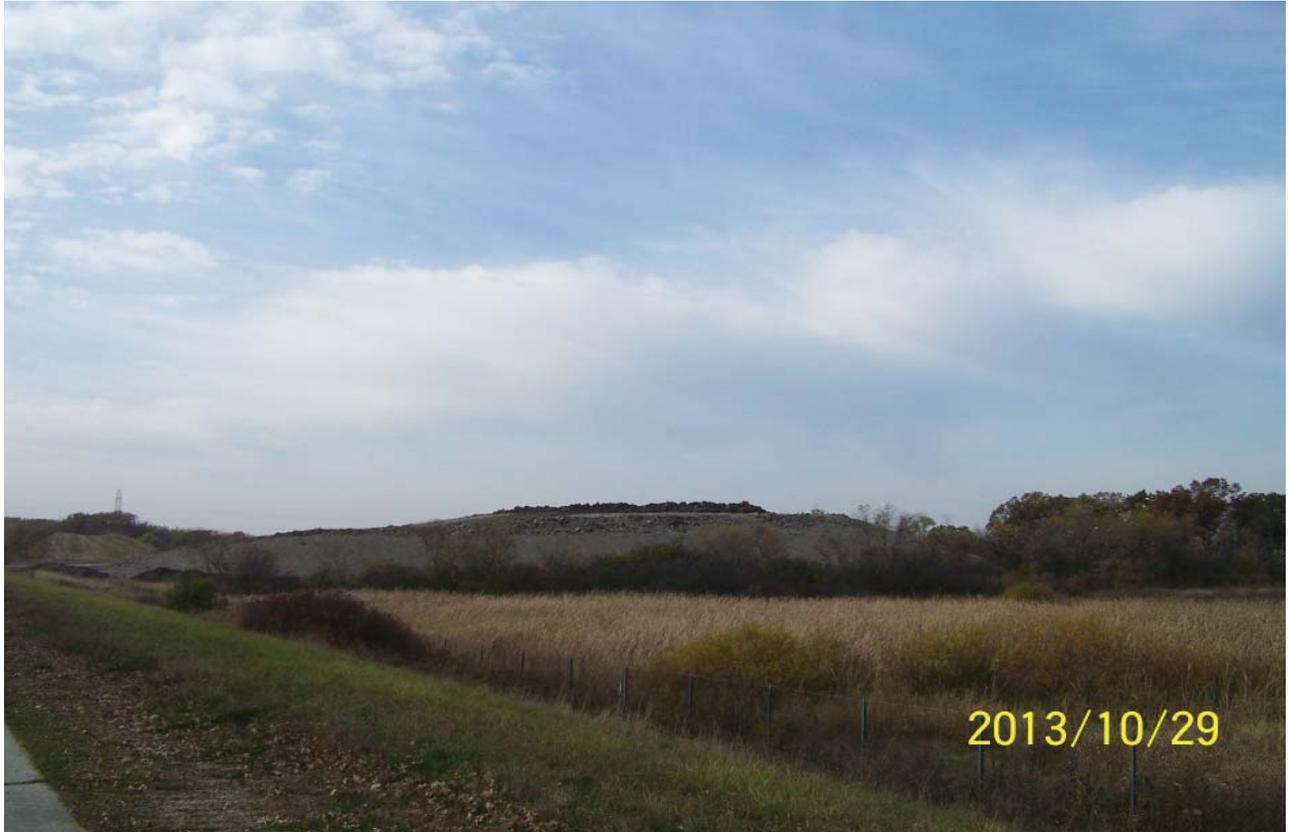
Eastern stockpile in Future Parkland, seeded for winter.

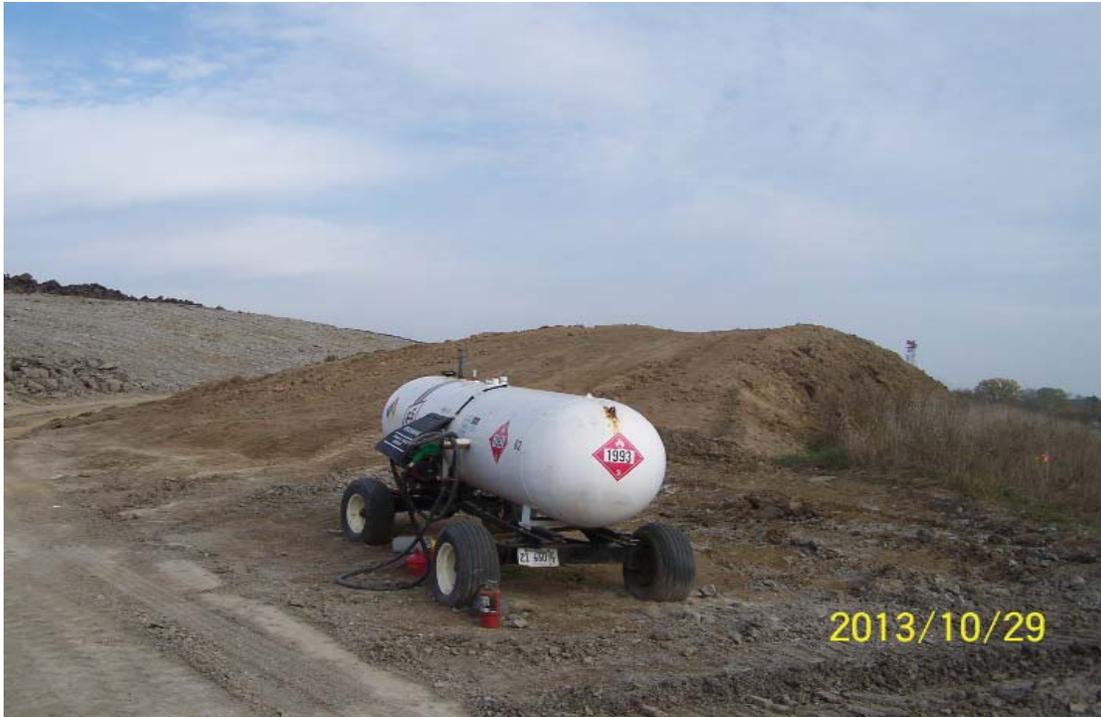
Stockpile in Future Parkland, brown clay desined for use in pond construction.

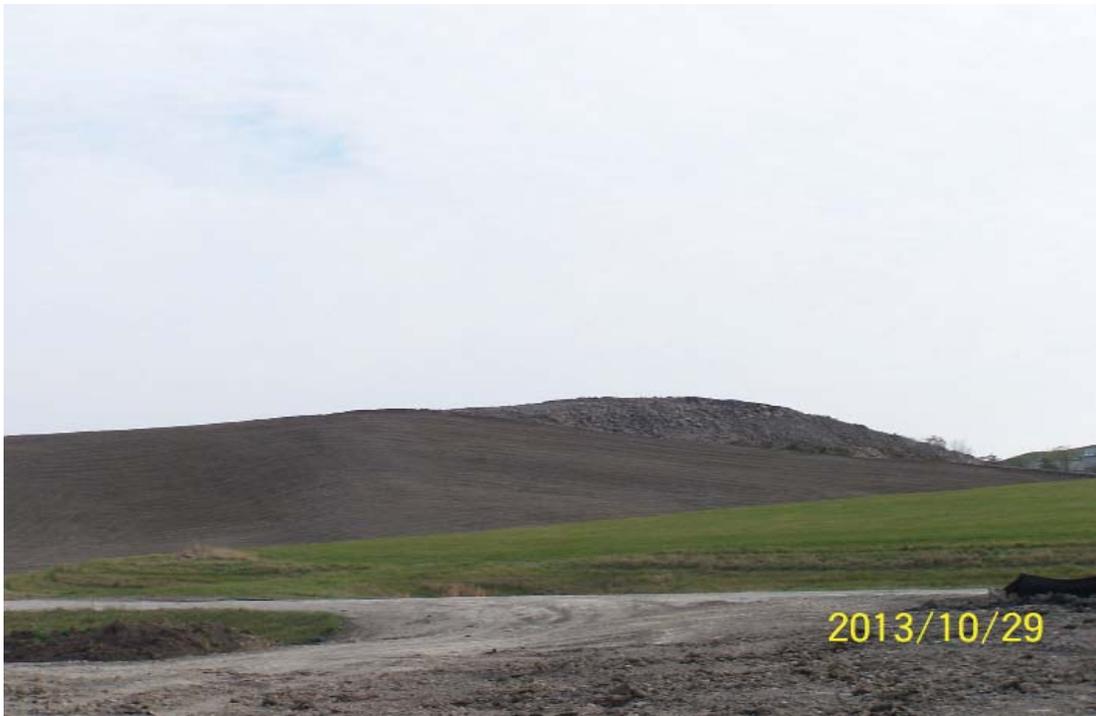
Stockpile in Future Parkland

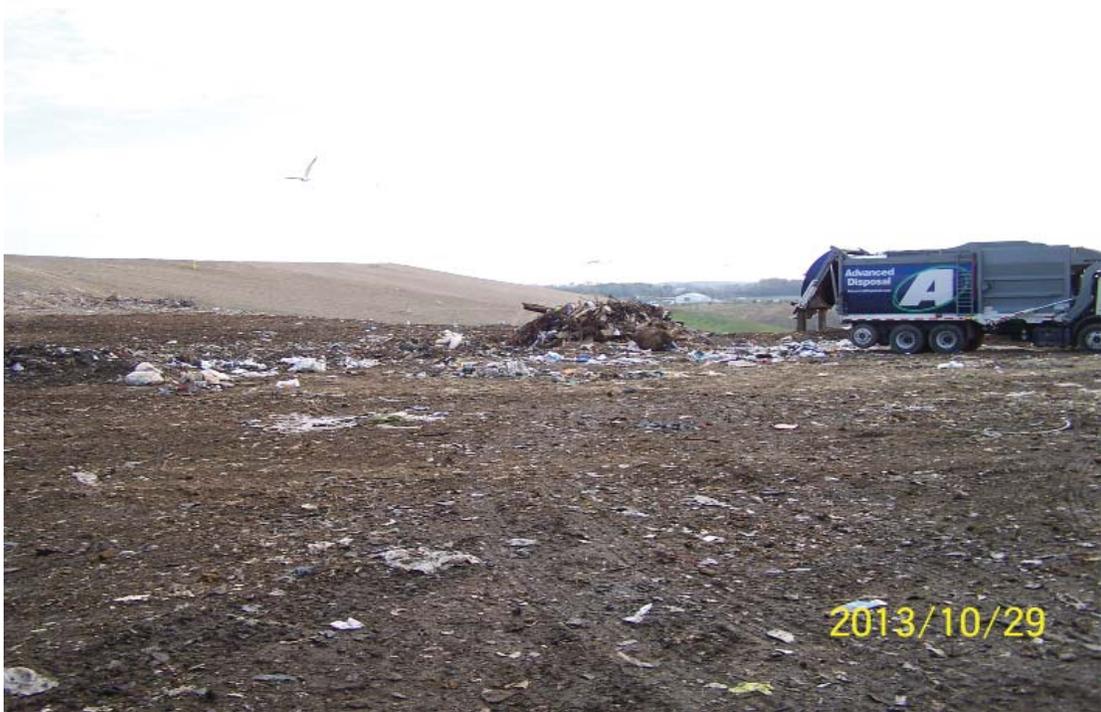
Clean out area

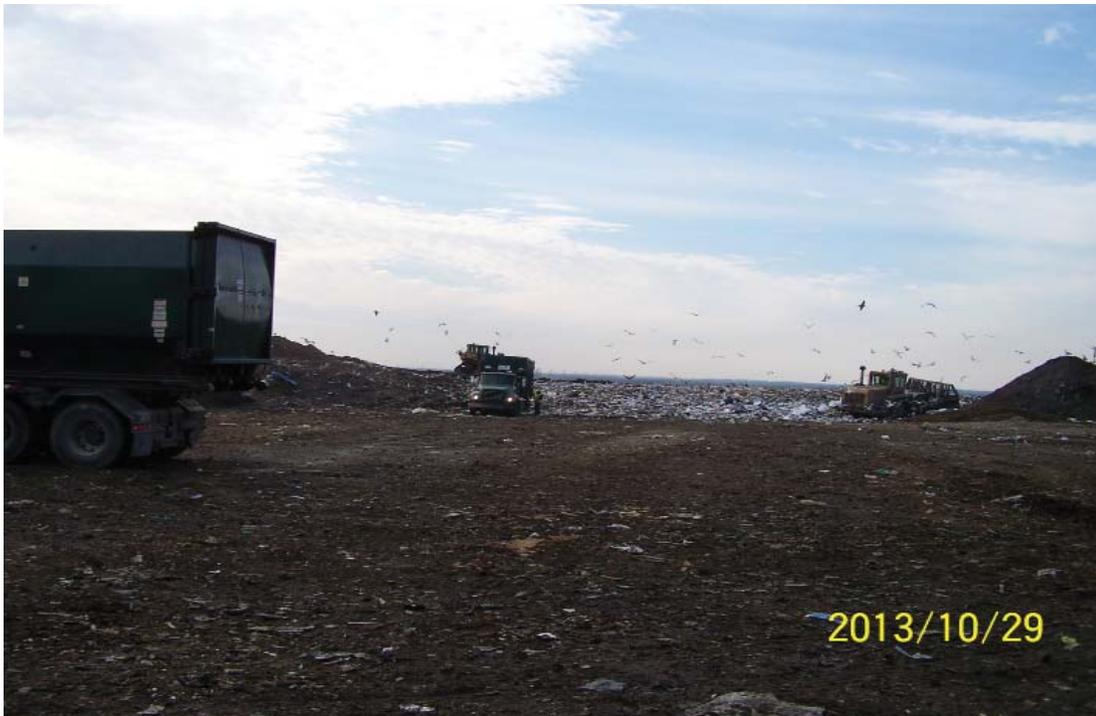
Working face west edge of Phase 7

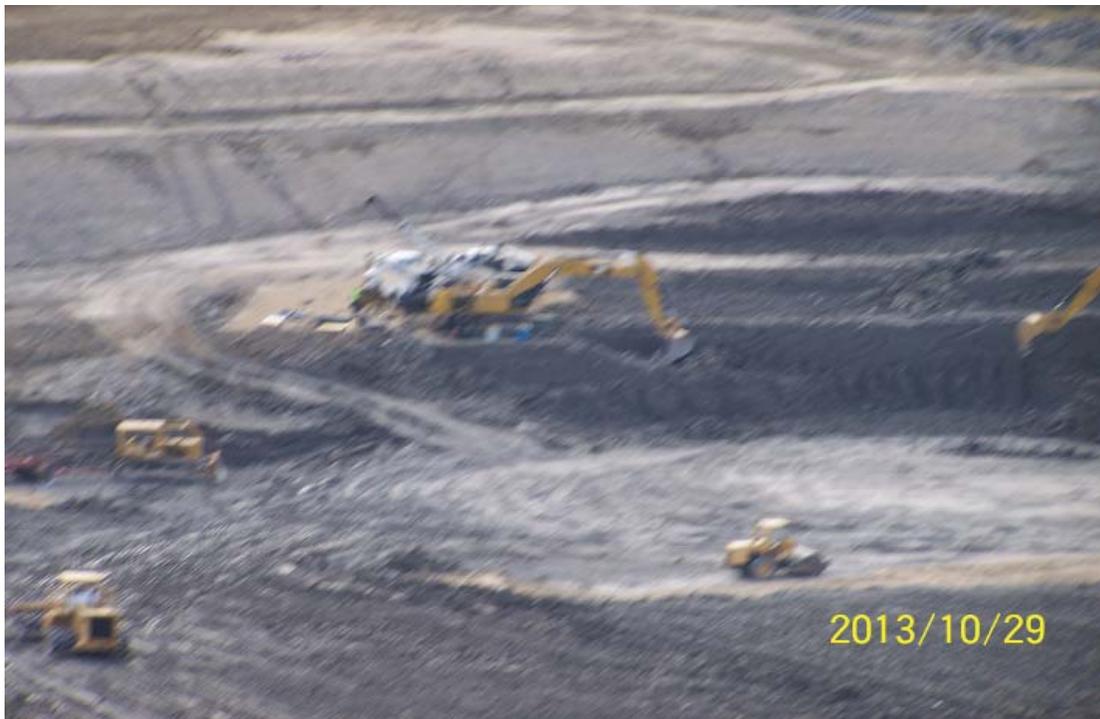
Excavation of side slopes on going. Slopes will not be lined, but will be pulled back to minimize erosion for 2014

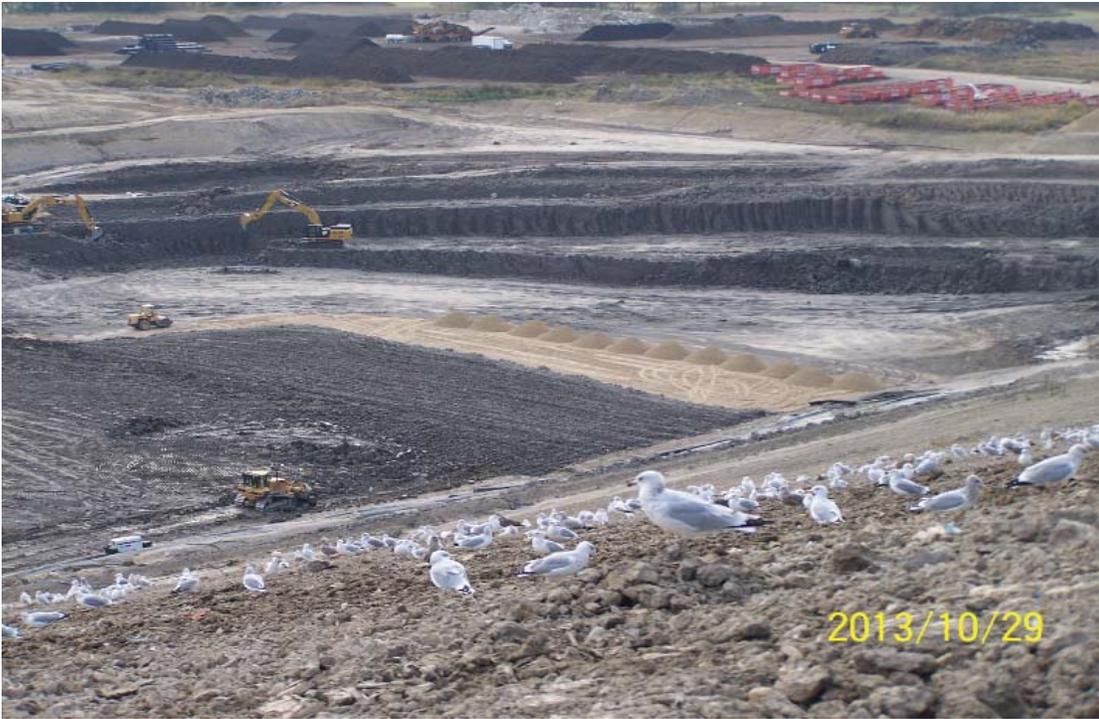
Remainder of gradient layer being placed

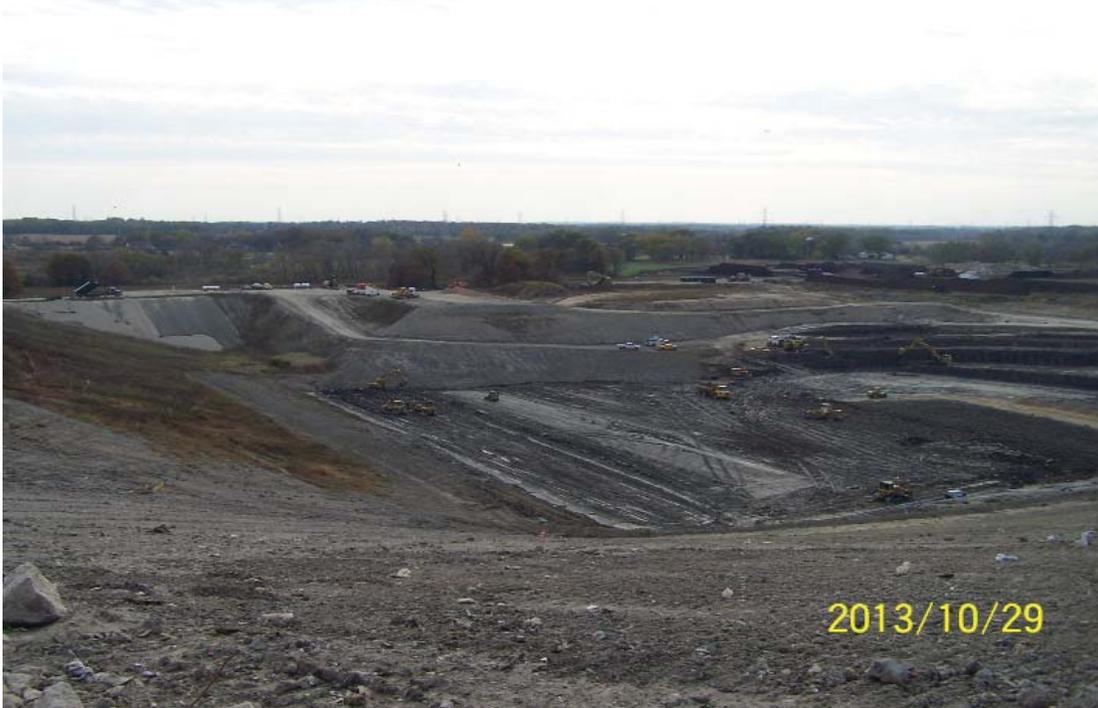
Phase 8 overall

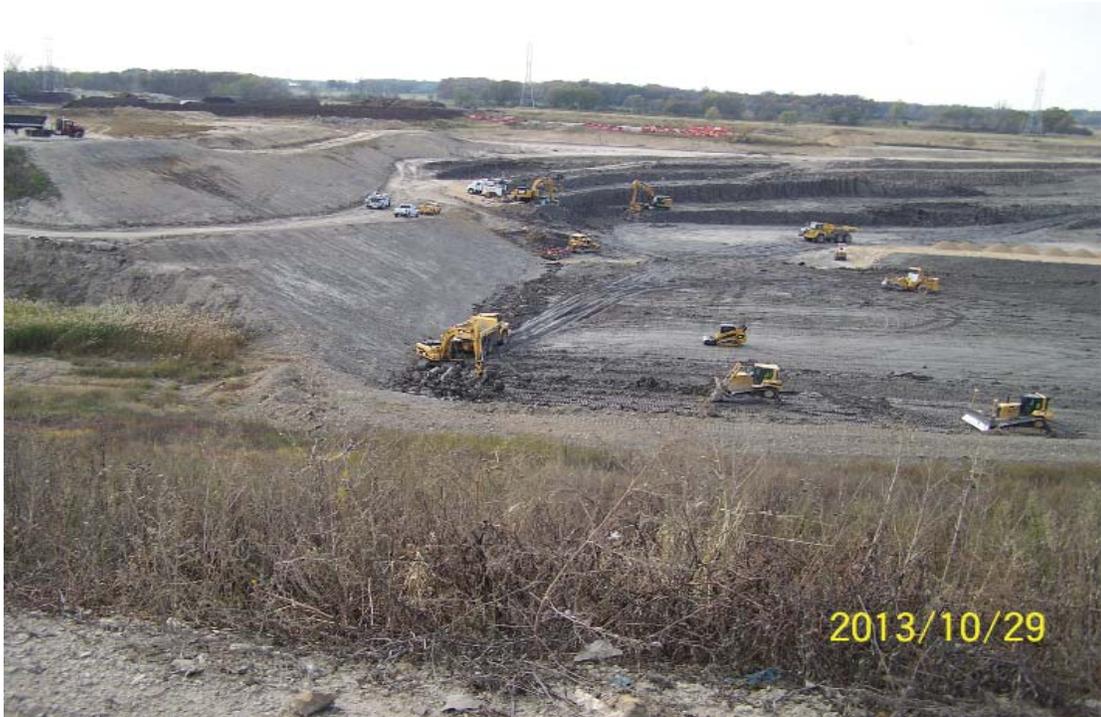
Clay being removed from Southeast corner to meet grades and compaction

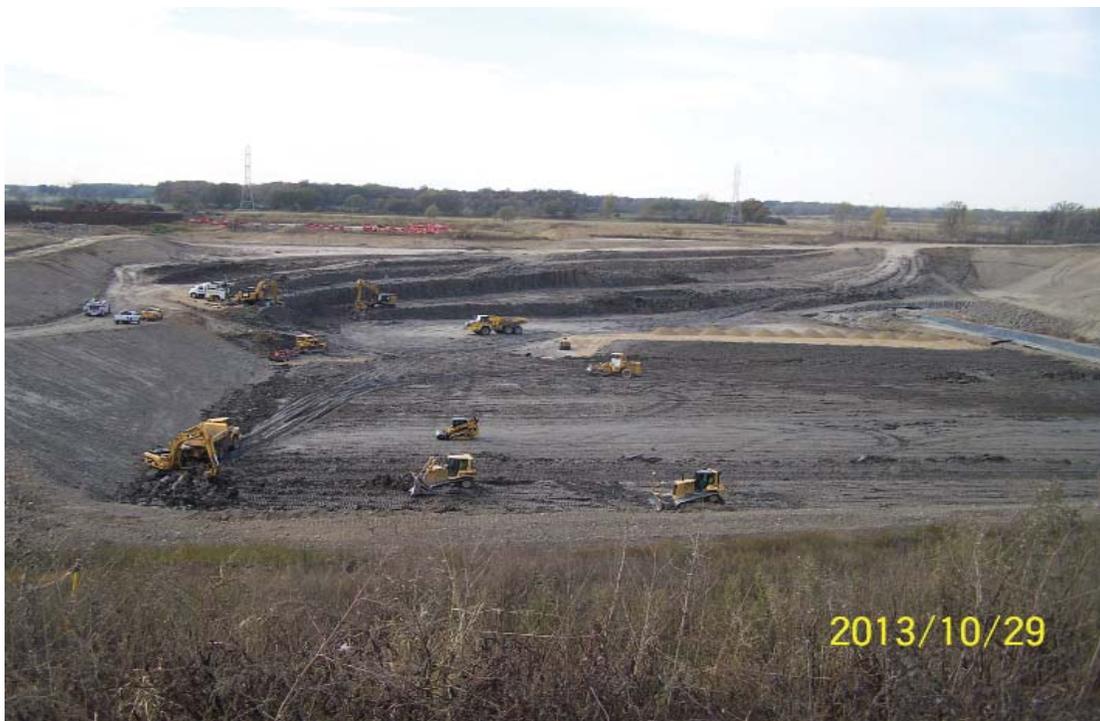
Clay placement over sand on going
