MEMORANDUM

ADS Emerald Park Landfill Audit Summary

PROJECT NUMBER: 1012.10030

**ADVANCED DISPOSAL SERVICES
EMERALD PARK LANDFILL / CITY OF MUSKEGO
AUDIT PHOTOS**

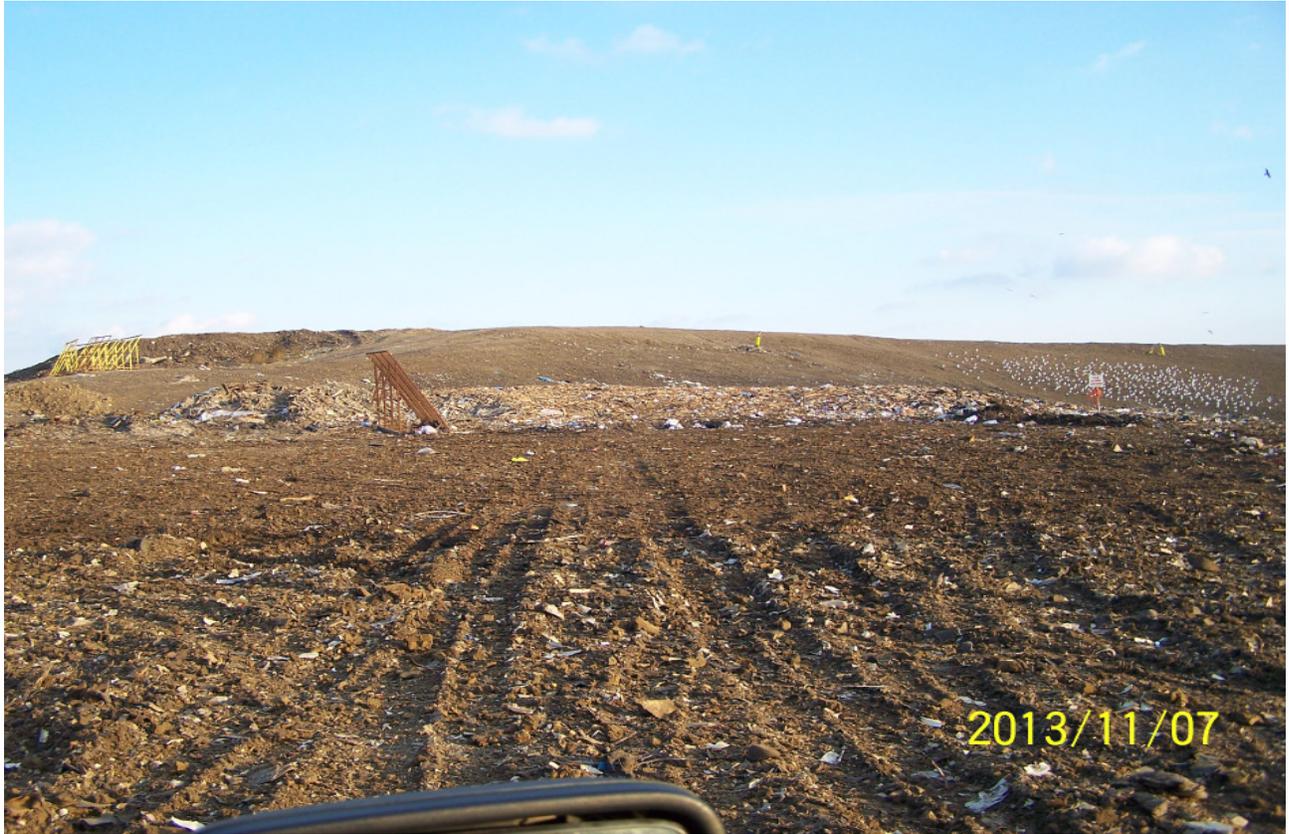
Active area

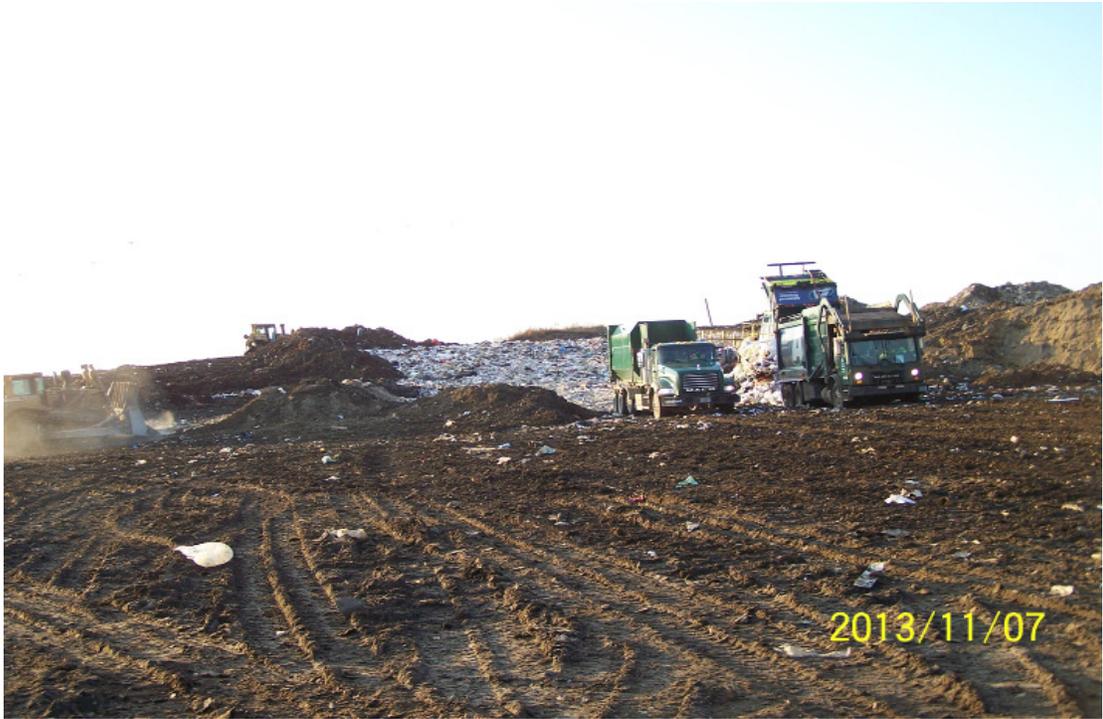
Working face

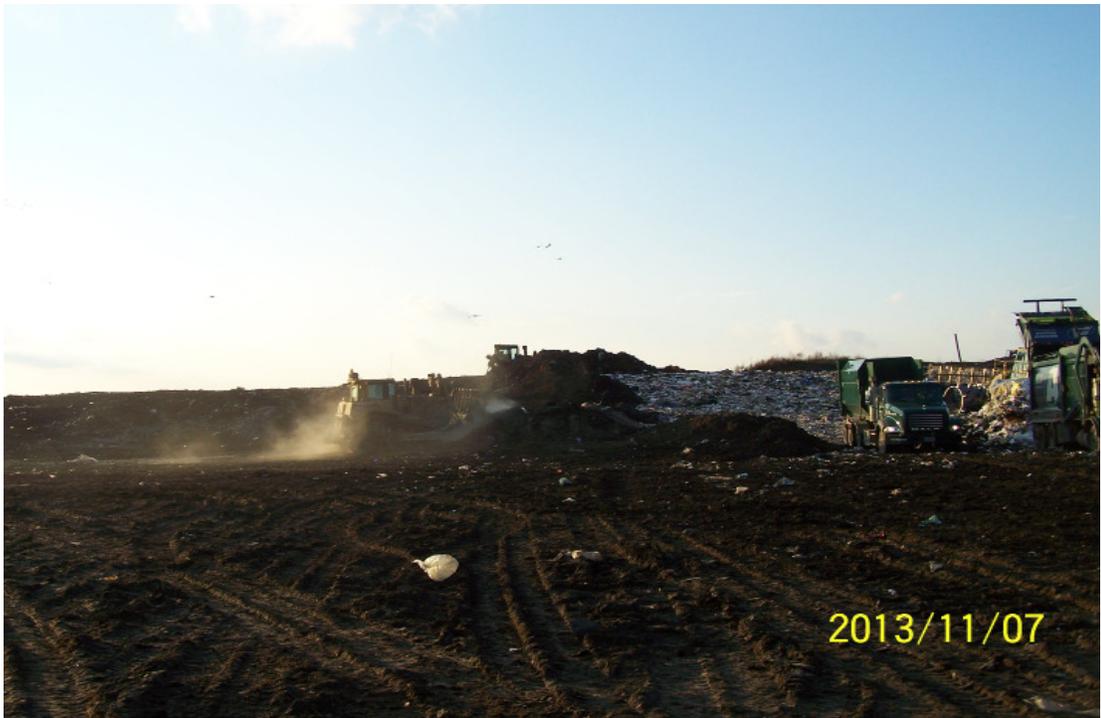
Working face

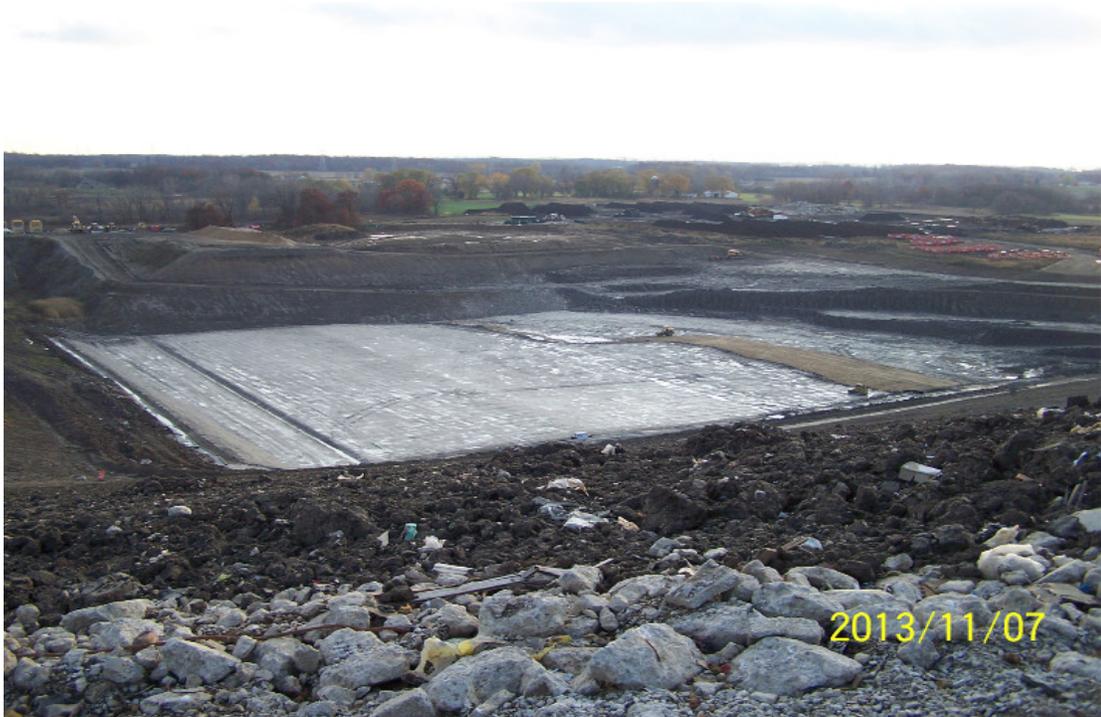
Phase 8 clay liner nearly complete

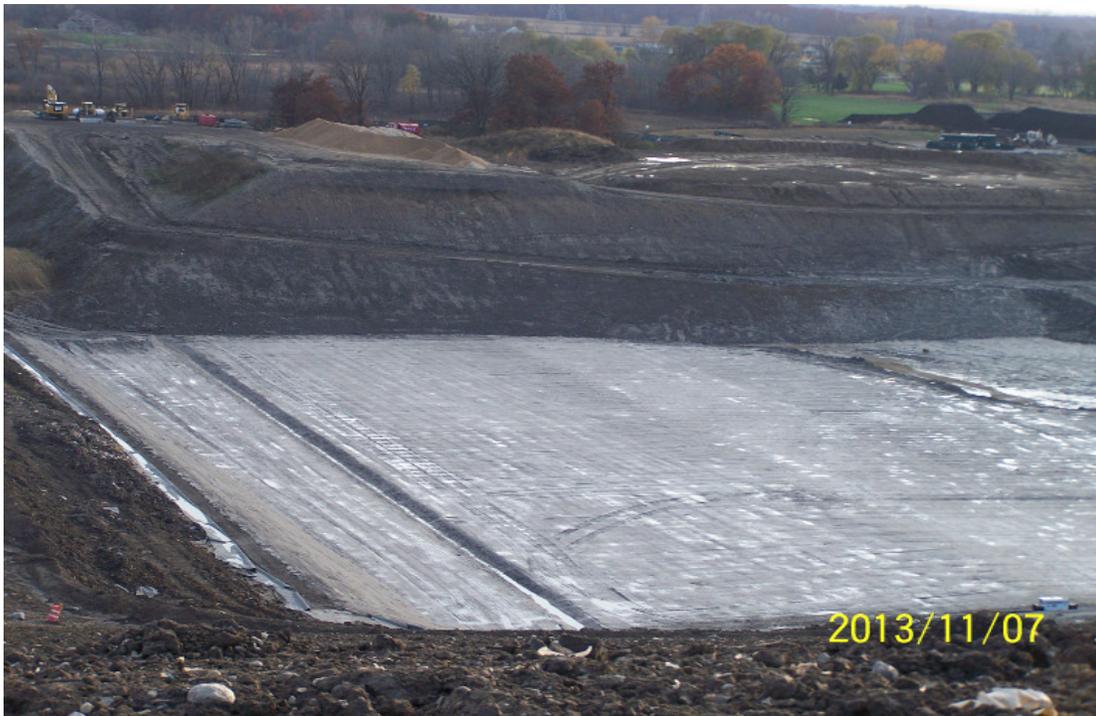
Phase 8 clay liner nearly complete

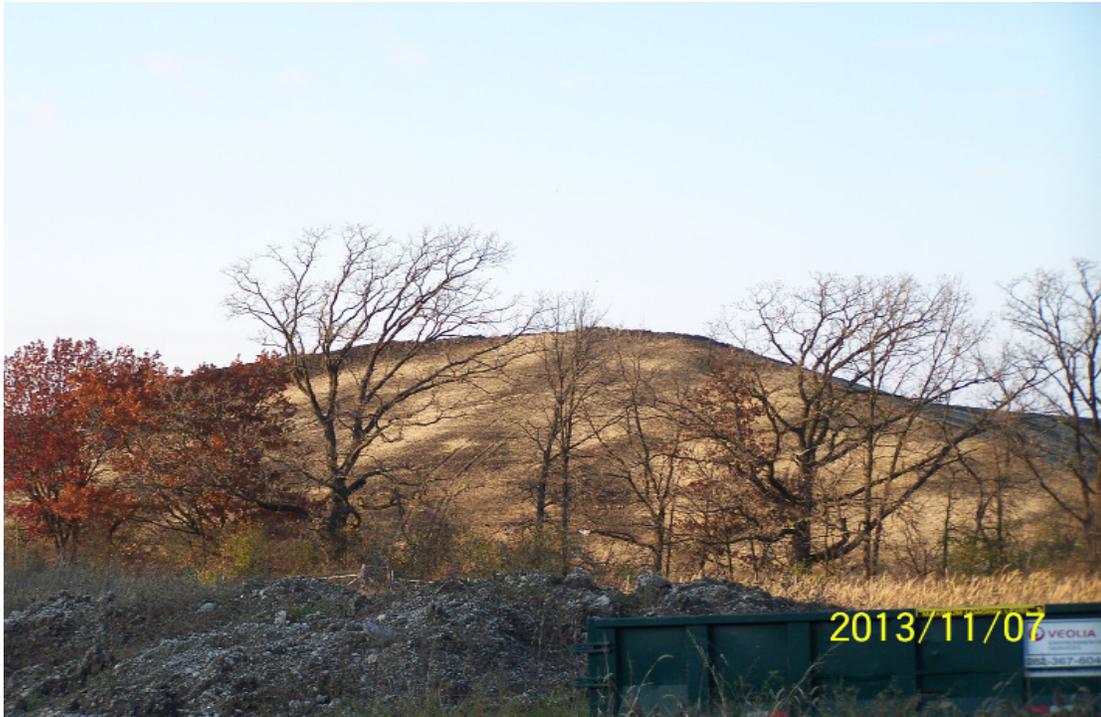
Eastern stockpile seeded and mulched

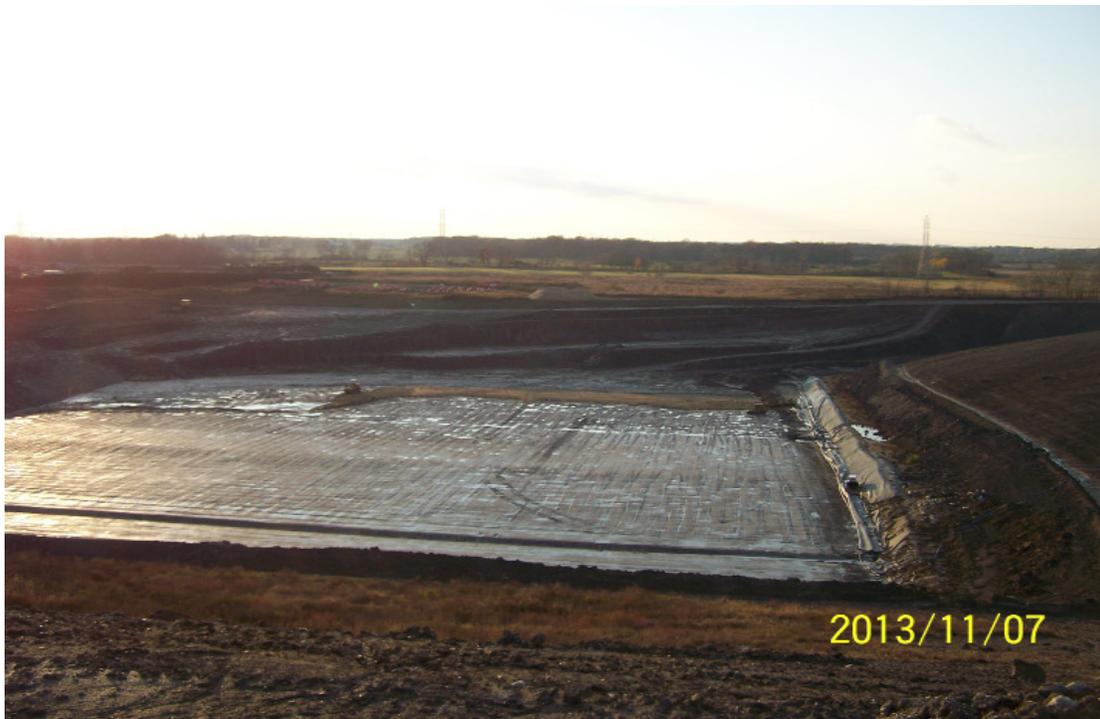
Clay base of liner nearly completed
