ADS Emerald Park Landfill Audit Summary

TO: ADS Emerald Park Landfill Standing Committee, City of Muskego

DATE: 12/9/13

PROJECT NUMBER: 1012.10030

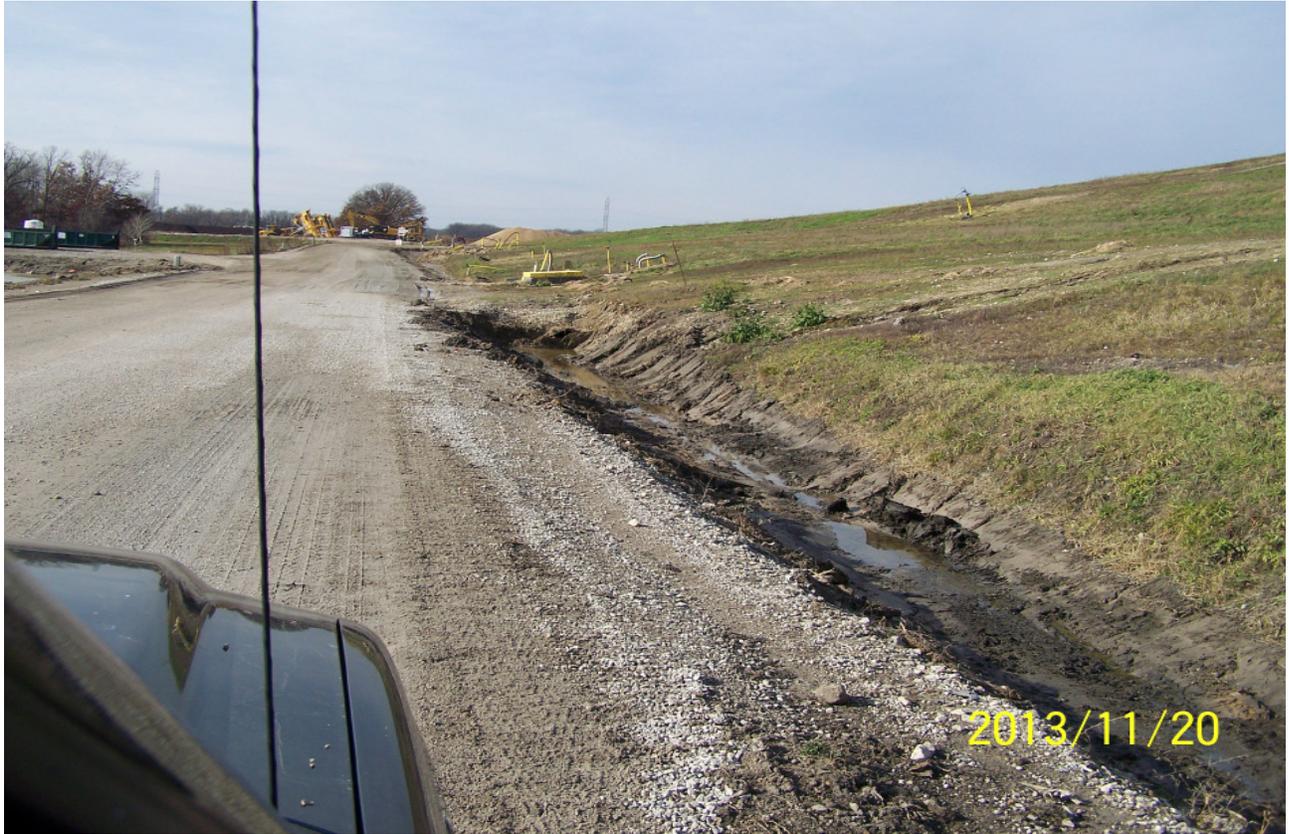
Ditch cleaned after leachate exposure.

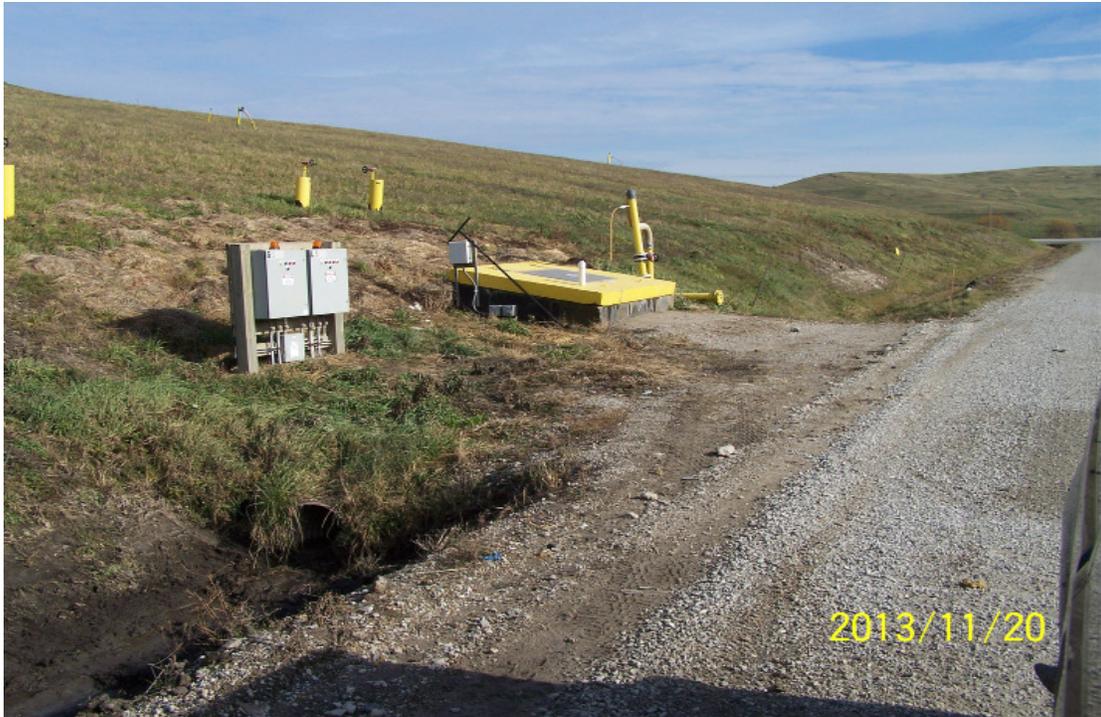
Vault with leaking flange. Cleanup completed, testing will be done to assure.

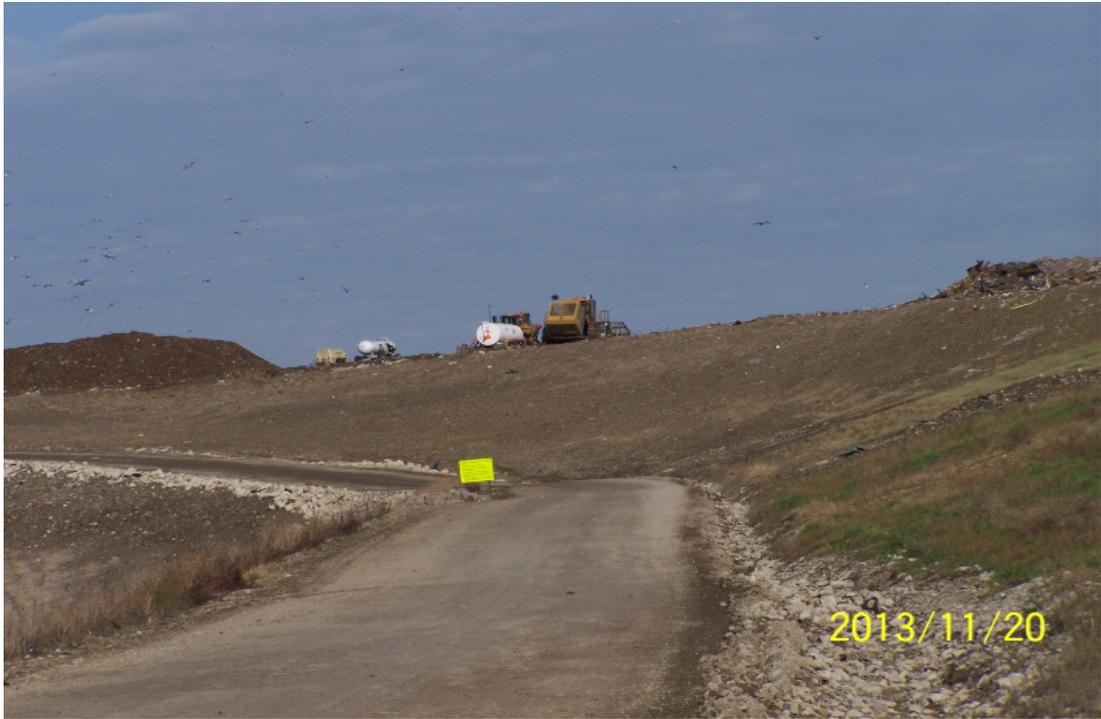
Approach to active area

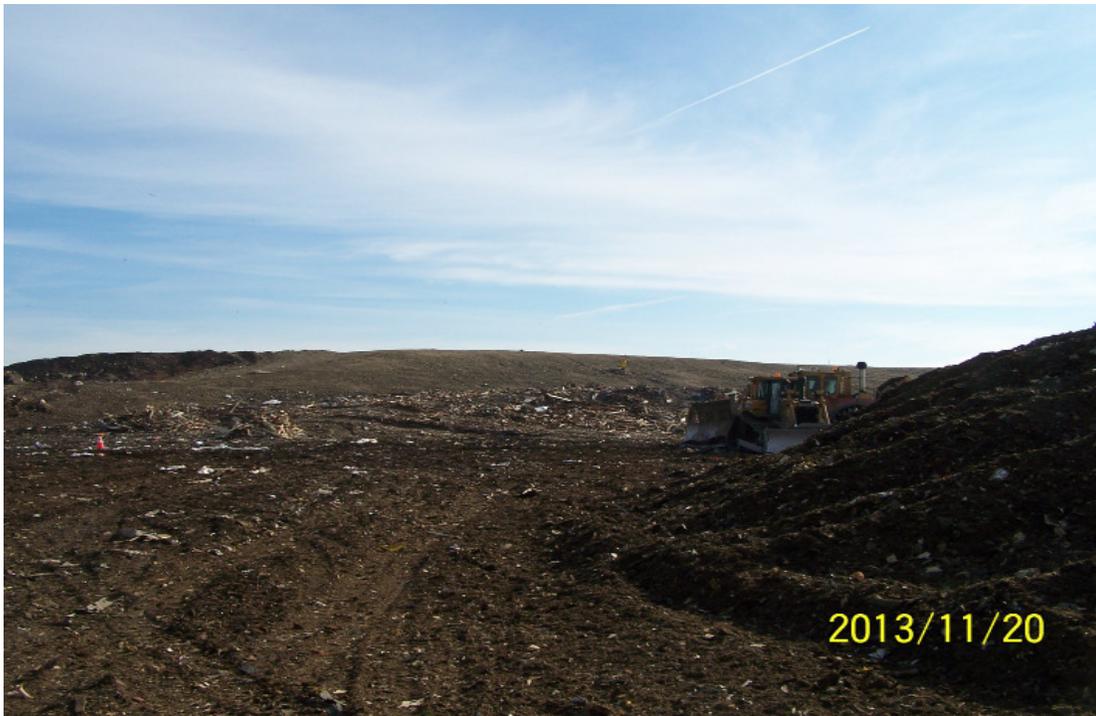
C&D stockpile at East end of Phase 7

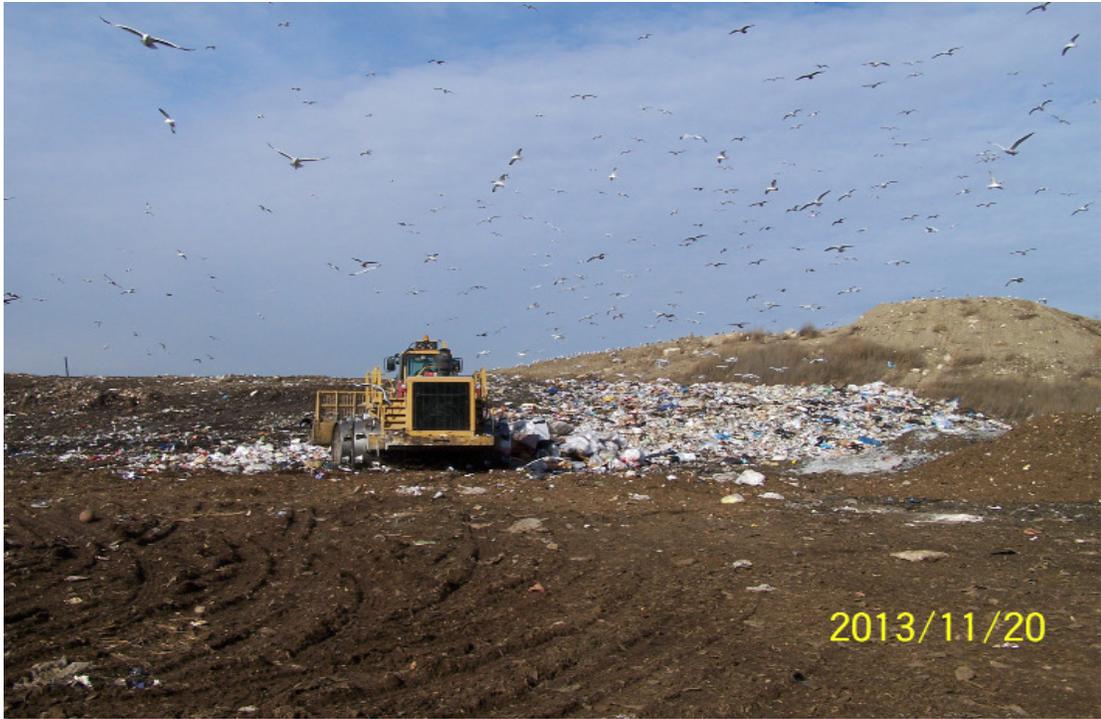
Working face

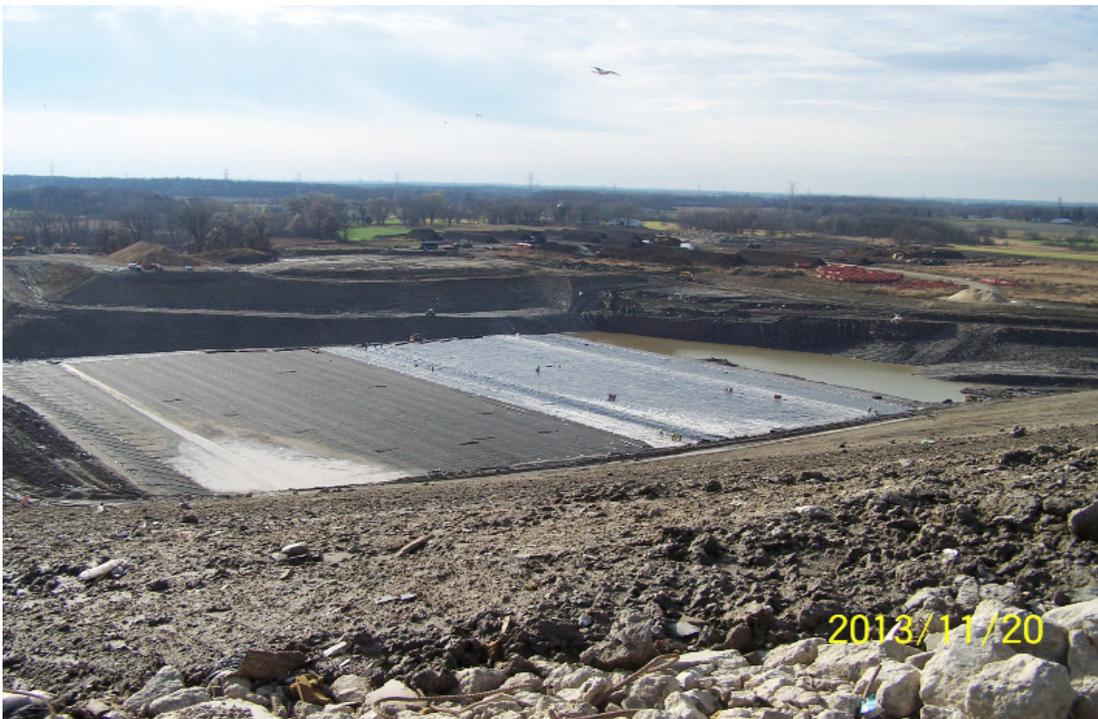
New Cell

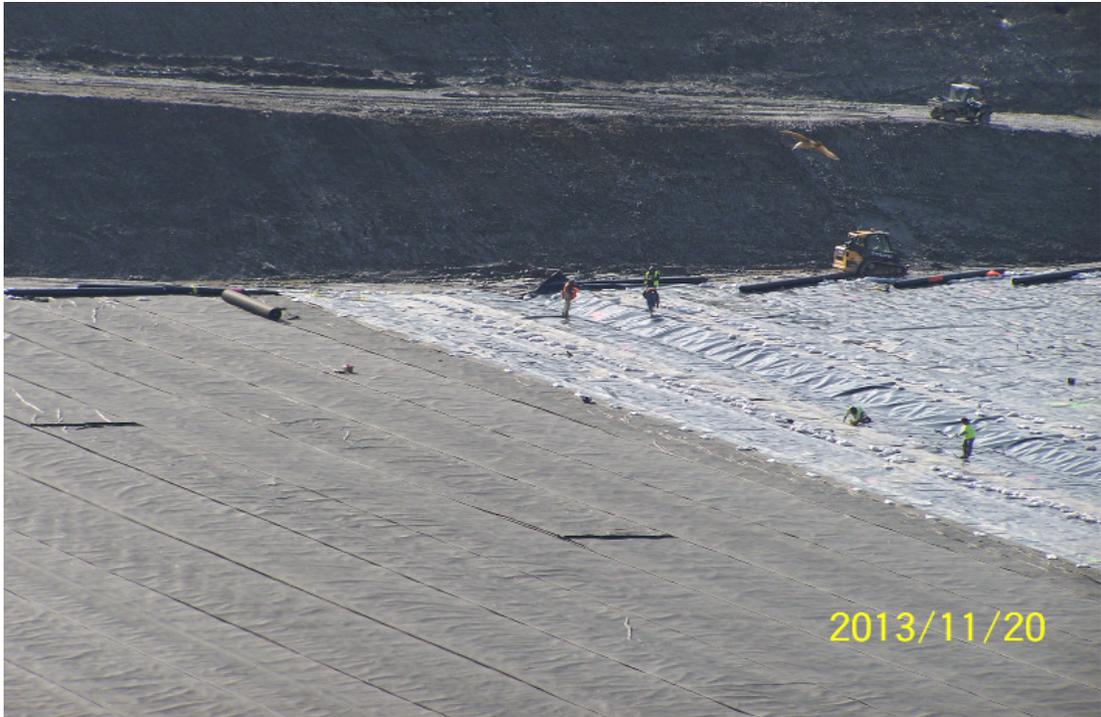
Geotextile over liner

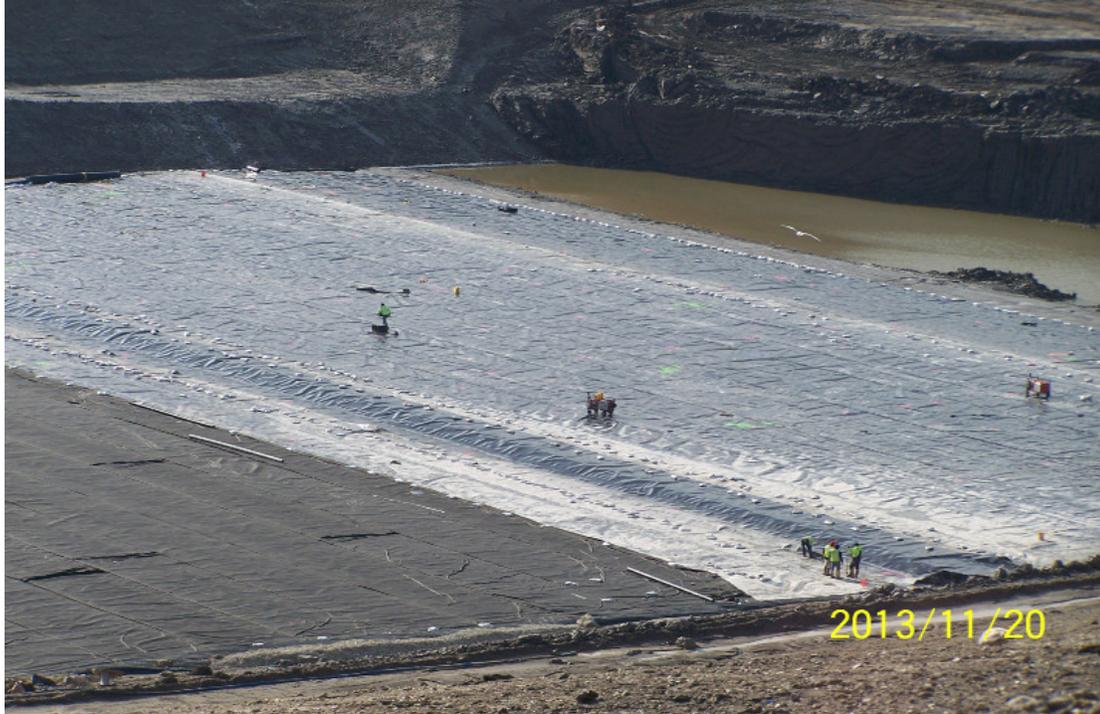
Half the lined area covered with geotextile for leachate collection. Collection ditch liner welding being attempted during audit

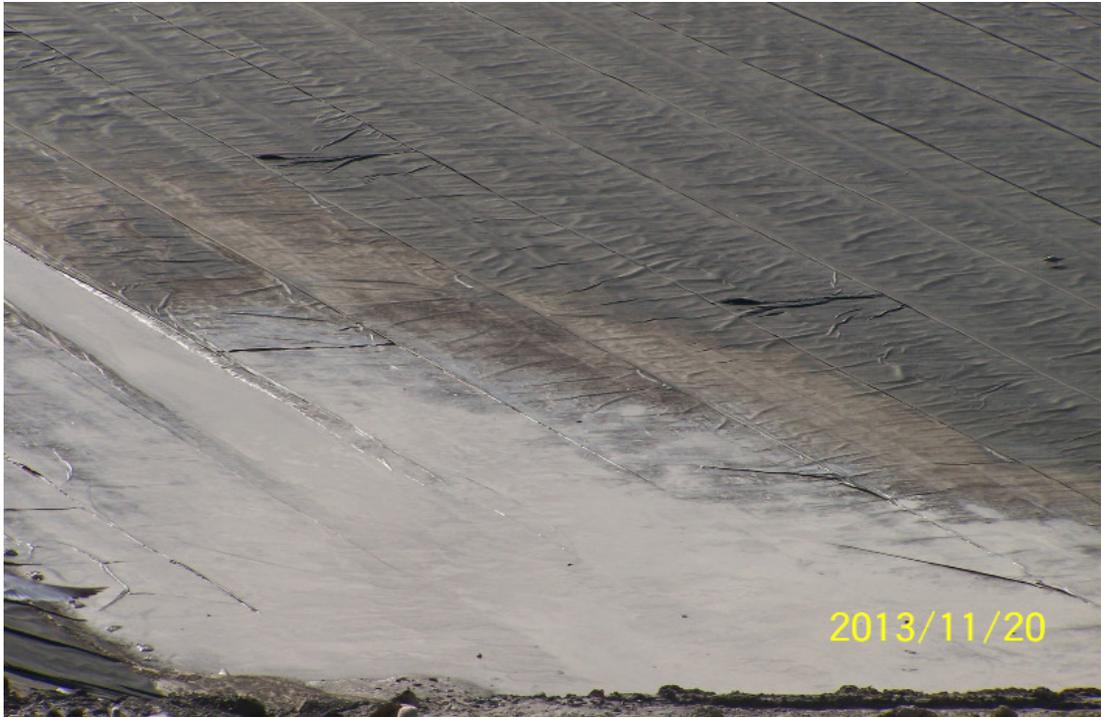
Silt on liner from storm events.

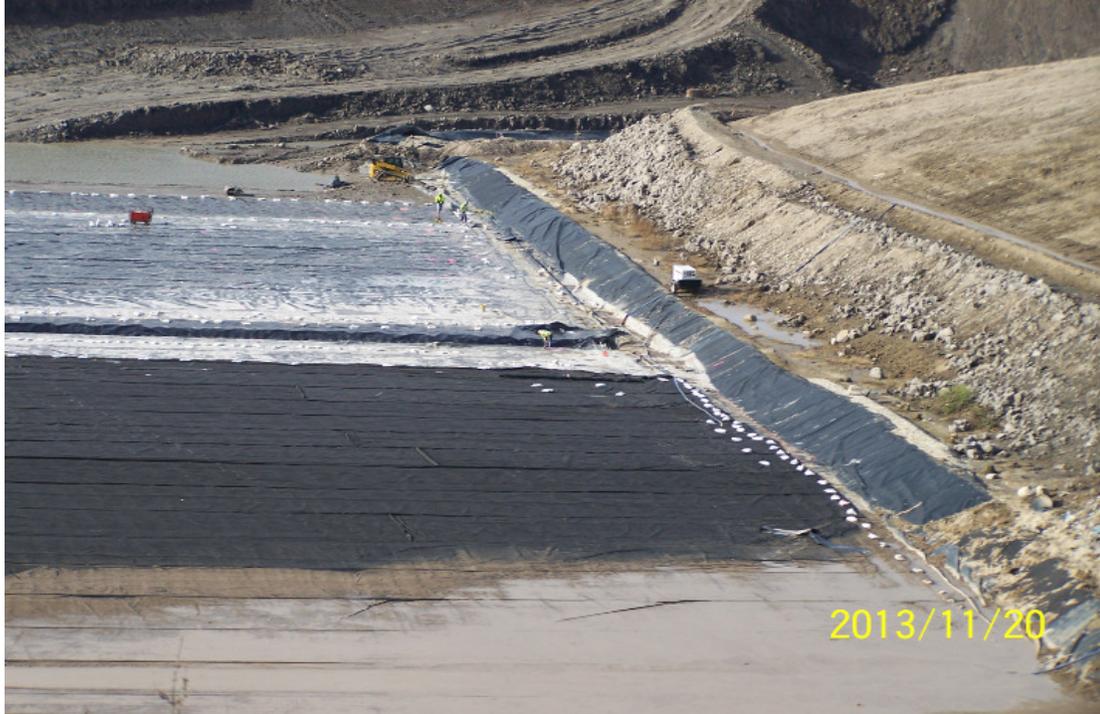
New Cell nearly lined, silt removal will be necessary before placement of drainage layer.

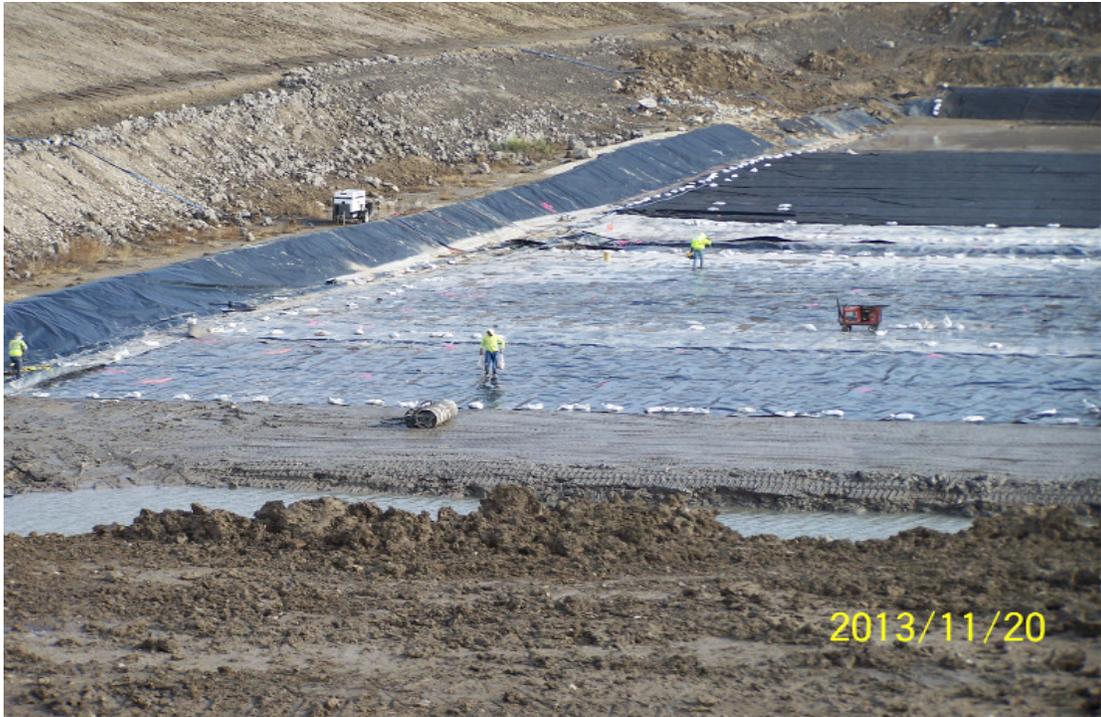
HDPE West edge of Phase 8

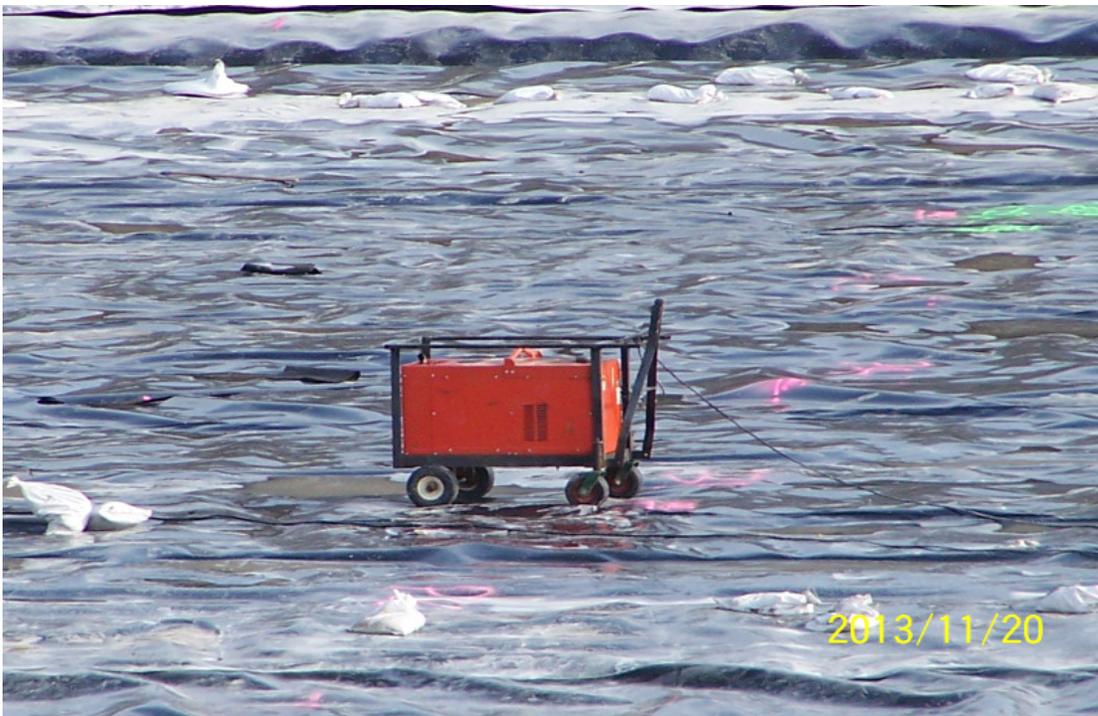
Generator, for powering welding equipment, on new liner

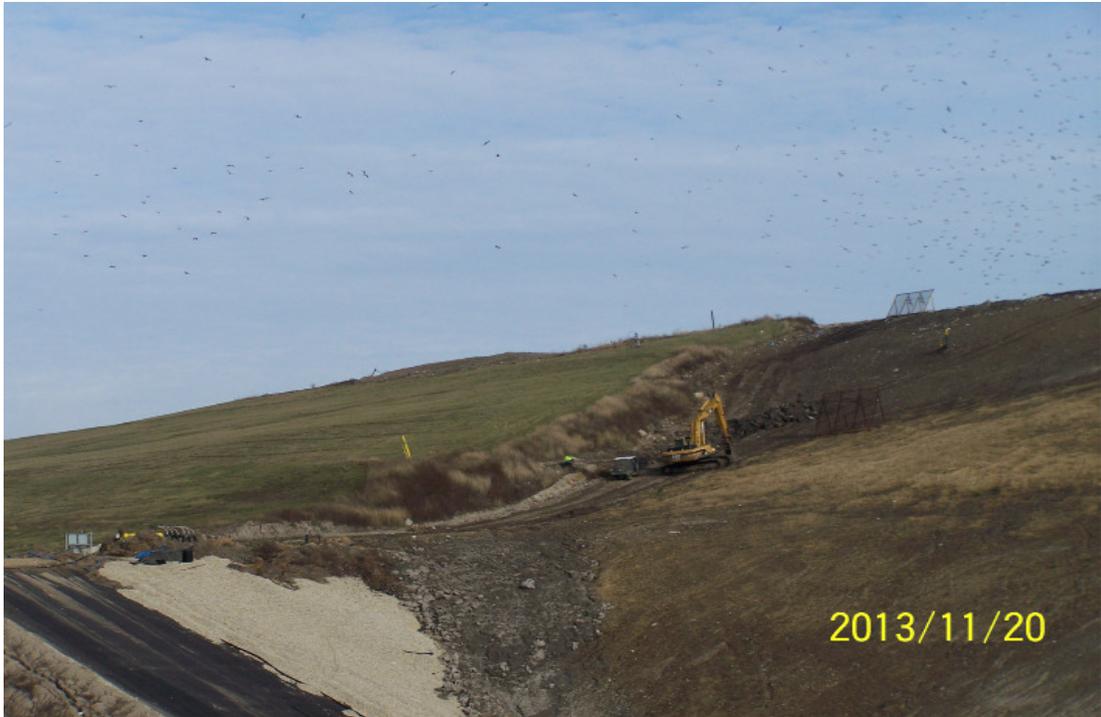
Digging in Phase 3, West slope, to repair lateral

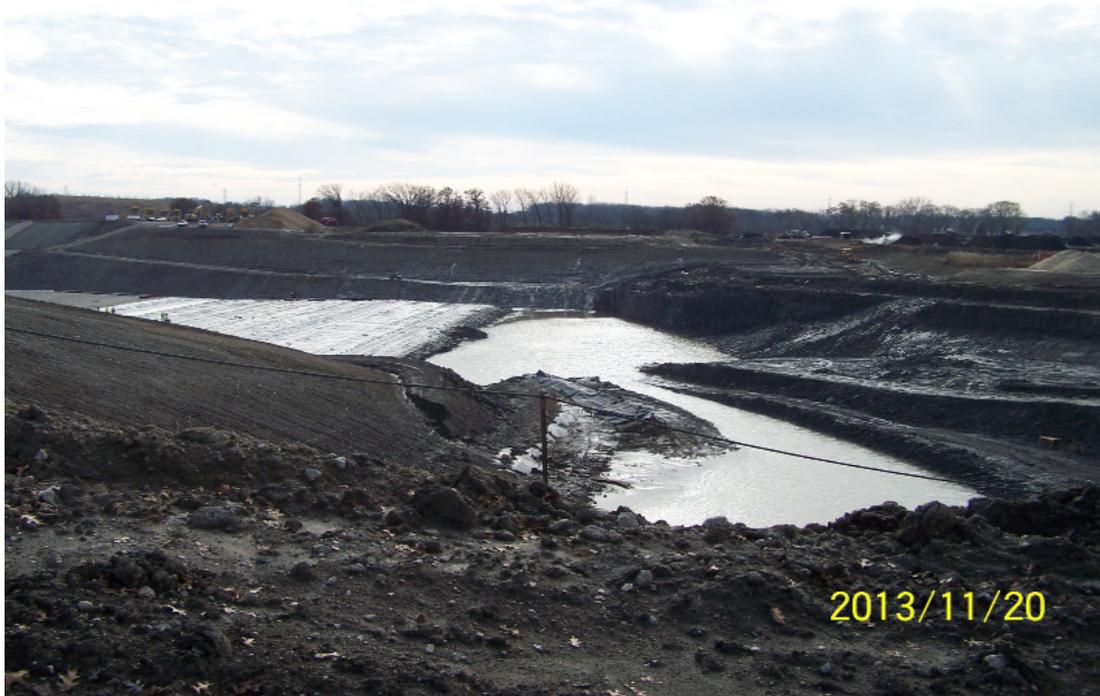
Sump and remainder of Phase 8
