# ADS Emerald Park Landfill Audit Summary

**TO:** ADS Emerald Park Landfill Standing Committee, City of Muskego

**DATE:** 12/11/2013

**PROJECT NUMBER:** 1012.10030

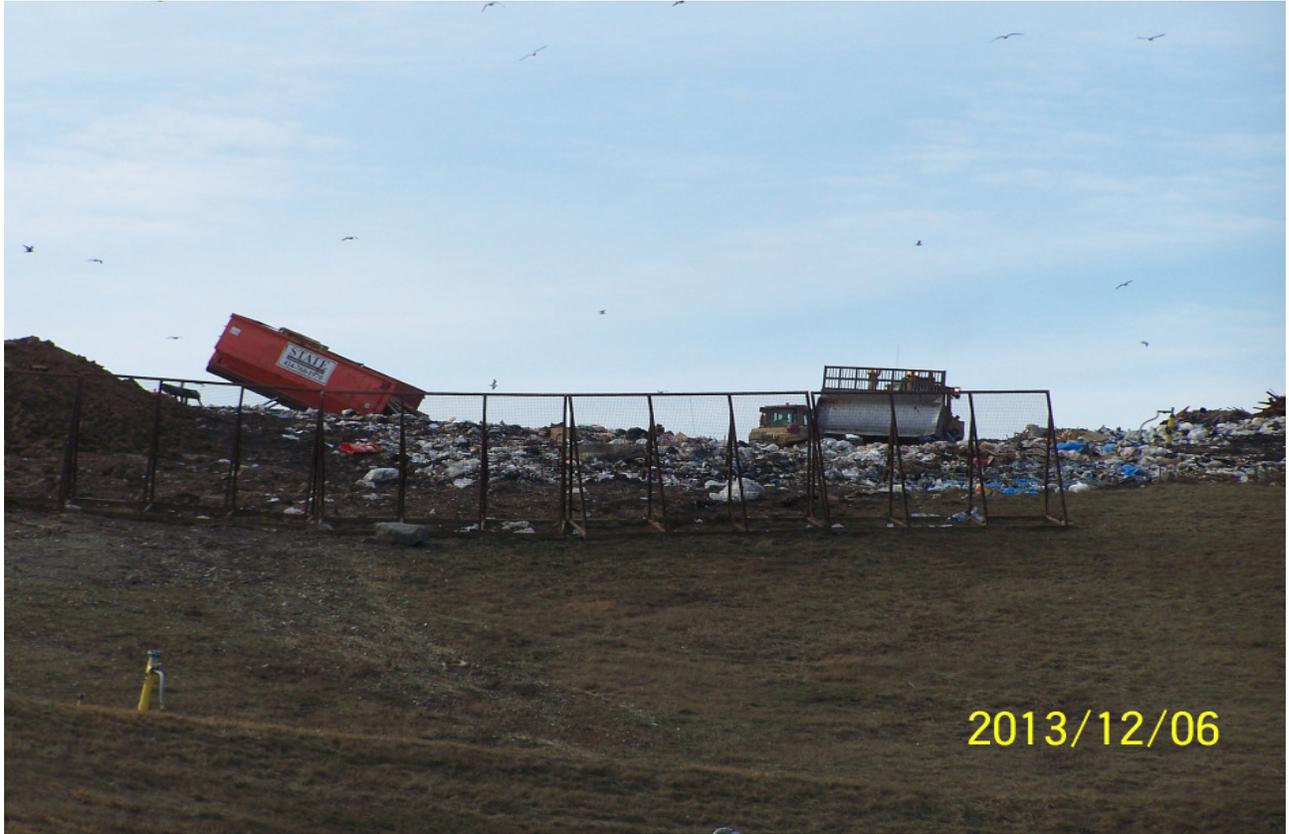
Working face

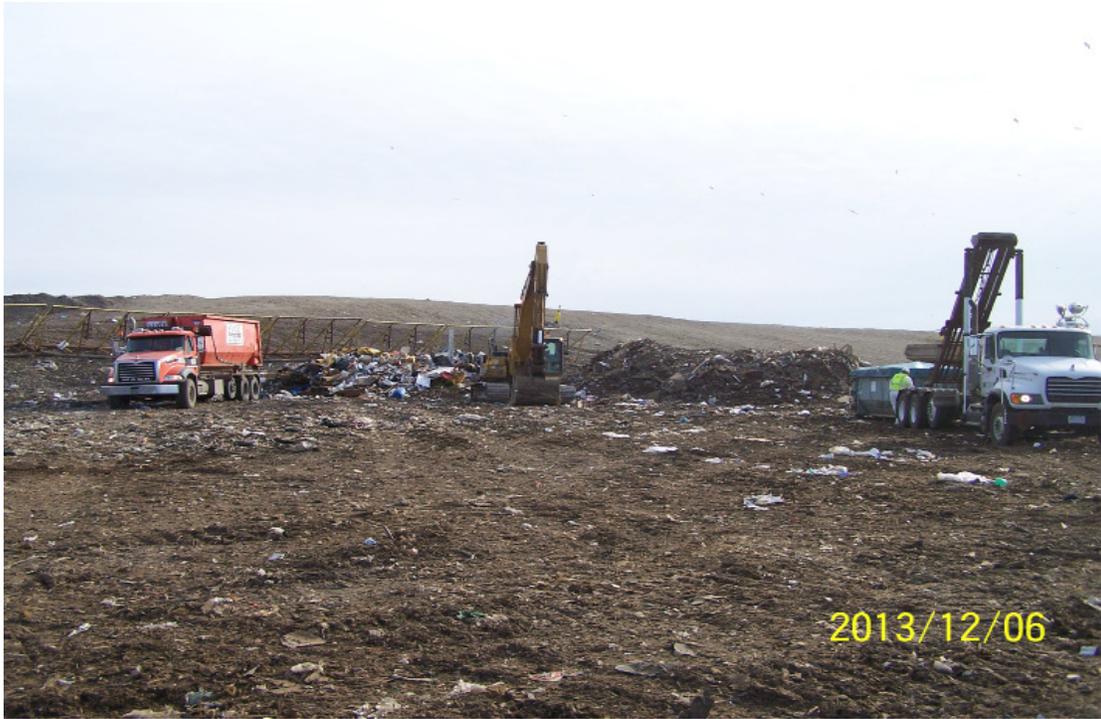
Working face, excavator digging out frozen loads

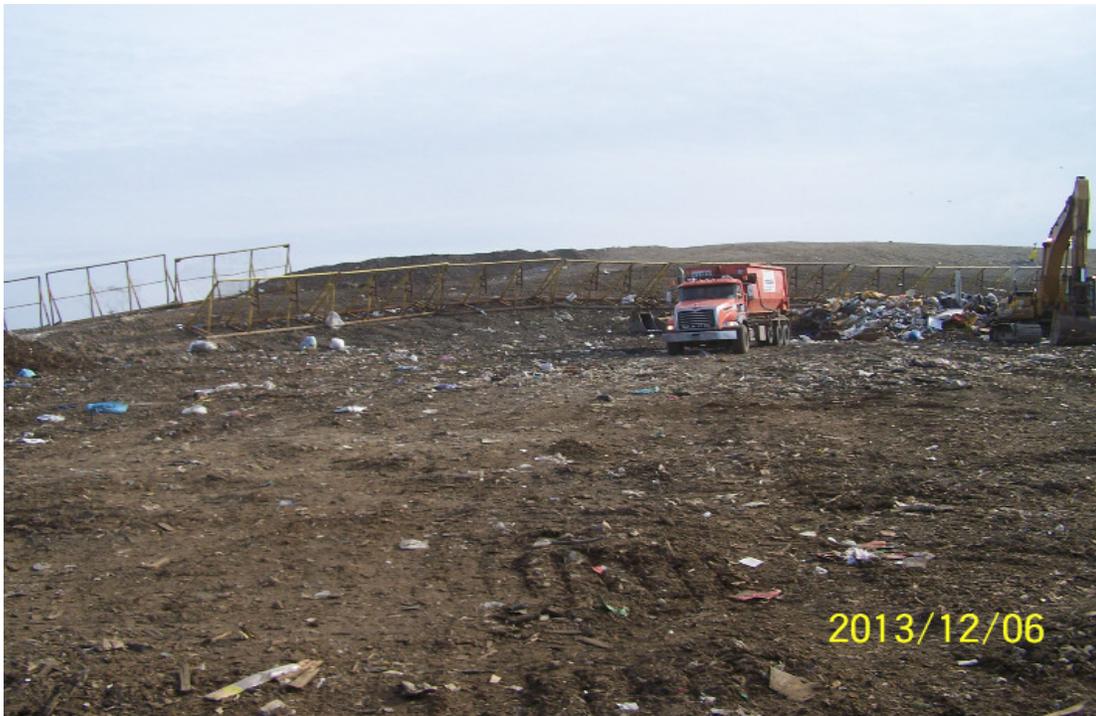
Active area around working face

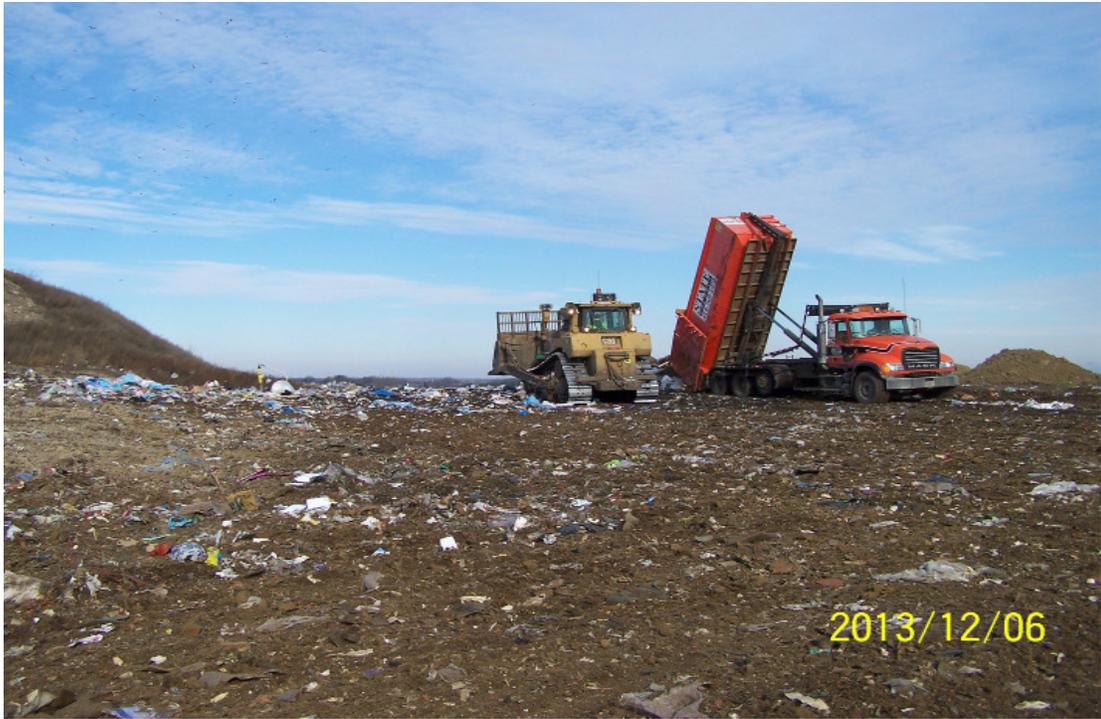
Cleanout area

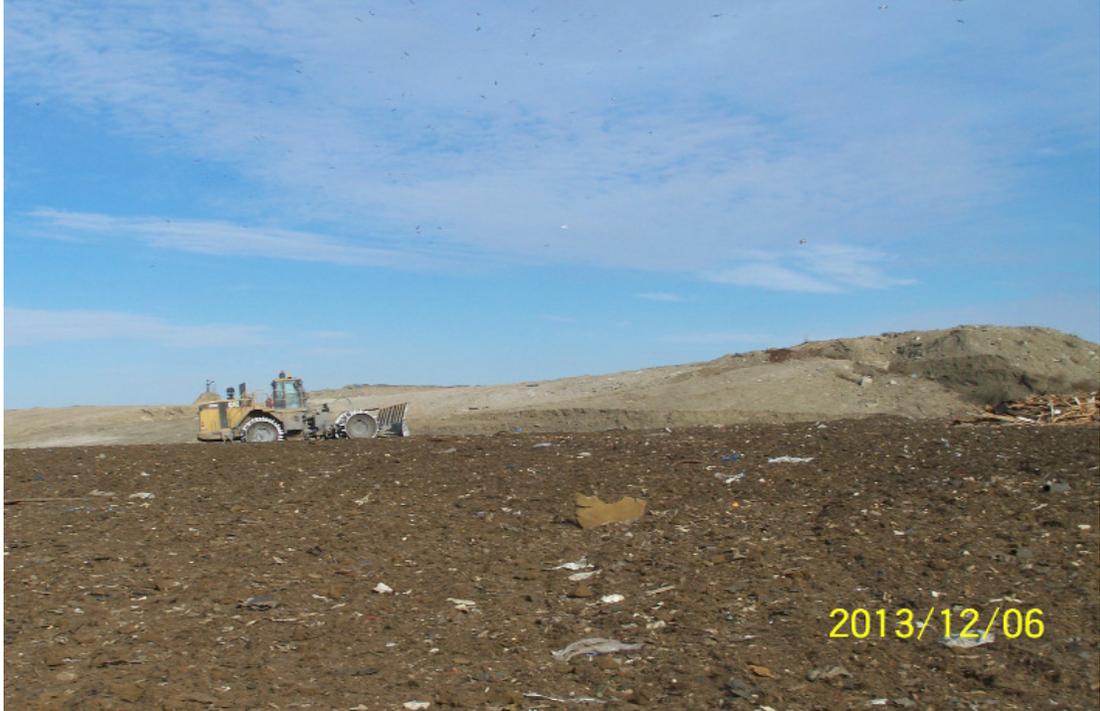
Working face, past lift

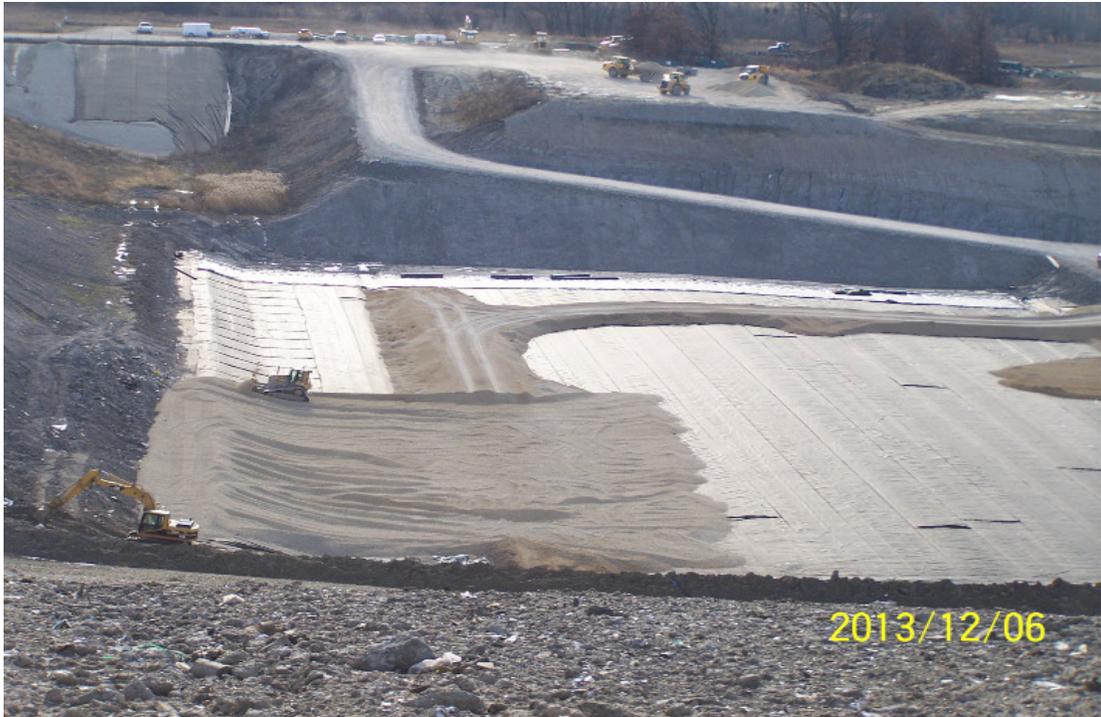
East side of Phase 9

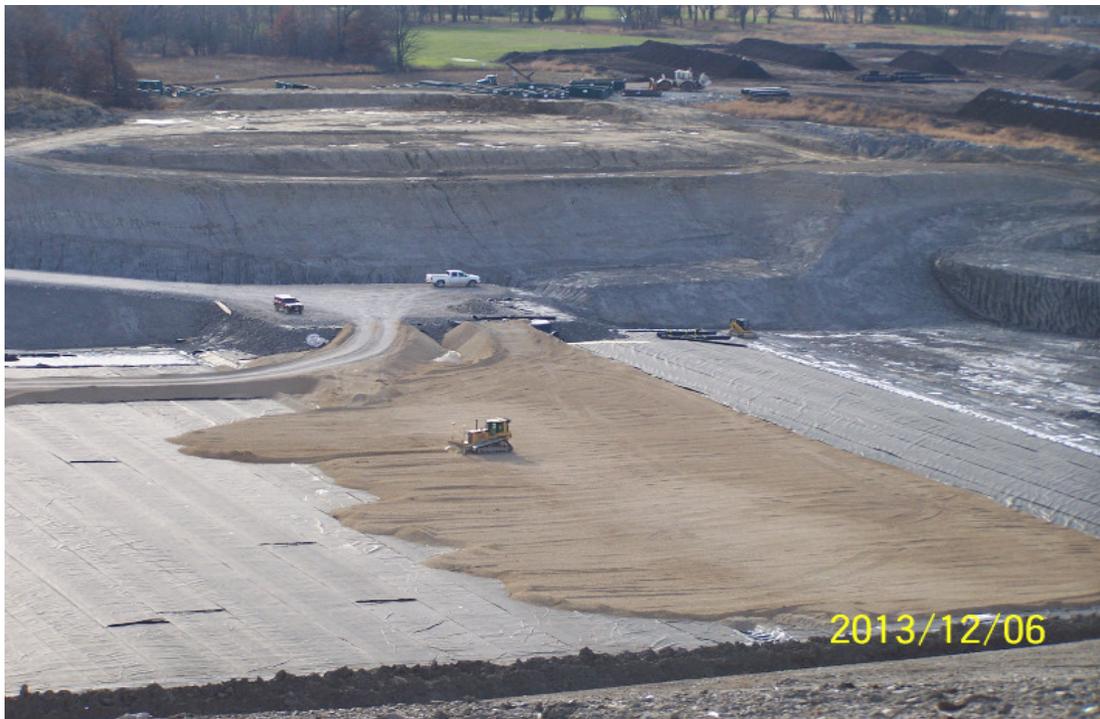
West side of Phase 9

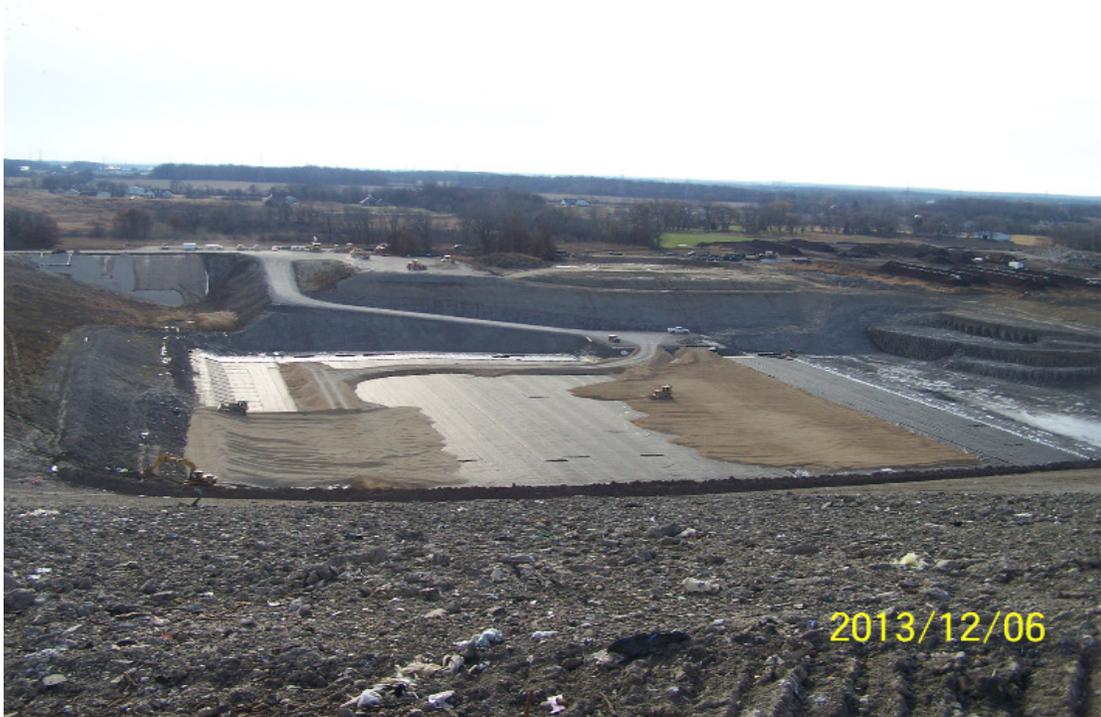
\* Drainage media being placed for leachate collection

Phase 9 drainage blanket installation

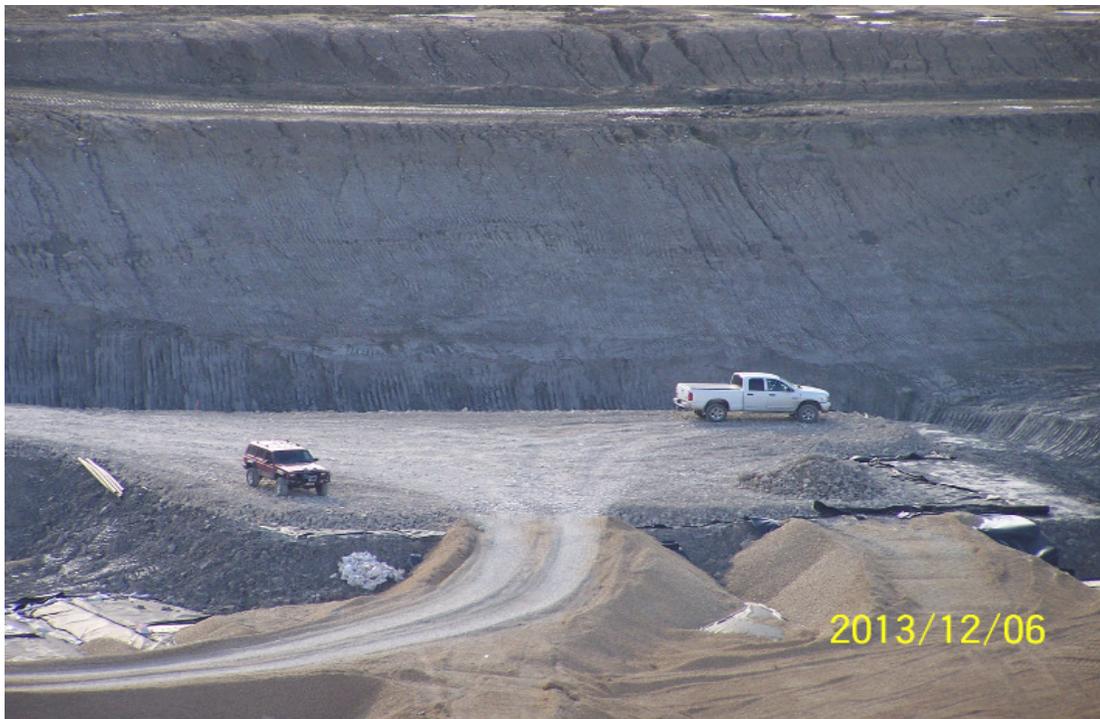
Access pad constructed above cell base for delivery of drainage media and eventually waste

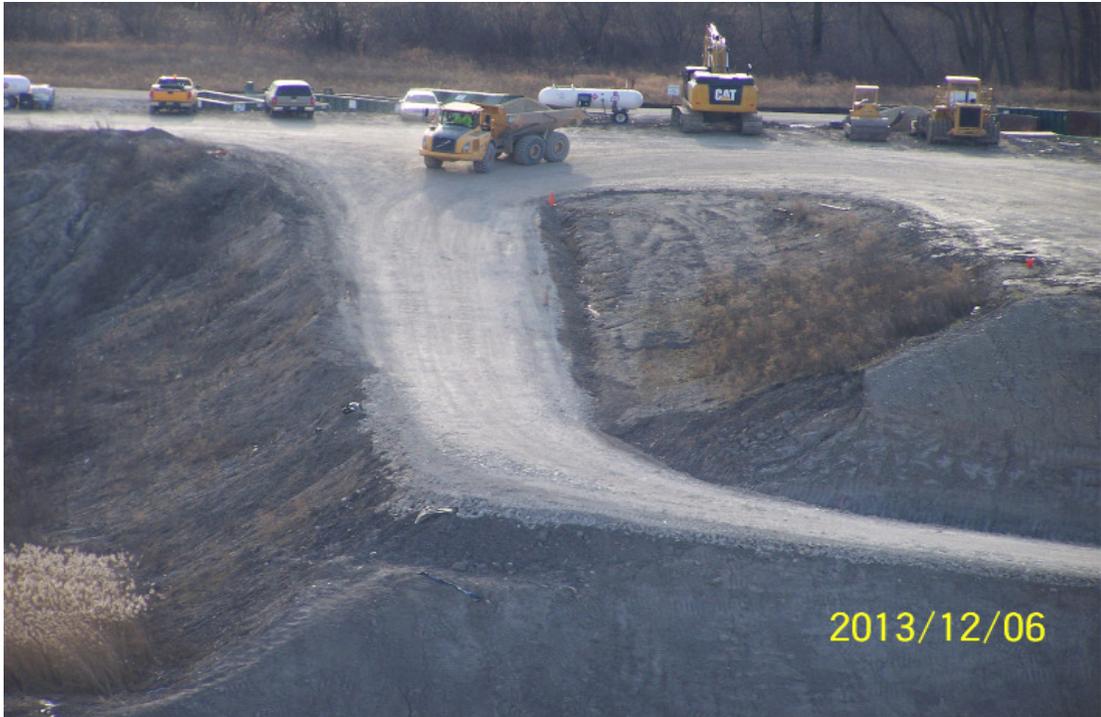
\* Access Road to Cell completed

Access road construction to new cell

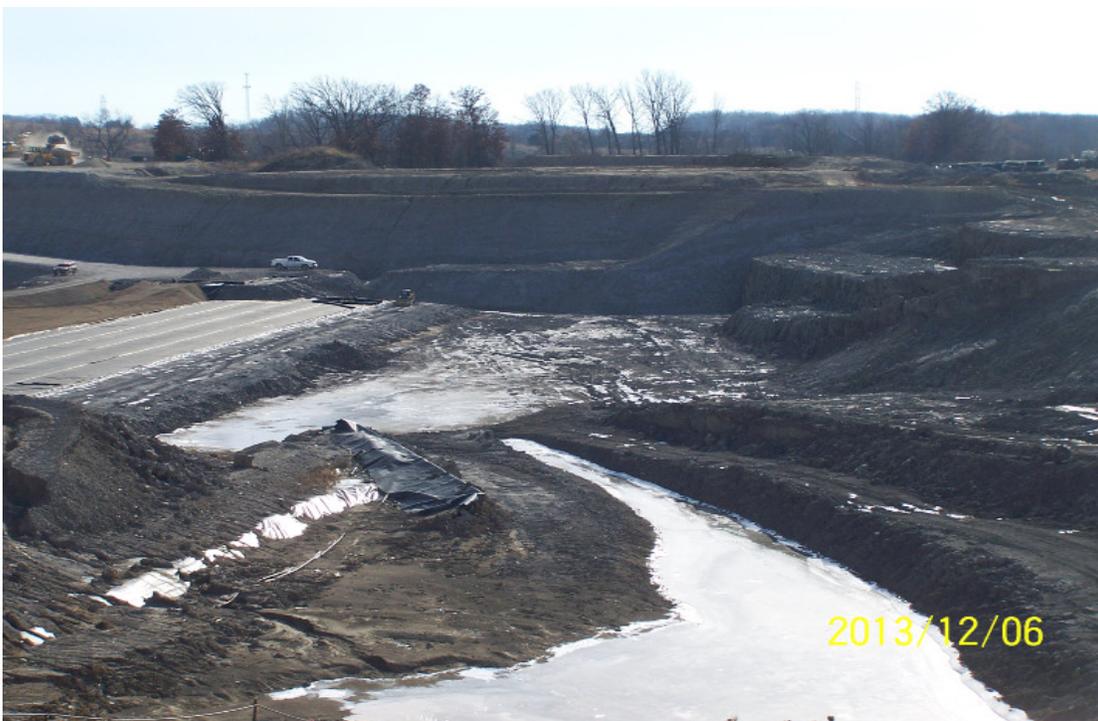
Sump and West edge of Phase 9

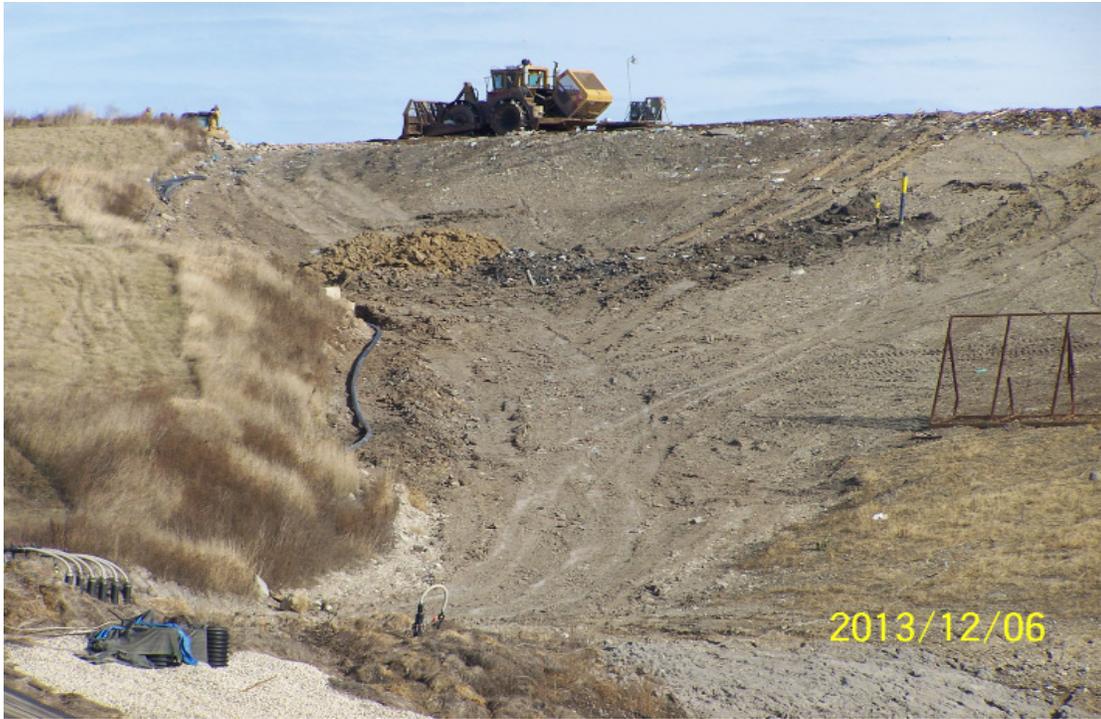
\* Gun range in use during audit  
\* Lateral repair completed on Southwest corner of Phase 3, soil placement over excavation completed as well

Lateral repaired on West slope of Phase 3
