# ADS Emerald Park Landfill Audit Summary

**TO:** ADS Emerald Park Landfill Standing Committee, City of Muskego  
**FROM:** Jo-Walter Spear, Jr., P.E.  
**COPIES:** File  
**DATE:** 12/30/2013  
**PROJECT NUMBER:** 1012.10030

**ADVANCED DISPOSAL SERVICES  
EMERALD PARK LANDFILL / CITY OF MUSKEGO  
AUDIT PHOTOS**

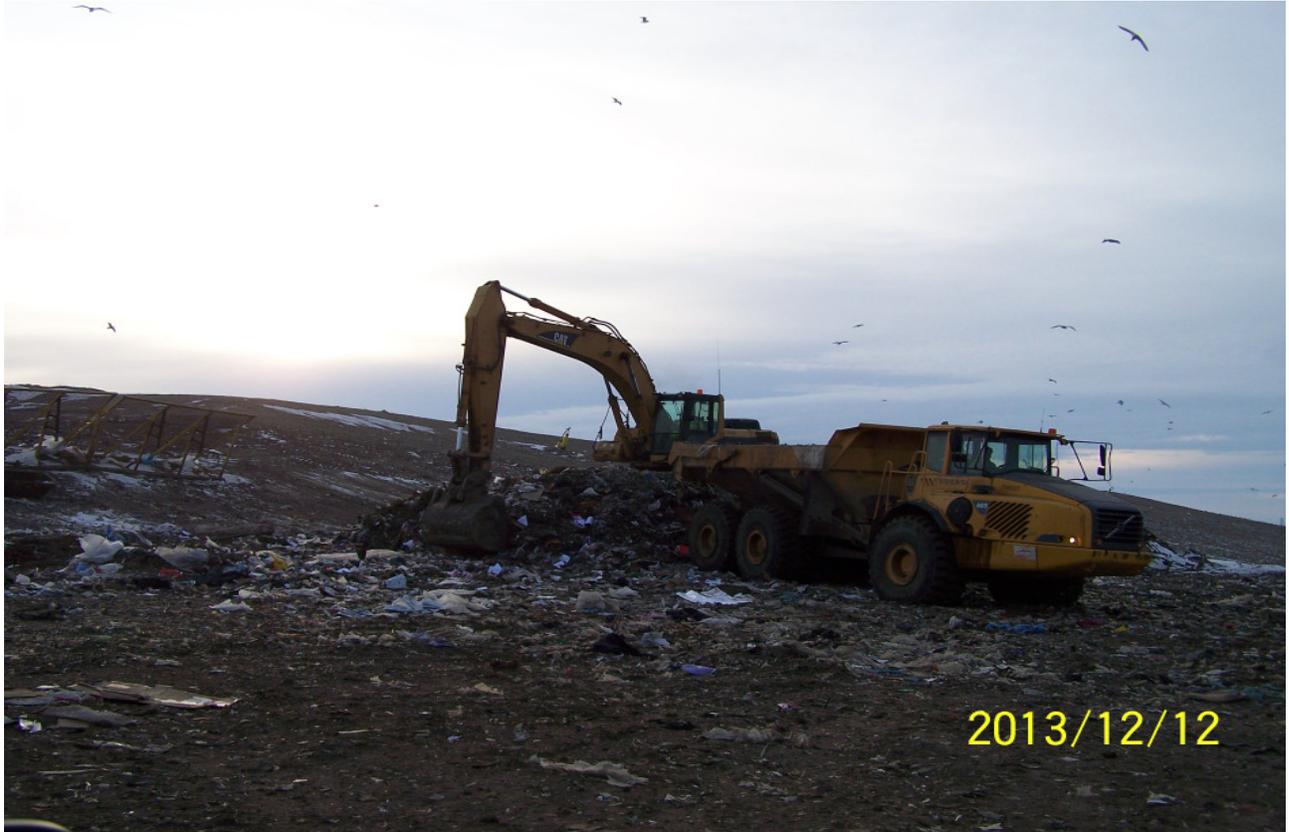
- Working face for MSW in Phase 7; adjacent to Phase 3
  - Receiving and C&D wastes
  - Filling shallow areas to complete slope in Phase 7
  - Materials from previous cleanout moved to working face by excavator and haul truck

Clean out area from previous days activities being moved to Working face

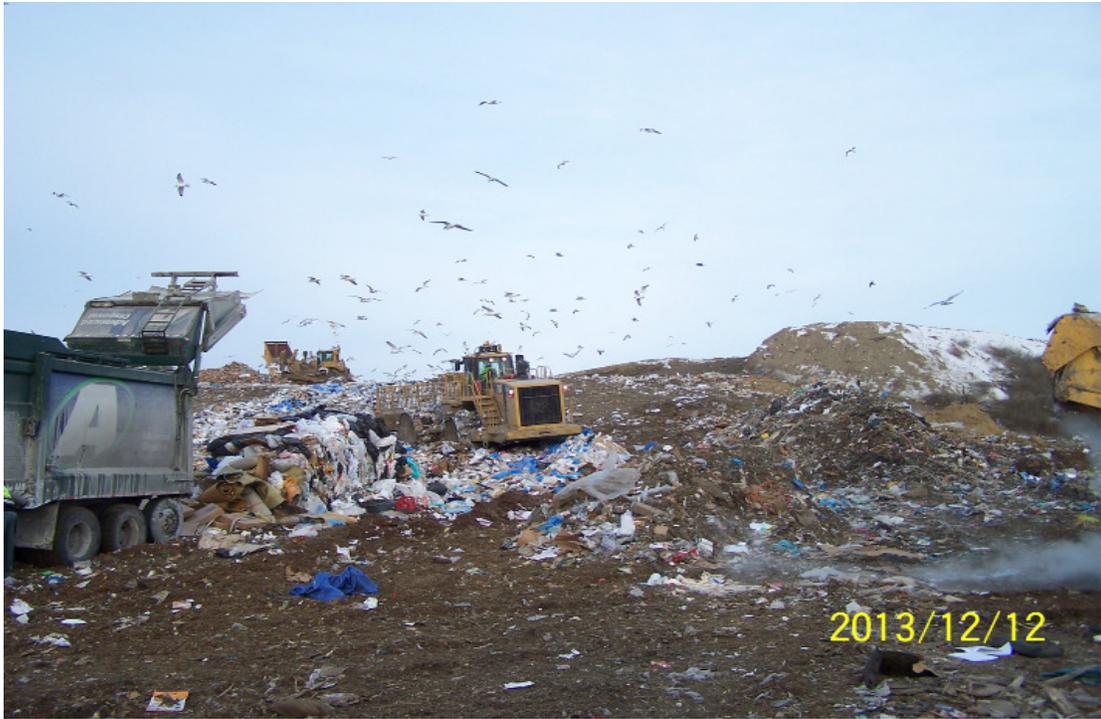
Working face

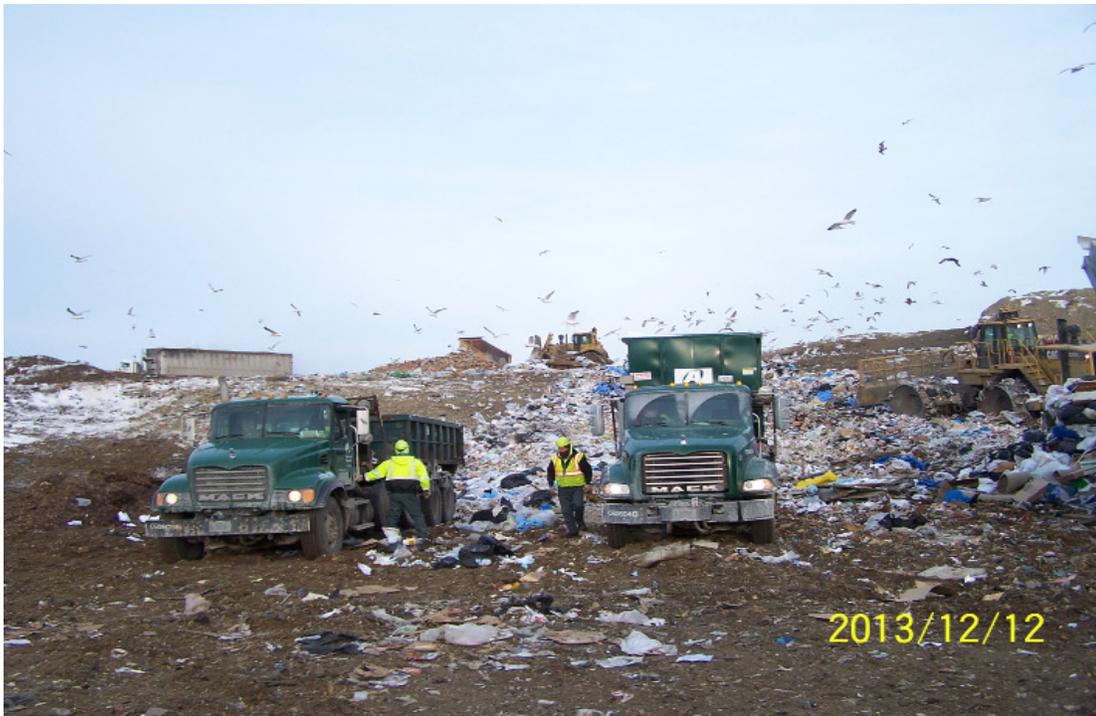
Working face

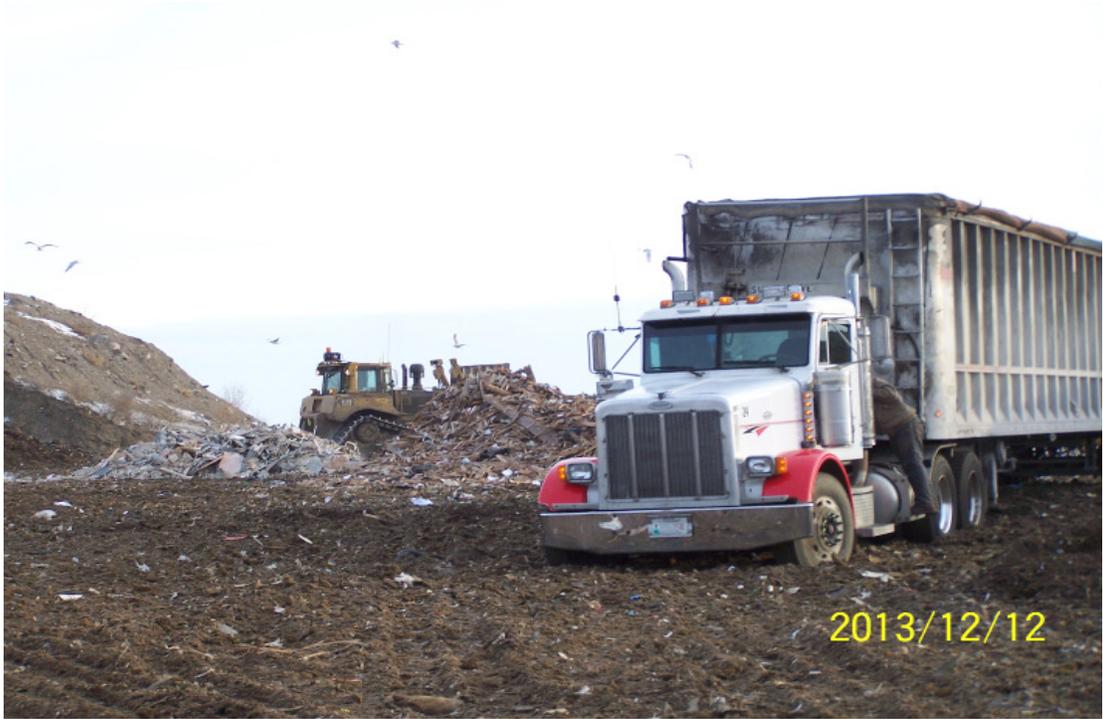
C&D & MSW being received. C&D aiding in cover.

C & D stock pile to be used to improve cover

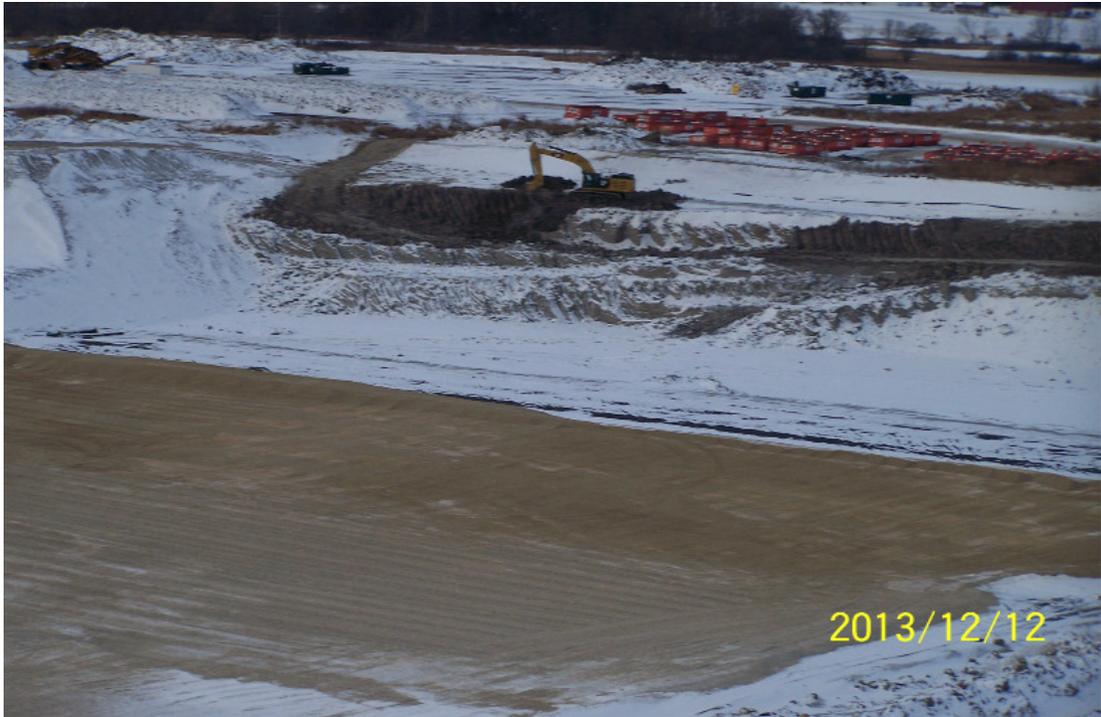
*Finish spreading of leachate collection layer*

Leachate collection layer of Phase 8, West edge with berm.

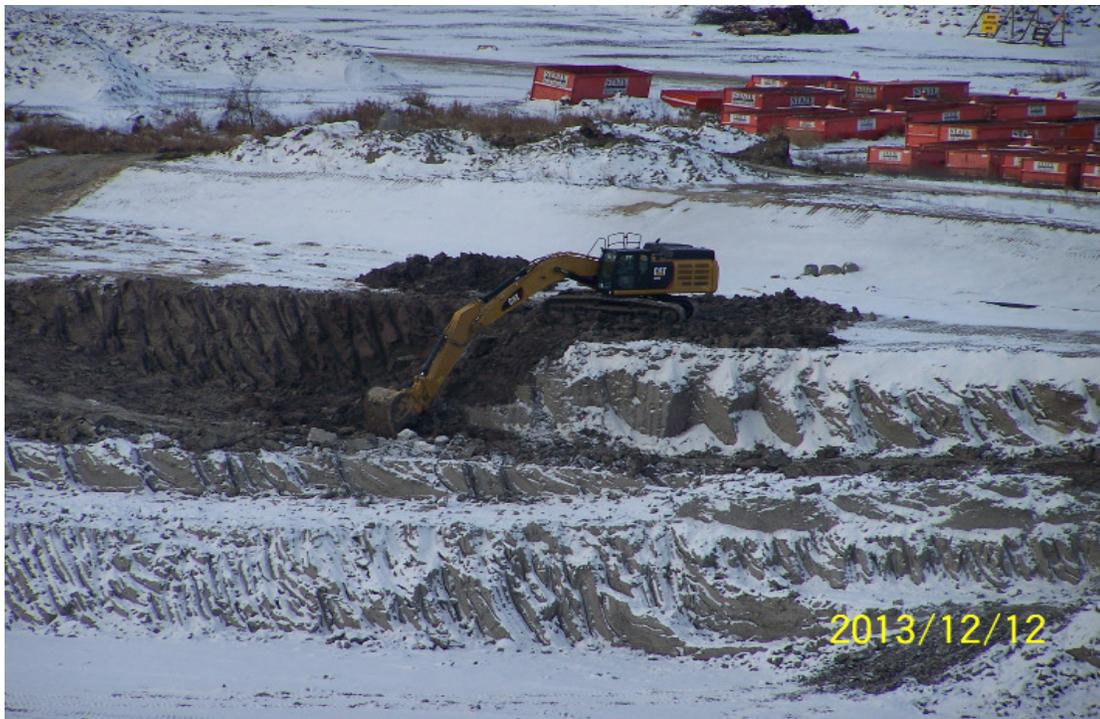
*Equipment clearing access road for equipment to get into Phase 3 for operations.*

Excavater developing equipment access road to Phase 8
