# ADS Emerald Park Landfill Audit Summary

**TO:** ADS Emerald Park Landfill Standing Committee, City of Muskego  
**FROM:** Jo-Walter Spear, Jr., P.E.  
**COPIES:** File  
**DATE:** 12/9/13  
**PROJECT NUMBER:** 1012.10030

Attached is the audit report for activities at the ADS Emerald Park Landfill for the week of November 25, 2013. The audit was performed at 12:15 PM on **November 27, 2013** by Jo Spear, Jr. in the presence of David Geier.

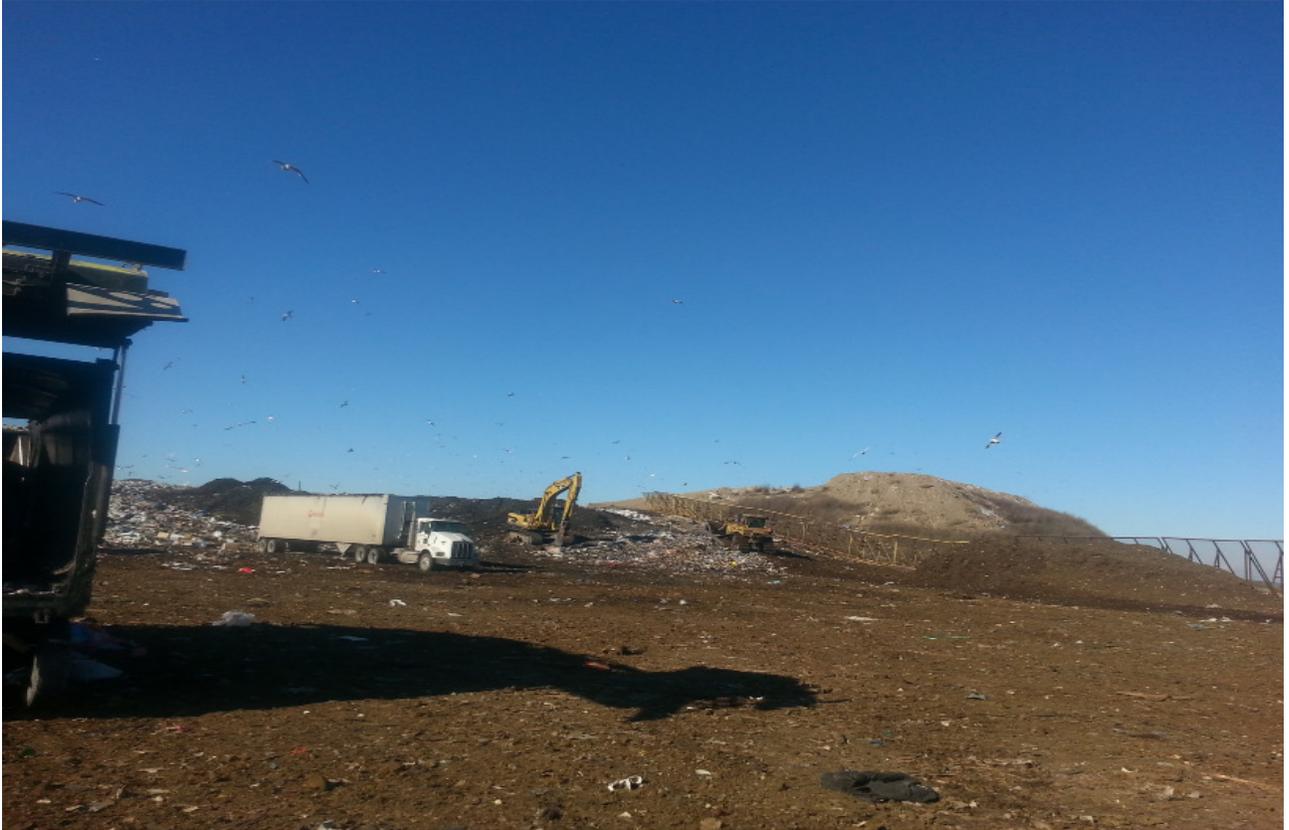
Active Area

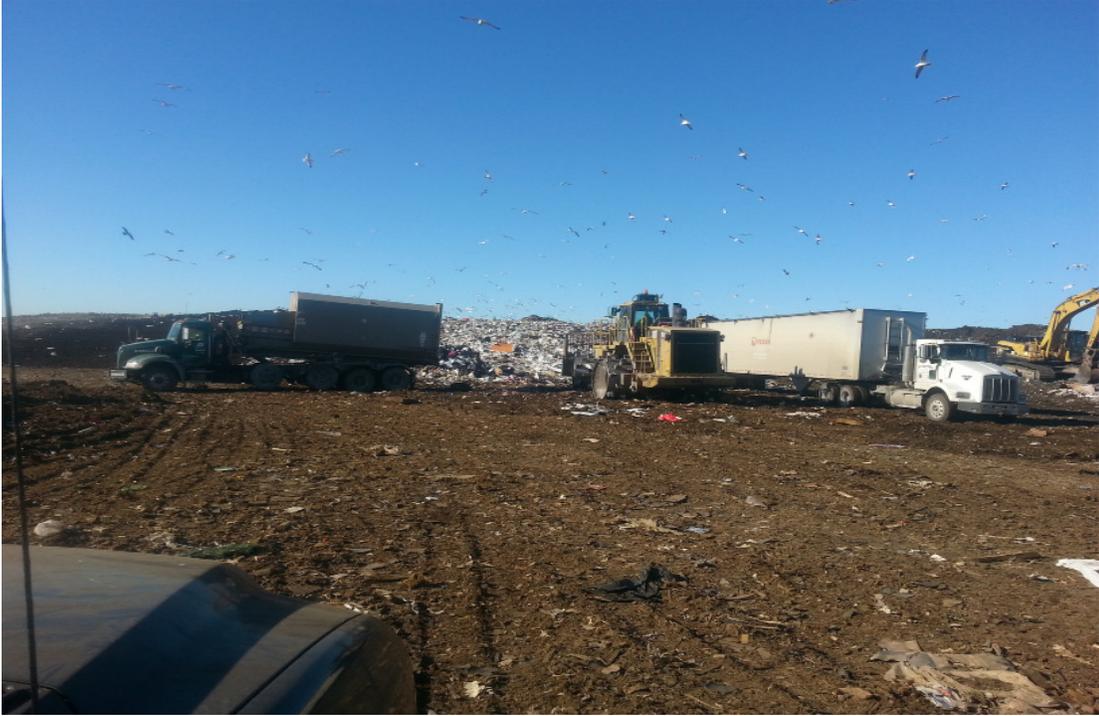
Working face still on West edge of Phase F  
Moving Eastward. Soils being tipped  
adjacent to working face for MSW.

Working face

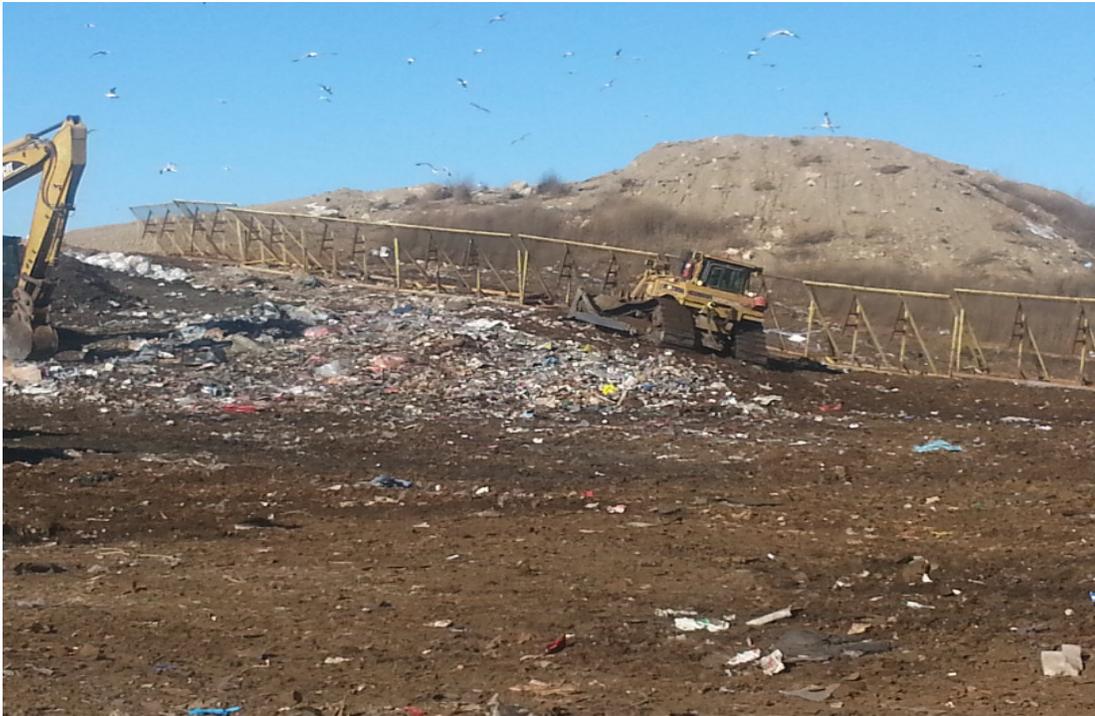
Note soil in back ground is soils in Phase 3

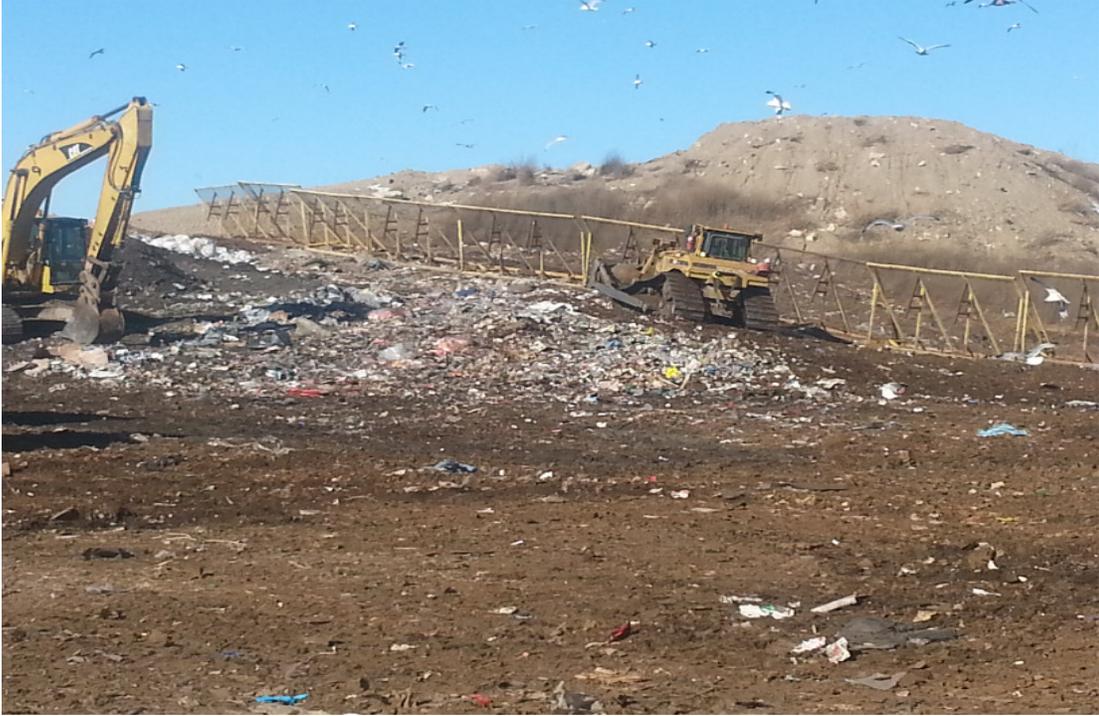
Dozer moving and covering waste

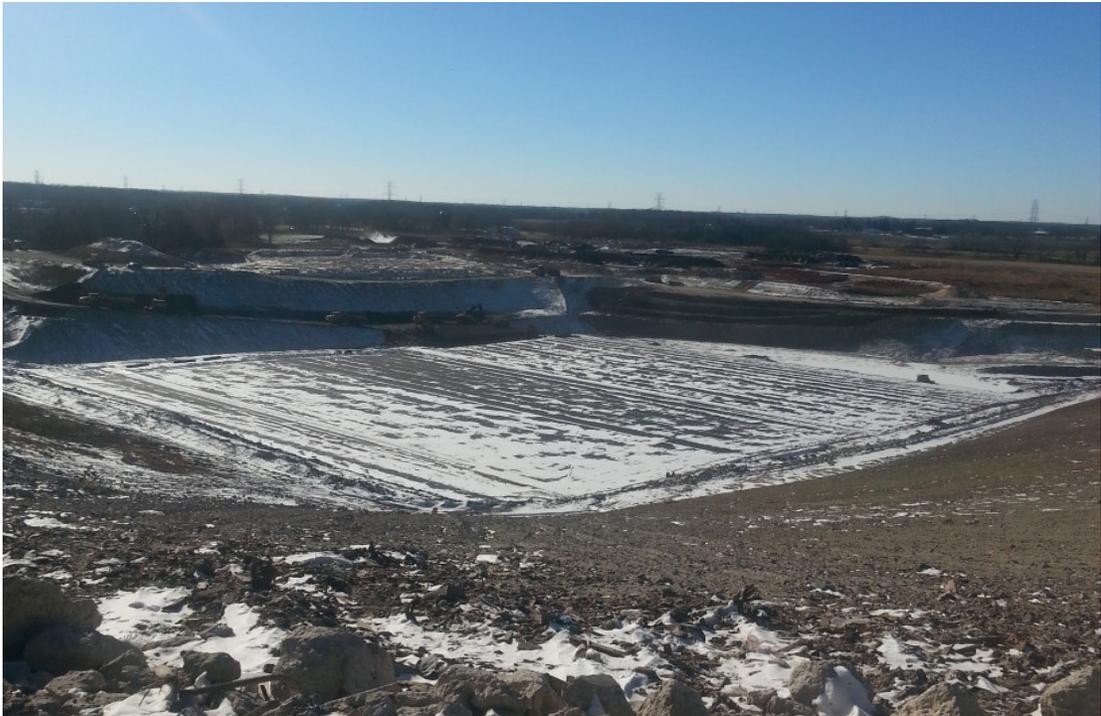
- Sand gradient layer nearly complete; only Southwest corner waiting for placement
- Clay liner placement and working of material on-going
- 2 excavators and 3 haul trucks in use
- Access for Phase 8 currently under construction
  - Working near base of Phase 7
- Excavated soils for access and remaining cell base stockpiled at Future Parkland

Nearly completed liner

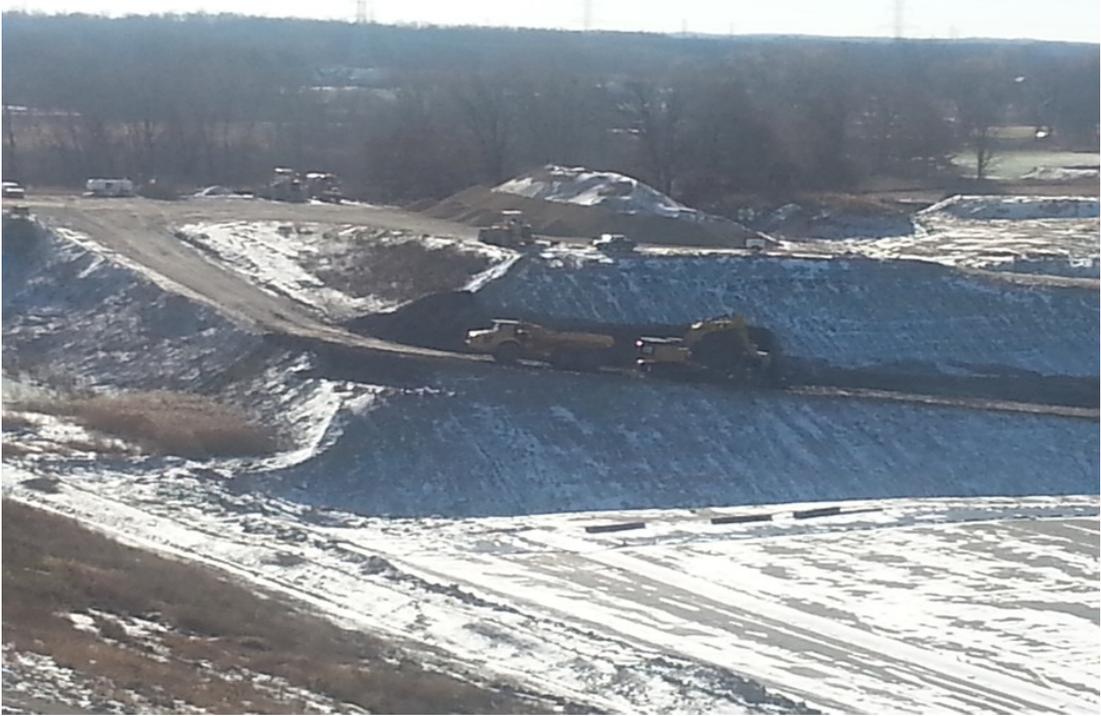
Construction of access to Phase 8 and staying at base to access Phase.

Access road construction to new cell

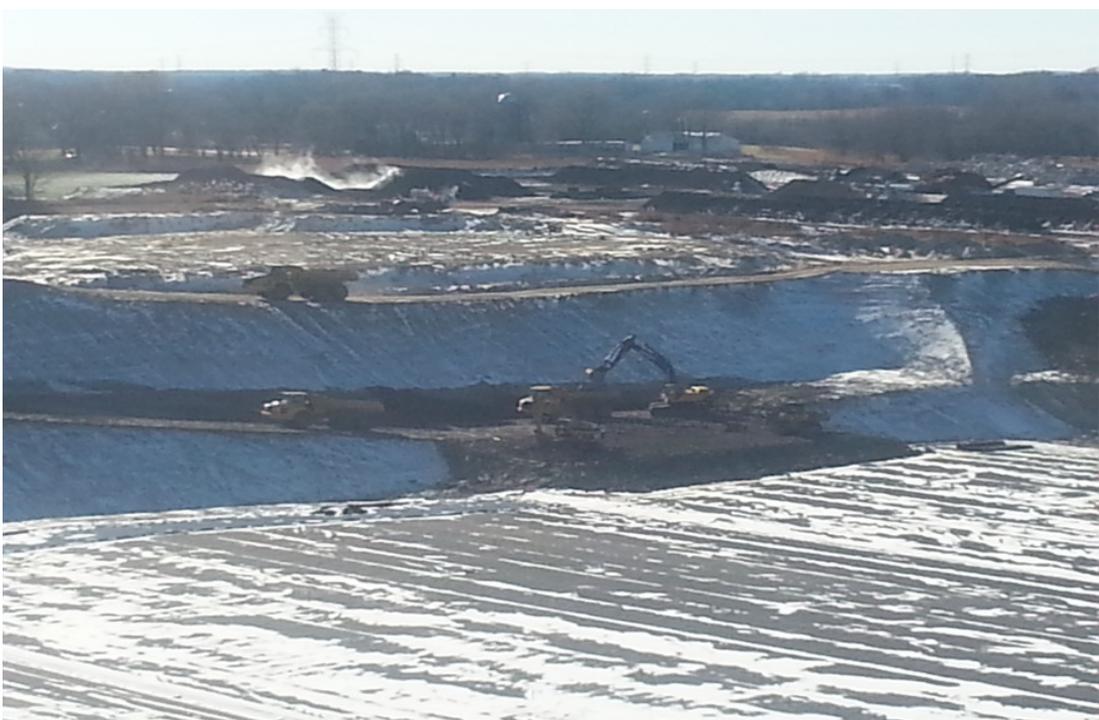
Access pad constructed above cell base for delivery of drainage media and eventually waste
