ADS Emerald Park Landfill Audit Summary

PROJECT NUMBER: 1012.10030

ADVANCED DISPOSAL SERVICES EMERALD PARK LANDFILL
 LANDFILL OPERATIONS AUDIT FORM
 CITY OF MUSKEGO

**ADVANCED DISPOSAL SERVICES
EMERALD PARK LANDFILL / CITY OF MUSKEGO
AUDIT PHOTOS**

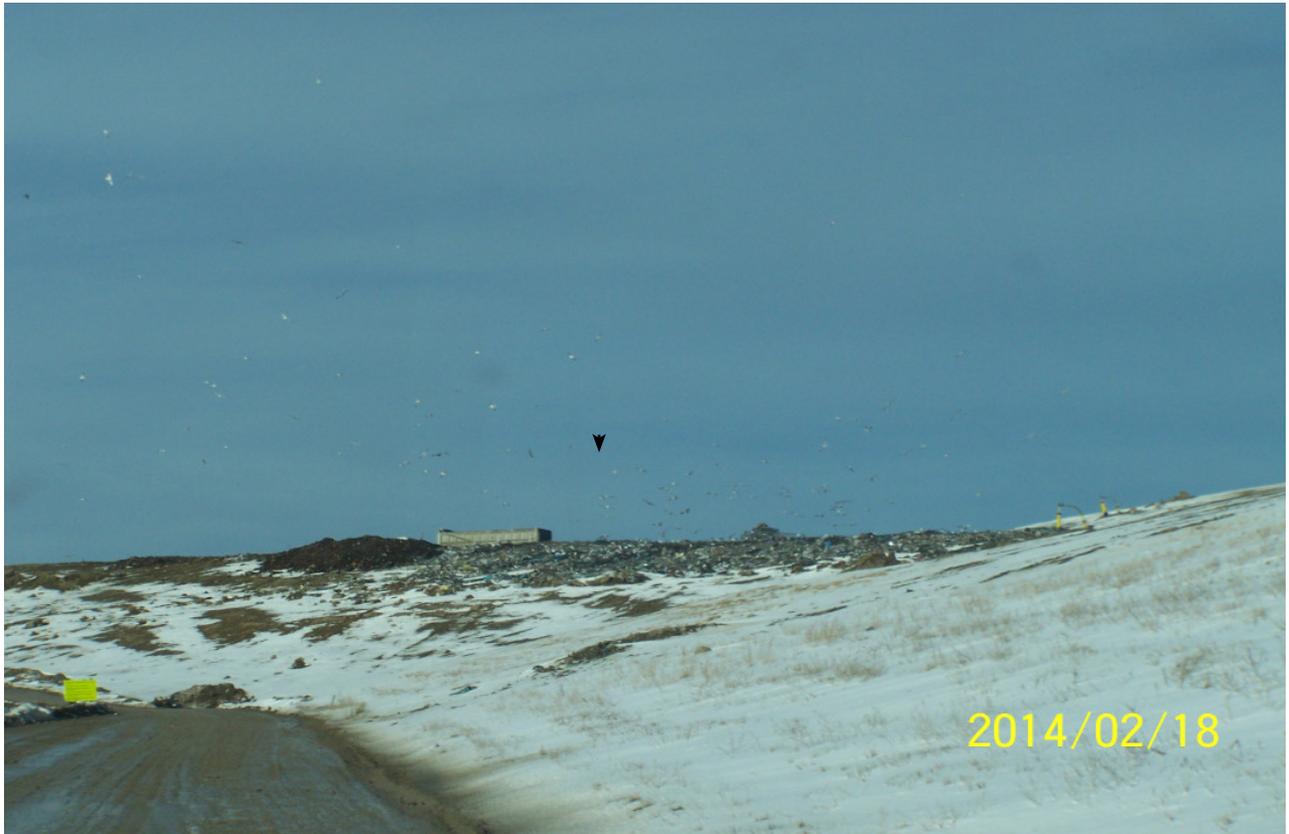
Working face in junction of phases 5,6,7

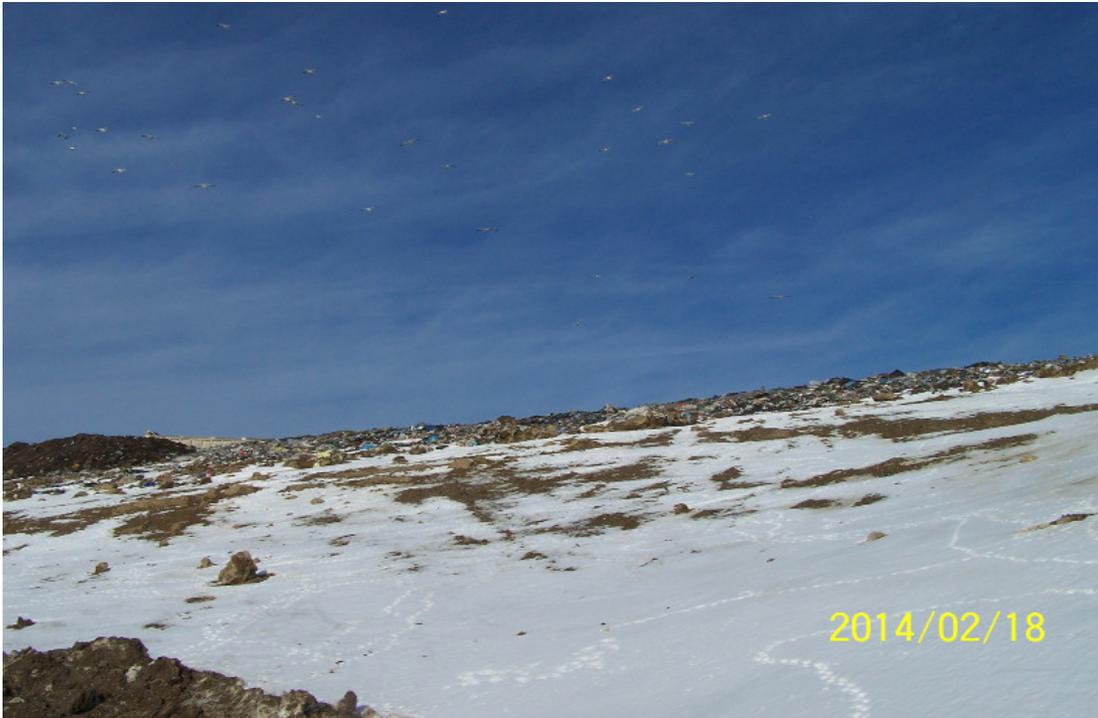
Working face viewed from South and below

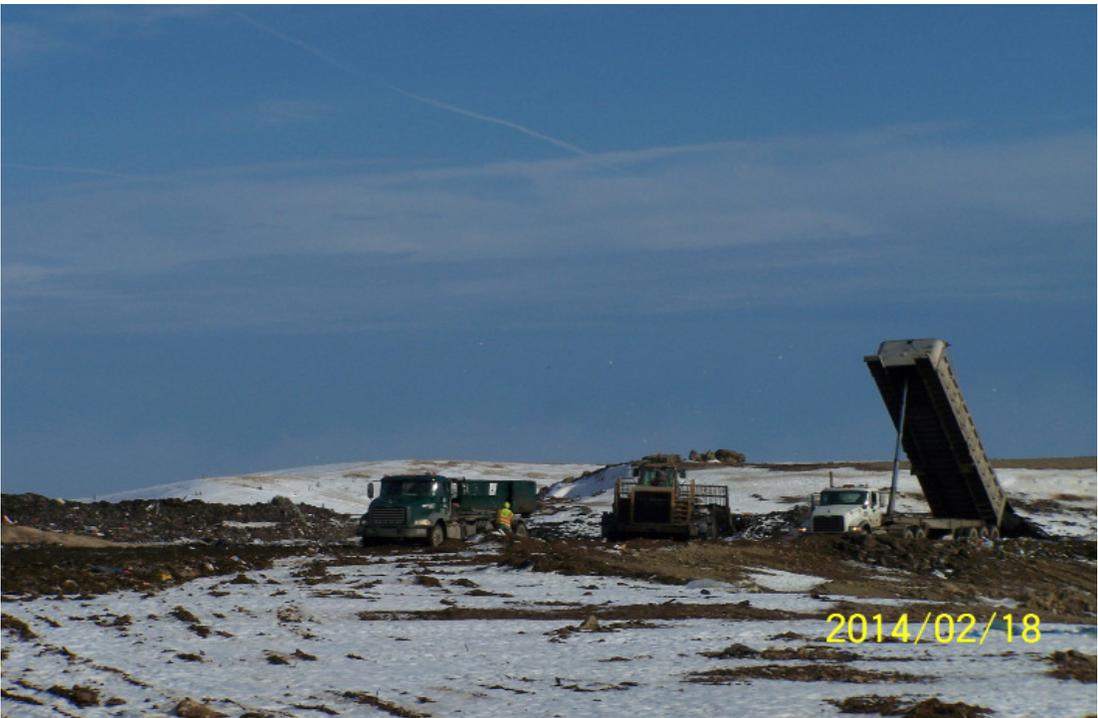
Working face in Phases 5,6,7

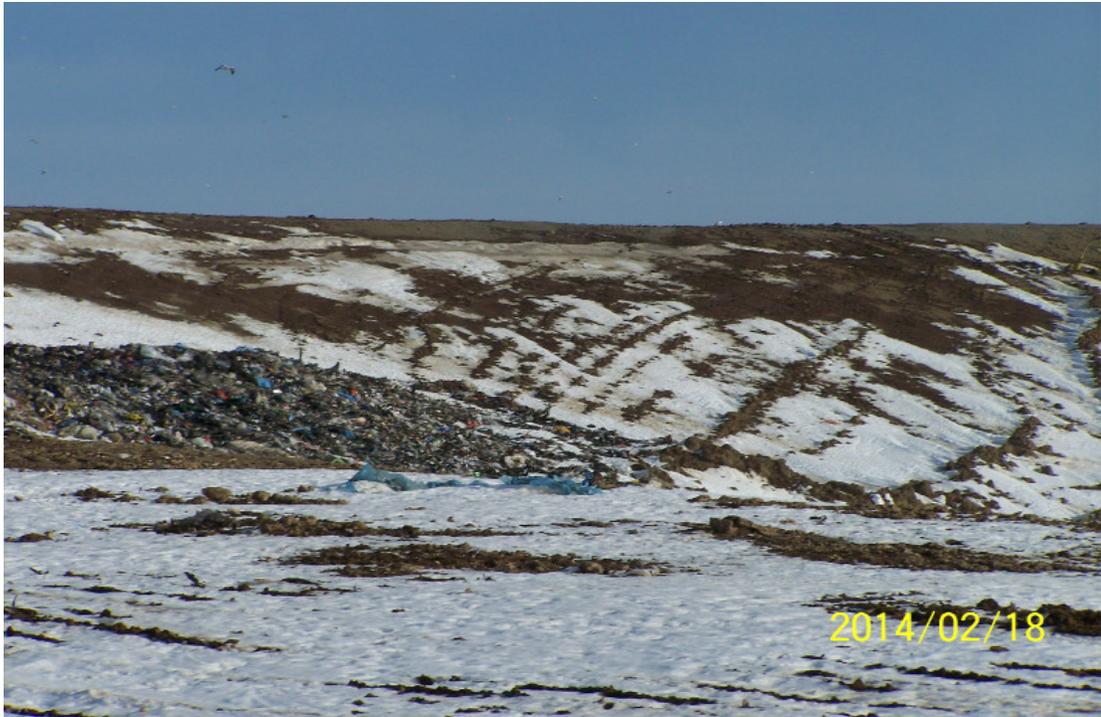
Working face in Phase 5,6,7

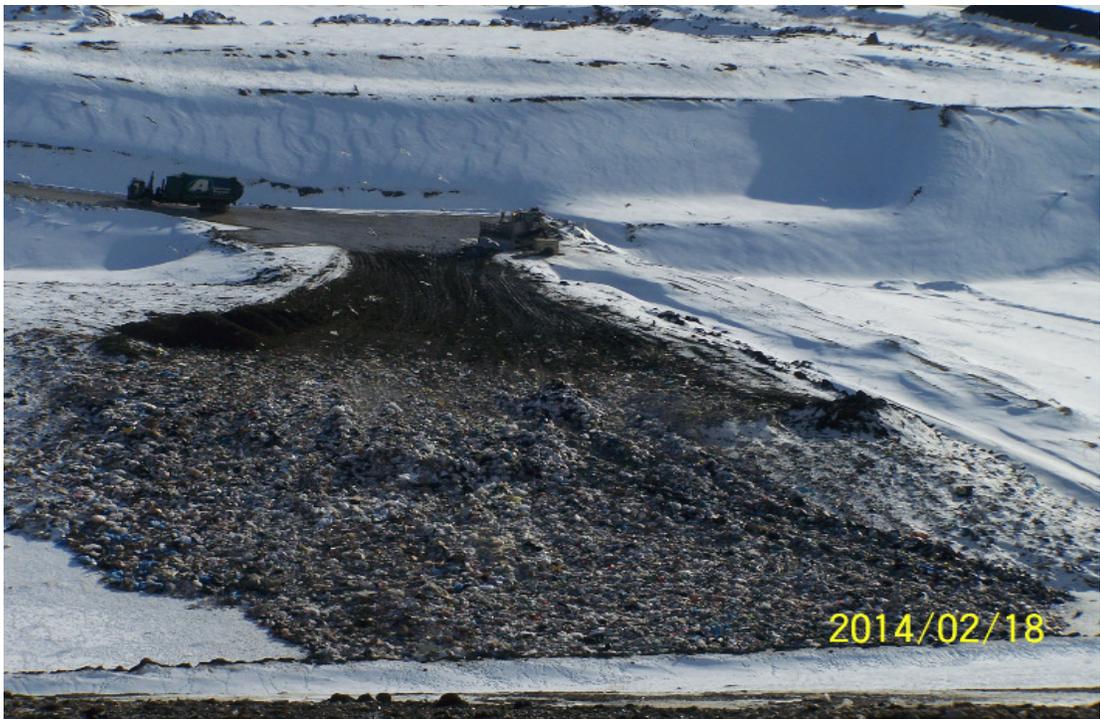
Leading edge of fluff layer

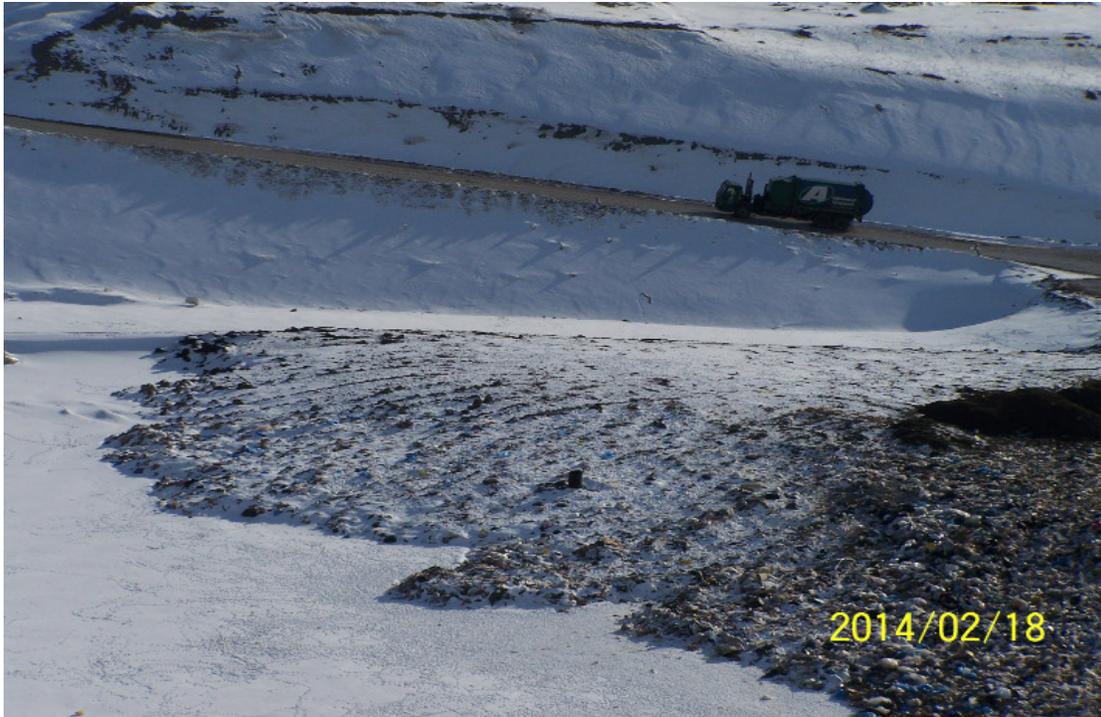
Previously placed fluff layer but not brought to grade

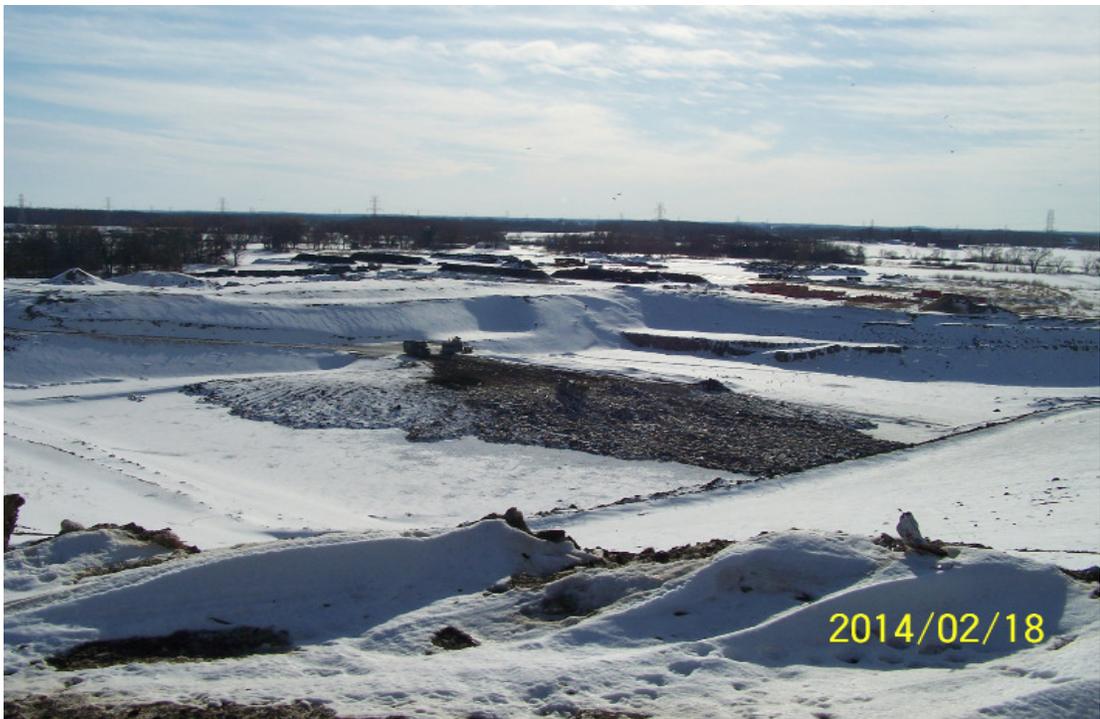
Phase 7B viewed from the Northeast

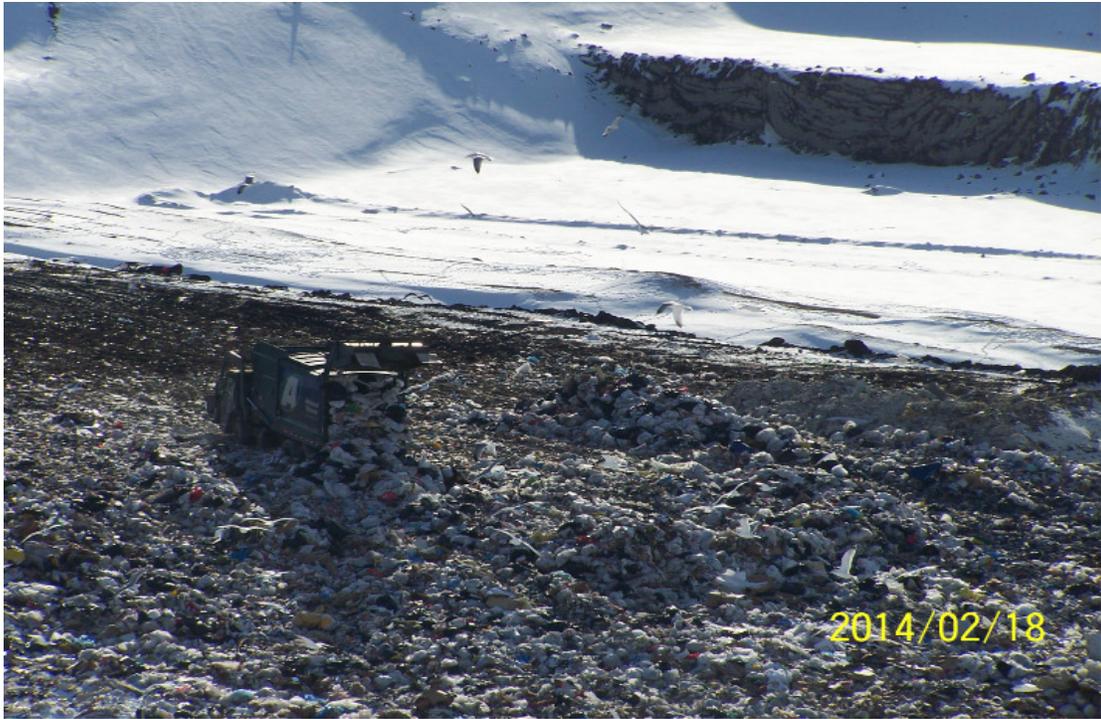
Fluff layer tipping continues
