# ADS Emerald Park Landfill Audit Summary

**TO:** ADS Emerald Park Landfill Standing Committee, City of Muskego

**DATE:** 03/13/14

**PROJECT NUMBER:** 1012.10030

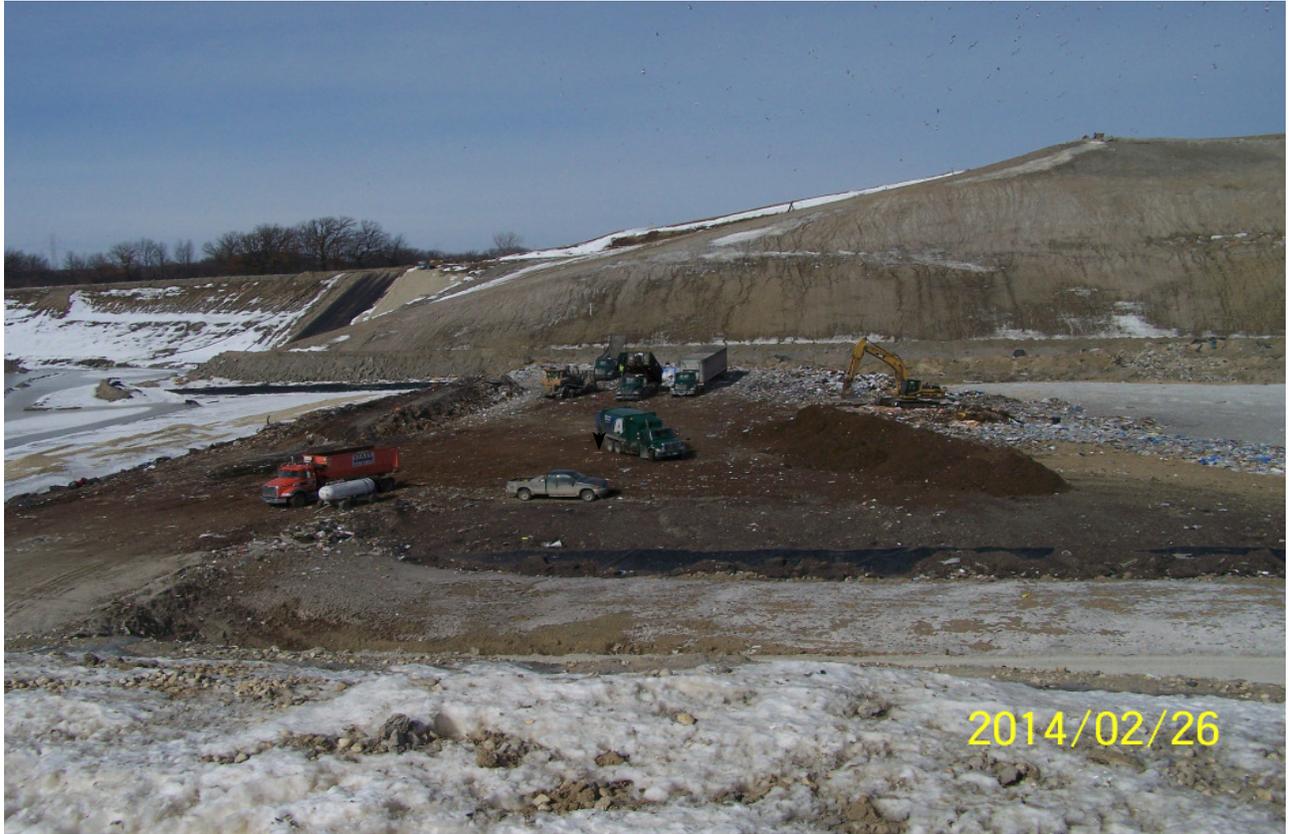
- MSW now being tipped in Phase 7b;
  - stretching out & stabilize fluff layer with MSW
  - Liquid loads also being tipped into Phase 7b
  - Waste not suitable for fluff layer going into Phases 5/6/7

Working face in Phase 7B

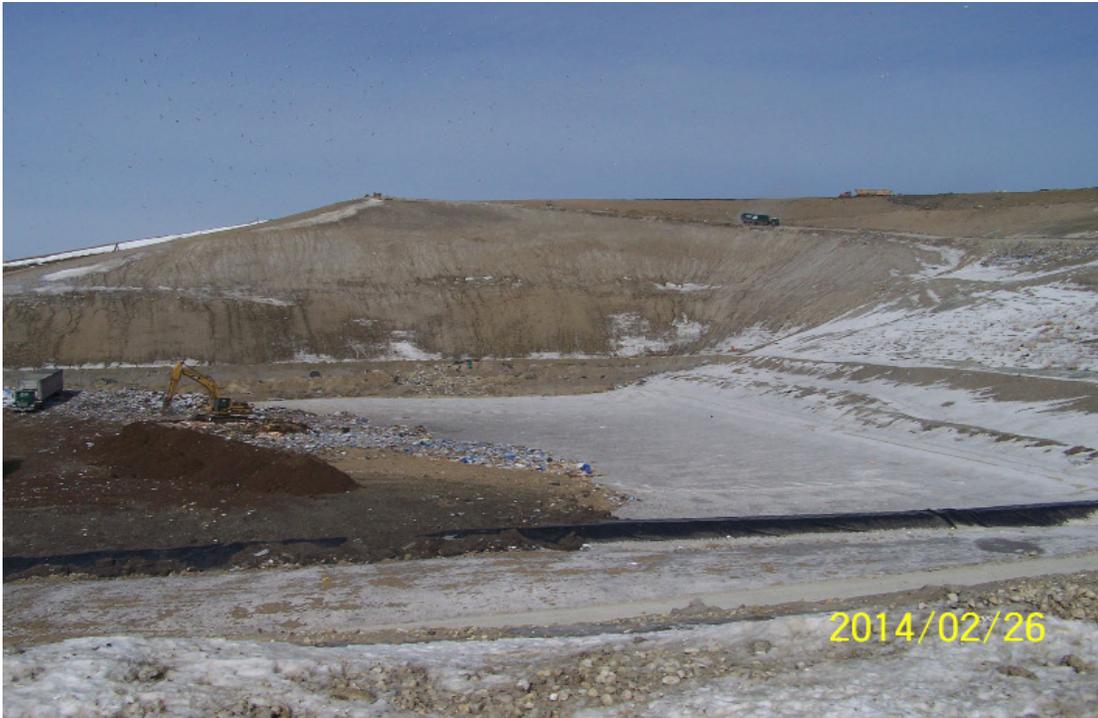
Phase 7B viewed from the South

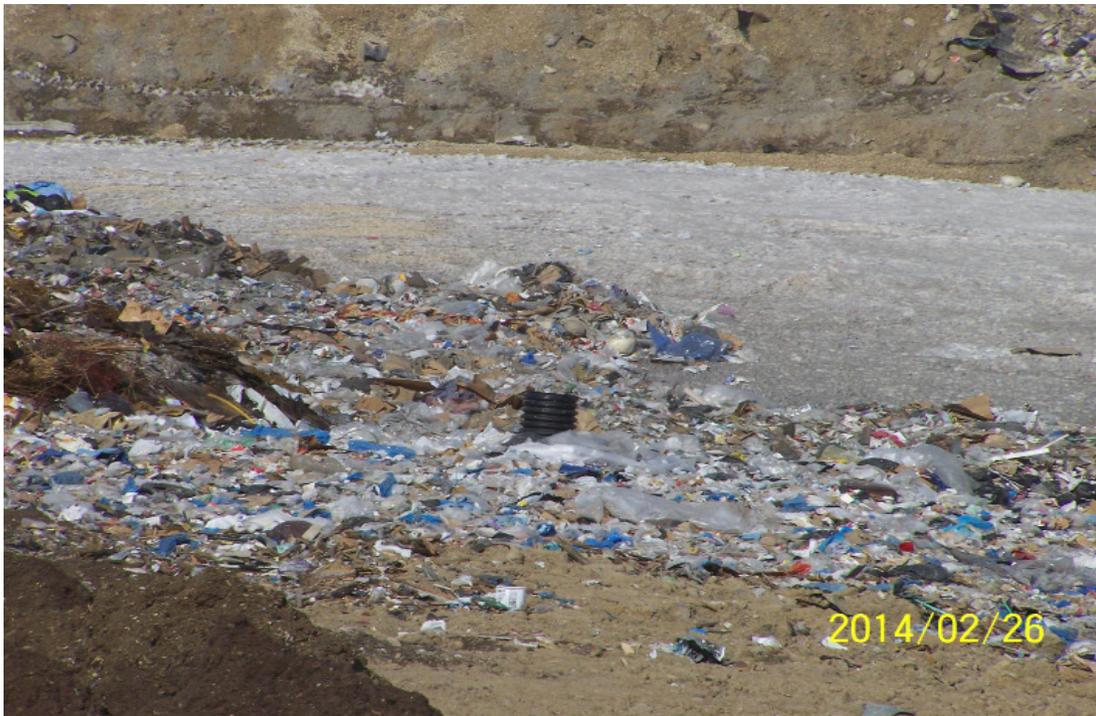
Leachate collection system being covered over by fluff layer

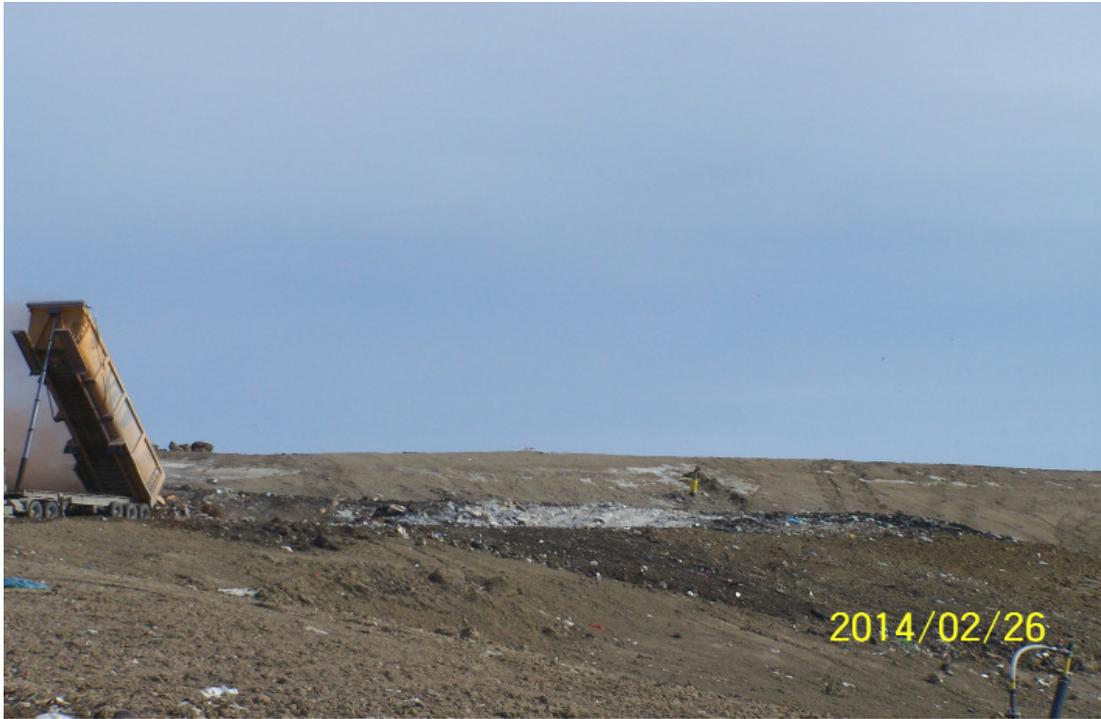
Working face in Phase 5

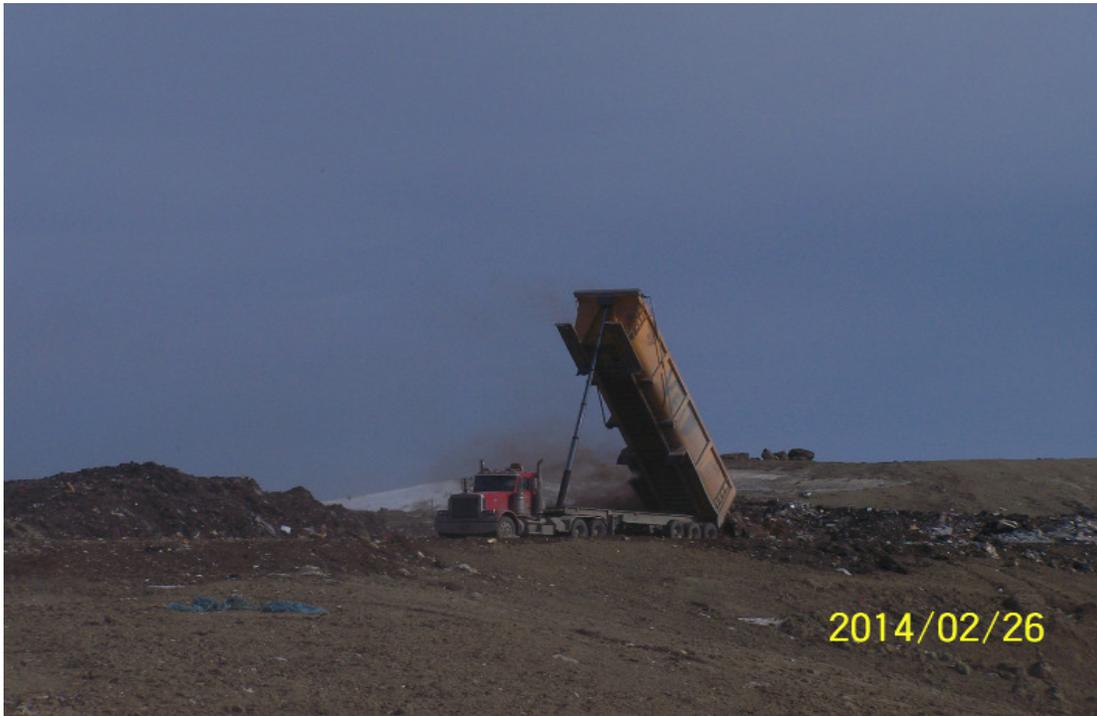
C&D tipping in Phase 5

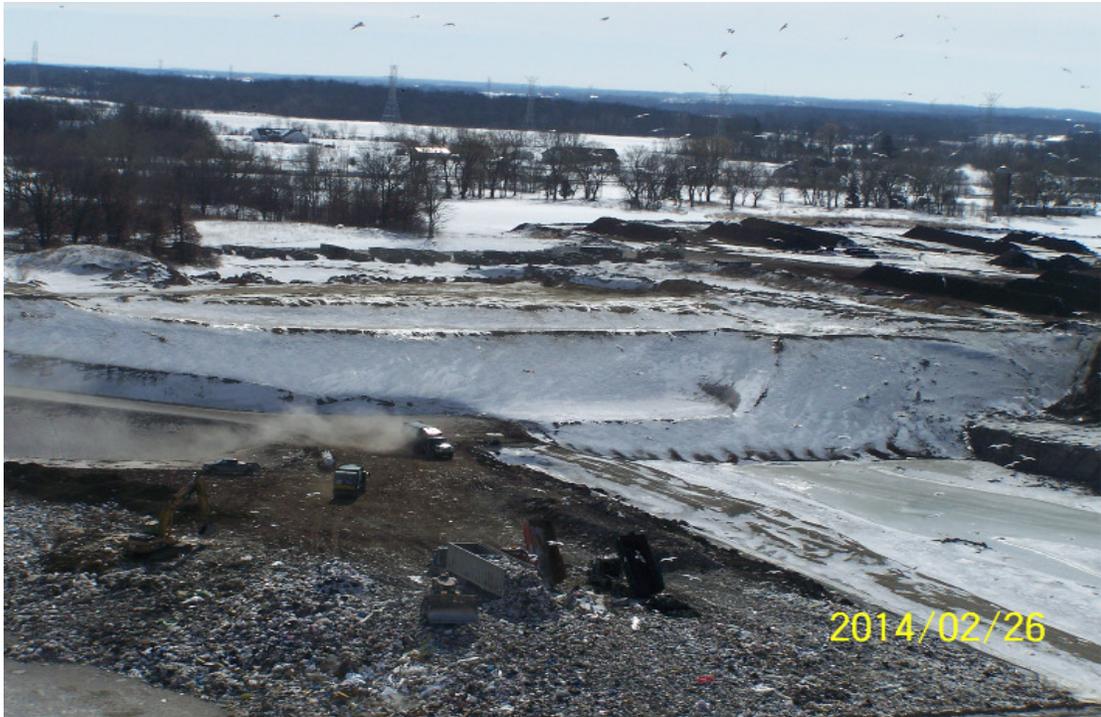
Fluff layer being pushed out to North

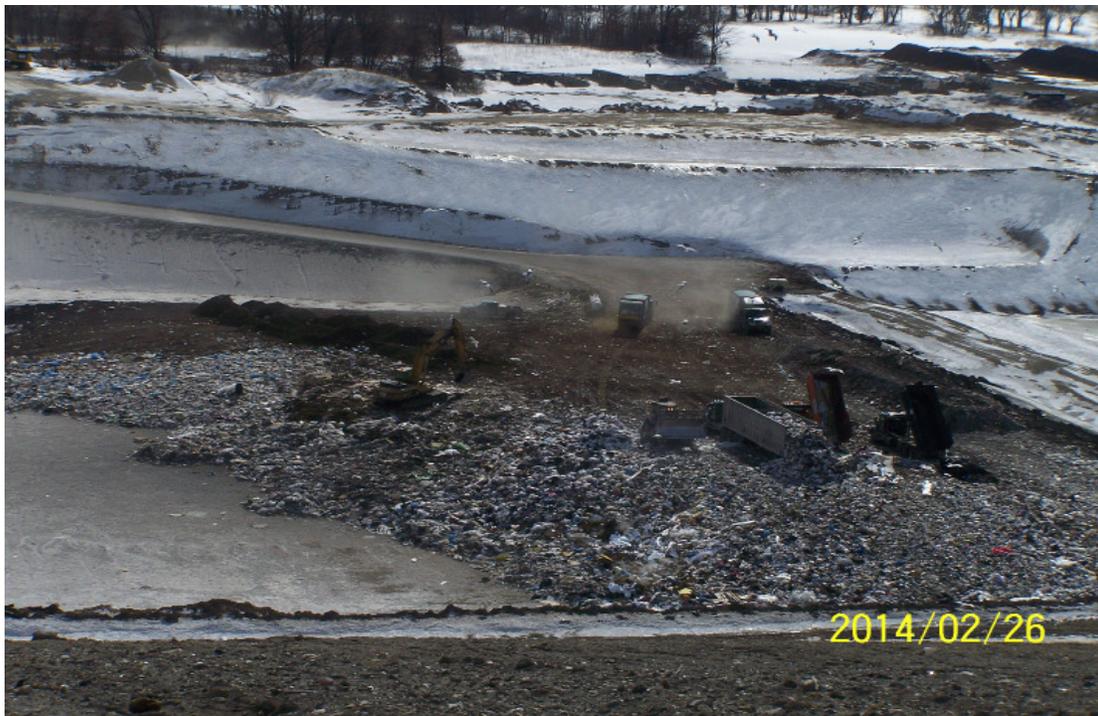
Phase 7B viewed from the Northeast
