## ADS Emerald Park Landfill Audit Summary

**To:** ADS Emerald Park Landfill Standing Committee, City of Muskego  
**FROM:** Faith Spear.  
**COPIES:** File  
**DATE:** 03/28/14  
**PROJECT NUMBER:** 1012.10030

Attached is the audit report for activities at the ADS Emerald Park Landfill for the week of March 3, 2014. The audit was performed at 11:10 AM on March 6, **2014** by Jo Spear, Jr. in the presence of Mike Hackney.

**ADVANCED DISPOSAL SERVICES  
EMERALD PARK LANDFILL / CITY OF MUSKEGO  
AUDIT PHOTOS**

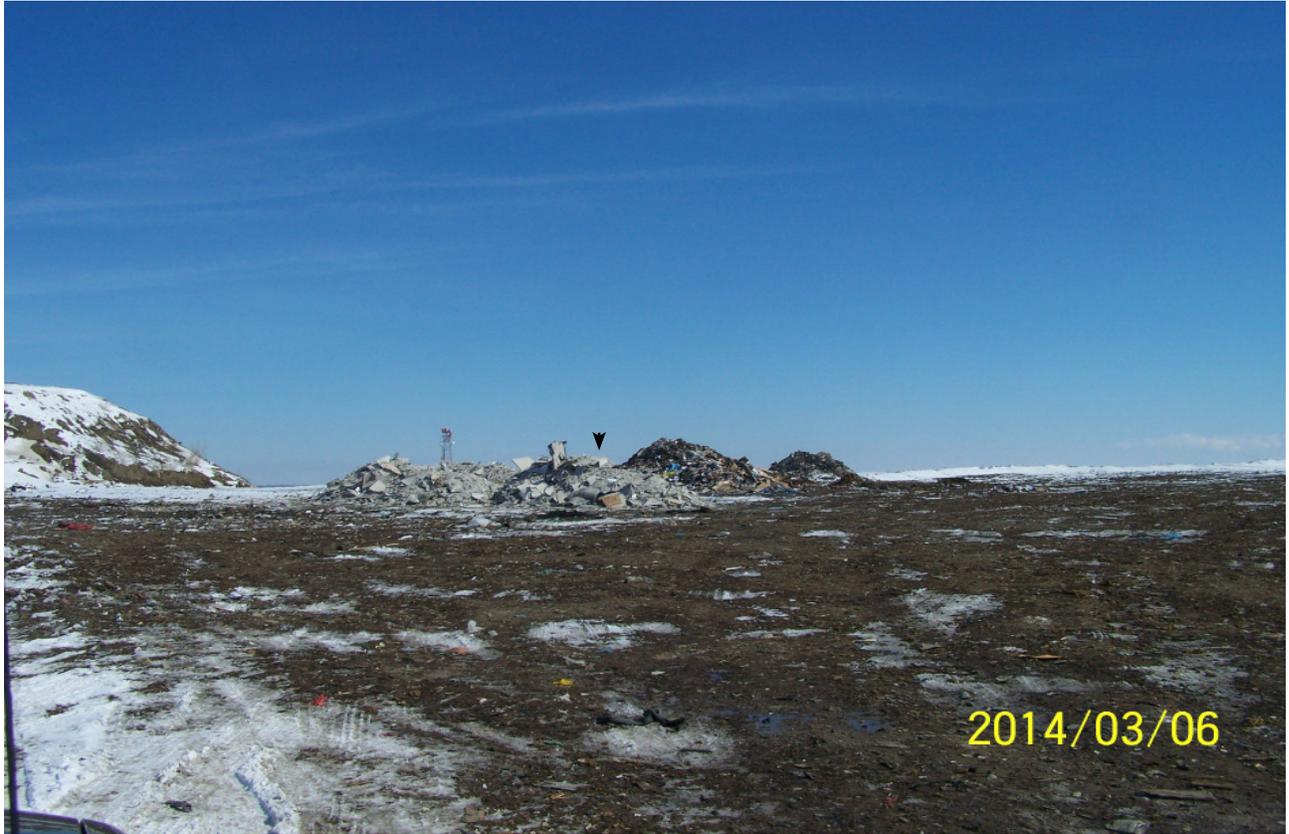
C&D Materials stockpiled in Phase 4

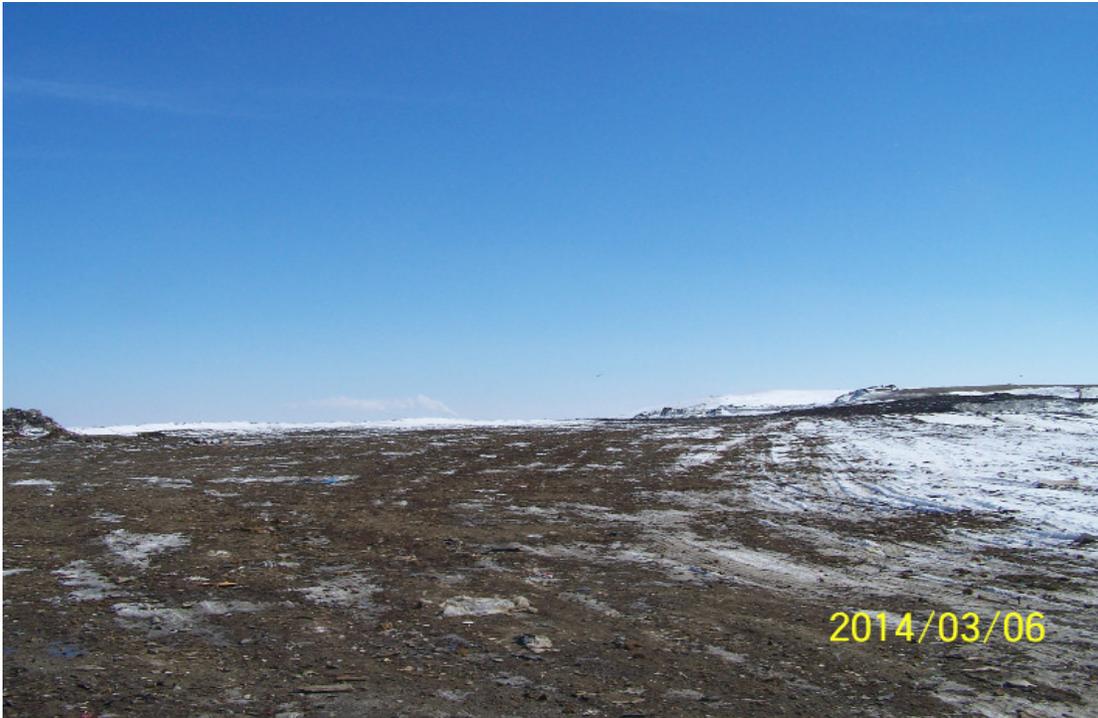
Top of Phases 4-7A, unused during audit

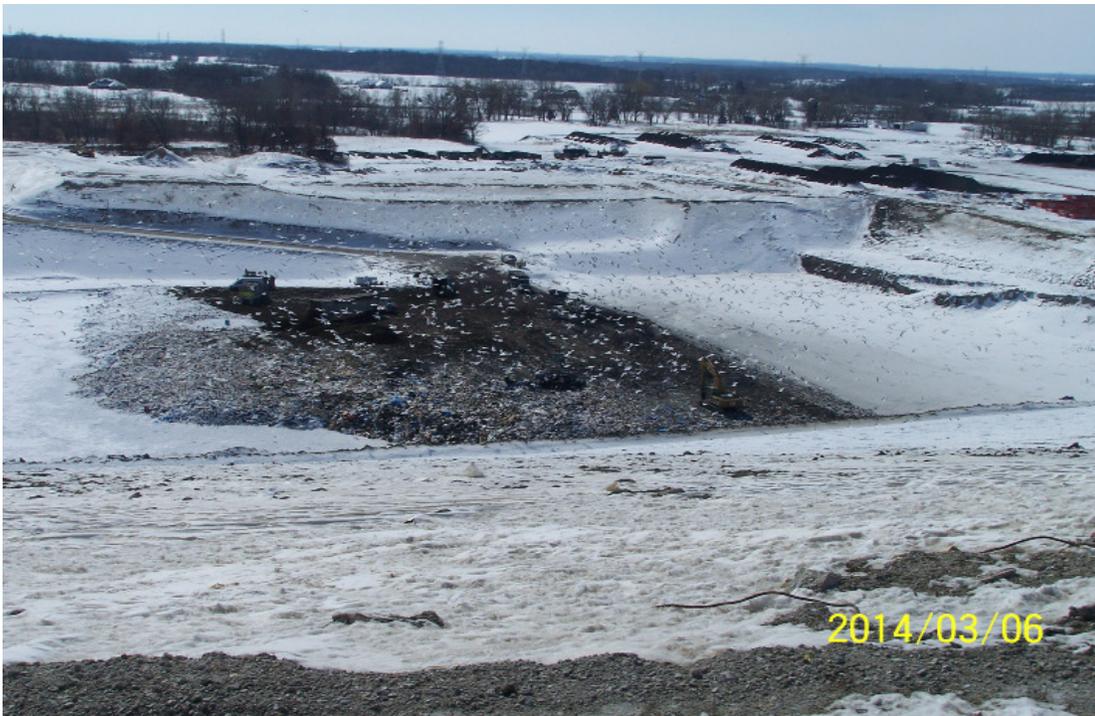
Phase 7B fluff layer placement ongoing.

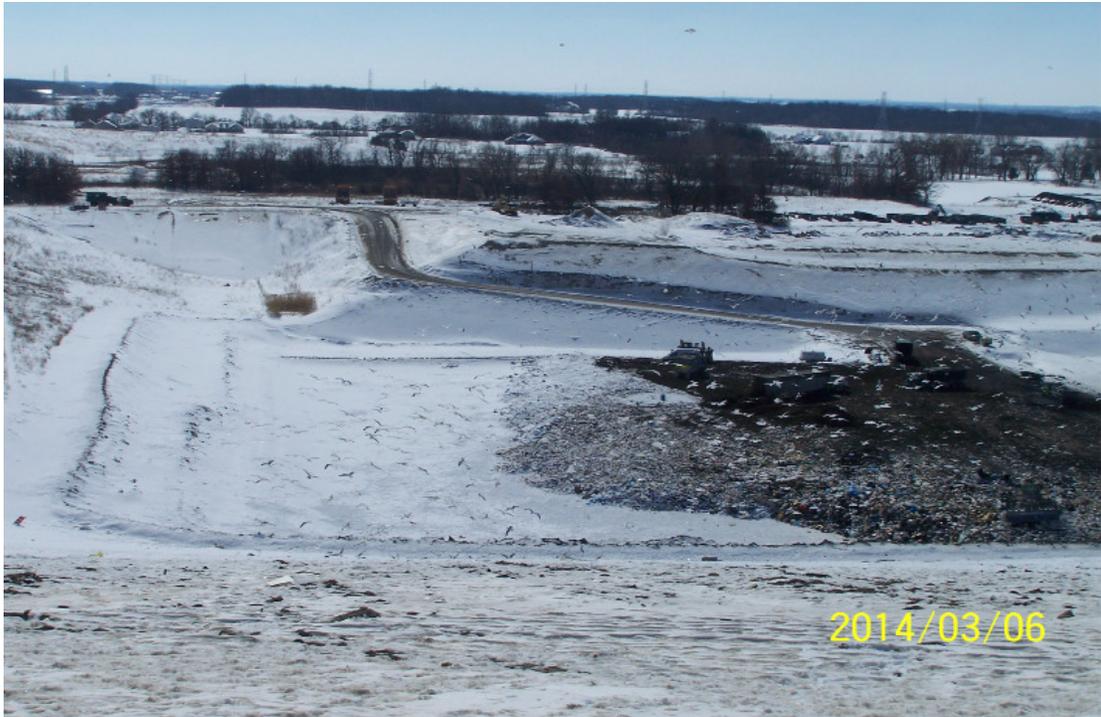
Working face in Phase 7B

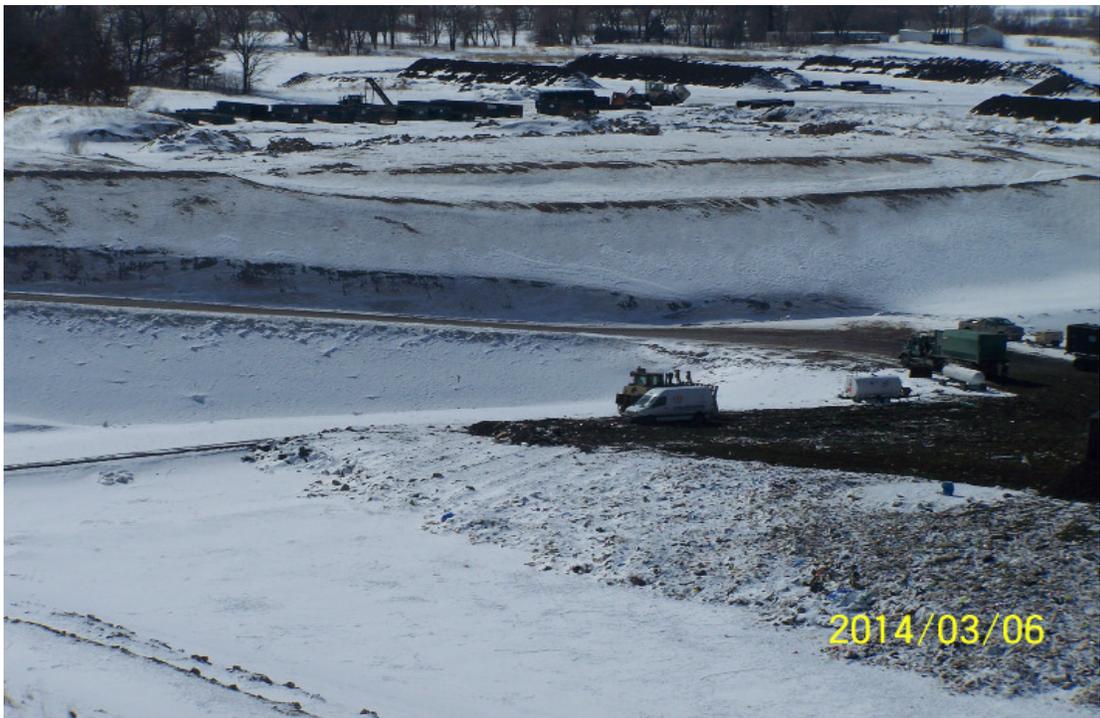
\* Dayer receiving repairs to fire suppression system during audit. Periodic maintenance

Dozer fire suppression being charged, Phase 7B
