# ADS Emerald Park Landfill Audit Summary

**To:** ADS Emerald Park Landfill Standing Committee, City of Muskego  
**FROM:** Faith Spear.  
**COPIES:** File  
**DATE:** 04/10/14  
**PROJECT NUMBER:** 1012.10030

Attached is the audit report for activities at the ADS Emerald Park Landfill for the week of March 24, 2014. The audit was performed at 3 PM on March 28, 2014 by JW Spear, Sr. in the presence of David Geier.

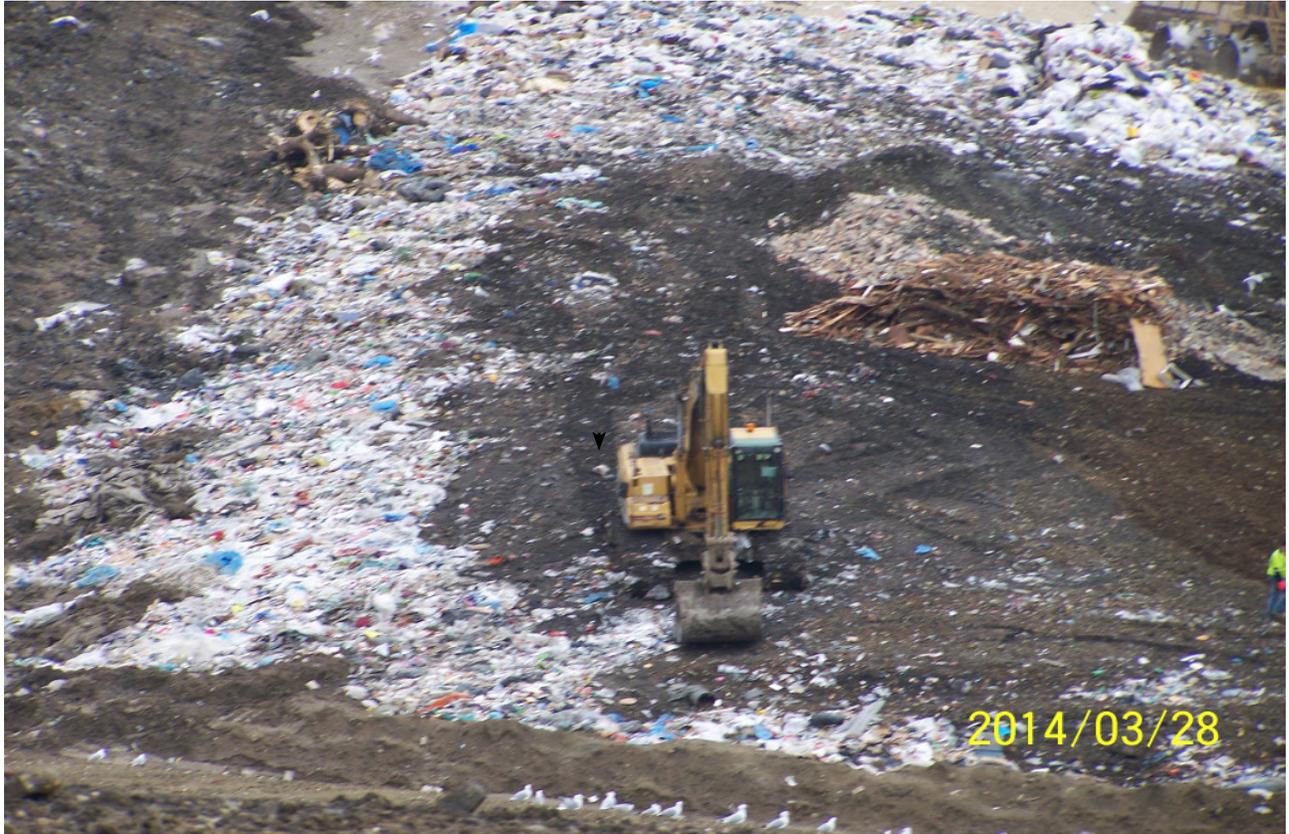
Junction of Phase 7B with Phases 6 & 7A

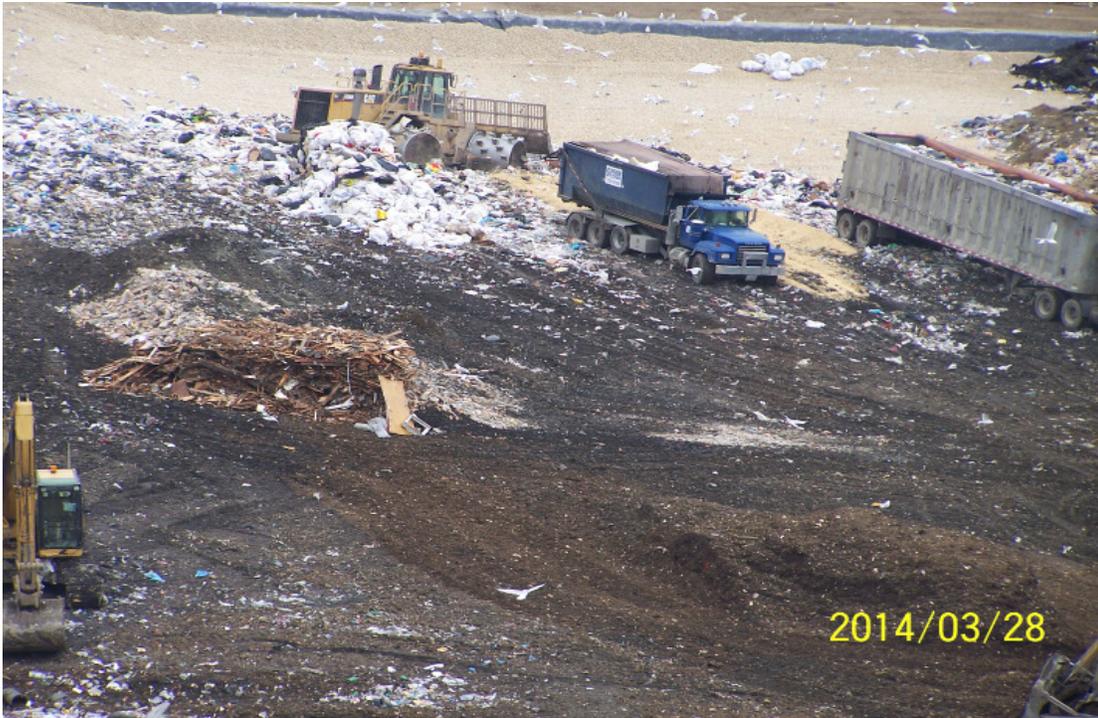
Working face of Phase 7B

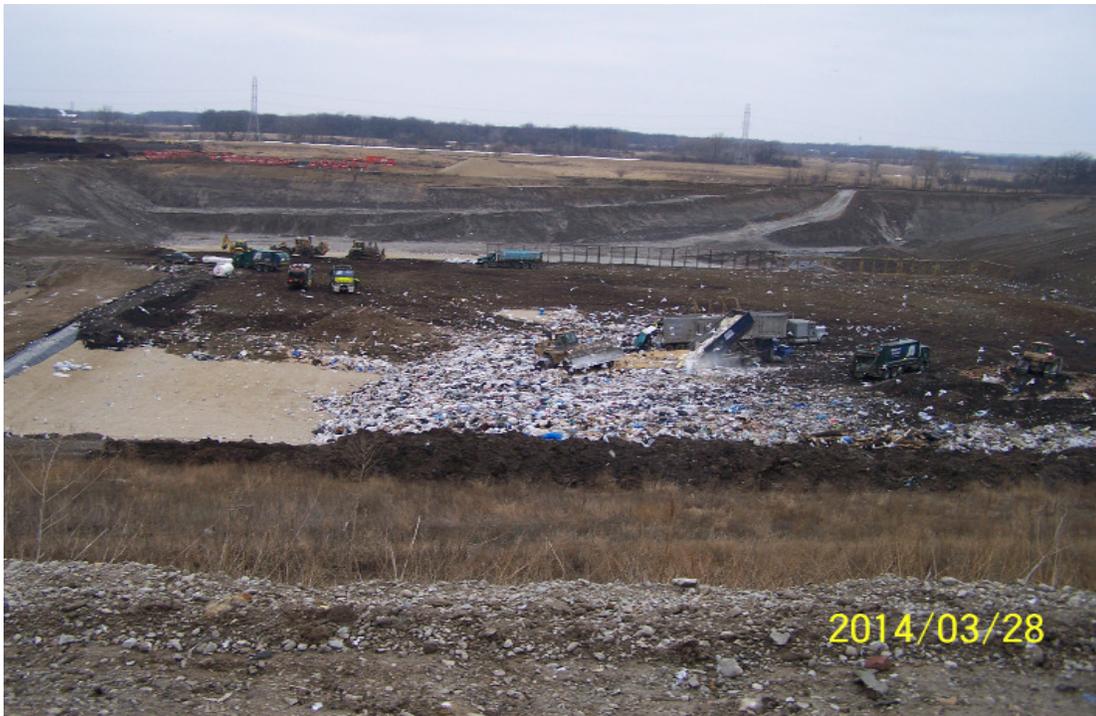
Phase 7B viewed from the North
