# ADS Emerald Park Landfill Audit Summary

**To:** ADS Emerald Park Landfill Standing Committee, City of Muskego  
**FROM:** Faith Spear.  
**COPIES:** File  
**DATE:** 04/14/14  
**PROJECT NUMBER:** 1012.10030

Attached is the audit report for activities at the ADS Emerald Park Landfill for the week of April 7, 2014. The audit was performed at 2:05 PM on April 9, 2014 by Jo Spear, Jr. in the presence of Michael Hackney.

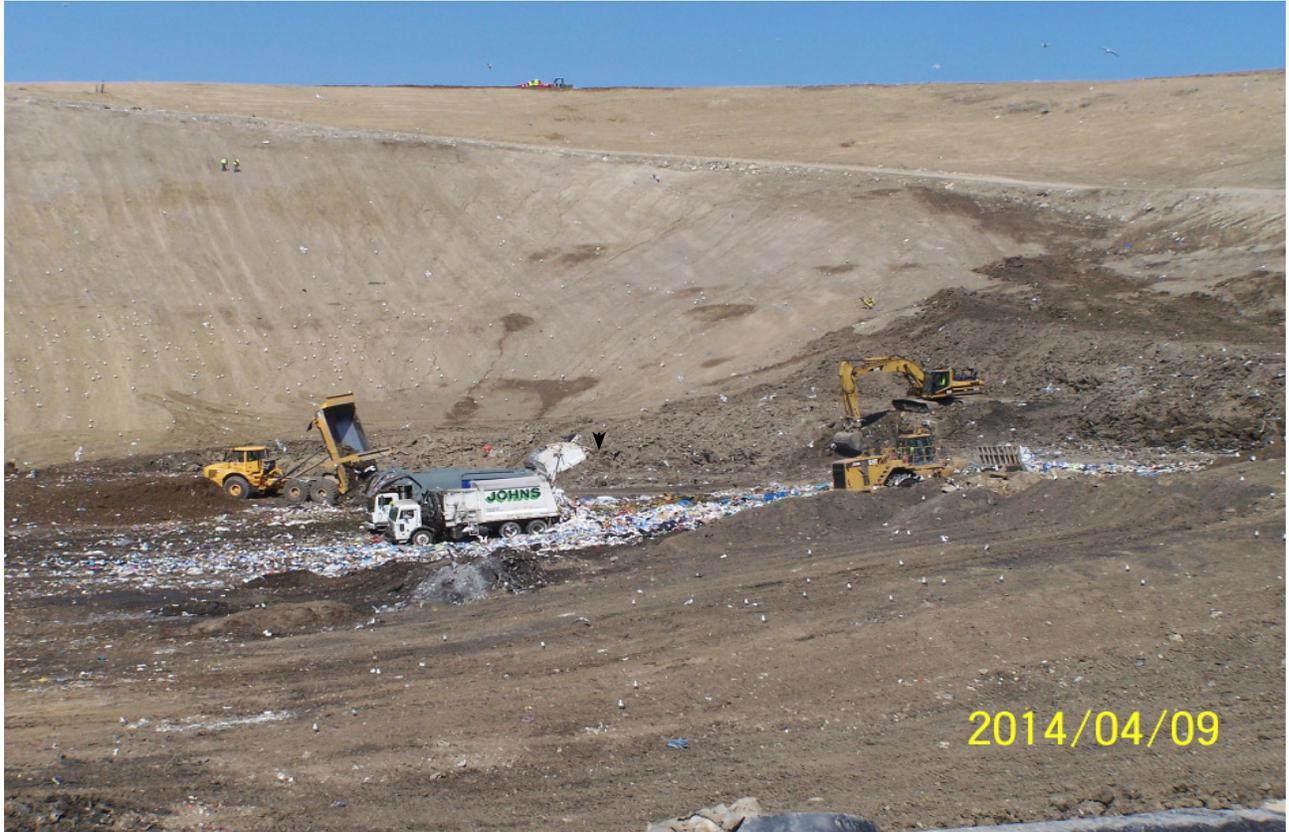
Working face.

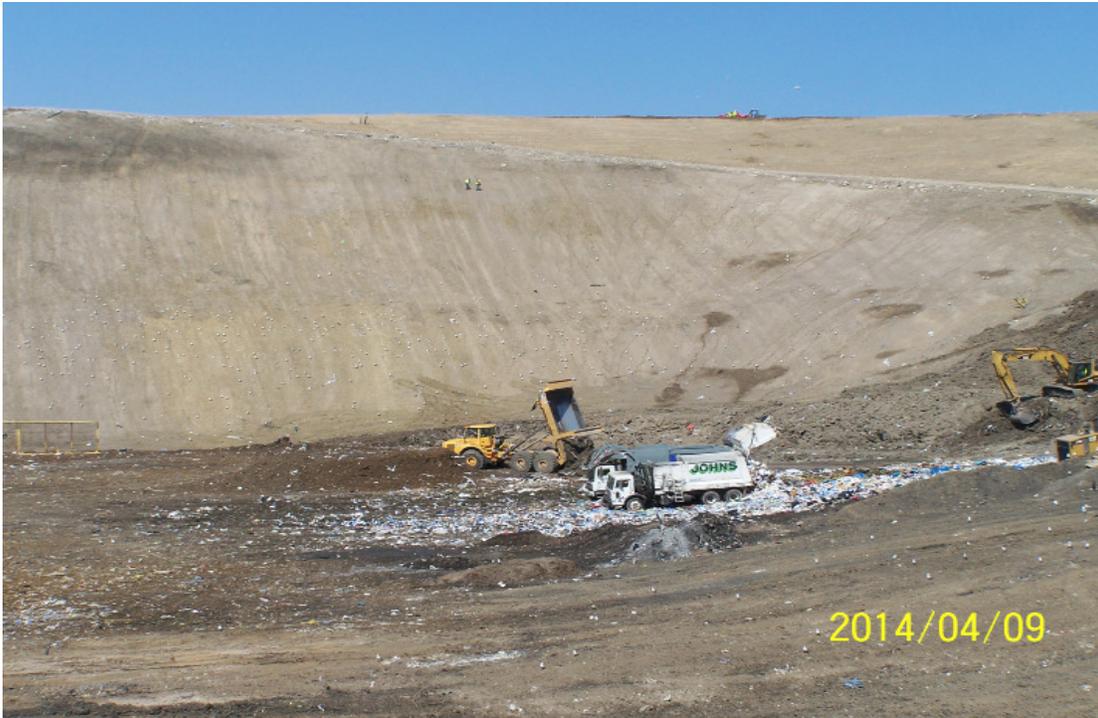
Working face on Eastern edge of Phase 7B, junction with Phase 6

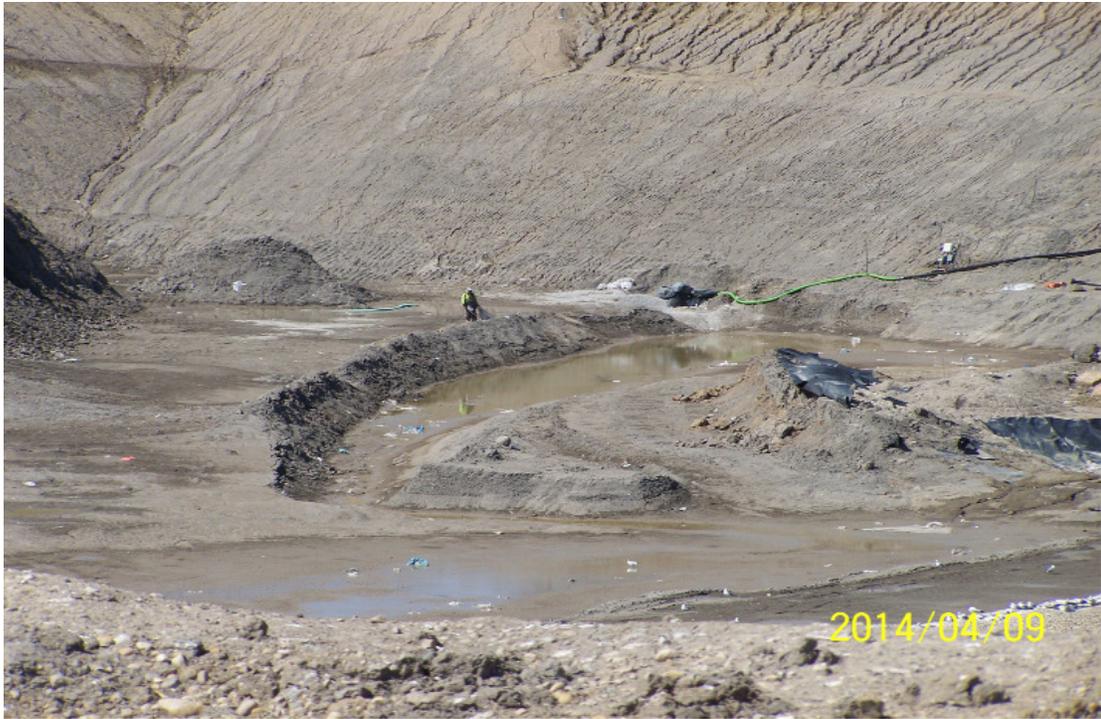
Sump viewed from the Southeast

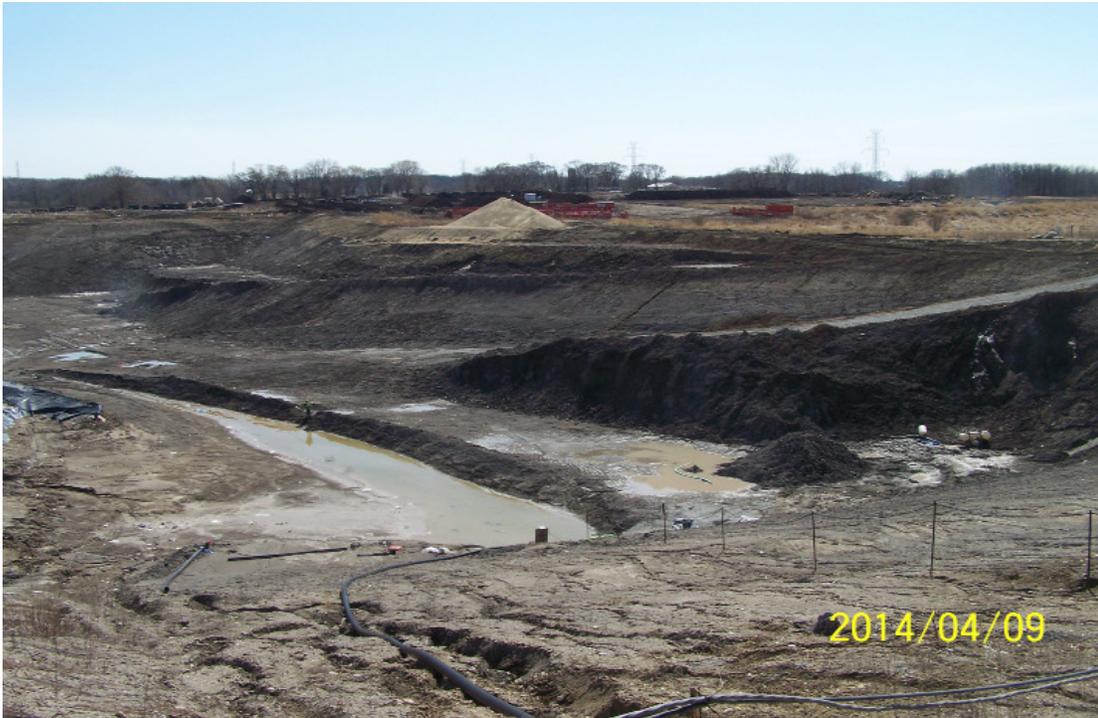
Current sump on West edge of Phase 7. To be extended and deepened to the West.
