ADS Emerald Park Landfill Audit Summary

PROJECT NUMBER: 1012.10030

VEOLIA Emerald Park Landfill
Action Items Checklist
City of Muskego Audit

**ADVANCED DISPOSAL SERVICES
EMERALD PARK LANDFILL / CITY OF MUSKEGO
AUDIT PHOTOS**

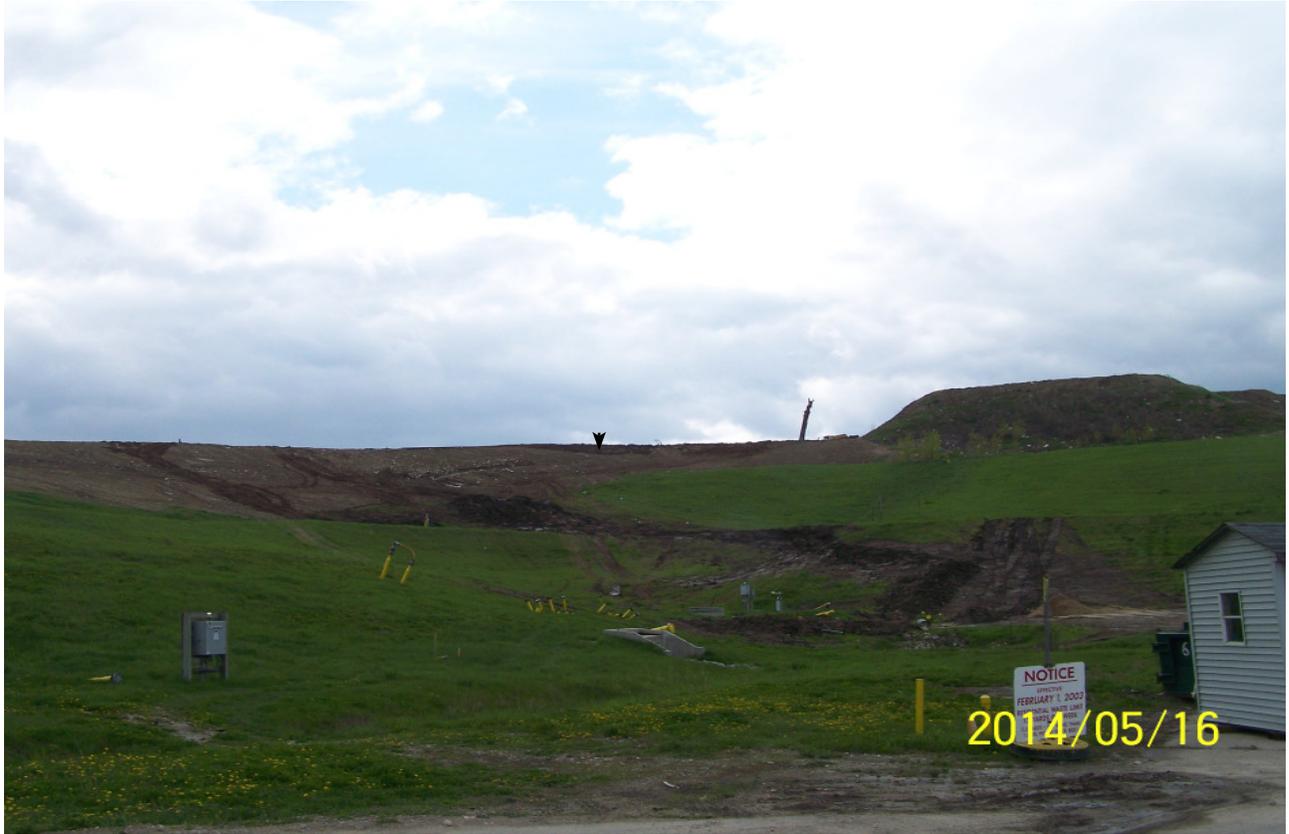
Phase 4, Northeast slope, restored soils after gas management system installation. Seeding will be at end of gas management system construction.

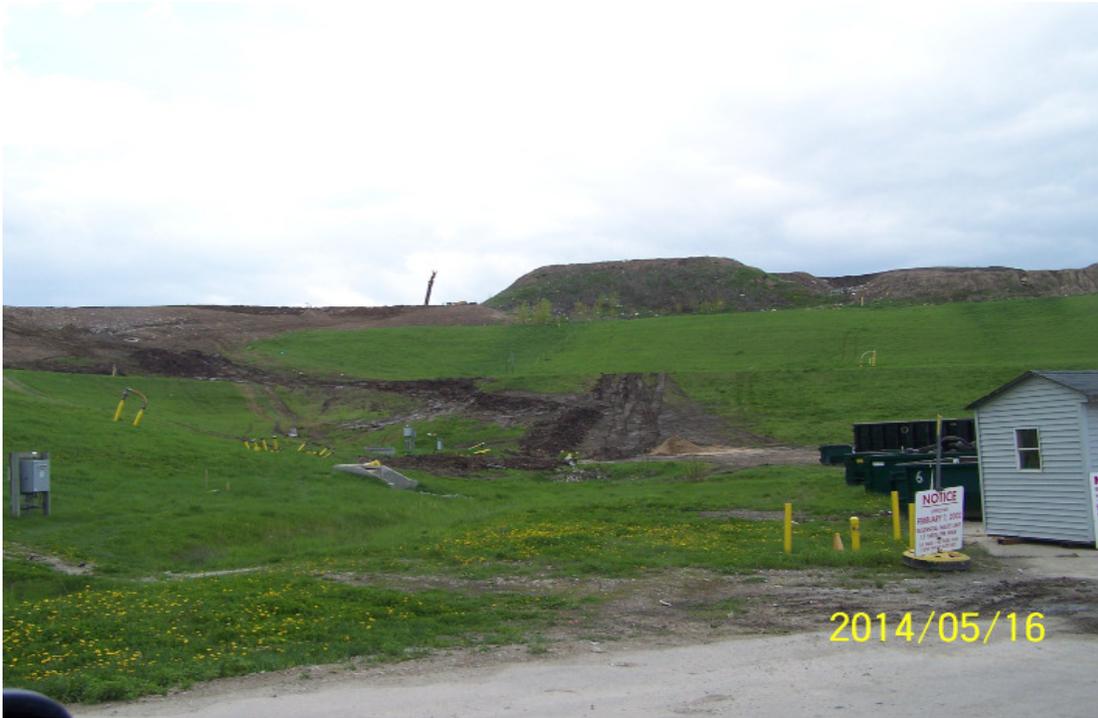
Headers placed during last audit have had trenches backfilled.

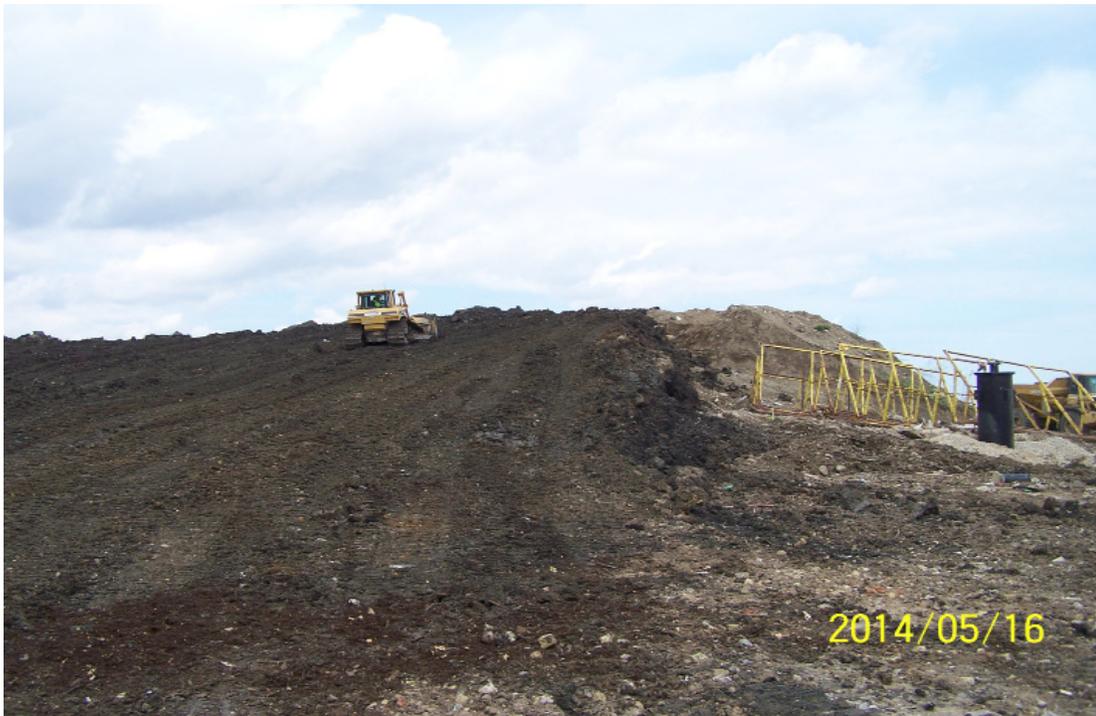
Management of Bio-soils on Phase 3

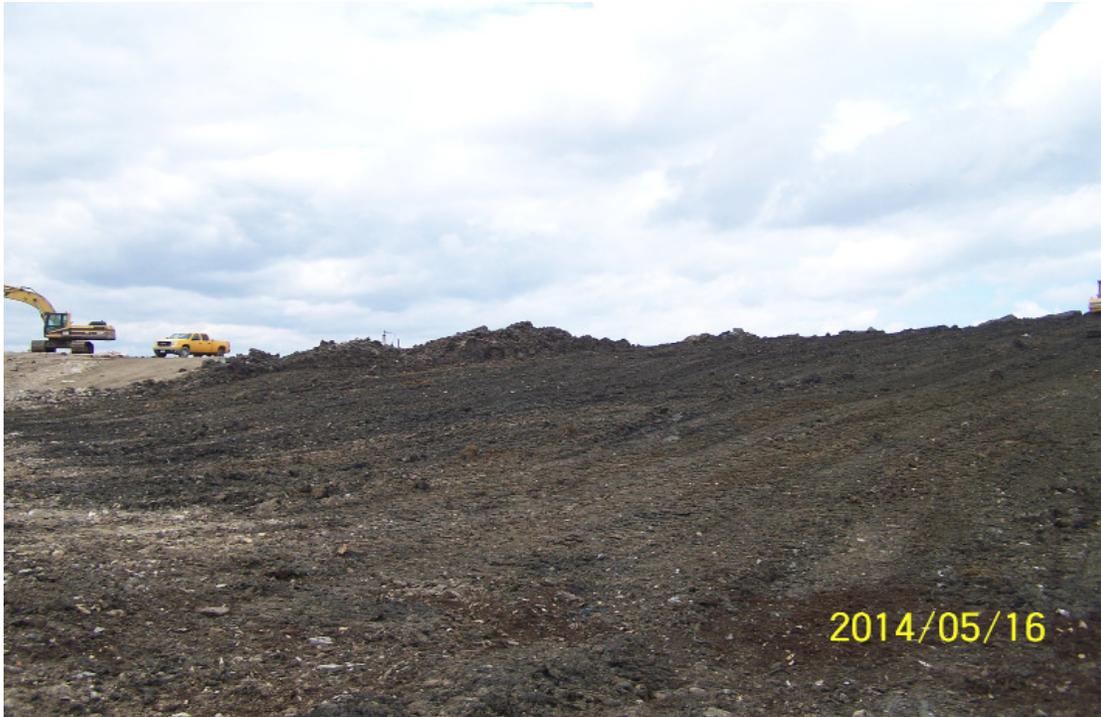
Repaired slope, West slope of Phase 6, after gas management system installation.

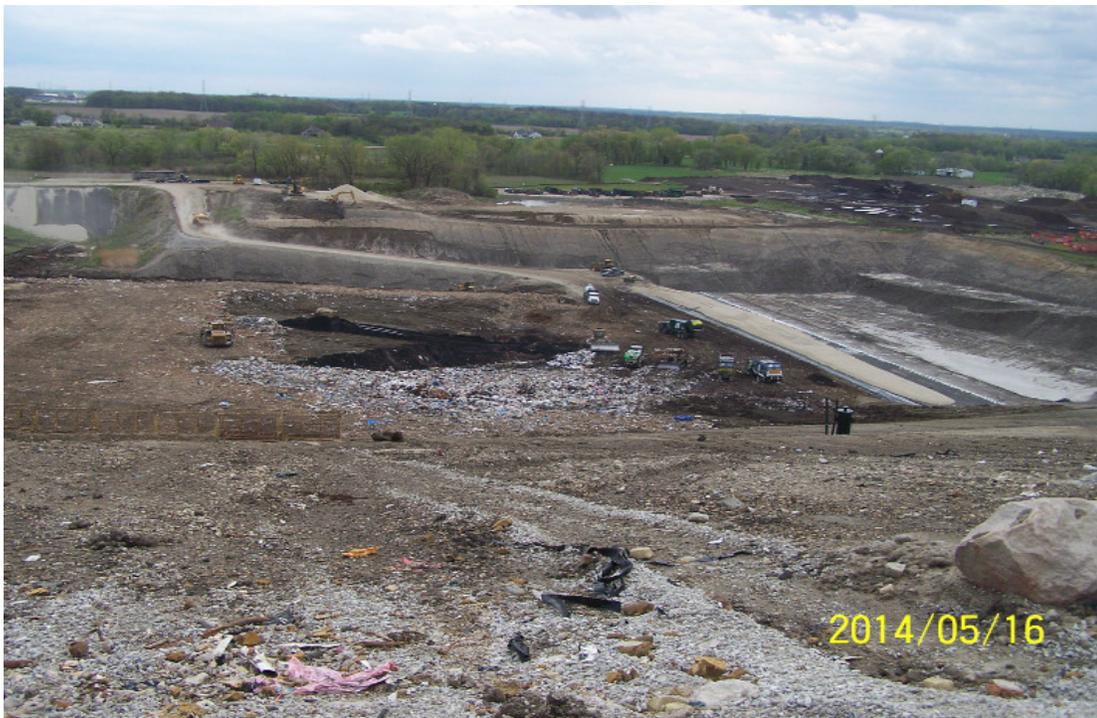
Active area viewed from North

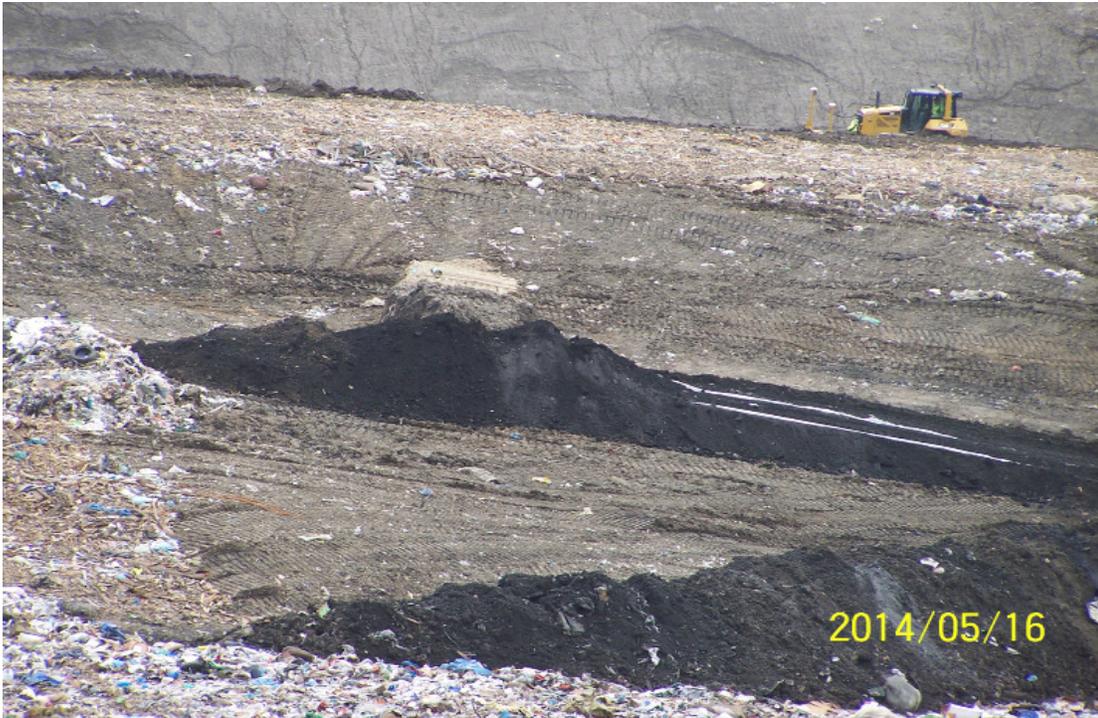
Landfill direct soil to be used for cover

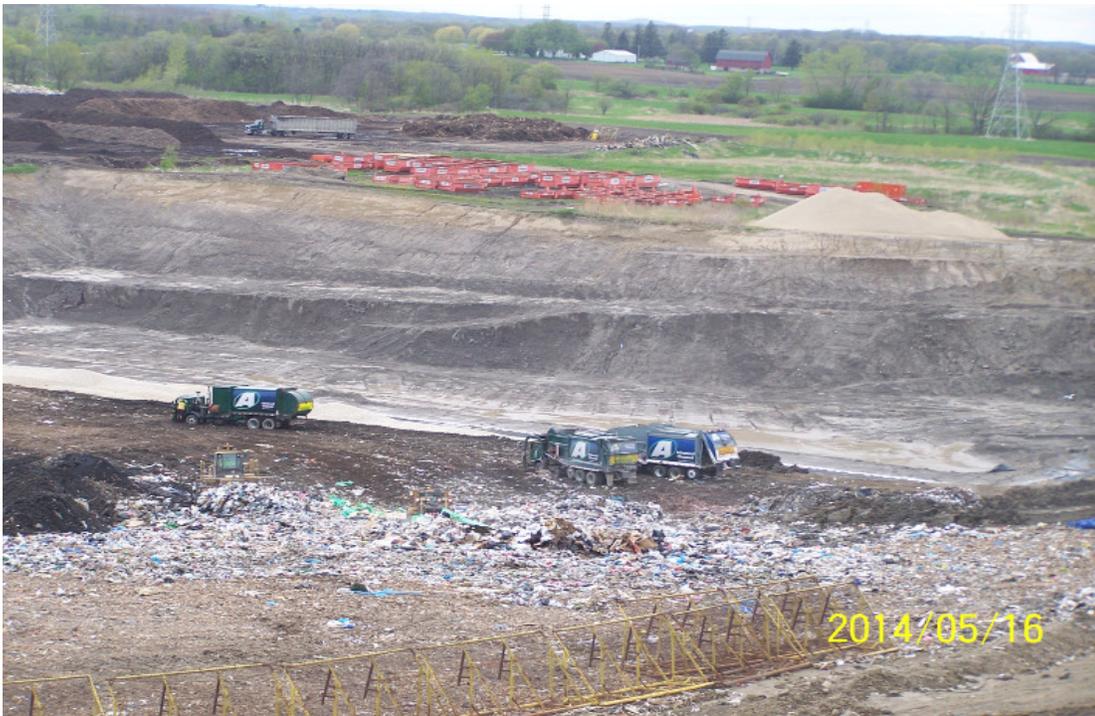
Working face viewed from Northeast

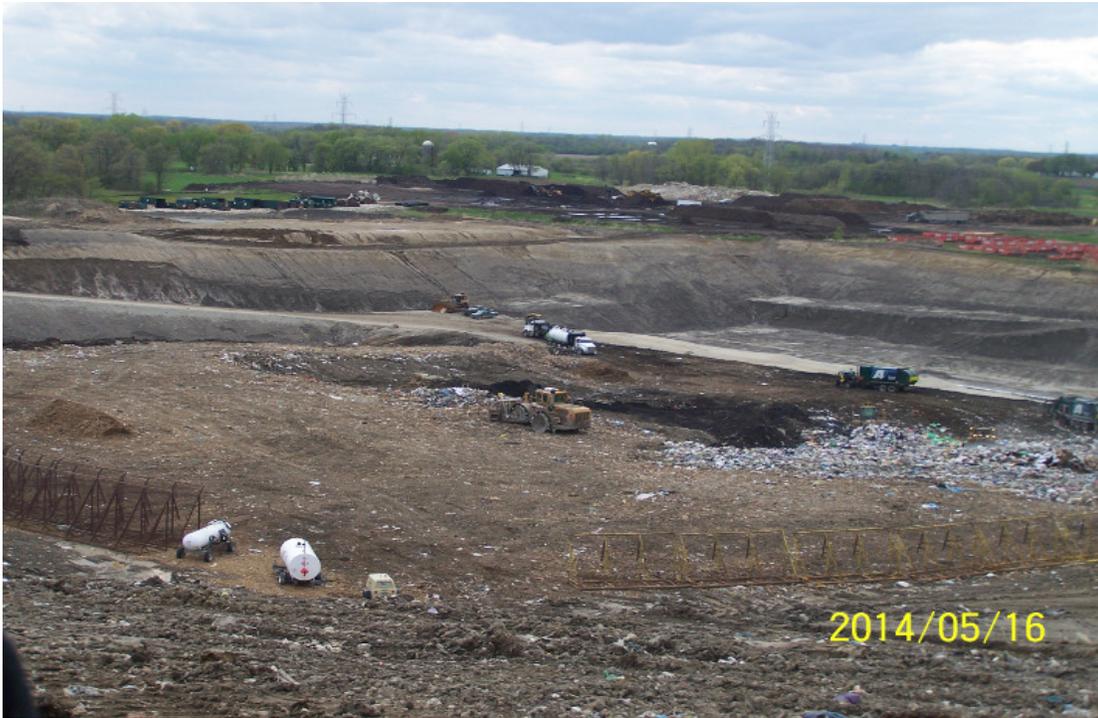
Active Area viewed from the Northeast

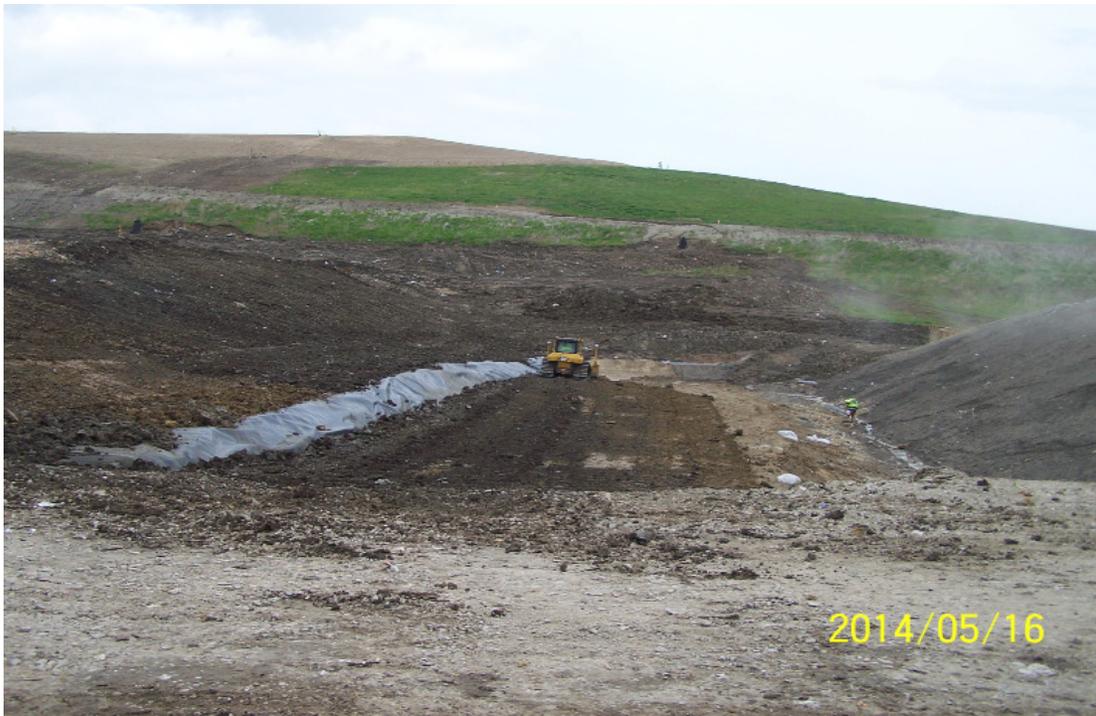
Dozer cleaning and backdragging soil South of Phase 7B

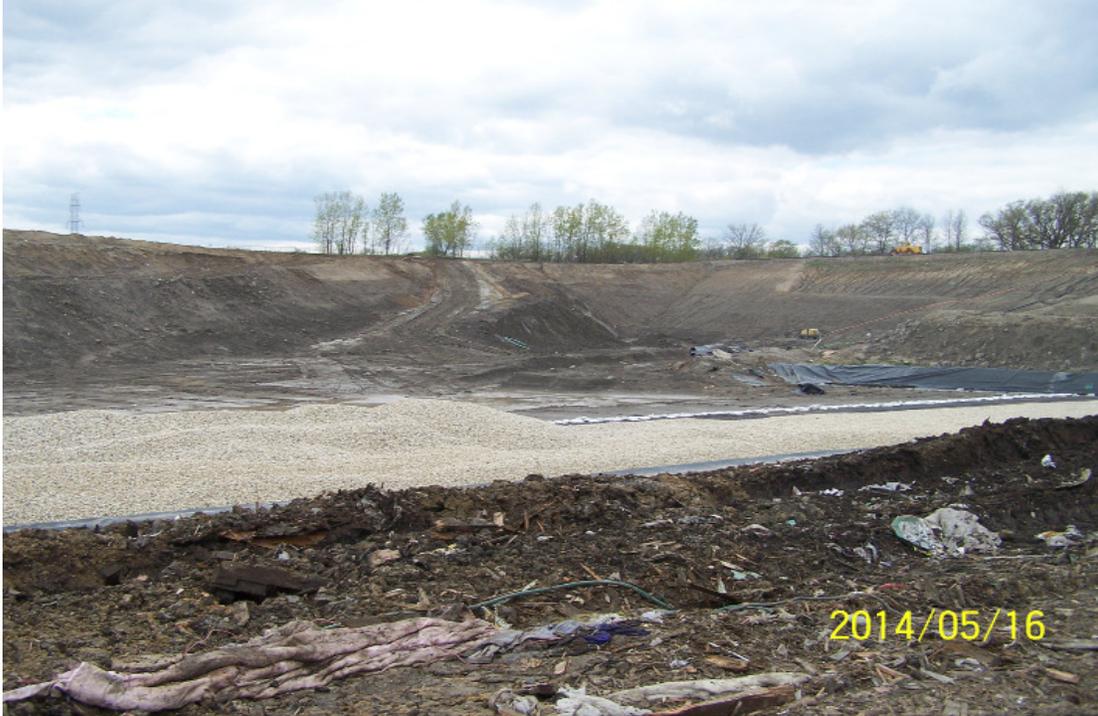
Berm along West edge of Phase 7B
