## ADS Emerald Park Landfill Audit Summary

**To:** ADS Emerald Park Landfill Standing Committee, City of Muskego  
**FROM:** Faith Spear.  
**COPIES:** File  
**DATE:** 06/26/14  
**PROJECT NUMBER:** 1012.10030

Attached is the audit report for activities at the ADS Emerald Park Landfill for the week of May 19, 2014. The audit was performed at 10:41 AM on May 21, **2014** by Jo Spear, Jr. in the presence of Michael Hackney.

**ADVANCED DISPOSAL SERVICES  
EMERALD PARK LANDFILL / CITY OF MUSKEGO  
AUDIT PHOTOS**

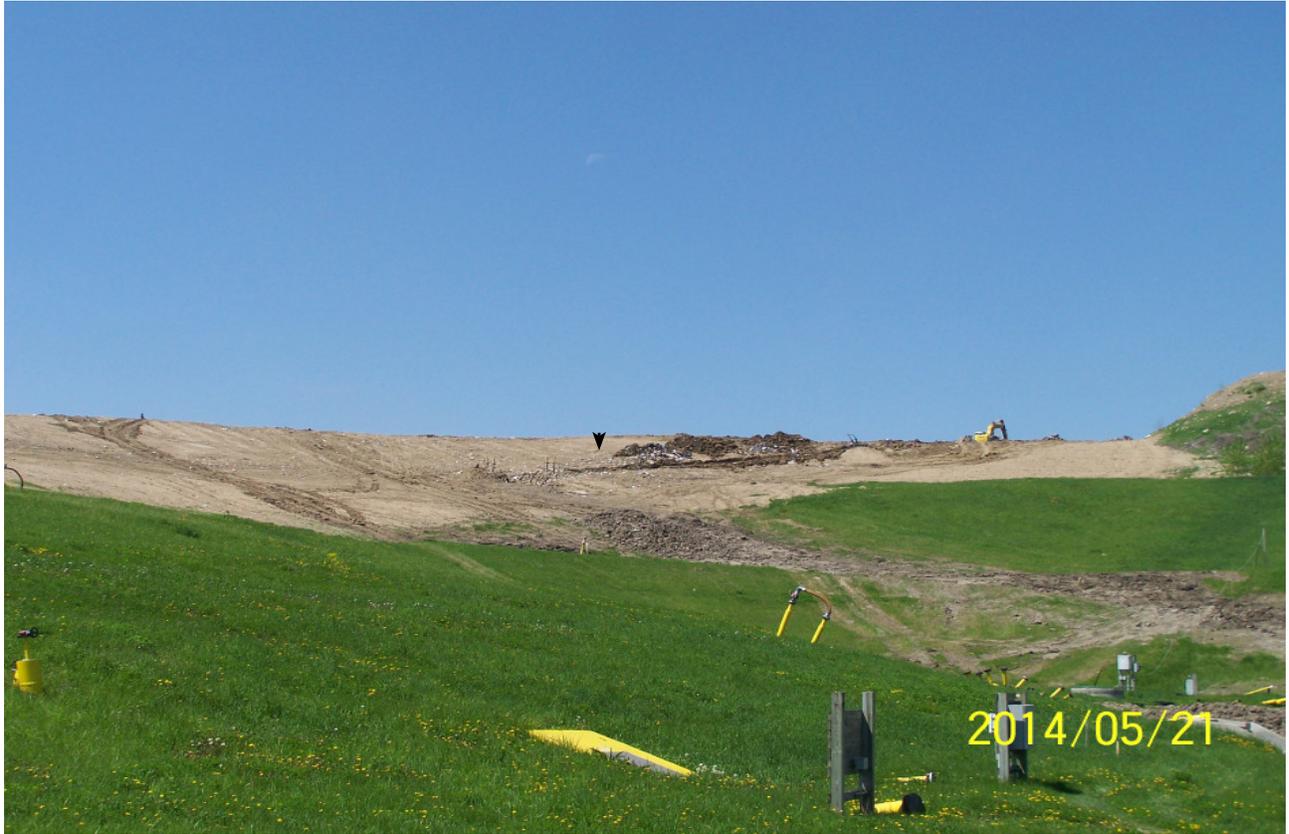
Header and well placement completed in Phase 3 & 4

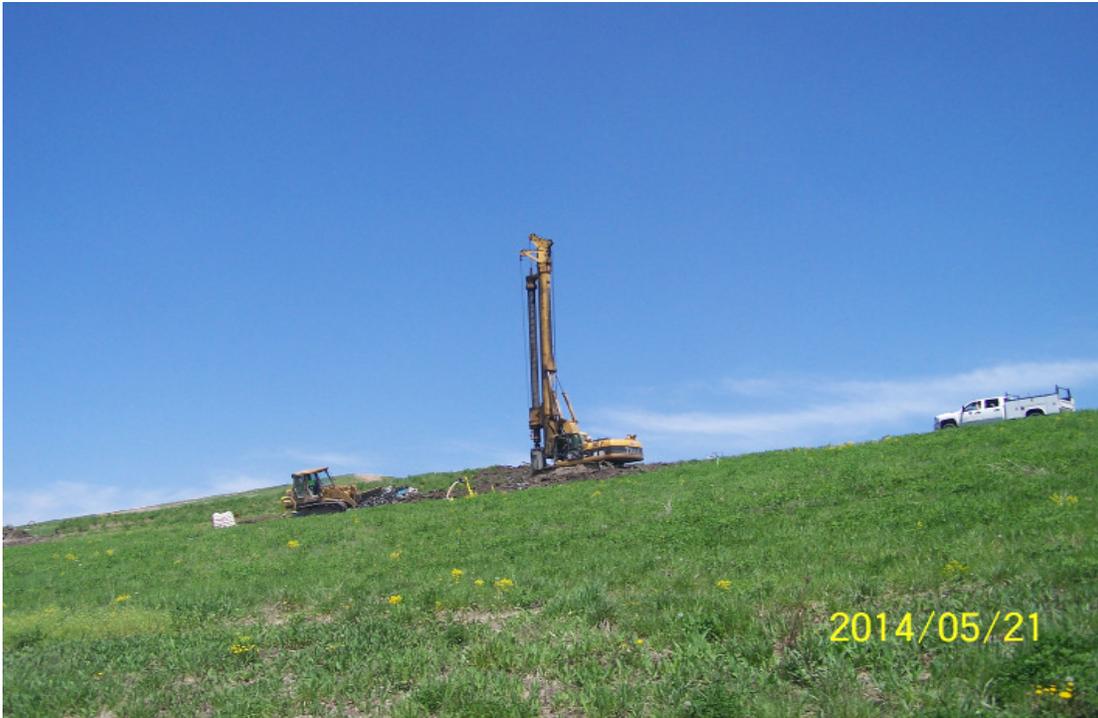
Well drilling on South slope of Phase 5

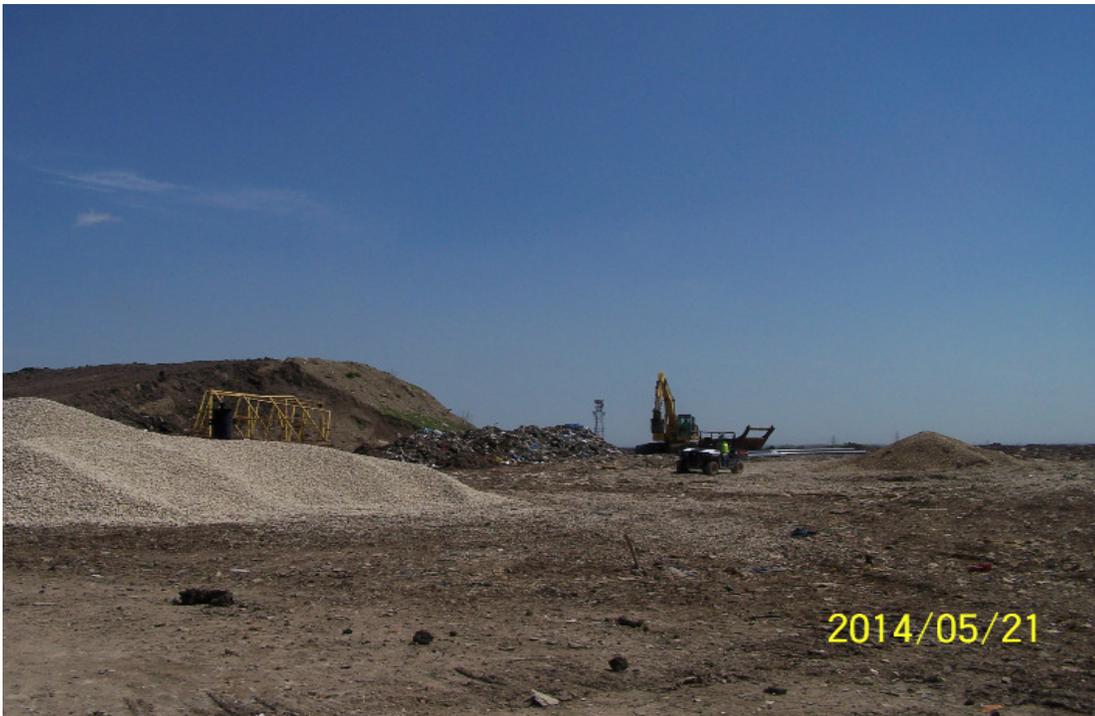
Bio soil stockpile and header installation in Phase 3

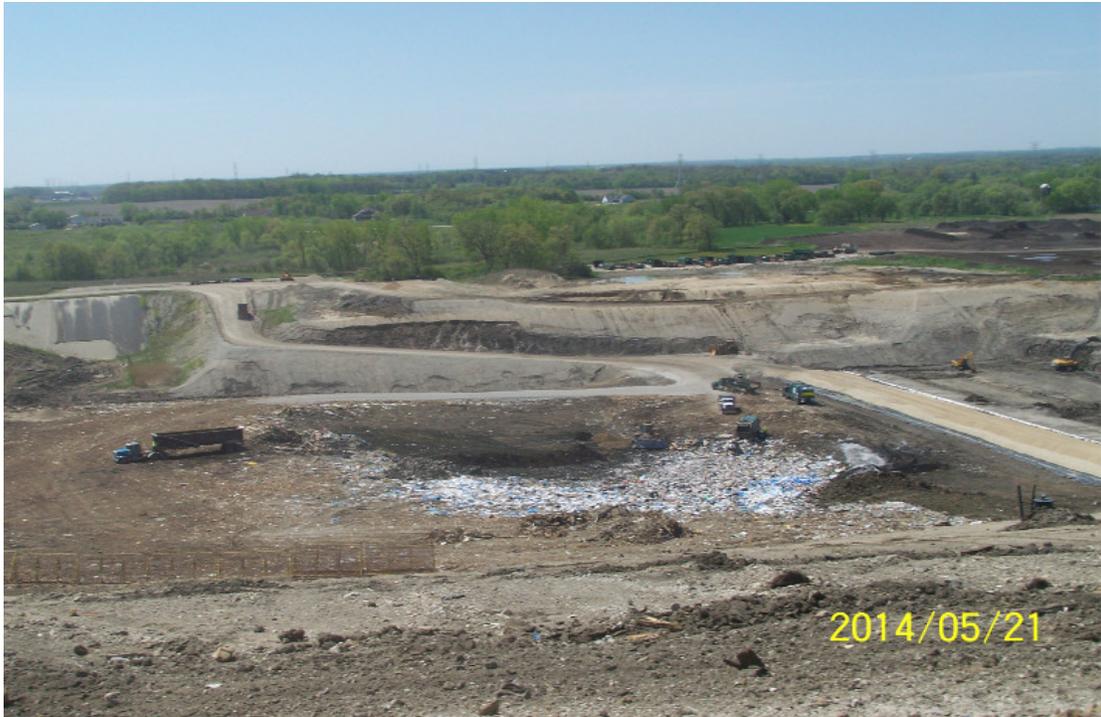
Working face viewed from North

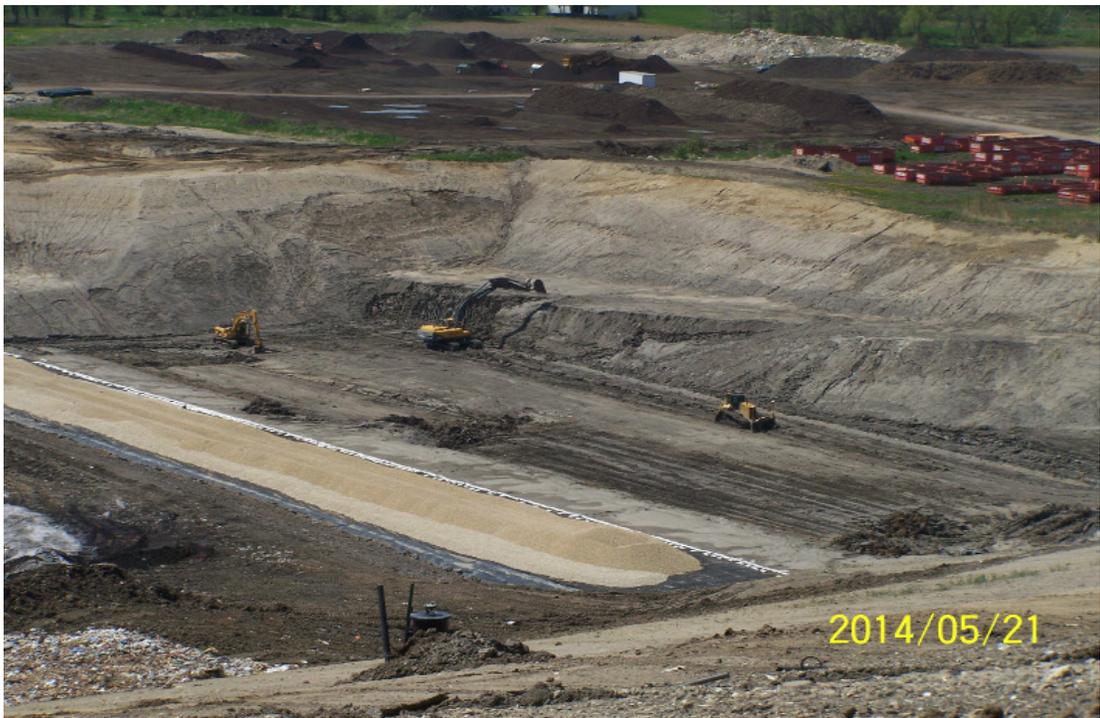
Ongoing construction of Phase 7B

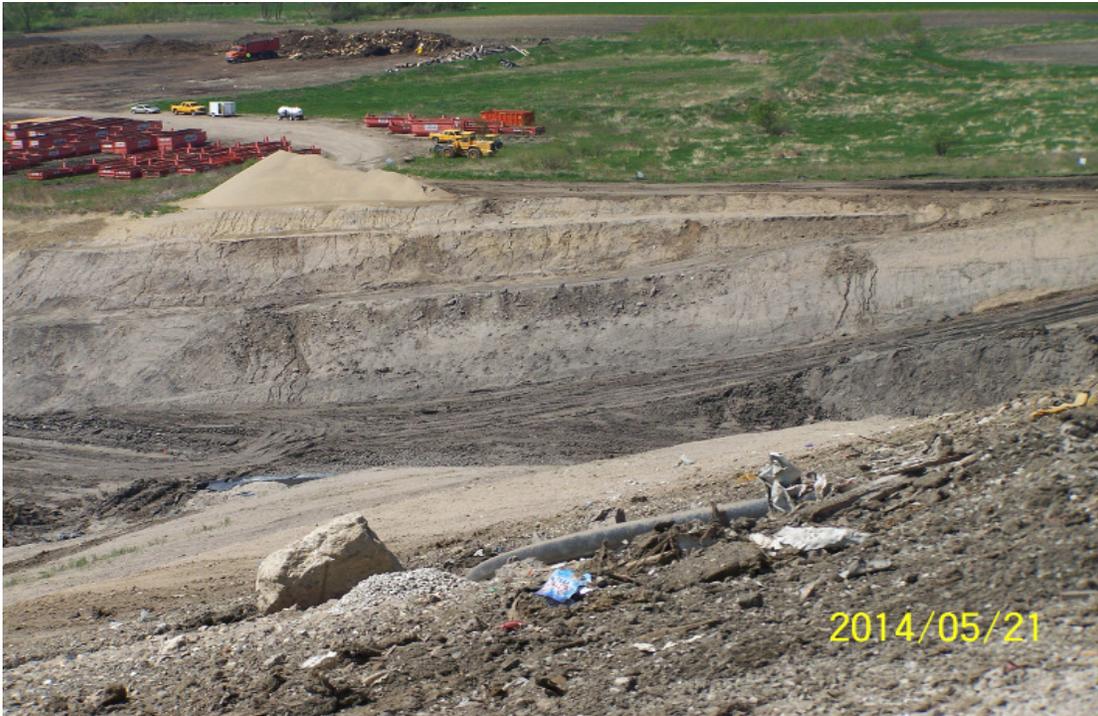
New gas line and limits of Western edge of Phase 7B

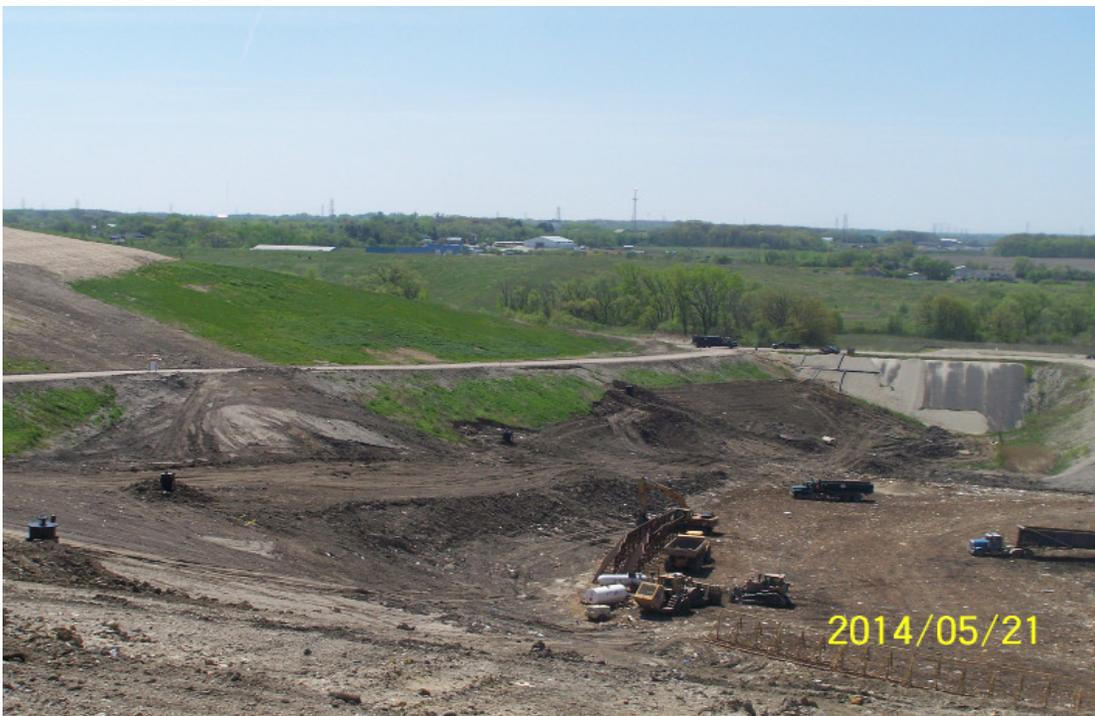
West slope of Phase 6, above Phase 7B, soil restored after gas system installation

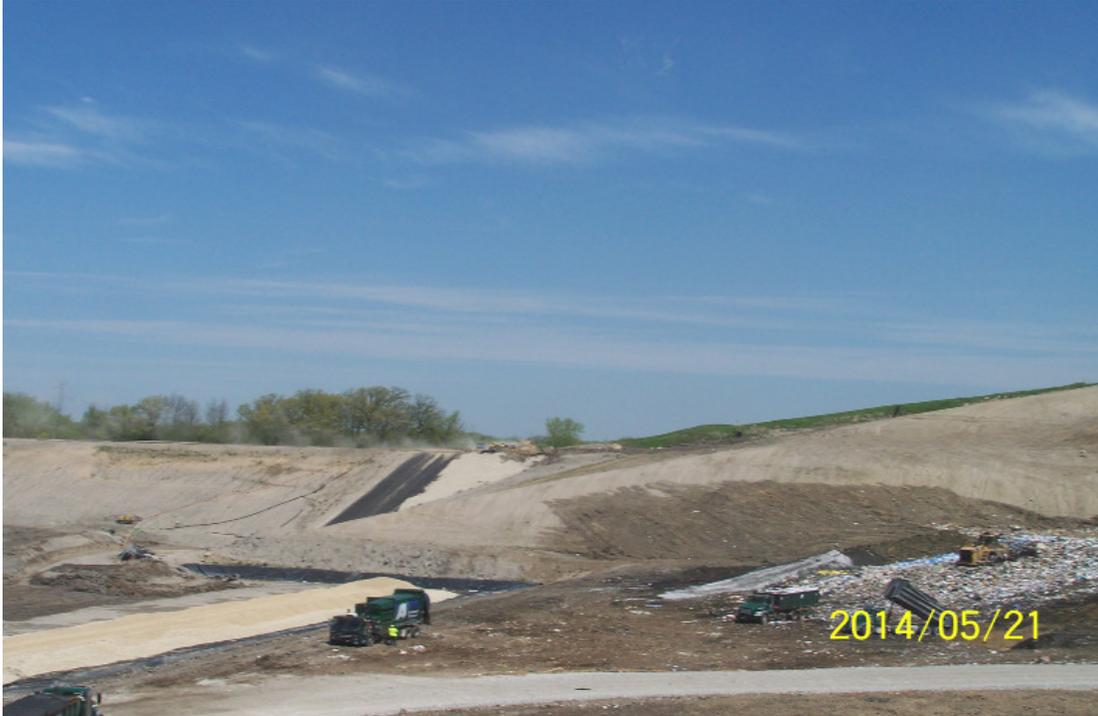
Active area

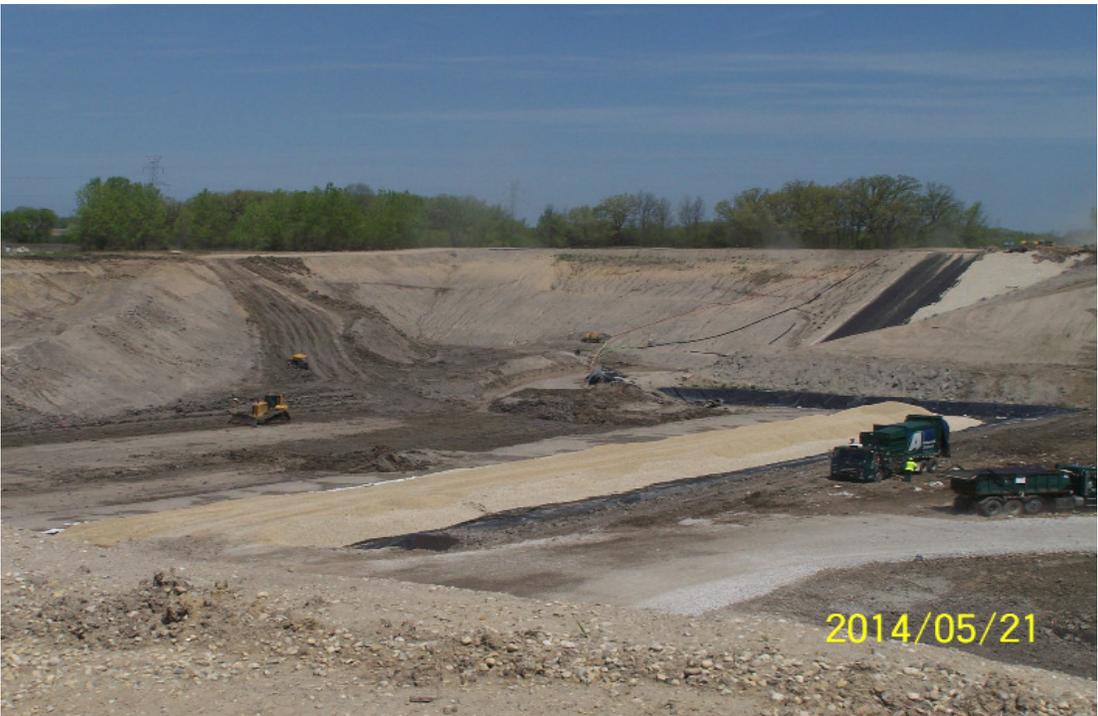
Construction on remainder of Phase 7B liner base
