MEMORANDUM

ADS Emerald Park Landfill Audit Summary

TO: ADS Emerald Park Landfill Standing Committee, City of Muskego
FROM: Faith Spear.
COPIES: File
DATE: 07/15/14
PROJECT NUMBER: 1012.10030

**ADVANCED DISPOSAL SERVICES
EMERALD PARK LANDFILL / CITY OF MUSKEGO
AUDIT PHOTOS**

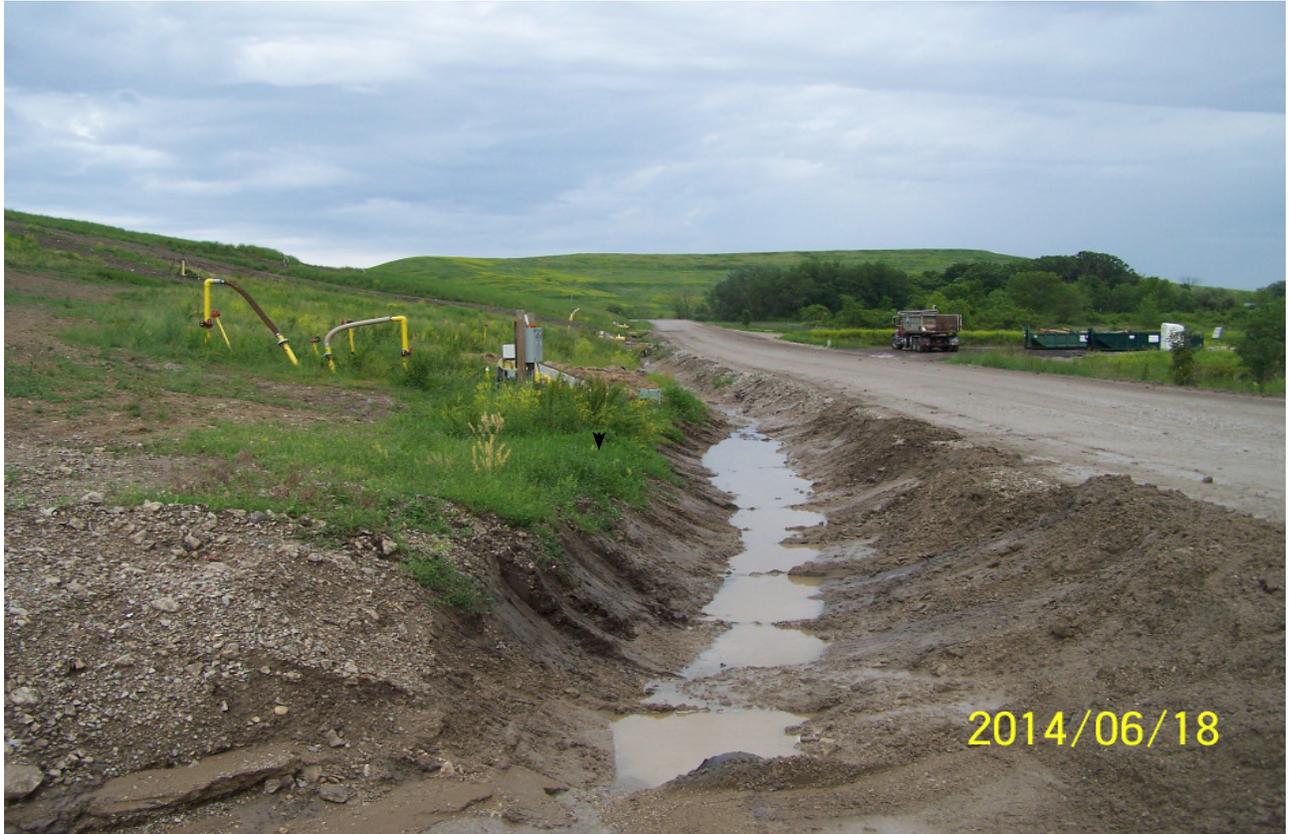
Ditches cleaned along South edge of Phases 5 & 6

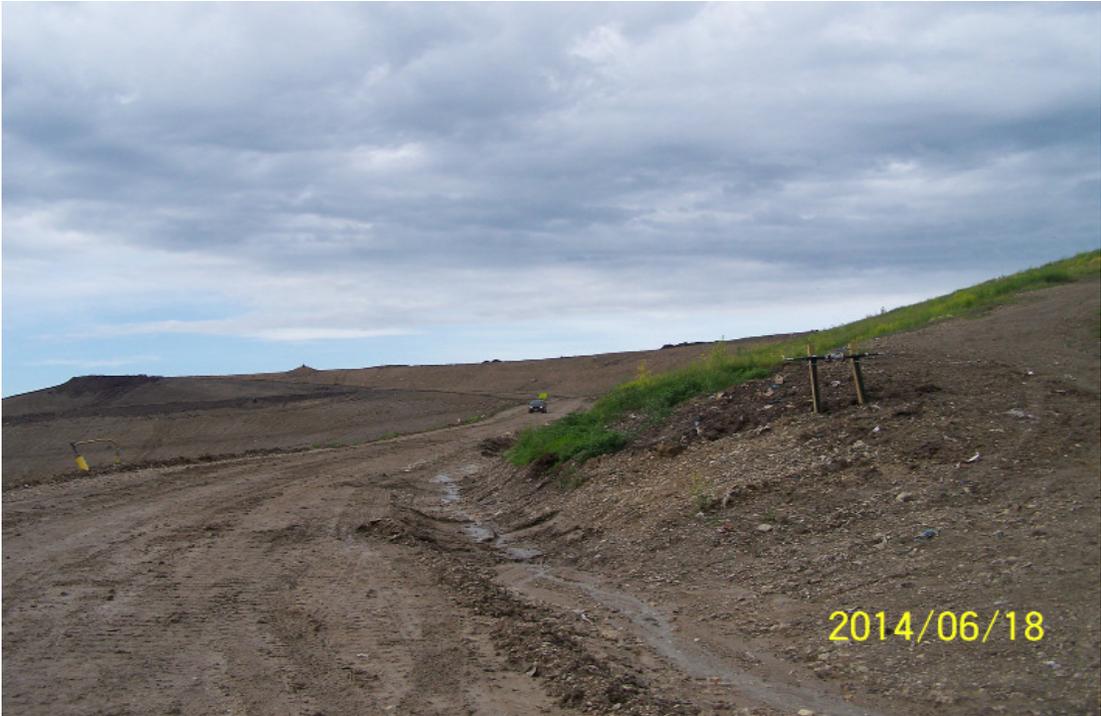
Ditch cleaning and restoration about Phase 5 Southwest corner

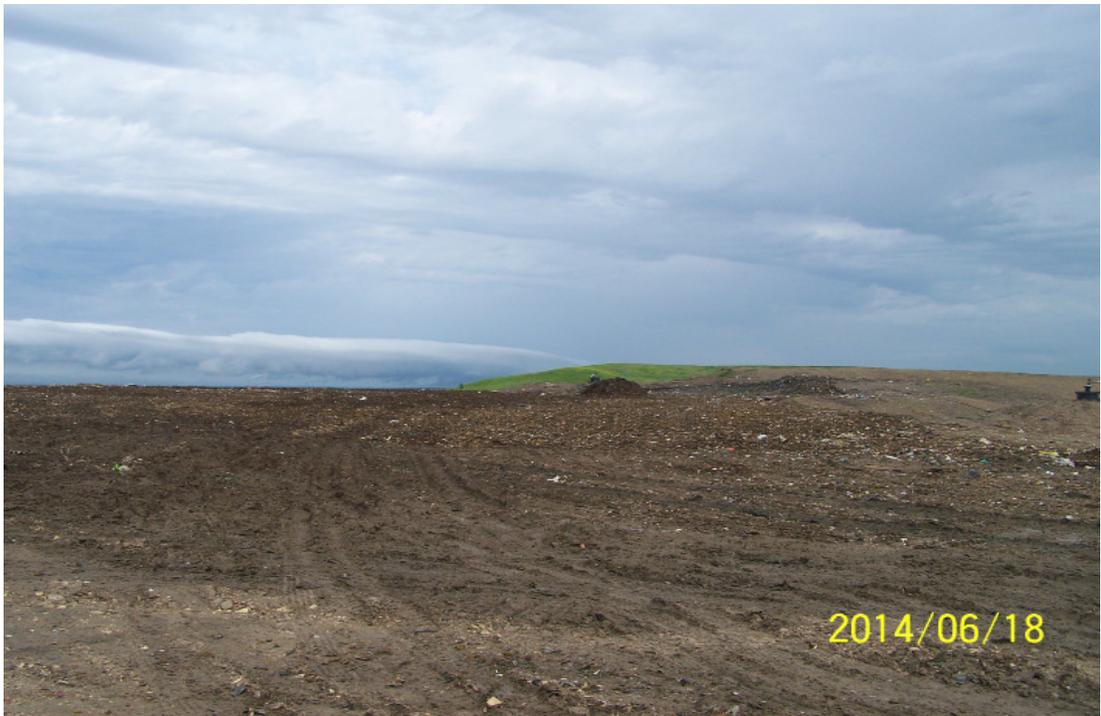
Phase 4, surface restored with C&D materials and intermediate cover

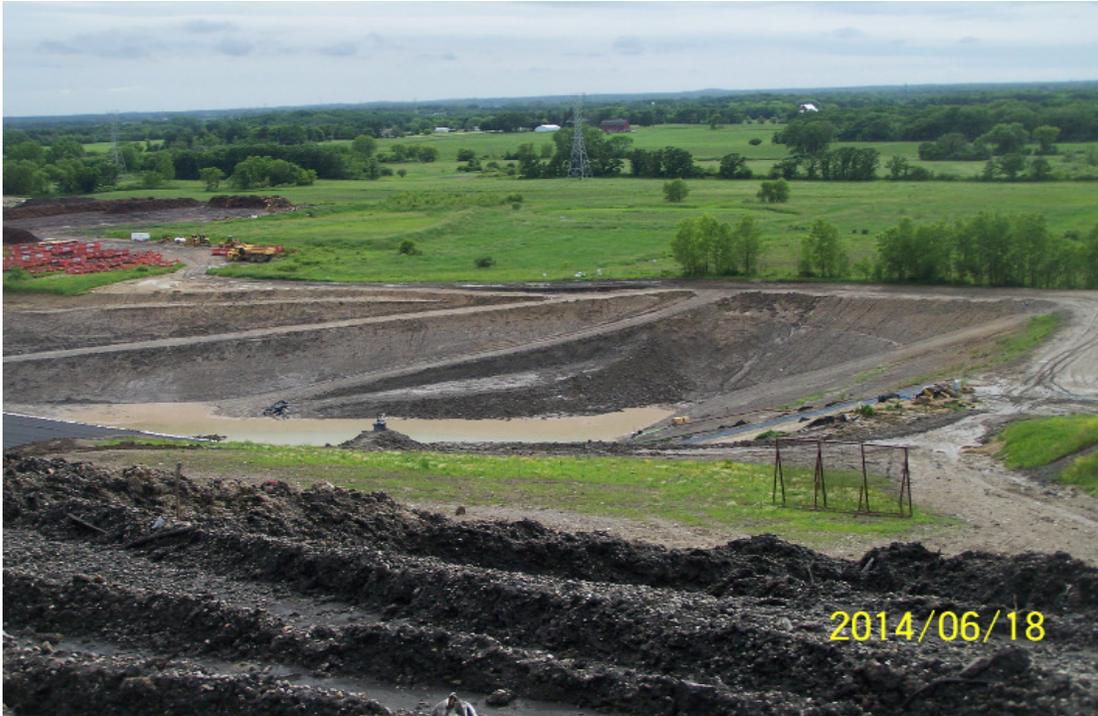
* Sump, temp sed basin, filled, but not
overflowing. Pumps active all day

Temp sed Basin and additional excavation location in Northwest Corner of Phase 7B

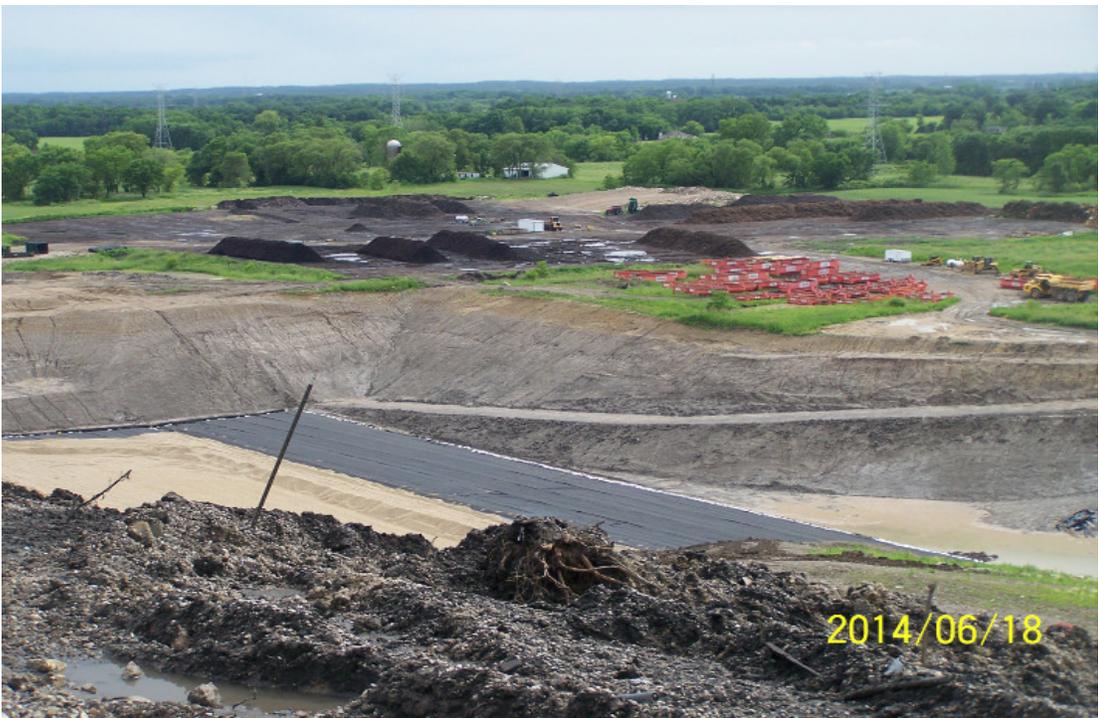
Phase 7B new liner deployment viewed from North

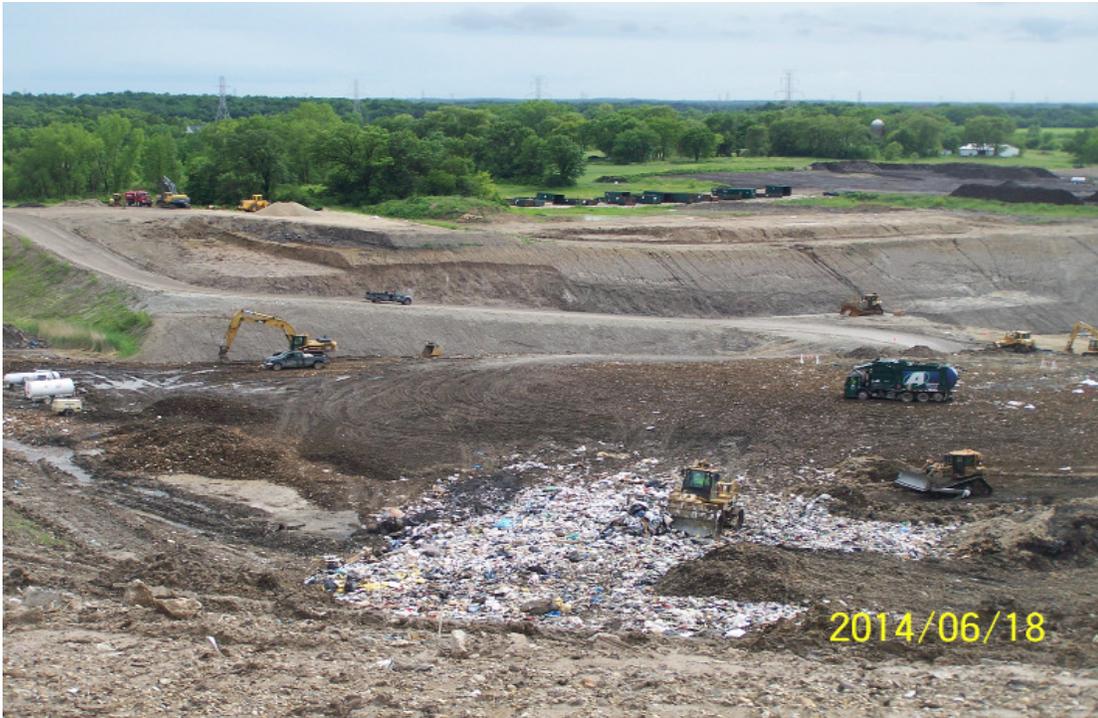
Phase 7B viewed from East

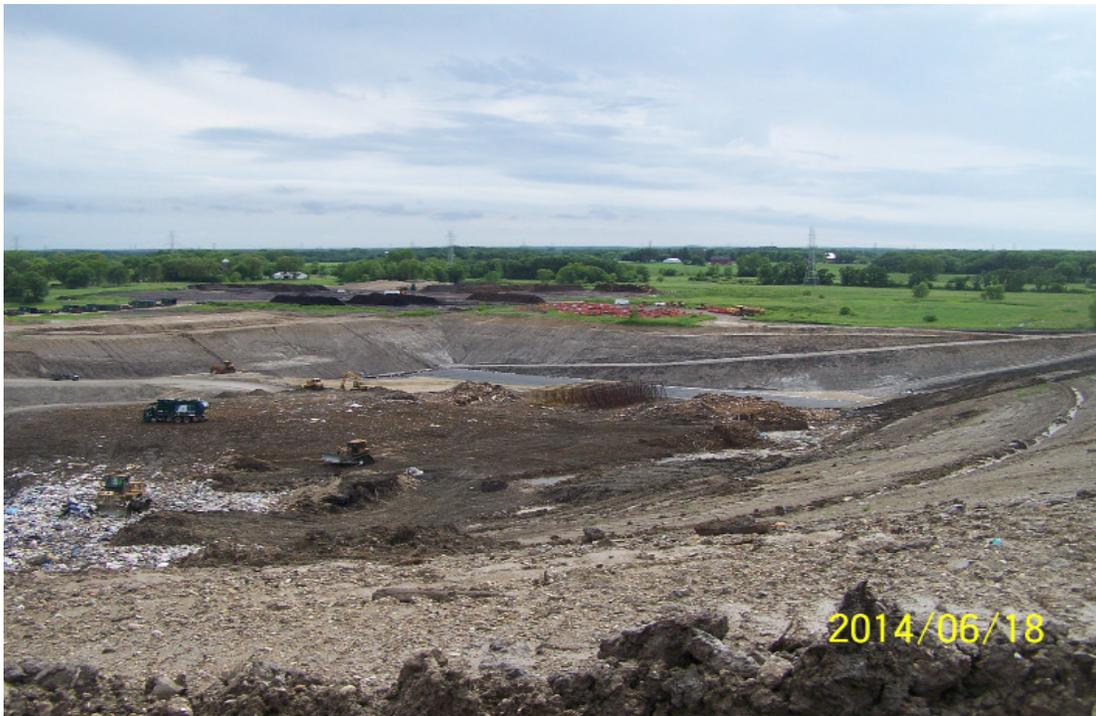
Phase 7B viewed from Northeast

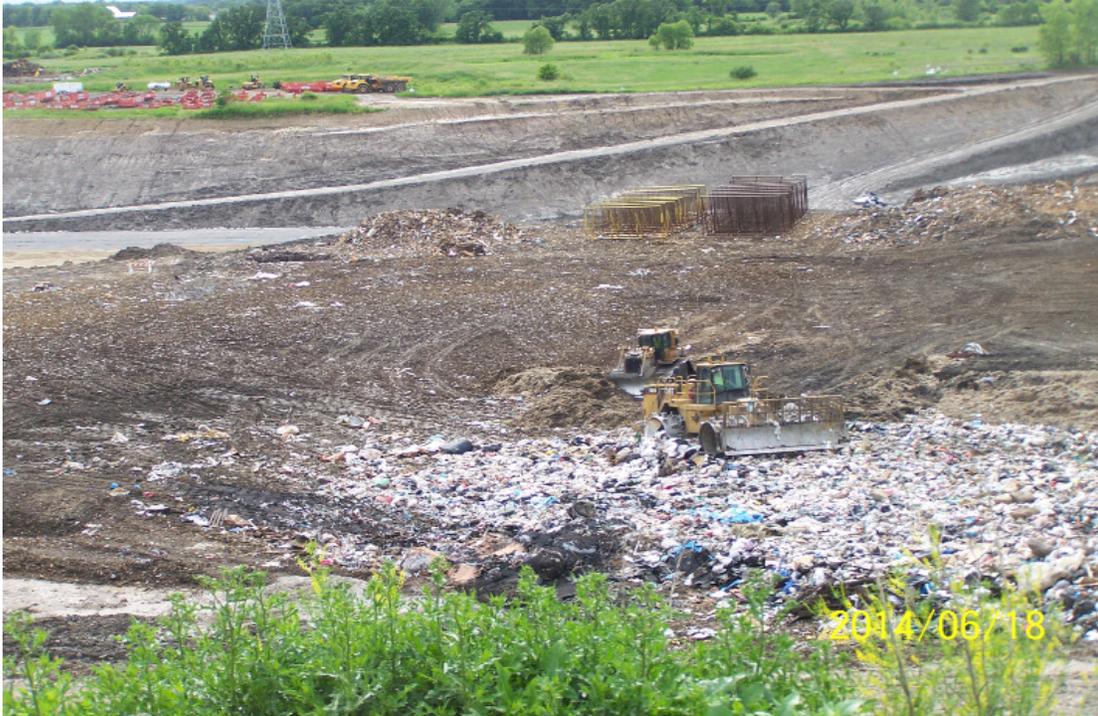
Working face is North east corner of Phase 7B.
Compactor finishing placement and Dozer
covering with plastic Waste Alternative
Daily Cover (ADC)

Working face in Phase 7B
