ADS Emerald Park Landfill Audit Summary

PROJECT NUMBER: 1012.10030

ADVANCED DISPOSAL SERVICES EMERALD PARK LANDFILL
 LANDFILL OPERATIONS AUDIT FORM
 CITY OF MUSKEGO

**ADVANCED DISPOSAL SERVICES
EMERALD PARK LANDFILL / CITY OF MUSKEGO
AUDIT PHOTOS**

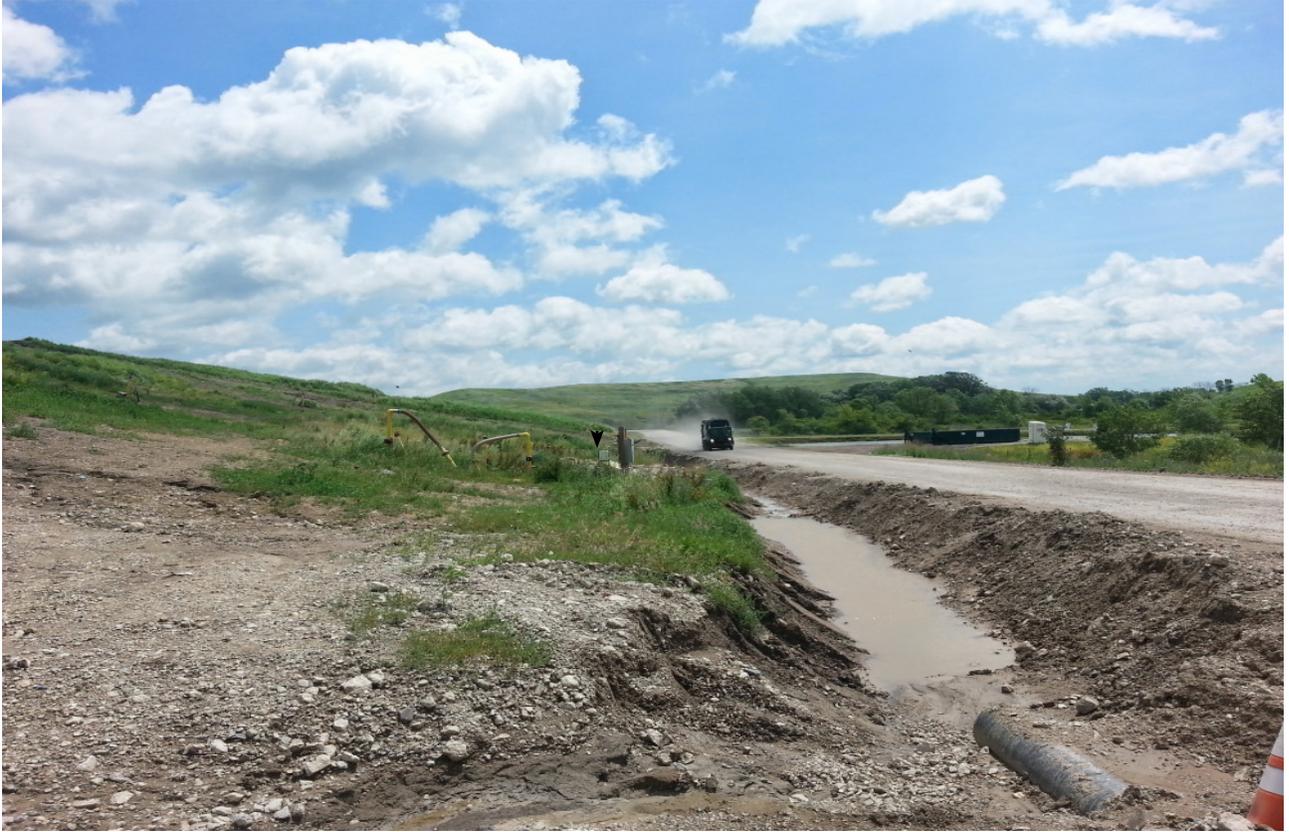
Ditches recut after storm events.

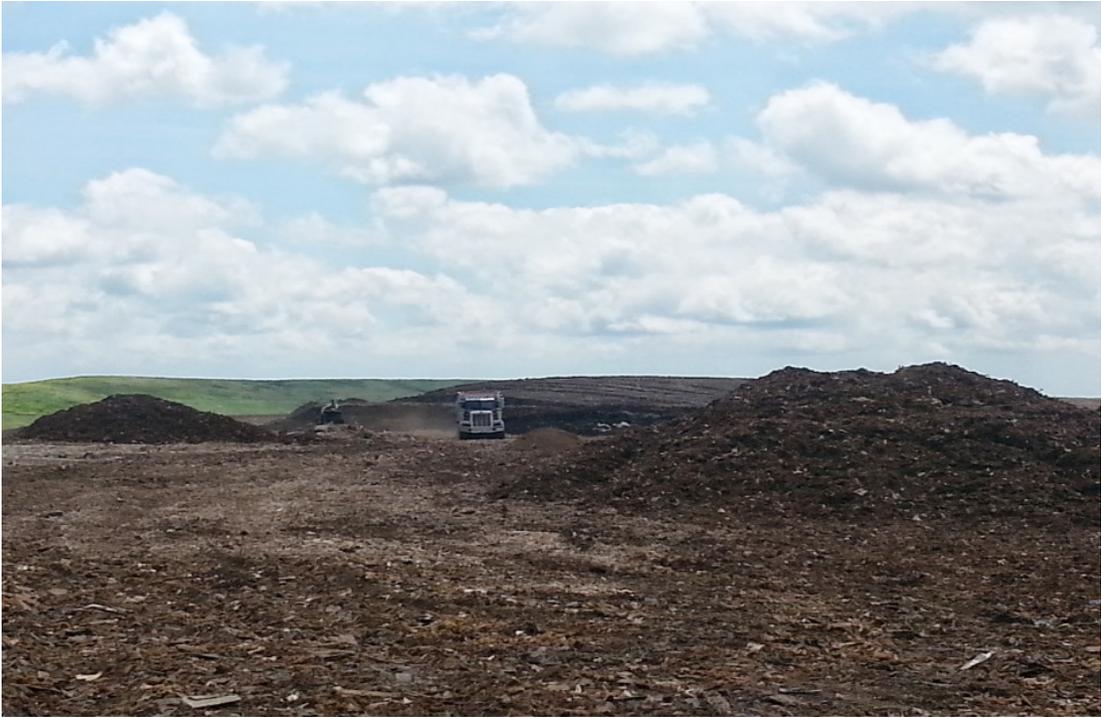
Landfill direct soil being tipped on top of Phase 5

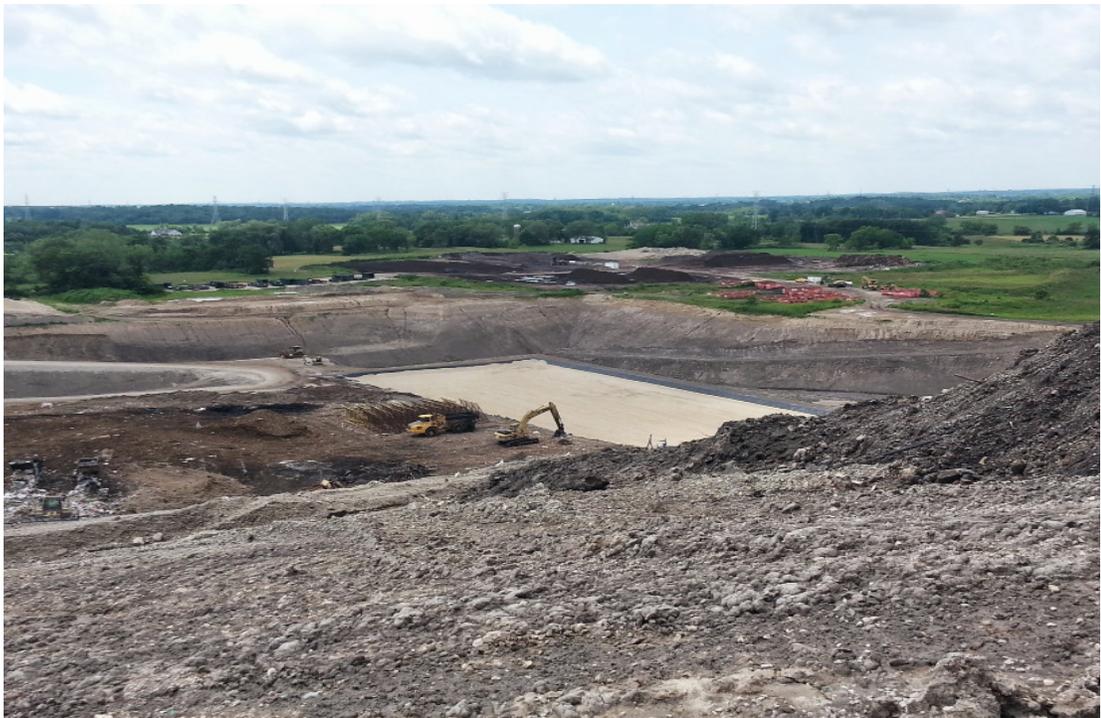
Phase 7B new base placement

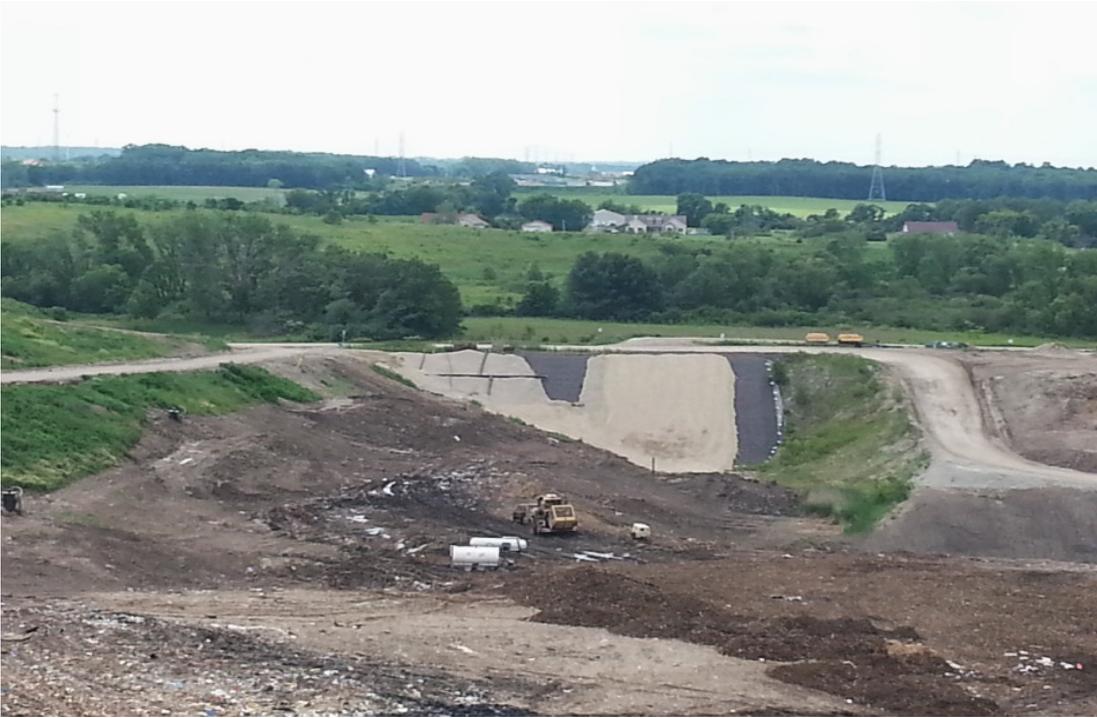
Leachate collection system media being restored on South Slope of Phase 6

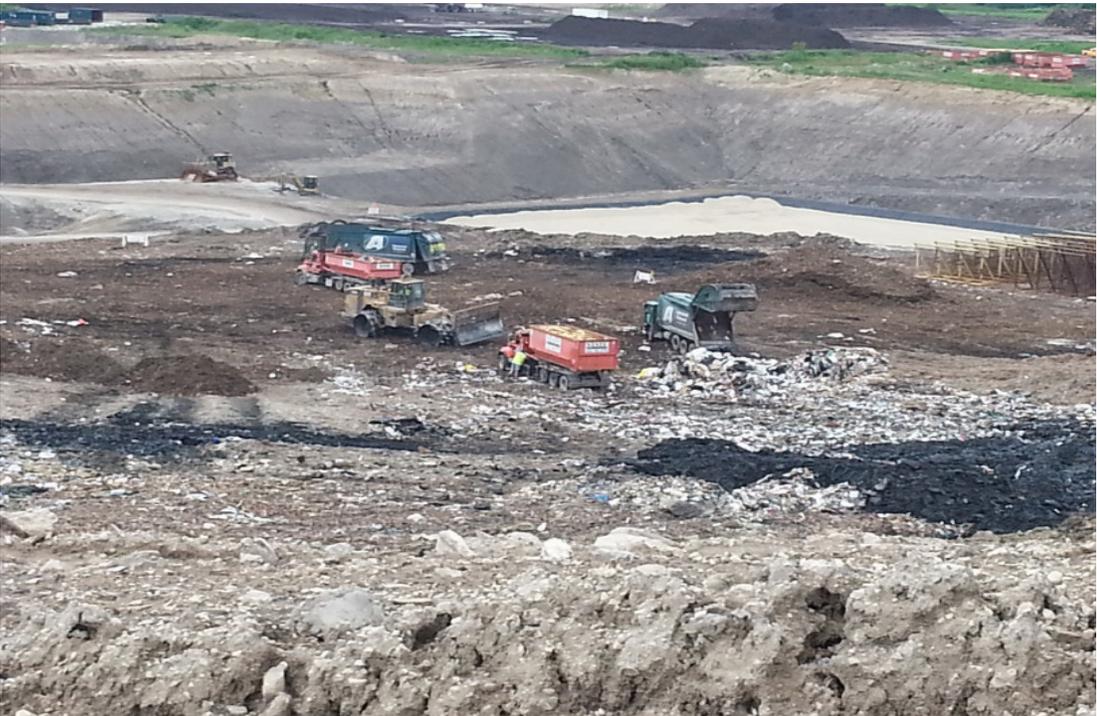
Working face in Phase 7B

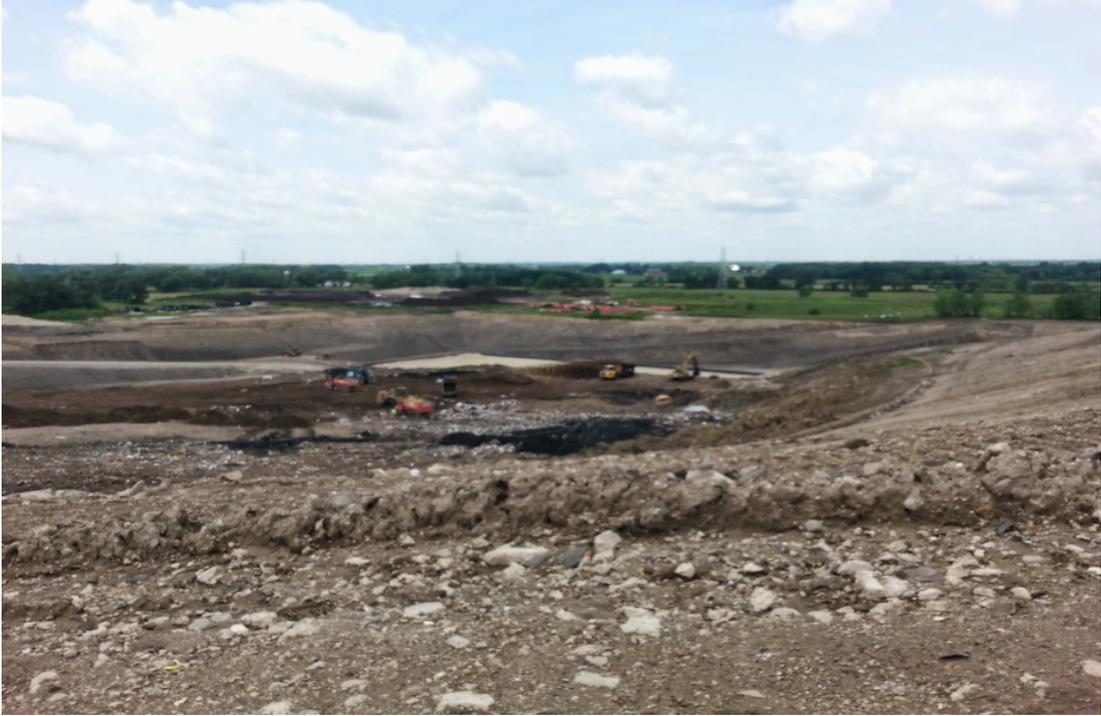
Active area viewed from West

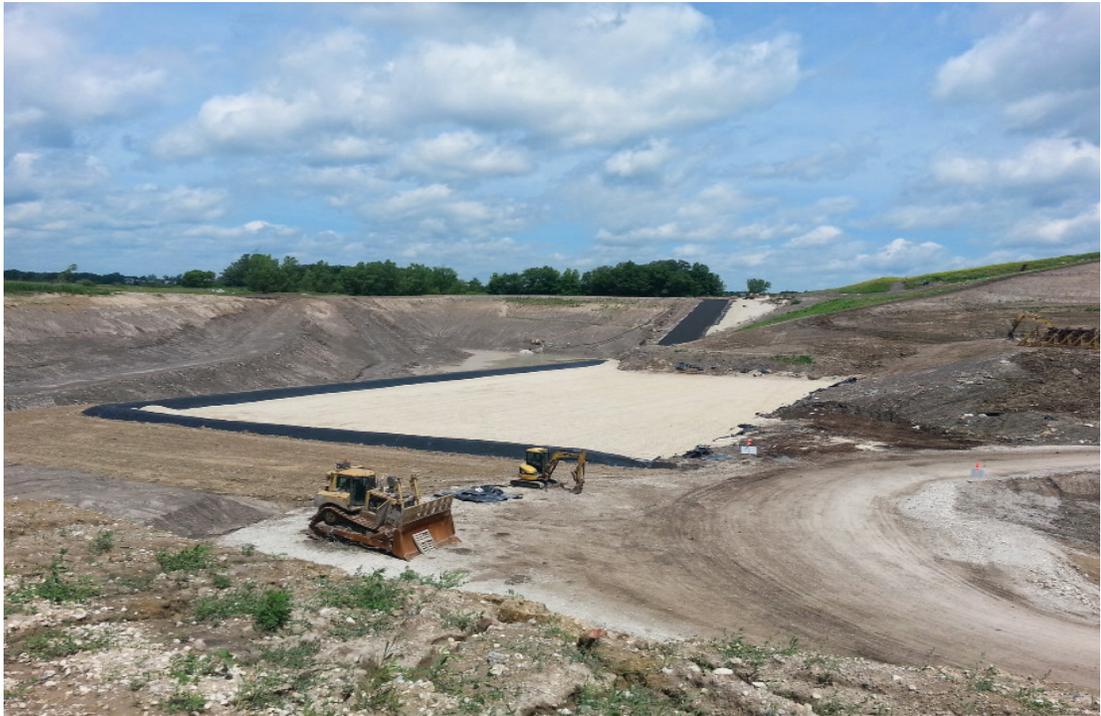
Completed base of cell
