ADS Emerald Park Landfill Audit Summary

PROJECT NUMBER: 1012.10030

**ADVANCED DISPOSAL SERVICES
EMERALD PARK LANDFILL / CITY OF MUSKEGO
AUDIT PHOTOS**

PROJECT NO. 1012.10030

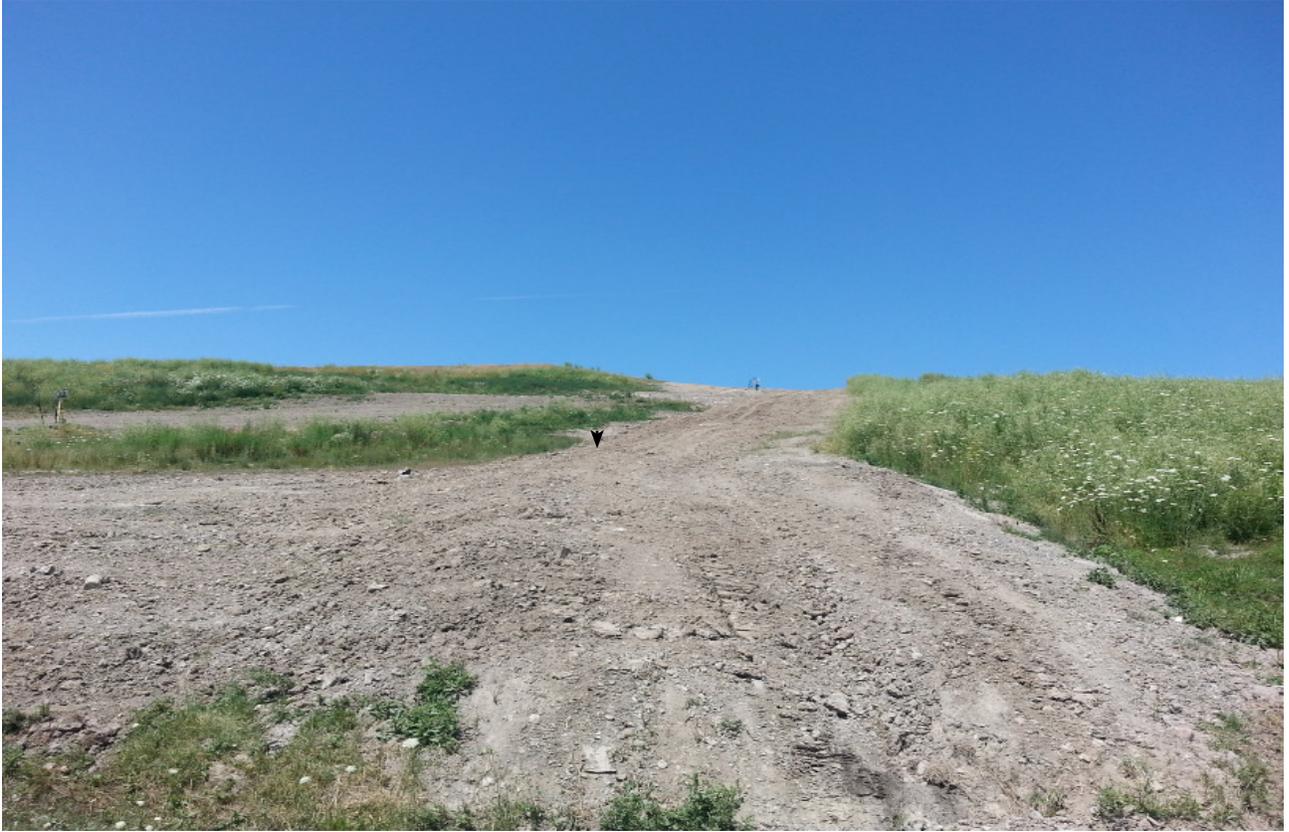
Slope repairs and sluce development on South slope of Phase 5.

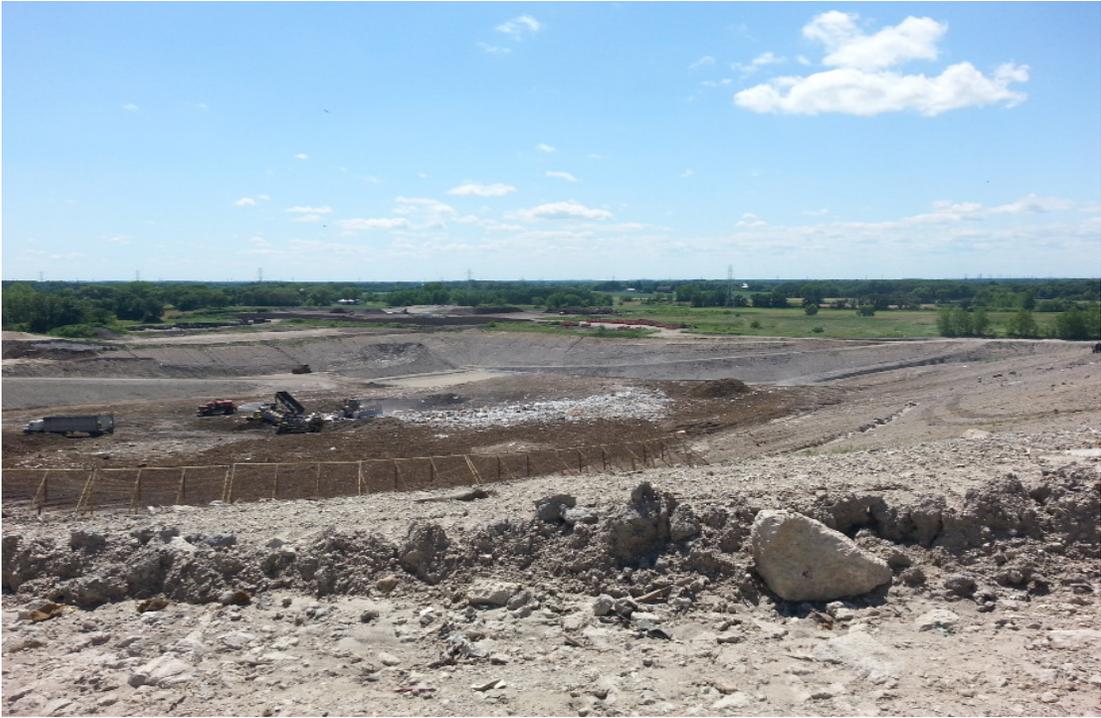
Active area in Phase 7B

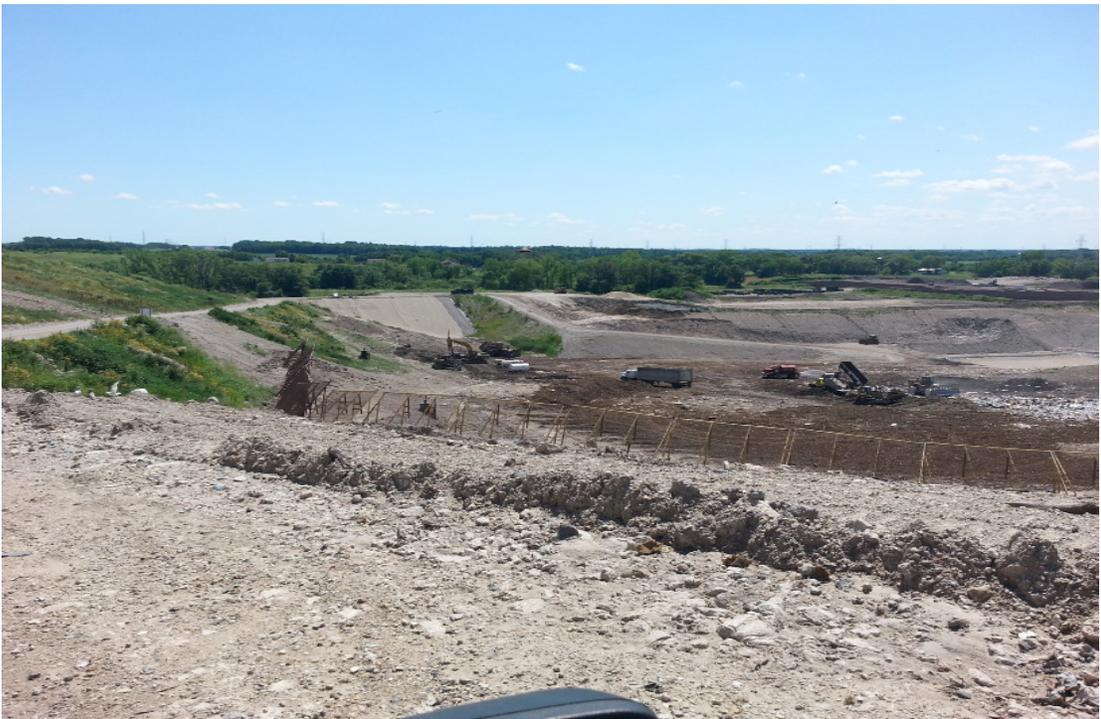
Active Area in Phase 7B

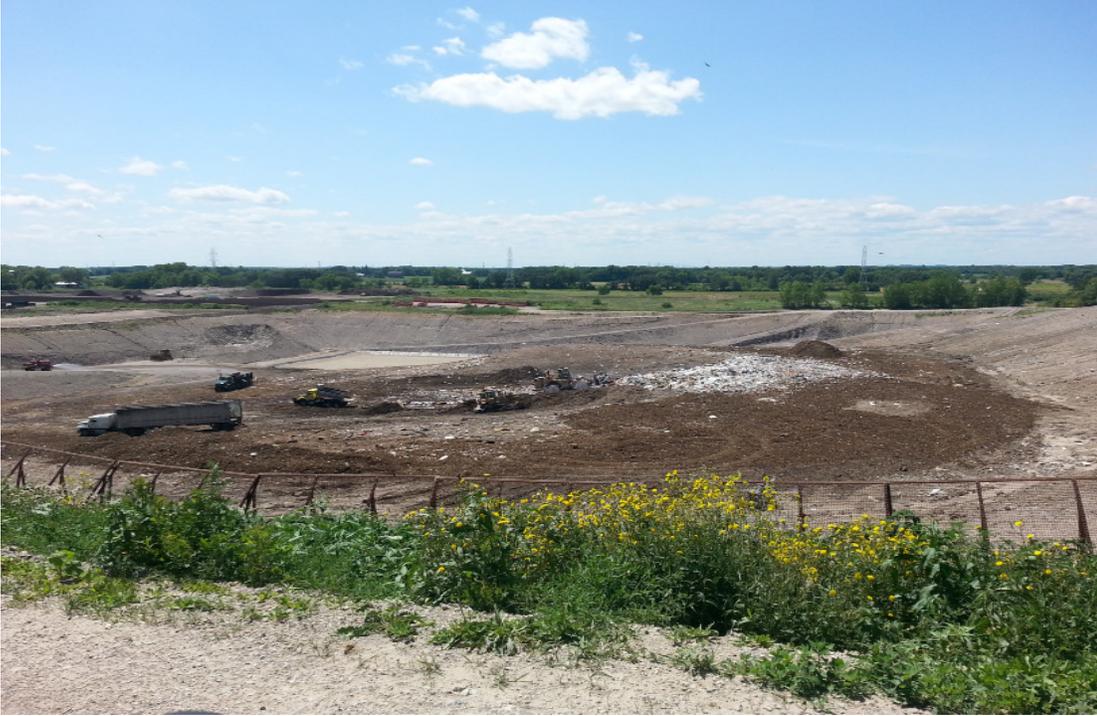
Active area in Phase 7B

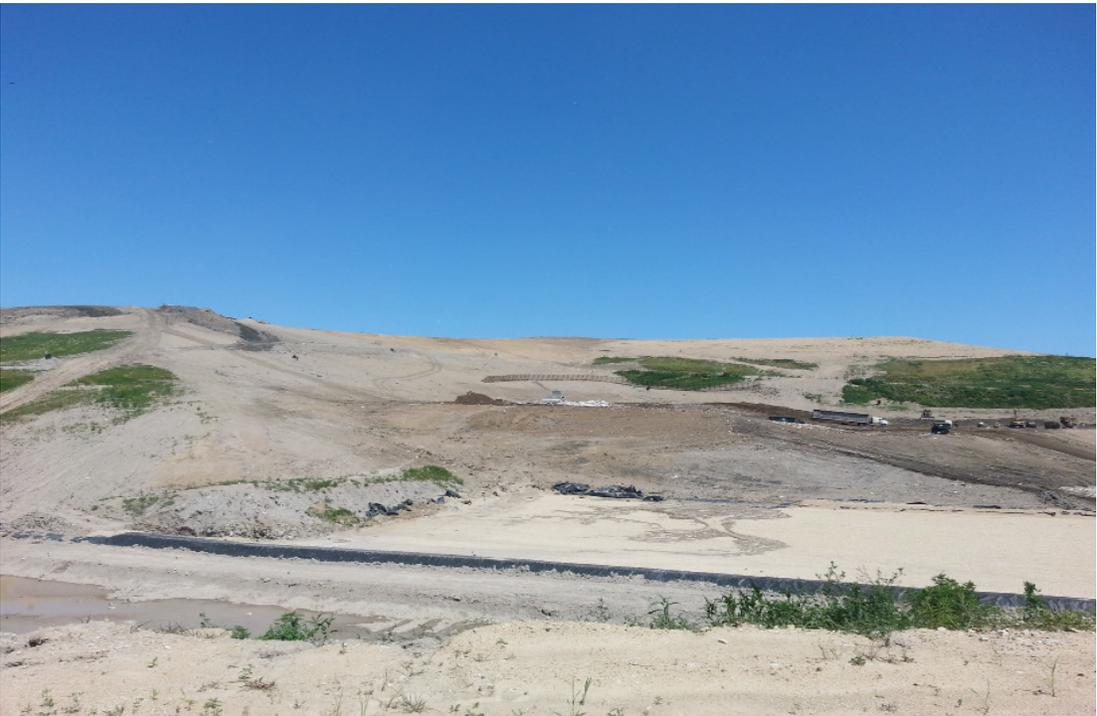
Cell base awaiting State approval

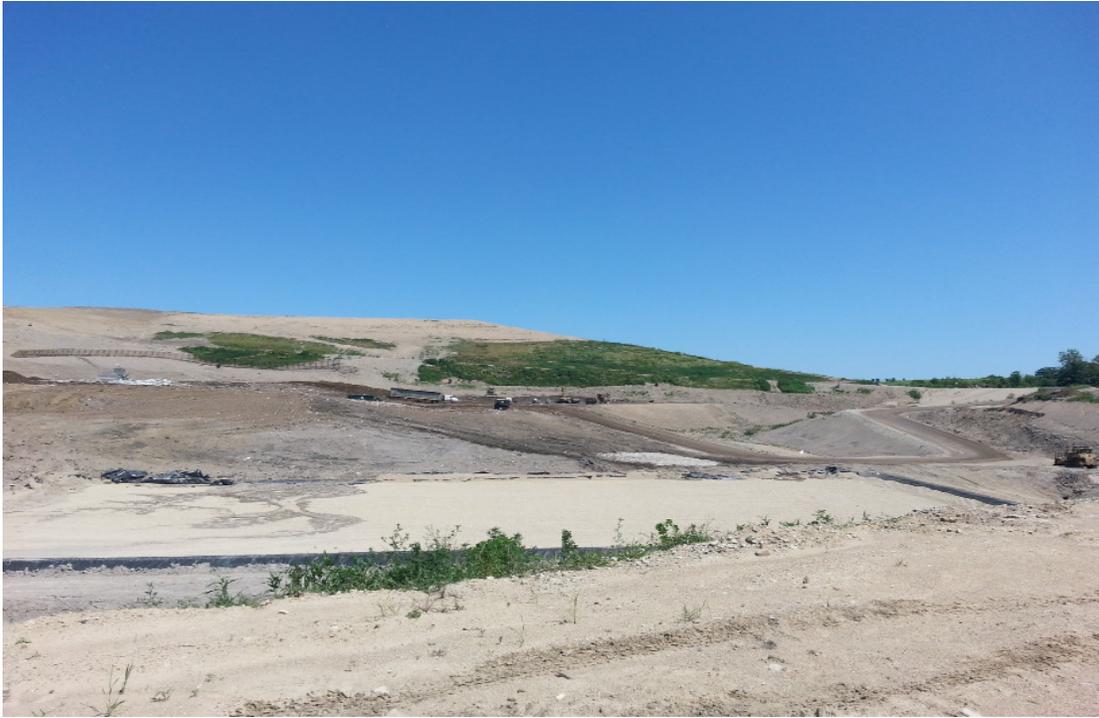
Phase 7B viewed from the West

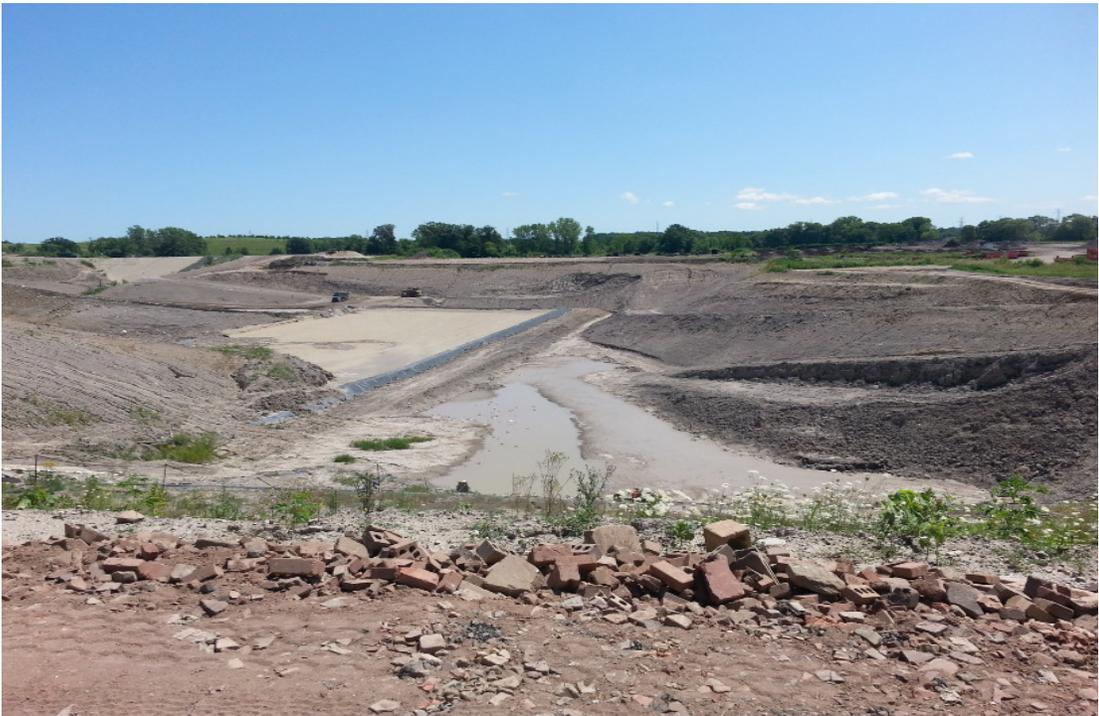
Sump for Phases 7 & 7B, and surrounding area runoff

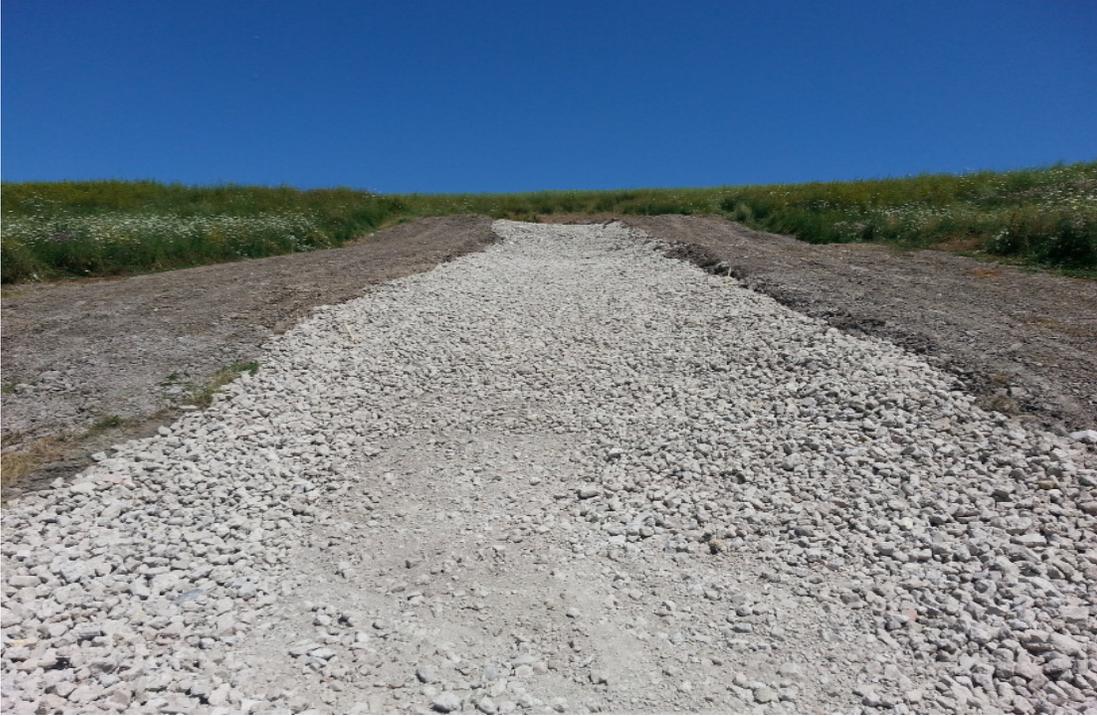
New drainage way on West Slope of Phase 2.
