MEMORANDUM

ADS Emerald Park Landfill Audit Summary

TO: ADS Emerald Park Landfill Standing Committee, City of Muskego
FROM: Faith Spear.
COPIES: File
DATE: 08/21/14
PROJECT NUMBER: 1012.10030

**ADVANCED DISPOSAL SERVICES
EMERALD PARK LANDFILL / CITY OF MUSKEGO
AUDIT PHOTOS**

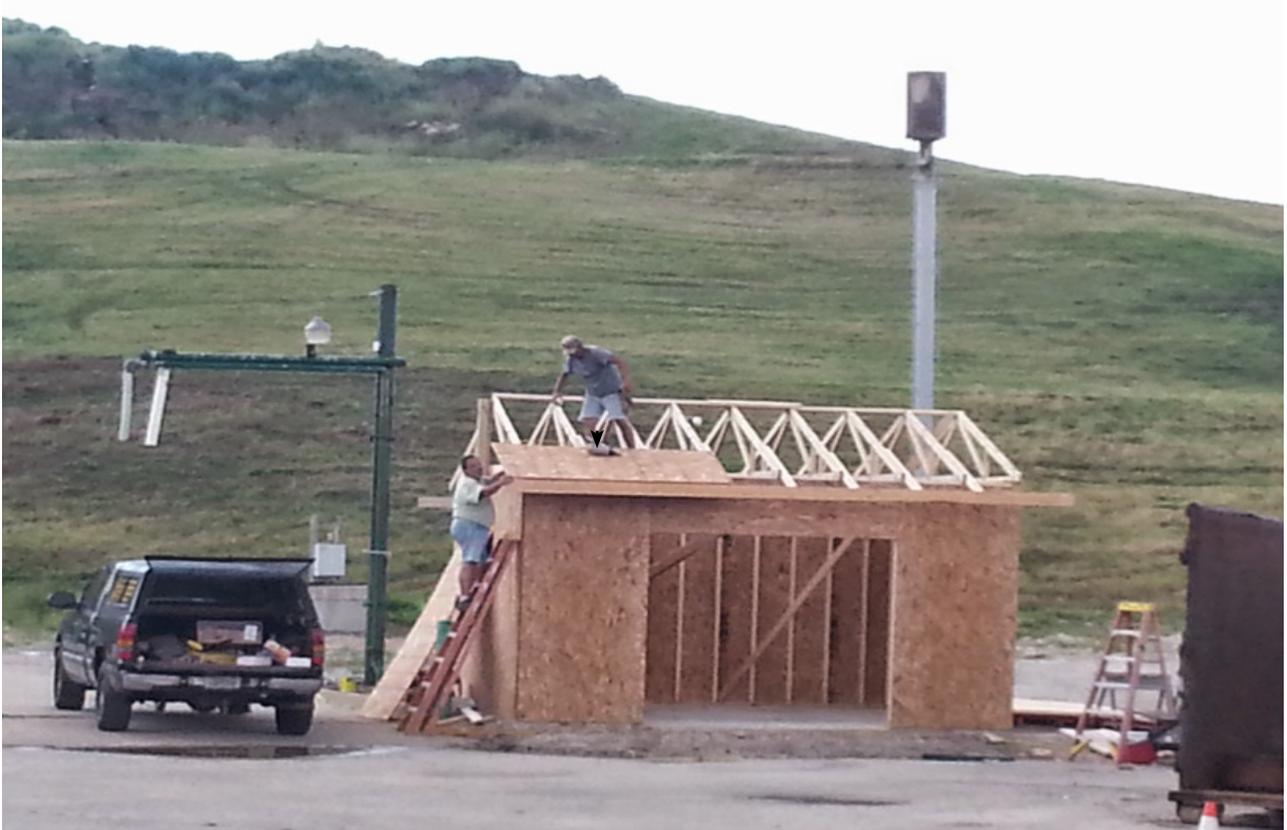
New pneumatic housing structure, South of Gas building

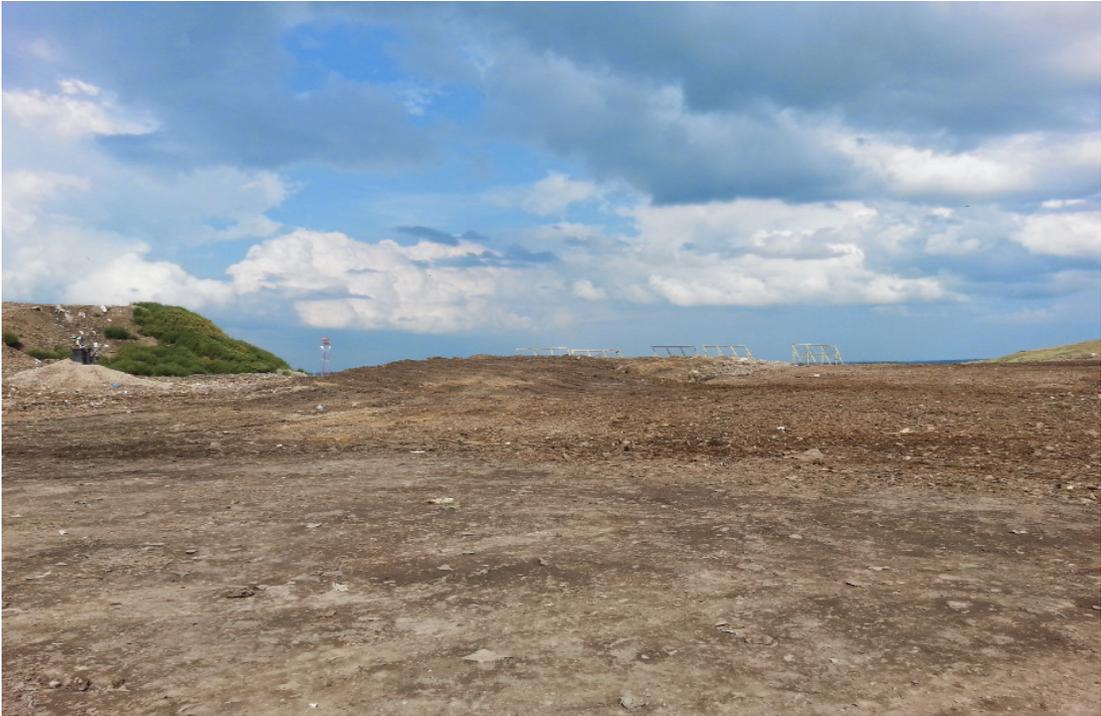
Bio soil received over last two days on Phase 3, 4,5 junction

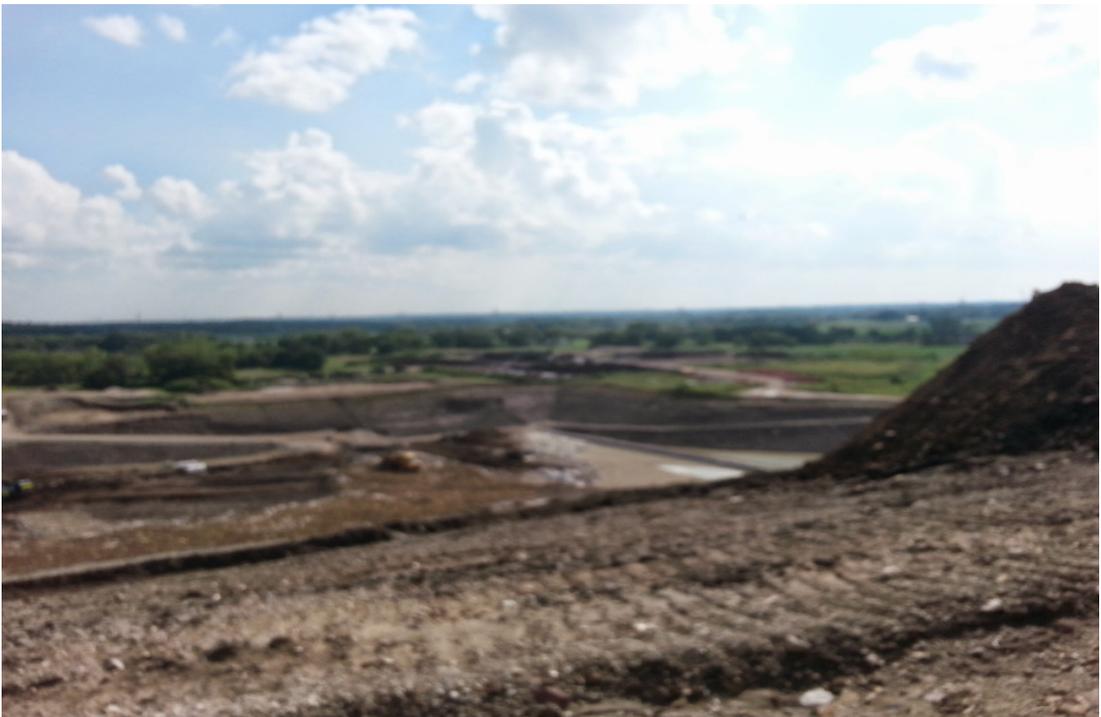
Fluff layer placement in Phase 7B West

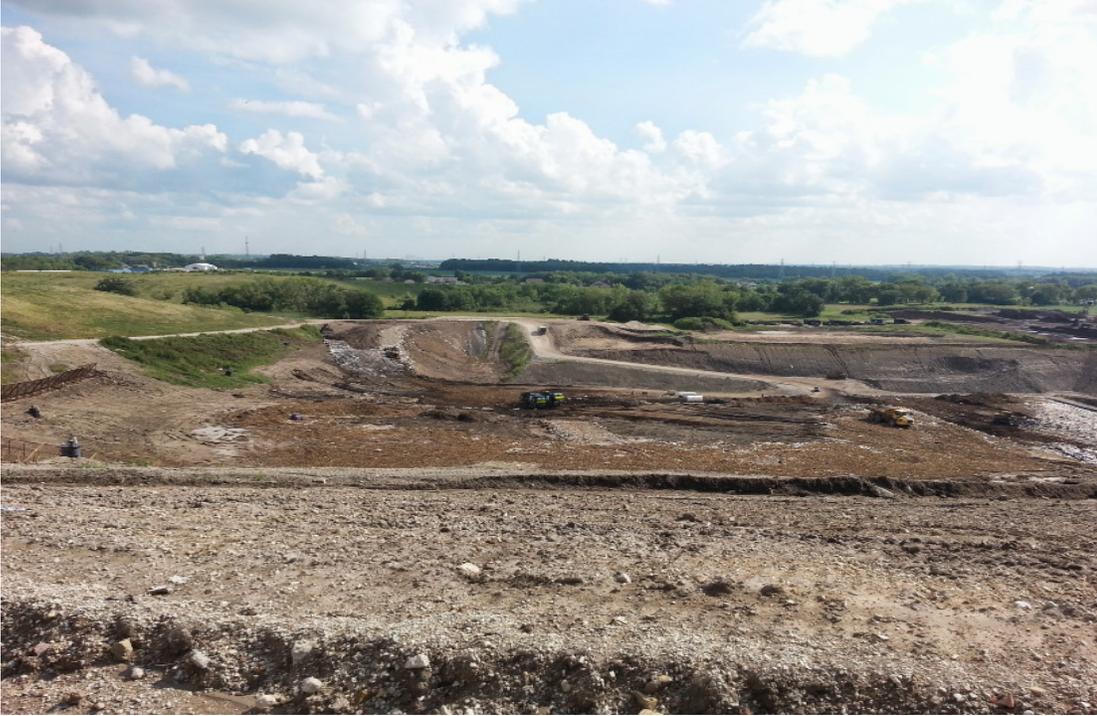
Active area viewed from the North

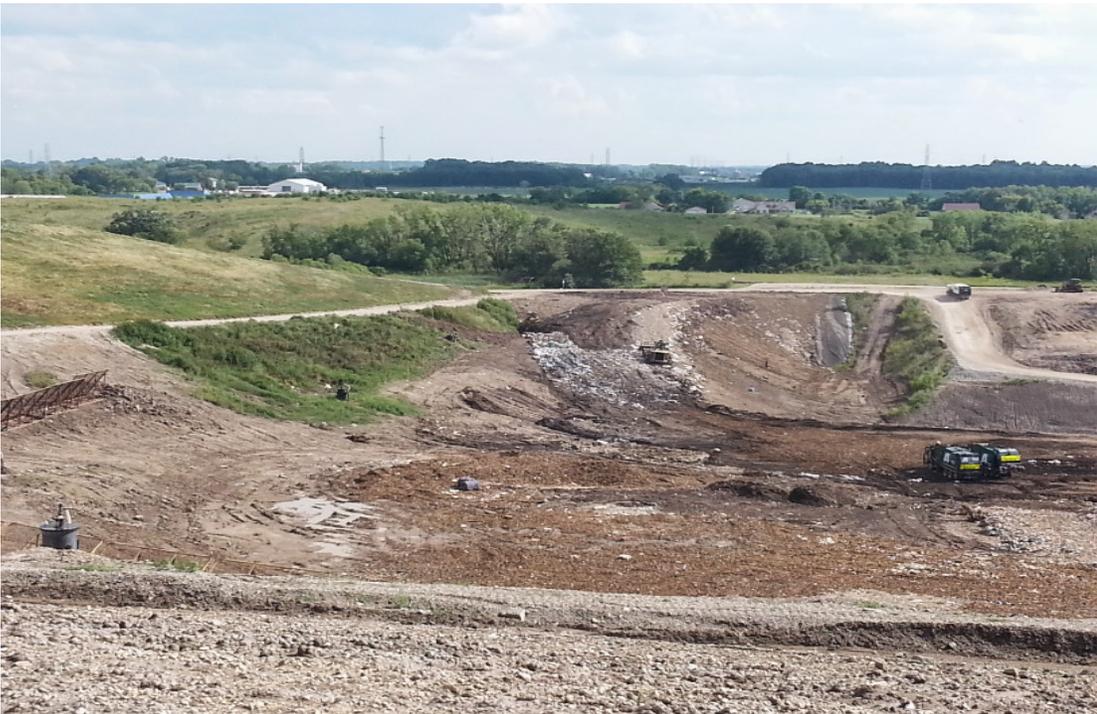
Working Phase on West slope of Phase 6

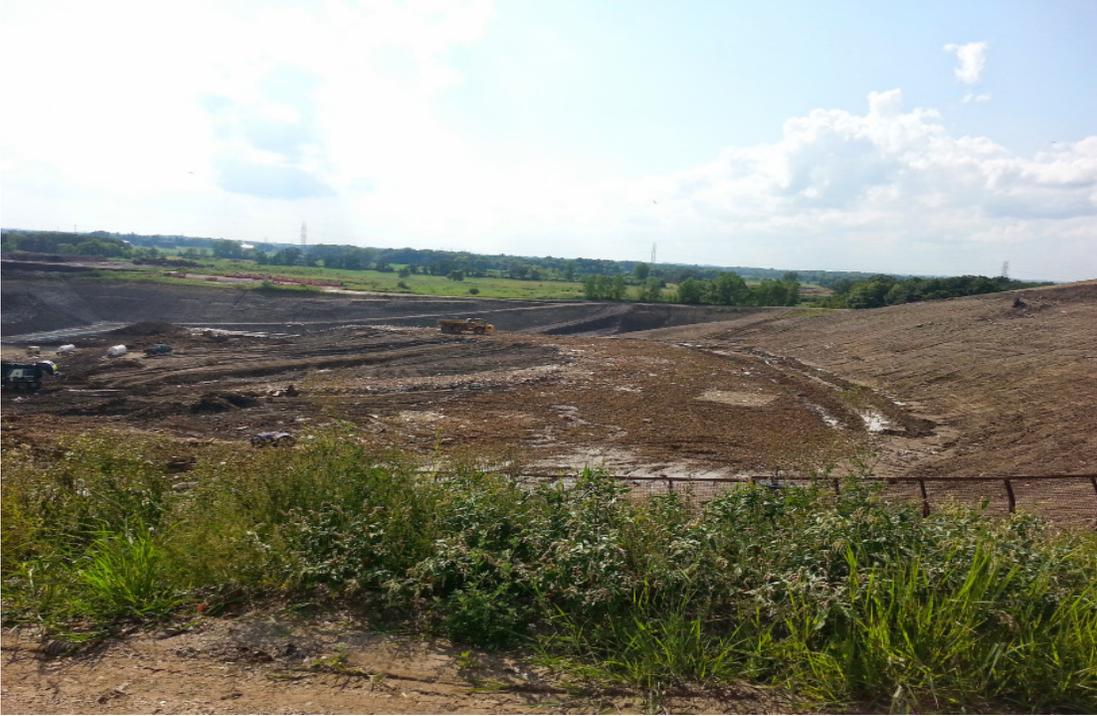
Active area viewed from Northeast

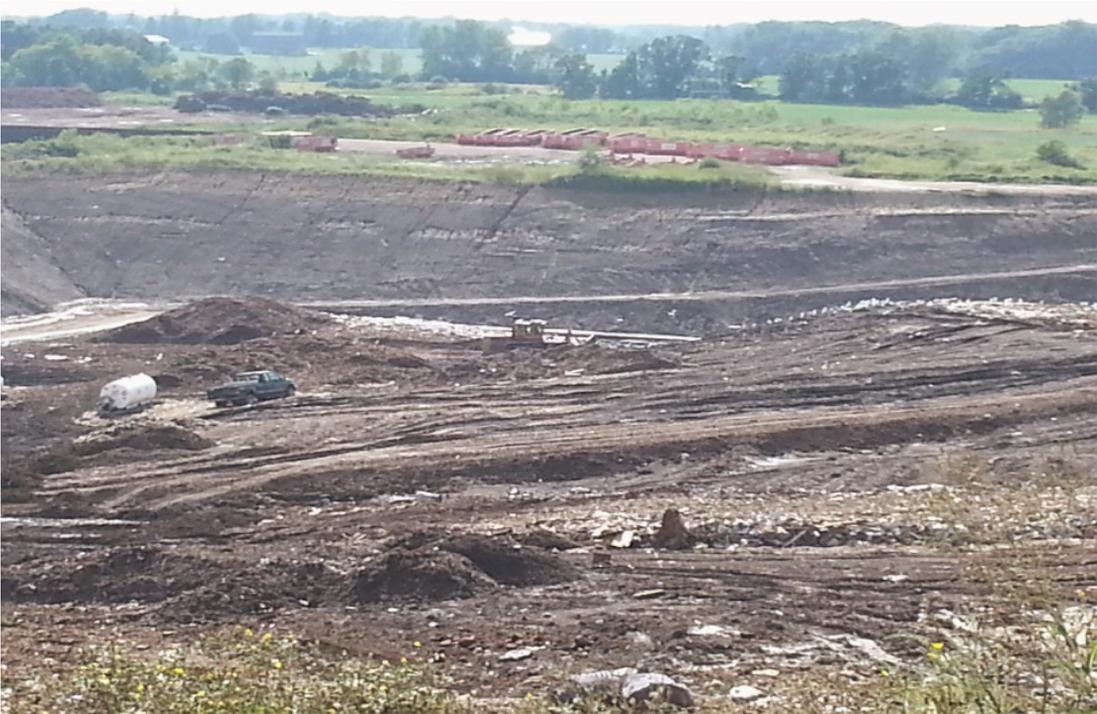
Active area viewed from the East
