ADS Emerald Park Landfill Audit Summary

TO: ADS Emerald Park Landfill Standing Committee, City of Muskego
FROM: Faith Spear.
COPIES: File
DATE: 09/26/14
PROJECT NUMBER: 1012.10030

**ADVANCED DISPOSAL SERVICES
EMERALD PARK LANDFILL / CITY OF MUSKEGO
AUDIT PHOTOS**

PROJECT NO. 1012.10030

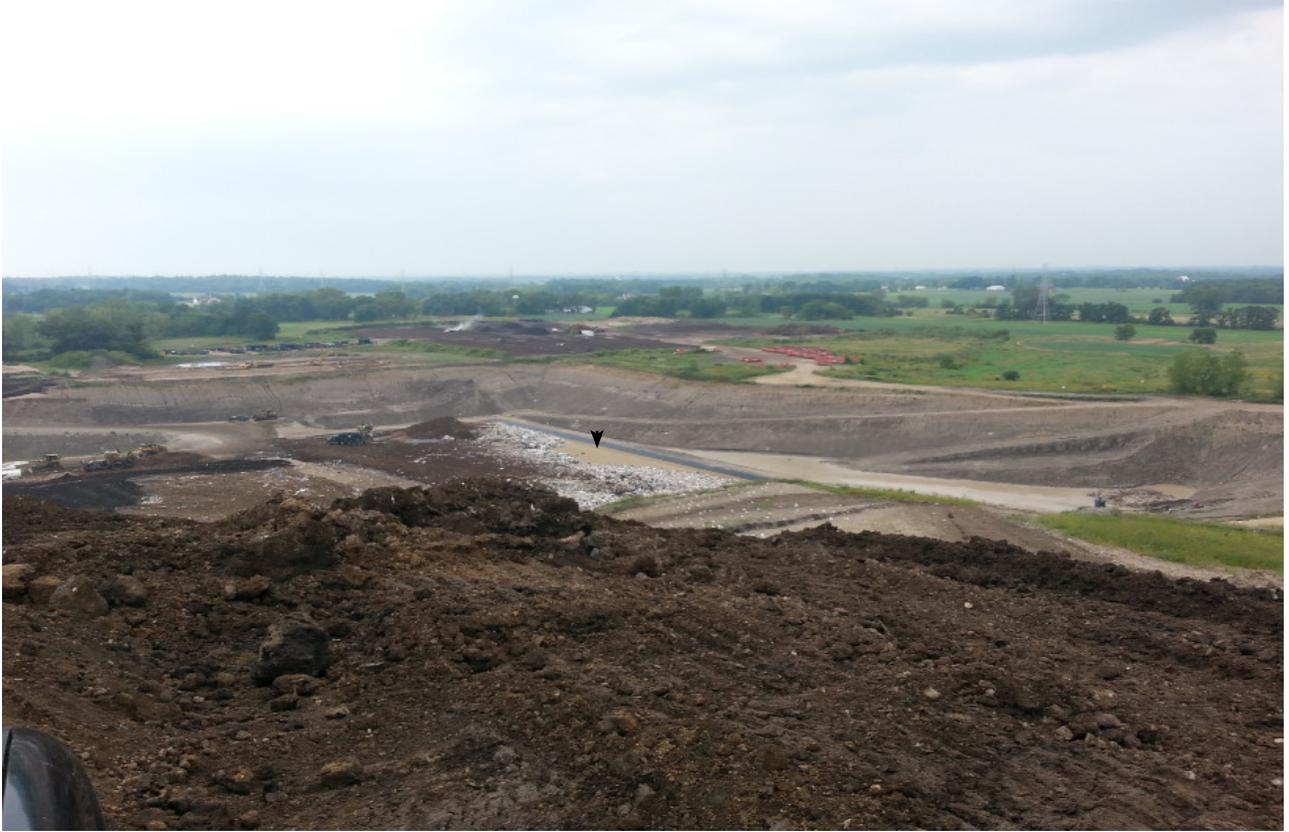
View of Emerald park from the North

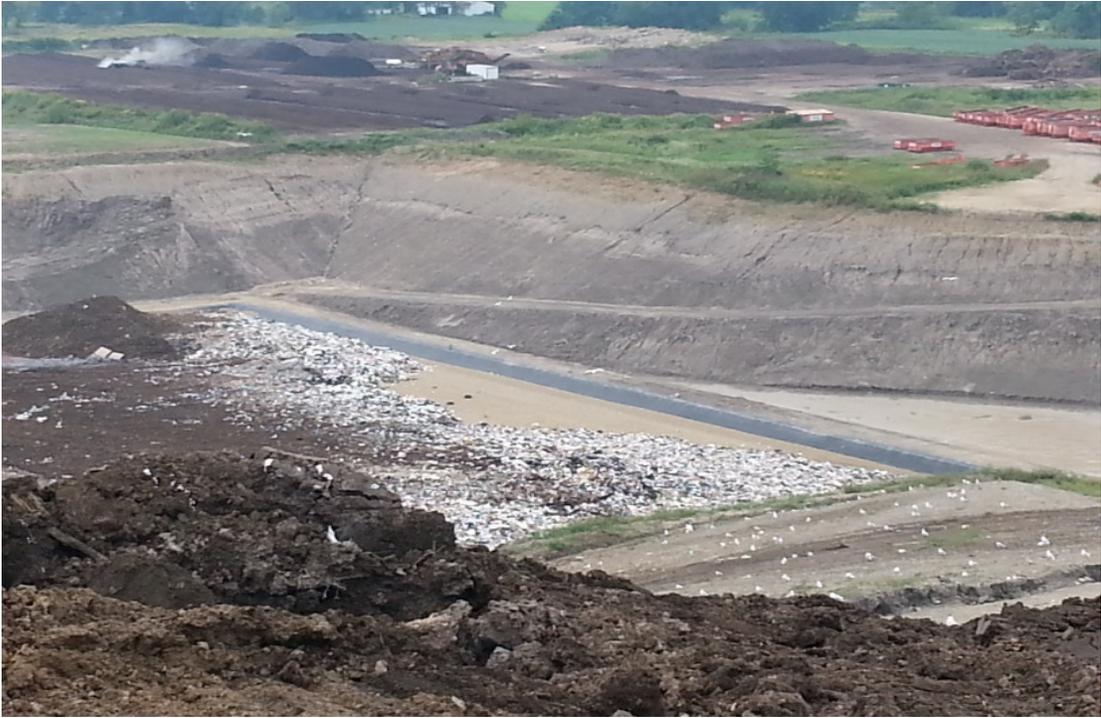
Phase 7B West

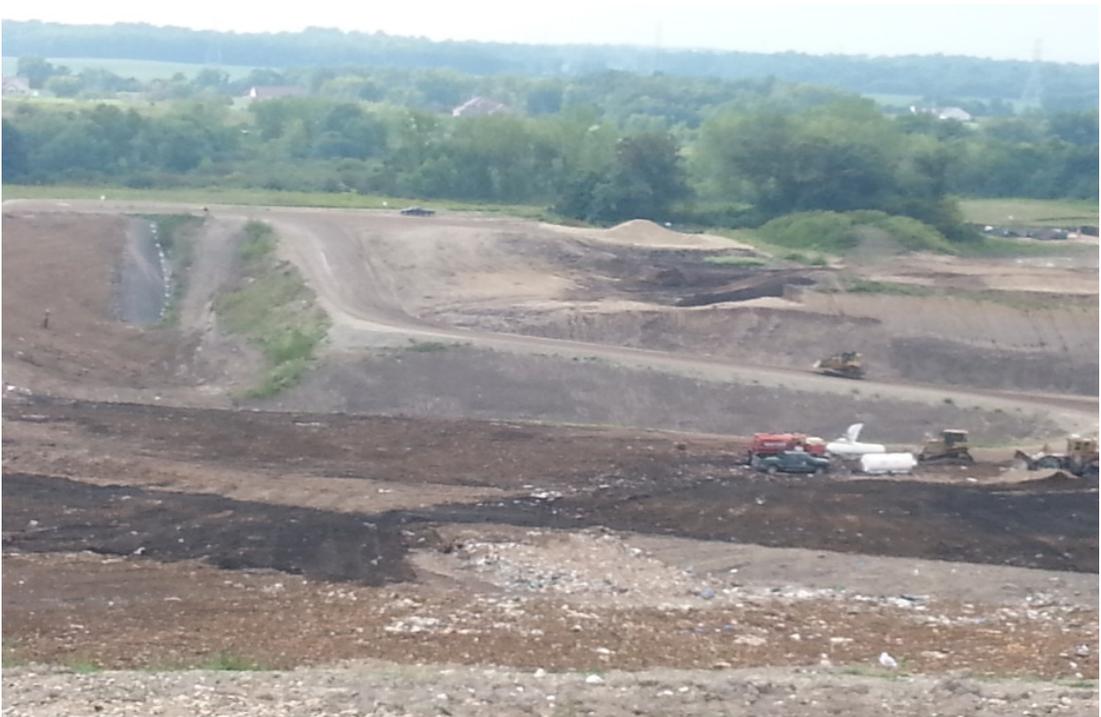
Various covers in Phase 7B

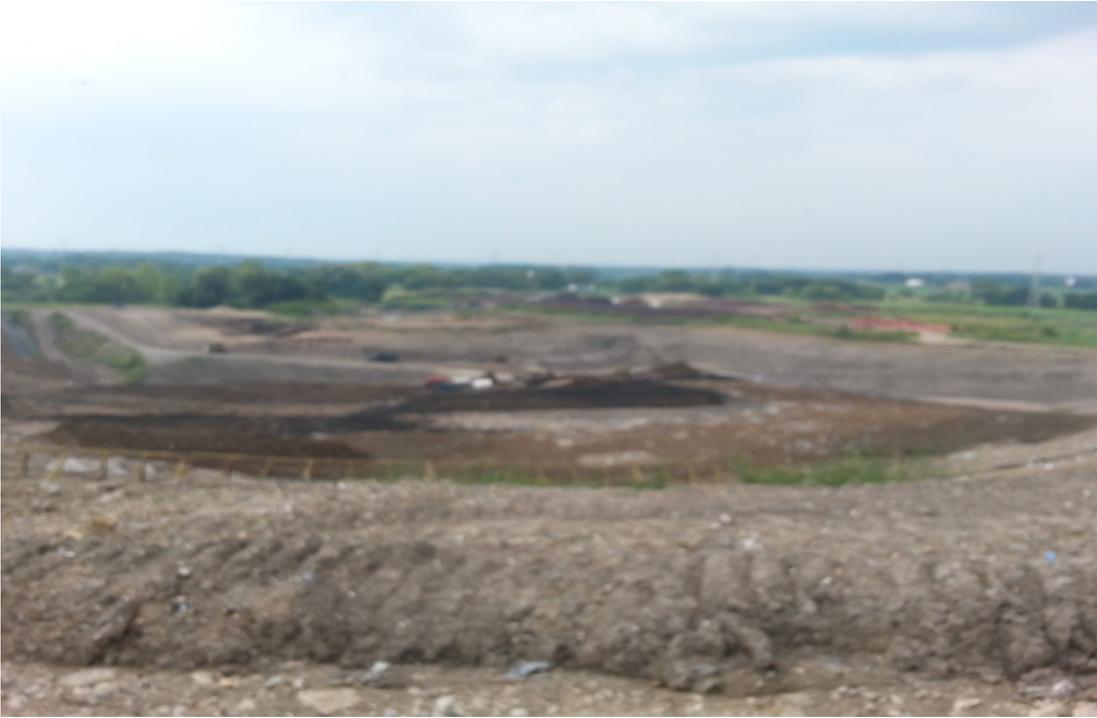
Active area viewed from the North

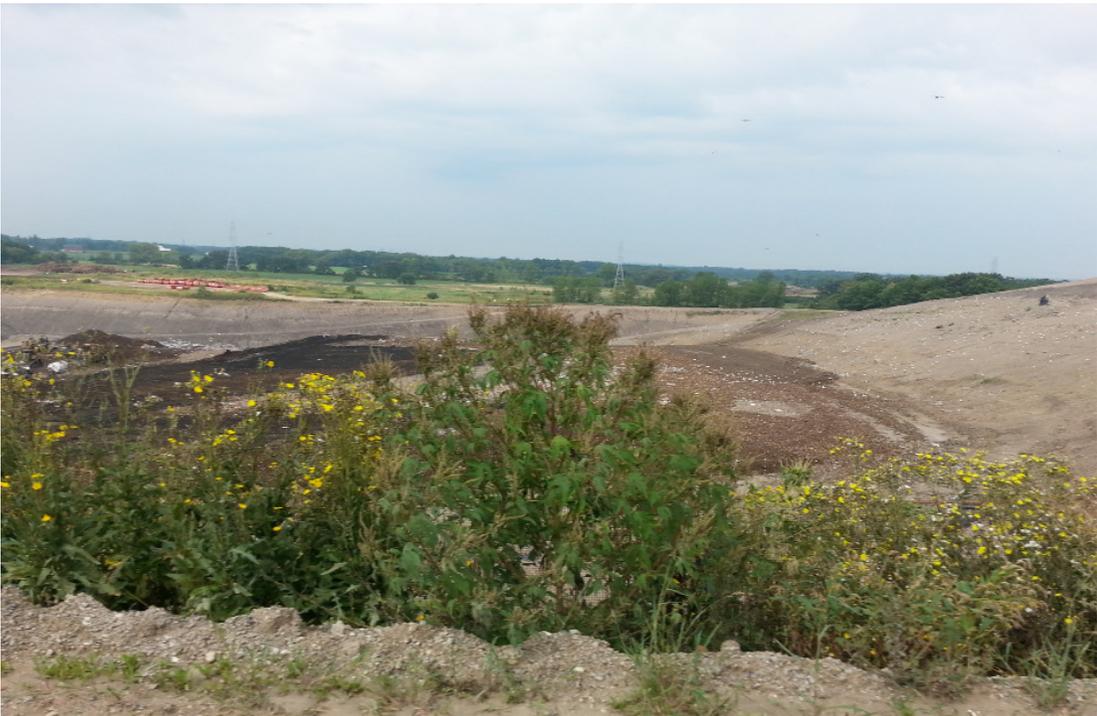
- All leachate discharging to MMSD; no recirculation
- Gas flow to MMSD 1,300 cfm
 - No flares in operation during audit
 - One blower in operation
 - Gas plant operating as designed
 - Vegetation in fair condition

Vegetation recovery without seeding on interior slopes

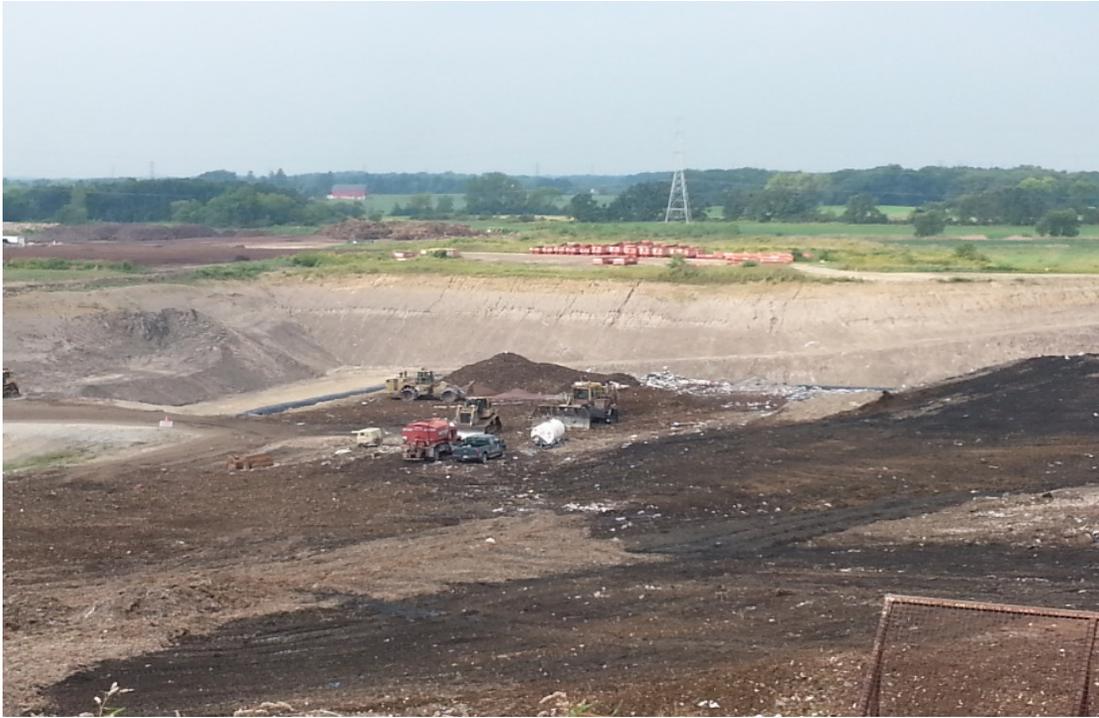
- Working face split between middle of Phase 7 and Phase 7B
 - MSW suitable for fluff layer going to Phase 7B
 - Rougher waste materials deposited in Phase 7
- Phase 7B fluff layer nearly complete

Working face with in phase 7B

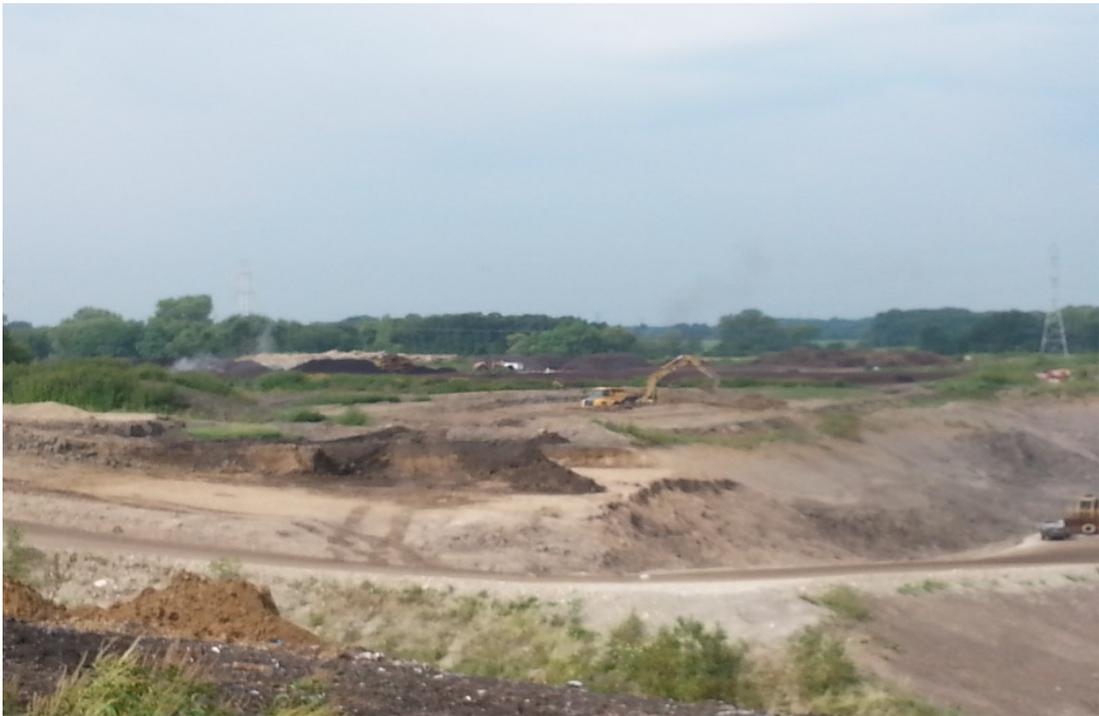
- Soils excavated from future Phase 8 used for intermediate cover on Phase 6 West slope
 - No contractors on site during audit

Soil excavations for site use

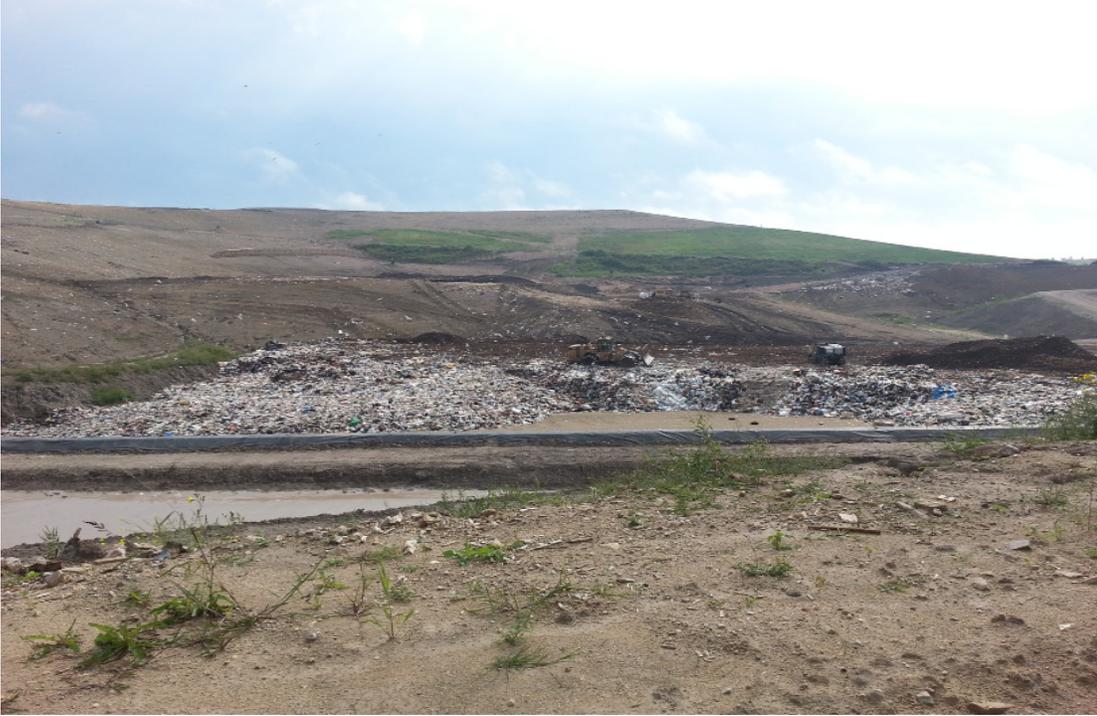
Fluff layer placement

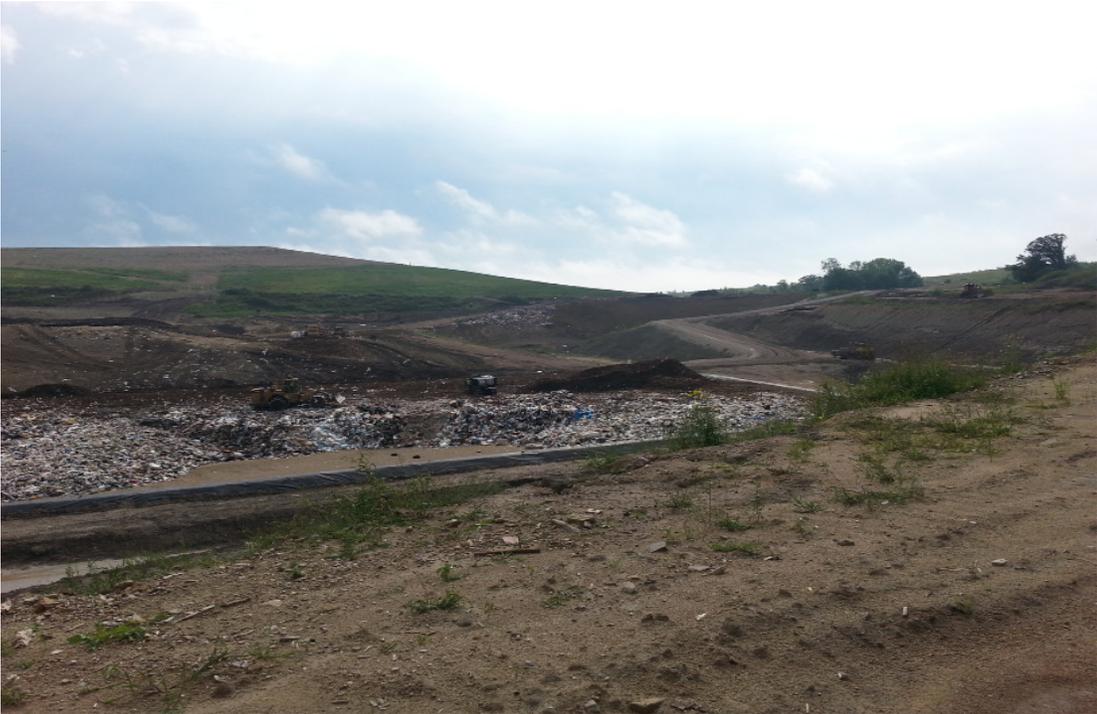
Fluff layer placement

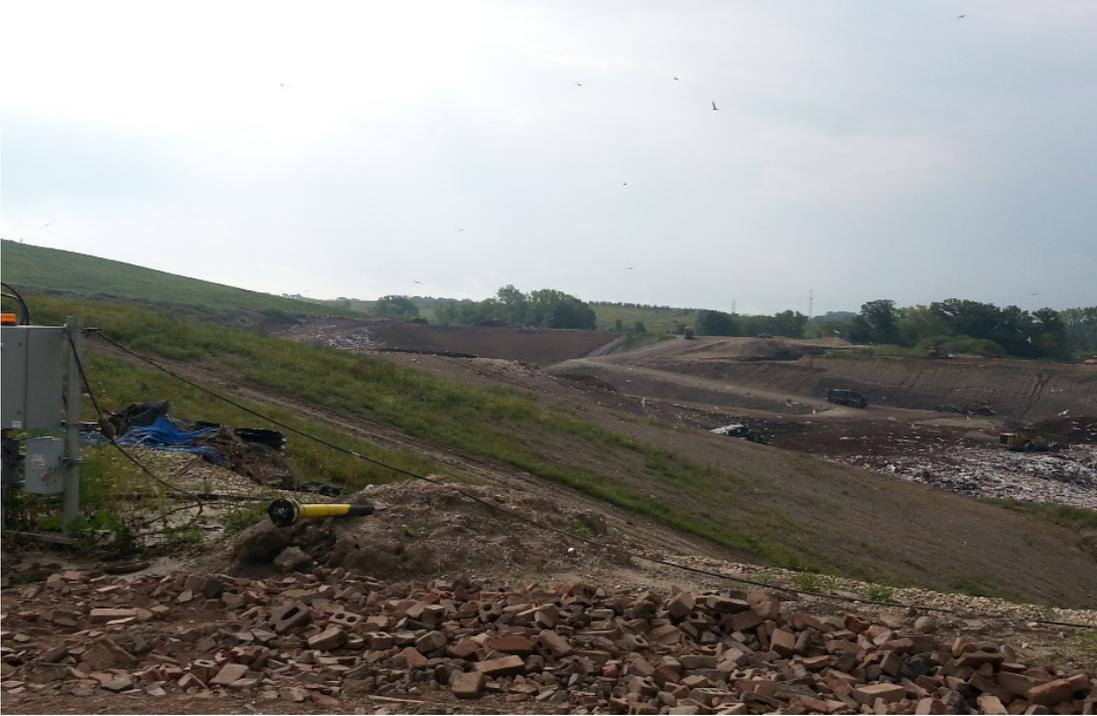
Active area viewed from Northwest

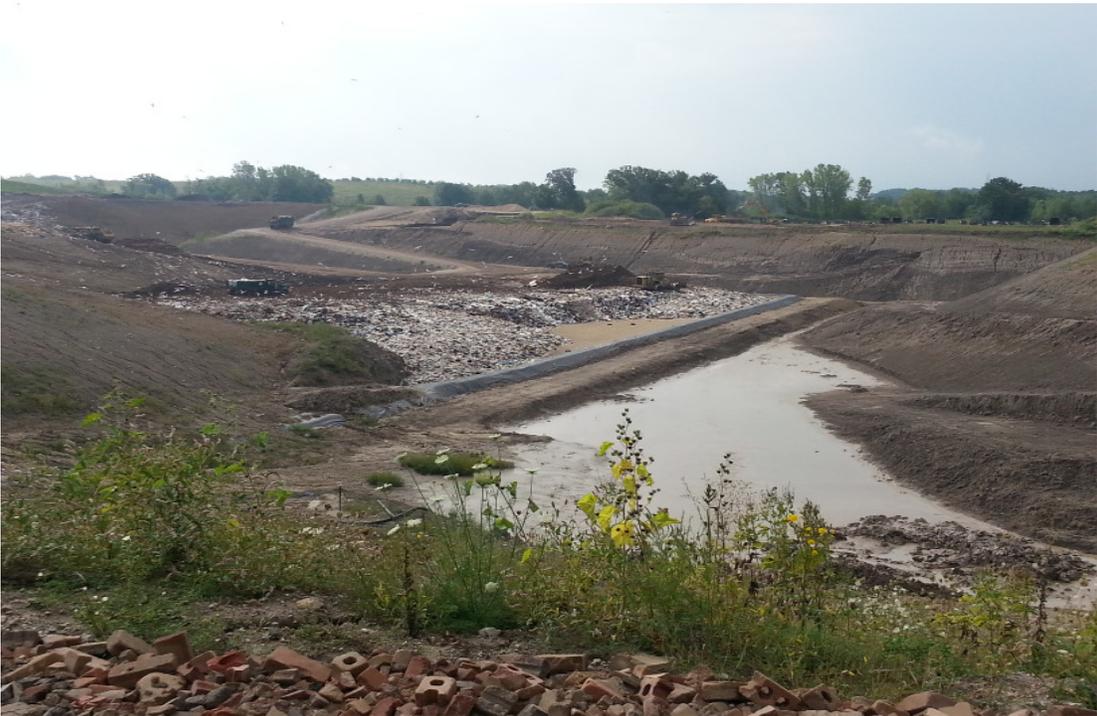
Temp sump being drained during audit
