# ADS Emerald Park Landfill Audit Summary

**To:** ADS Emerald Park Landfill Standing Committee, City of Muskego  
**FROM:** Faith Spear.  
**COPIES:** File  
**DATE:** 10/02/14  
**PROJECT NUMBER:** 1012.10030

Attached is the audit report for activities at the ADS Emerald Park Landfill for the week of September 15, 2014. The audit was performed at 14:04 PM on **September 18, 2014** by Jo Spear, Jr. in the presence of Michael Hackney, General Manager.

**ADVANCED DISPOSAL SERVICES  
EMERALD PARK LANDFILL / CITY OF MUSKEGO  
AUDIT PHOTOS**

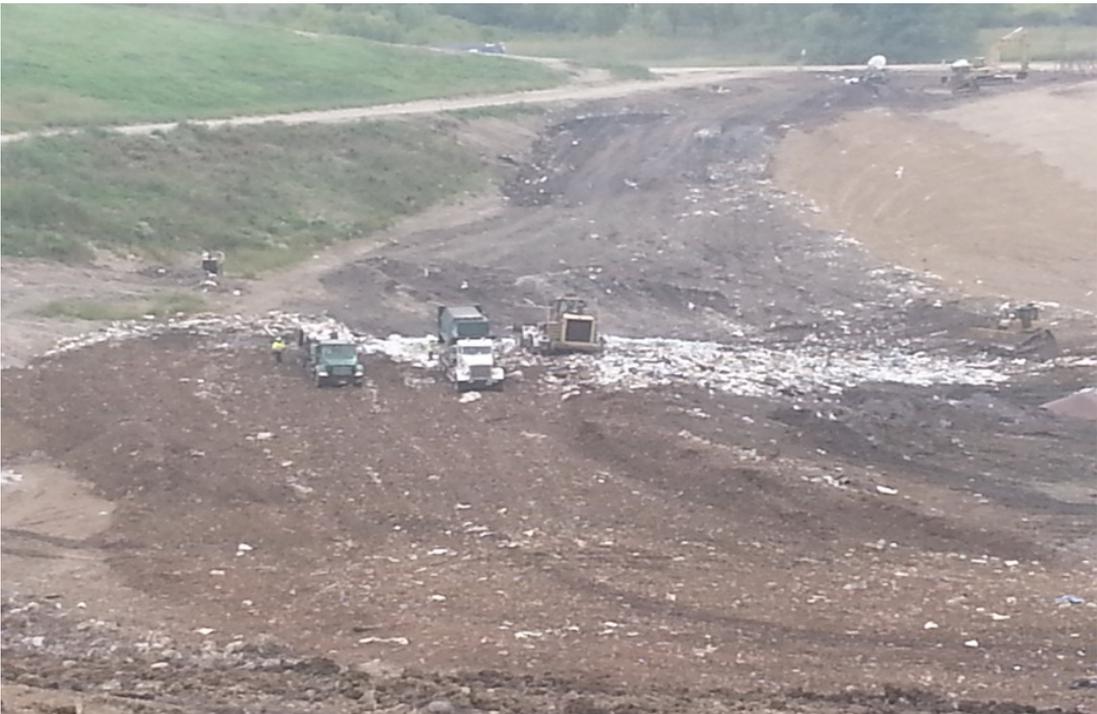
Working face in Phase 7B

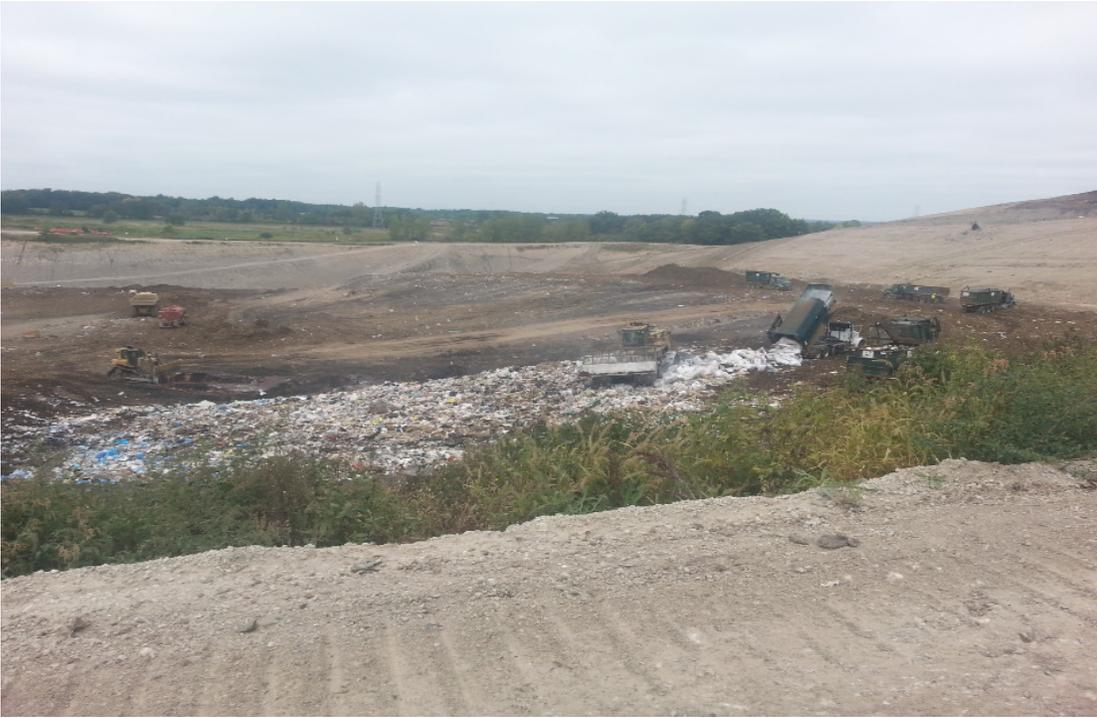
Working face in middle of Phase 7B
