# ADS Emerald Park Landfill Audit Summary

**TO:** ADS Emerald Park Landfill Standing Committee, City of Muskego  
**FROM:** Faith Spear.  
**COPIES:** File  
**DATE:** 10/07/14  
**PROJECT NUMBER:** 1012.10030

**ADVANCED DISPOSAL SERVICES  
EMERALD PARK LANDFILL / CITY OF MUSKEGO  
AUDIT PHOTOS**

PROJECT NO. 1012.10030

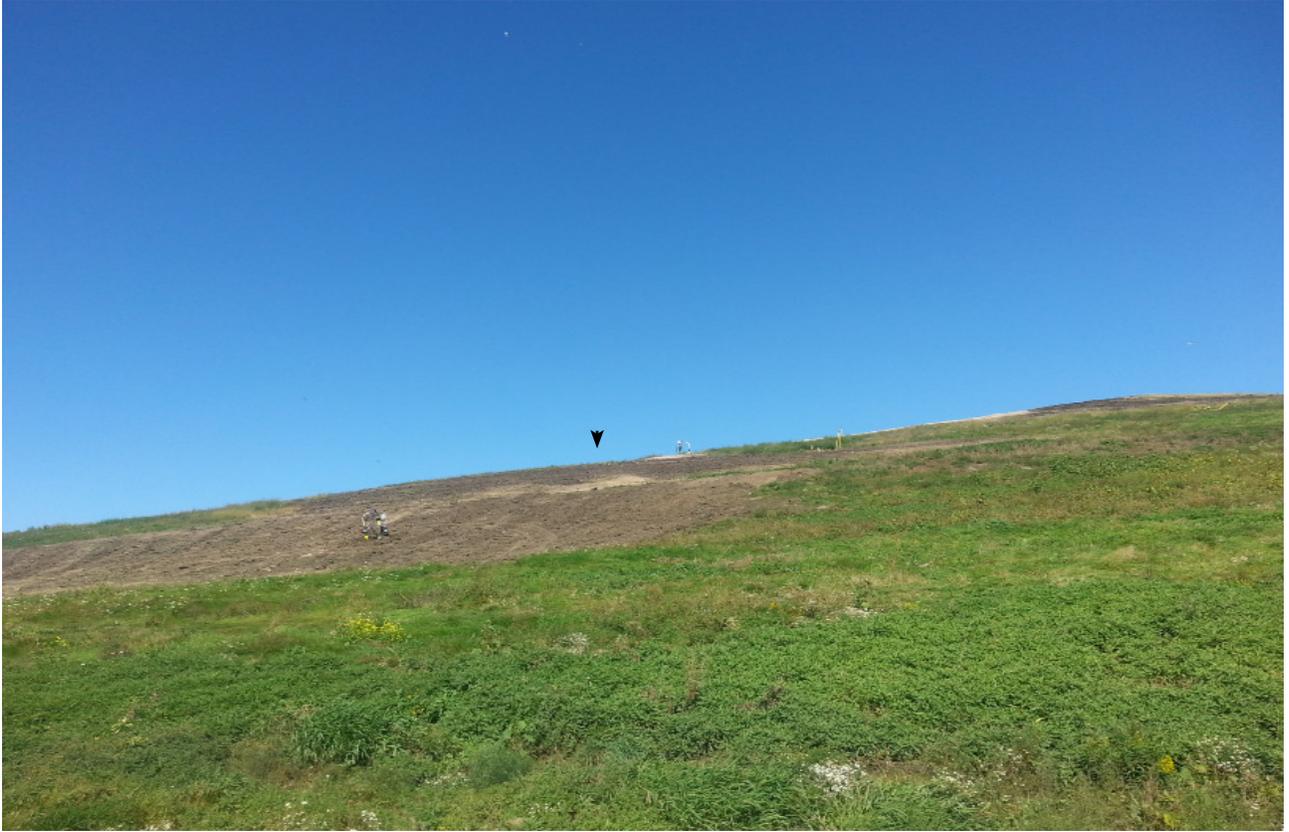
Soil repair work done on South slope of Phase 5

\* Site addressing soil conditions on South  
slope of Phase 5, repairing soil  
erosion & expected to seed this year

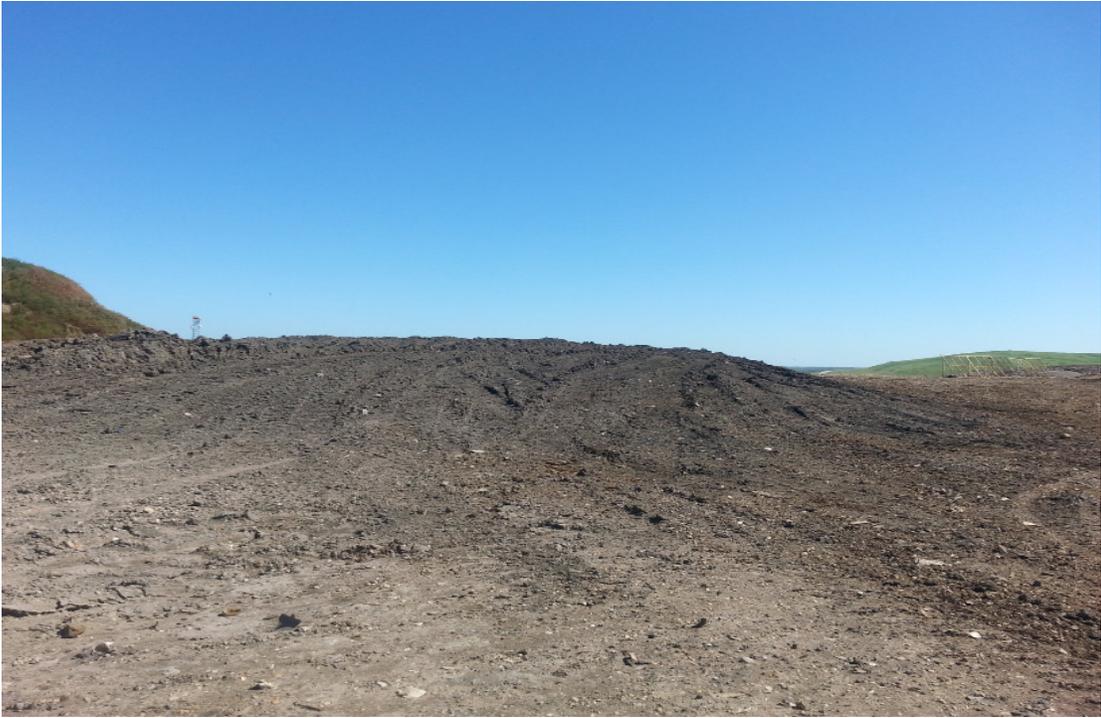
Bio-soils spread over top of Phase 5

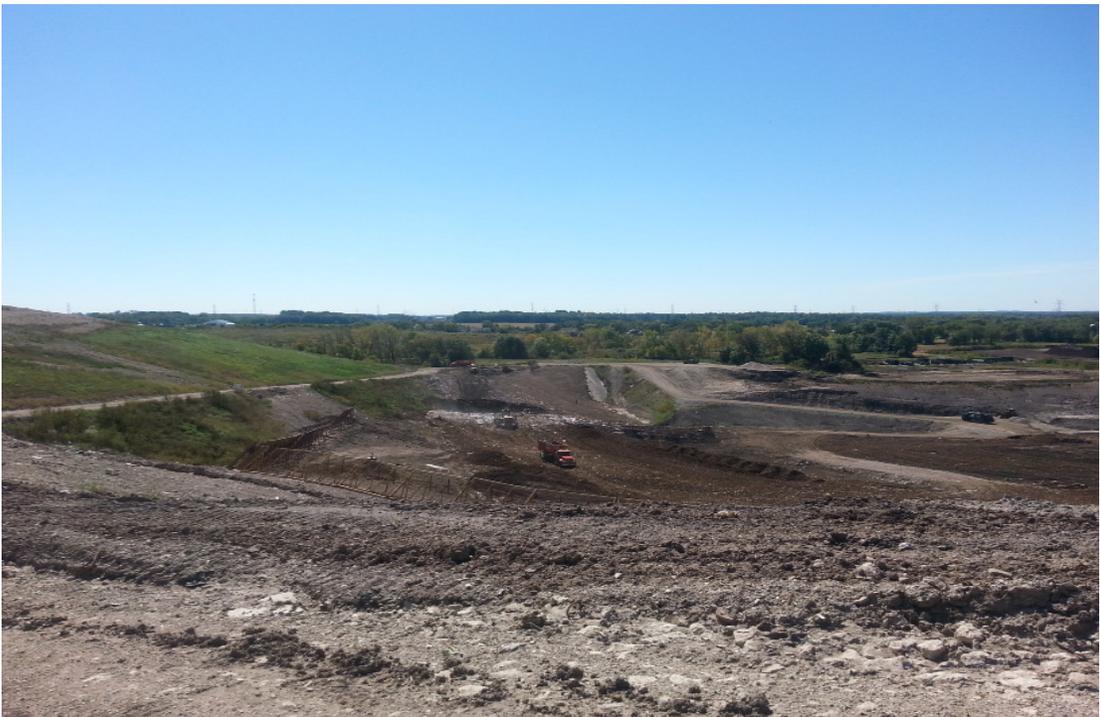
Phase 7B West viewed from the North

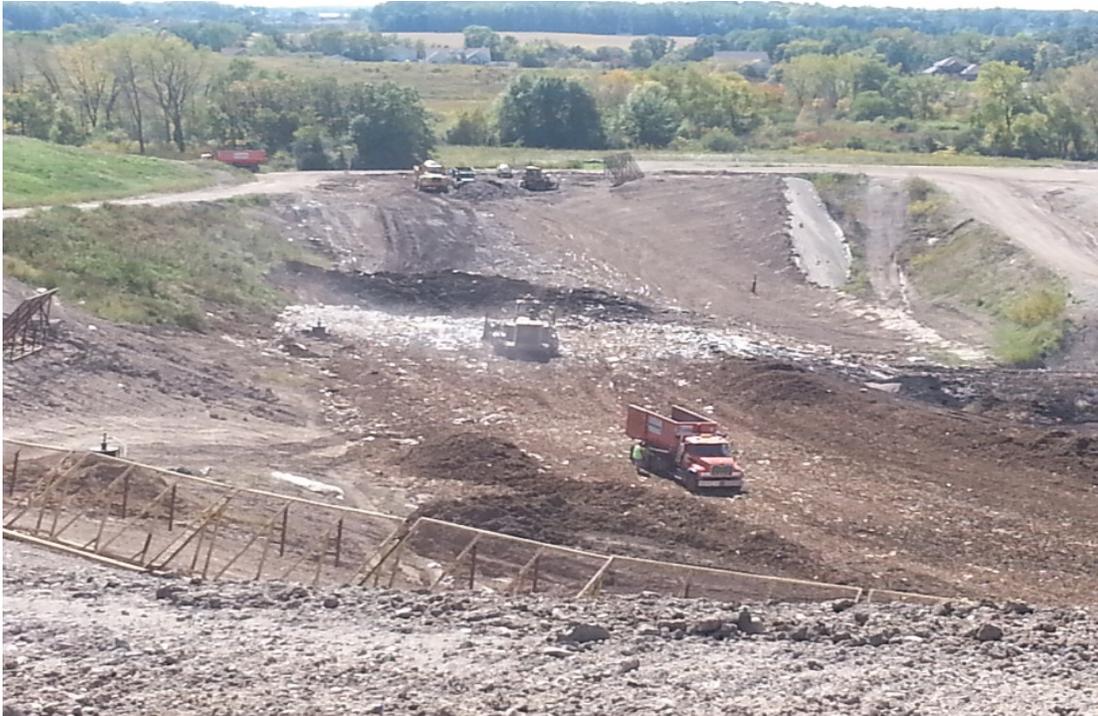
Northeast corner of Phase 7B, waste being added to develop access ramp to Phase 7B and Phase 7B West

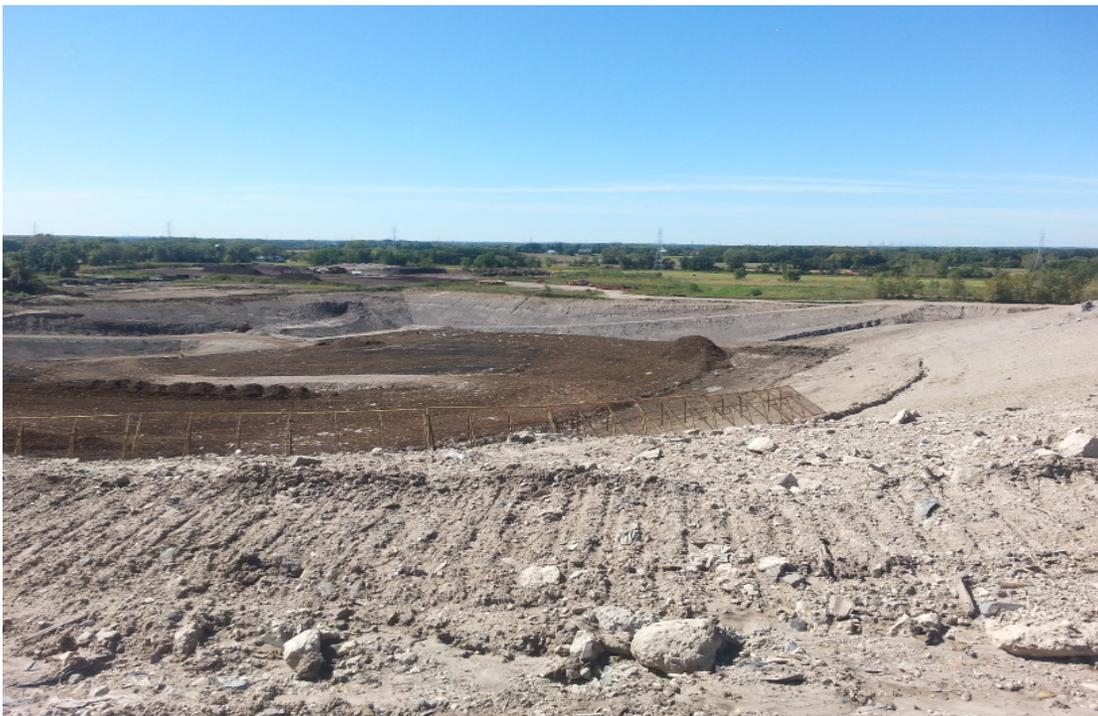
Phase 7B, light colored area is a ramp of C&D materials to aid trucks in moving Northward to tip

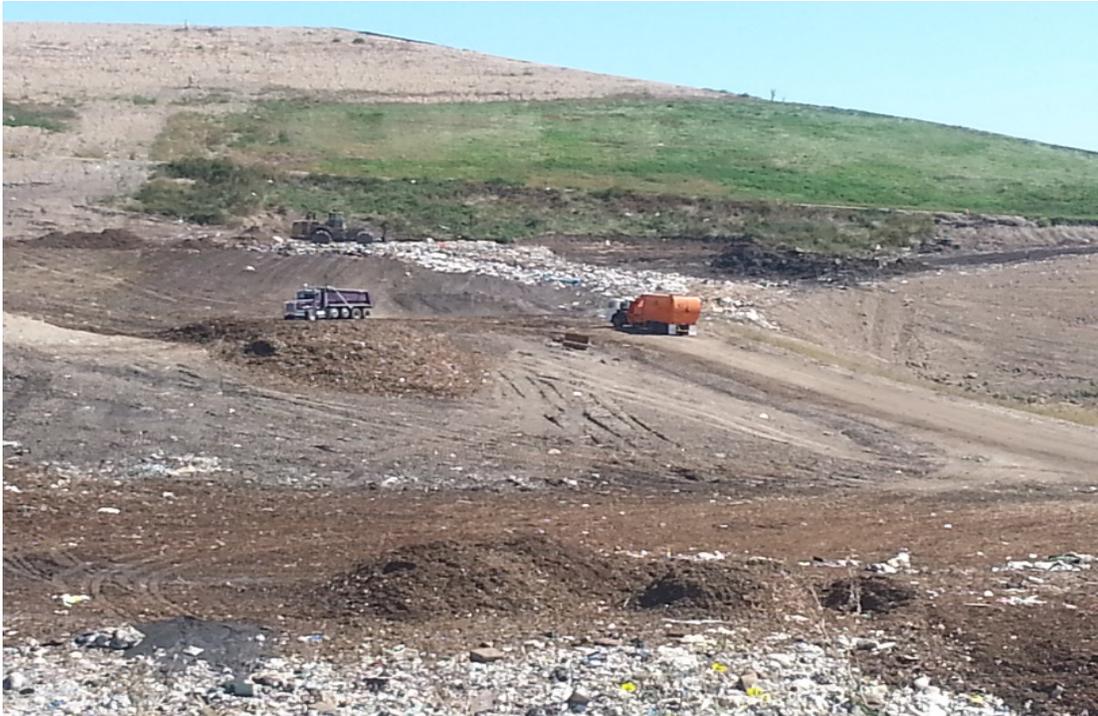
Working face in Phase 7B

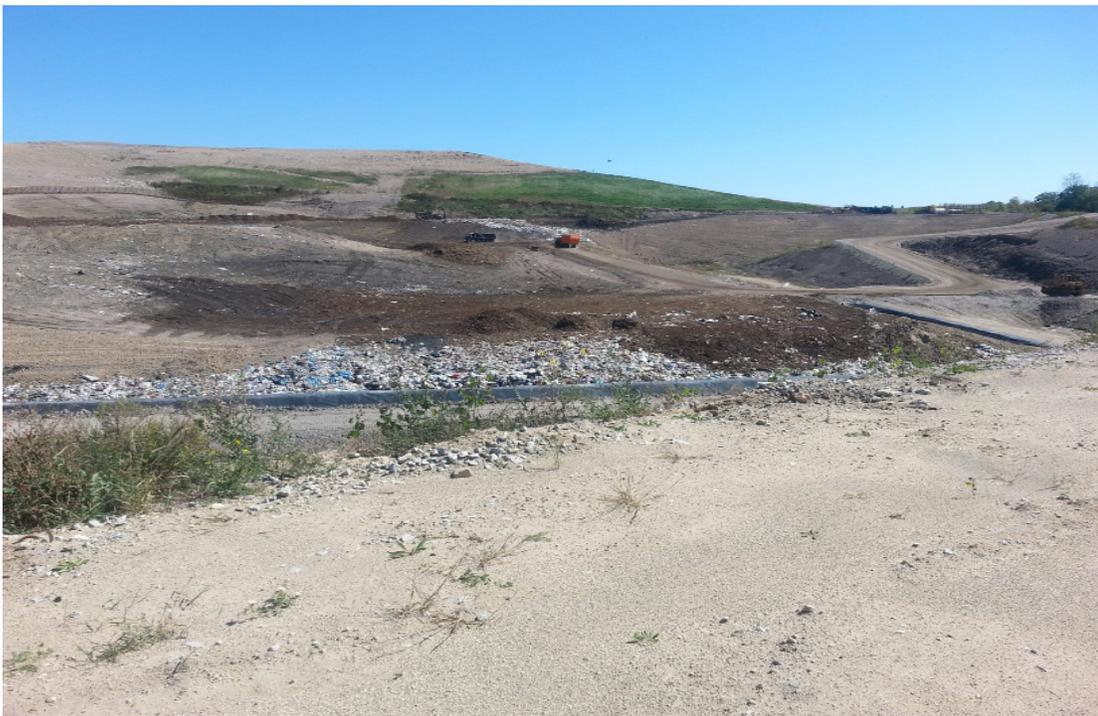
Western edge of Phase 7B West, waste will be added to shape slope and then covered with intermediate cover, which will be made of site soils
