# ADS Emerald Park Landfill Audit Summary

**To:** ADS Emerald Park Landfill Standing Committee, City of Muskego  
**FROM:** Faith Spear.  
**COPIES:** File  
**DATE:** 11/21/14  
**PROJECT NUMBER:** 1012.10030

Attached is the audit report for activities at the ADS Emerald Park Landfill for the week of October 6, 2014. The audit was performed at 12:00 PM on **October 6, 2014** by Jo Spear, Jr. in the presence of David Greir, Operations Manager.

PROJECT NO. 1012.10030

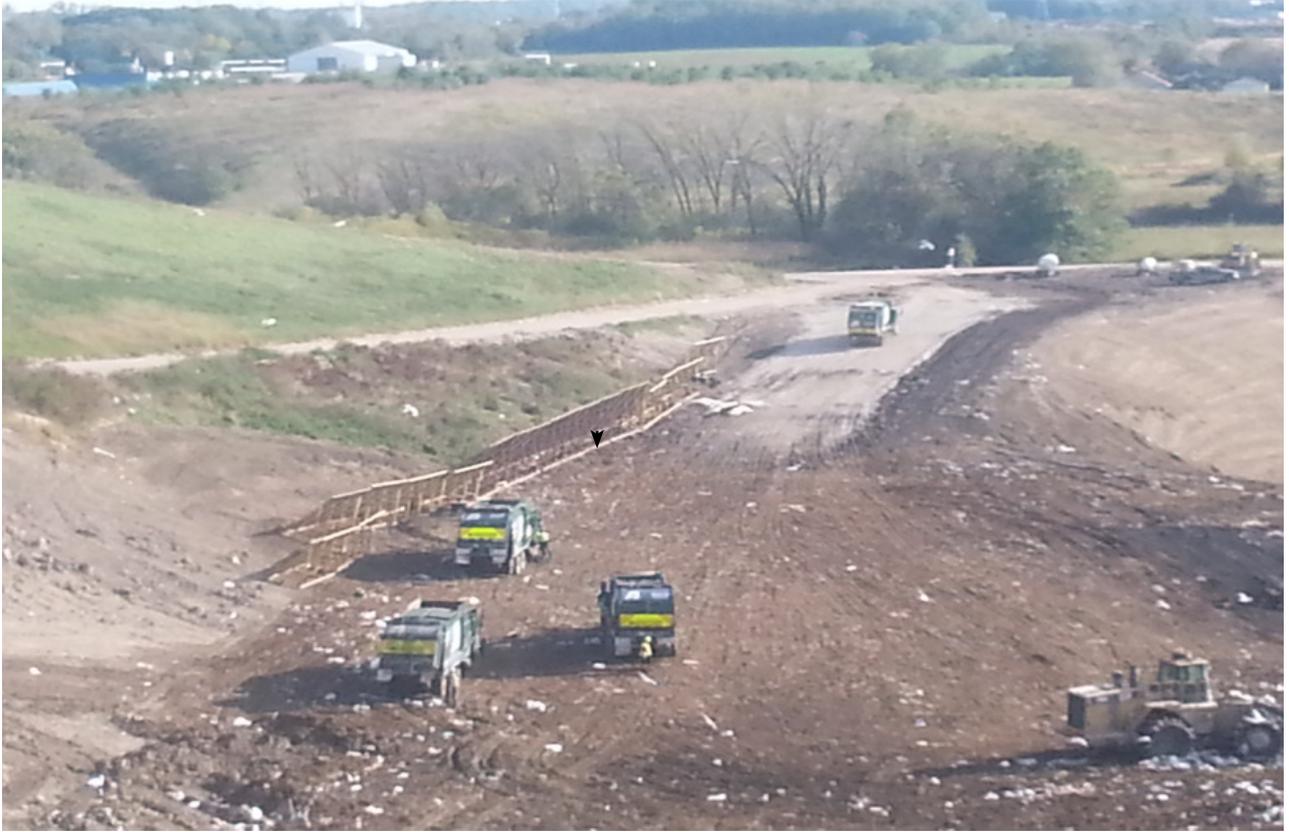
New access ramp into Phase 7B, located at South intersection of Phase 6 & 7

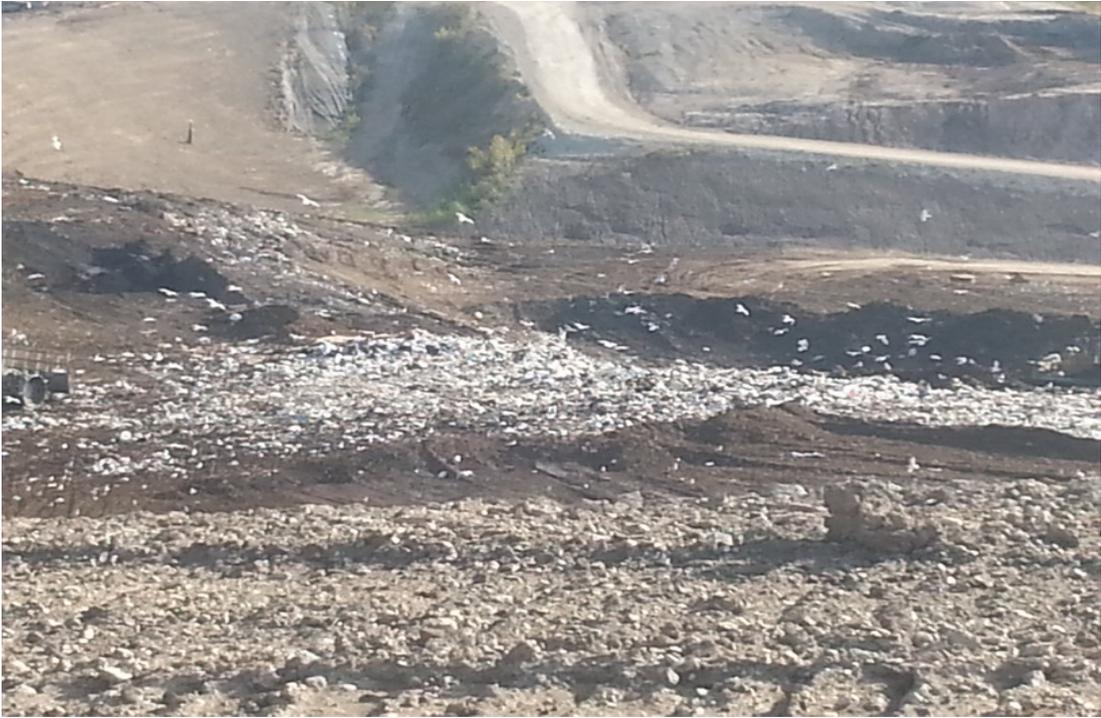
Working face about to receive daily cover at end of day

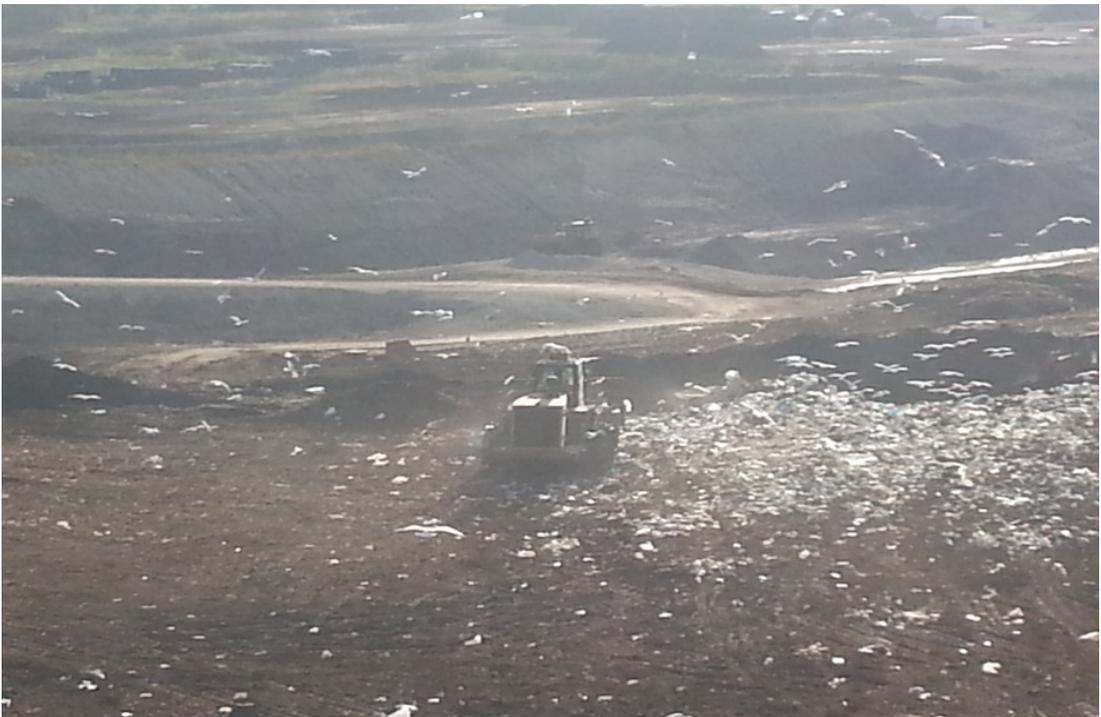
Working face in Phase 7B viewed from the North

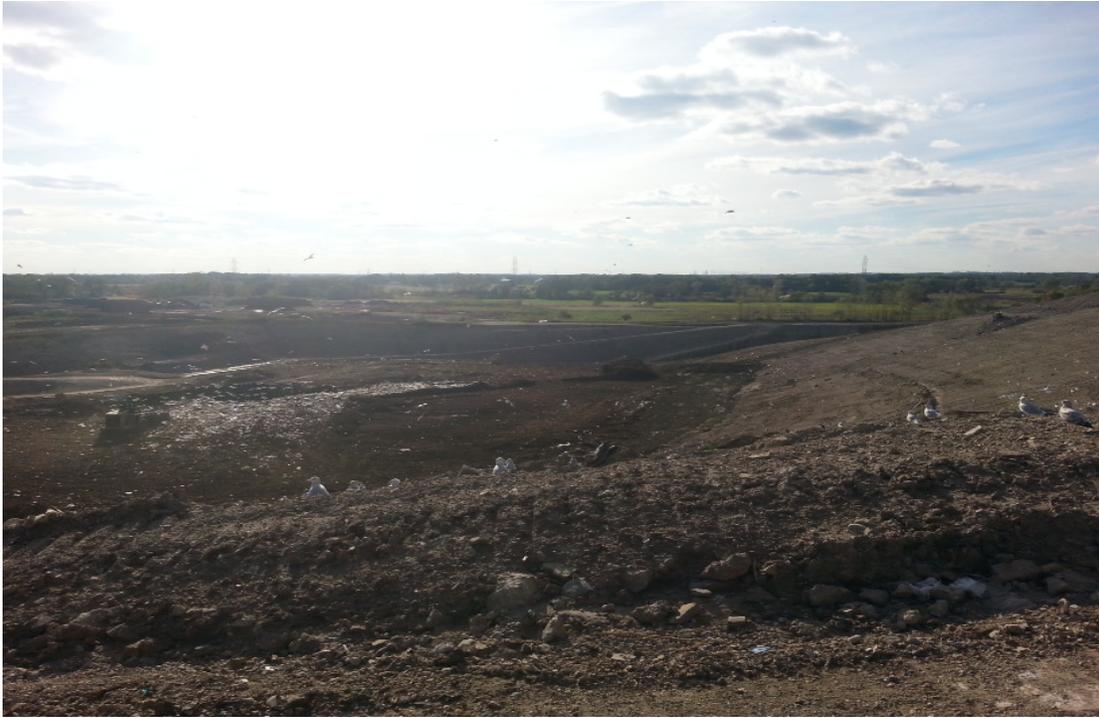
Working face in Phase 7B viewed from the East

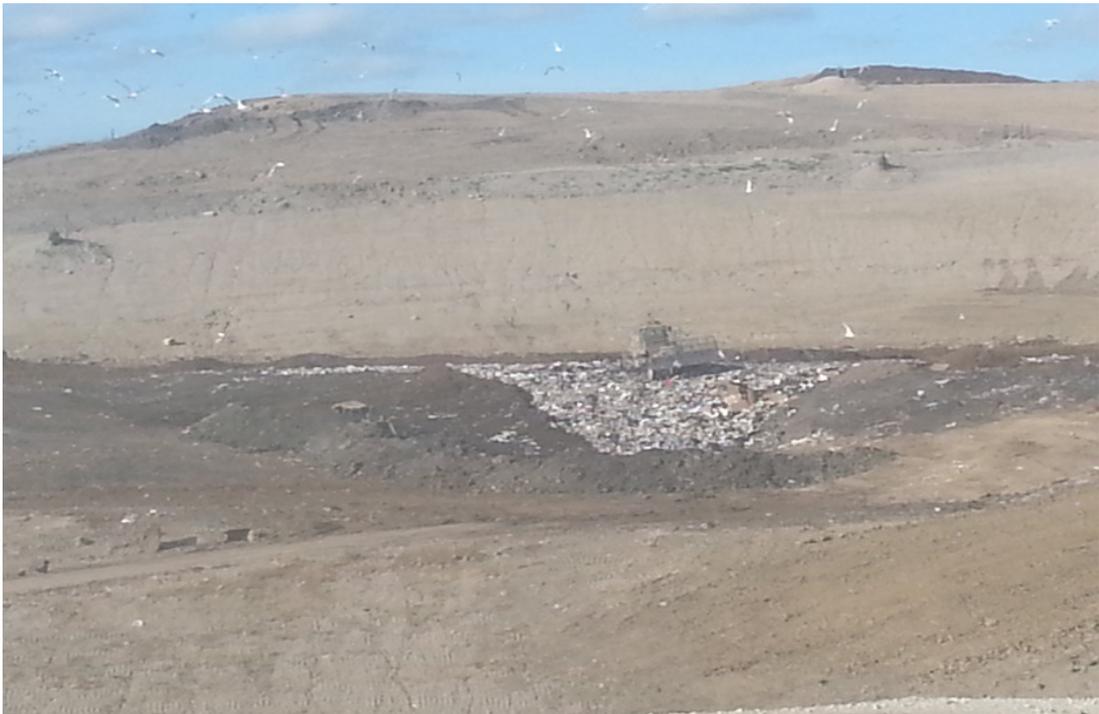
Working face in Phase 7B viewed from the South
