MEMORANDUM

ADS Emerald Park Landfill Audit Summary

TO: ADS Emerald Park Landfill Standing Committee, City of Muskego
FROM: Faith Spear.
COPIES: File
DATE: 11/24/14
PROJECT NUMBER: 1012.10030

**ADVANCED DISPOSAL SERVICES
EMERALD PARK LANDFILL / CITY OF MUSKEGO
AUDIT PHOTOS**

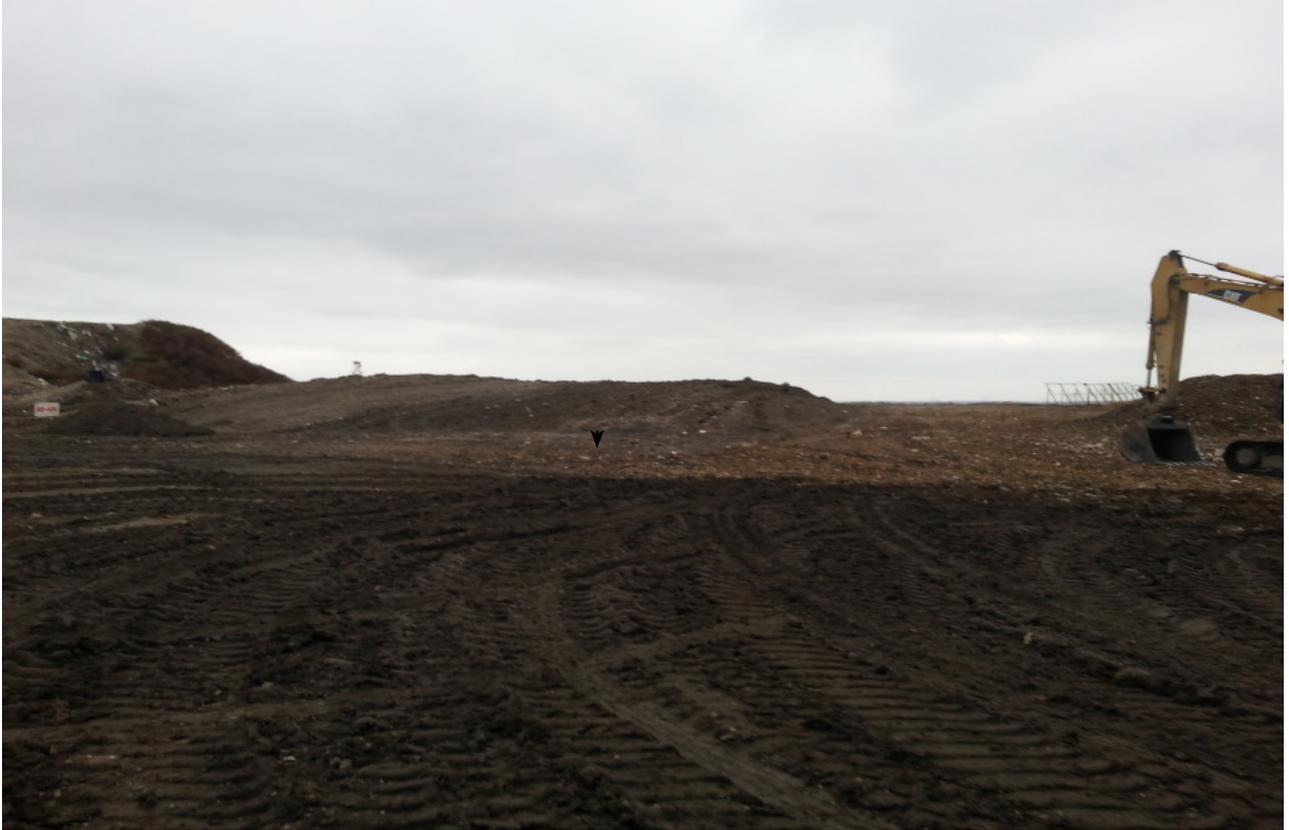
Bio soil pile in Phase 4/5

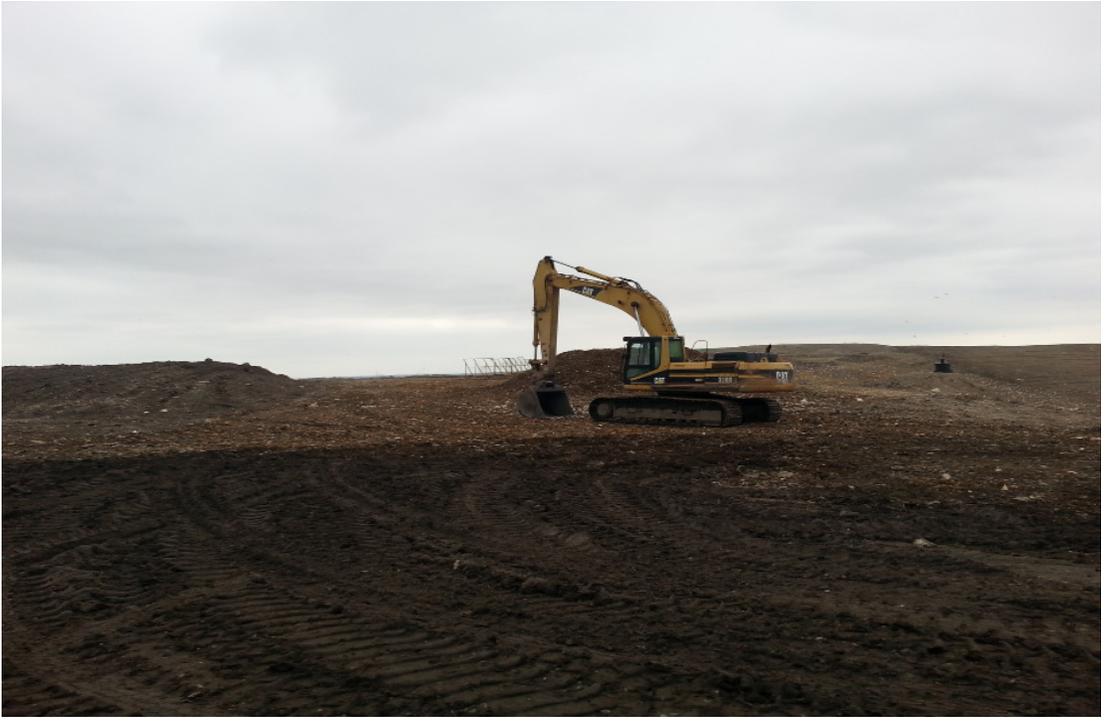
Top of Phase 4/5

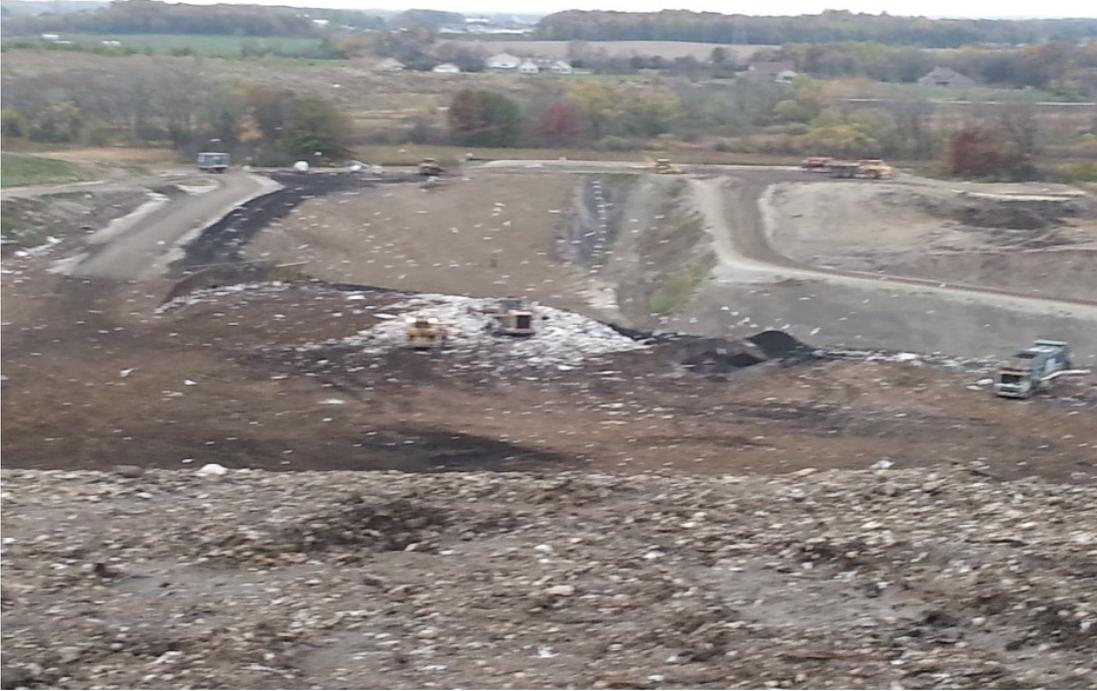
Working face in Phase 7B viewed from the North

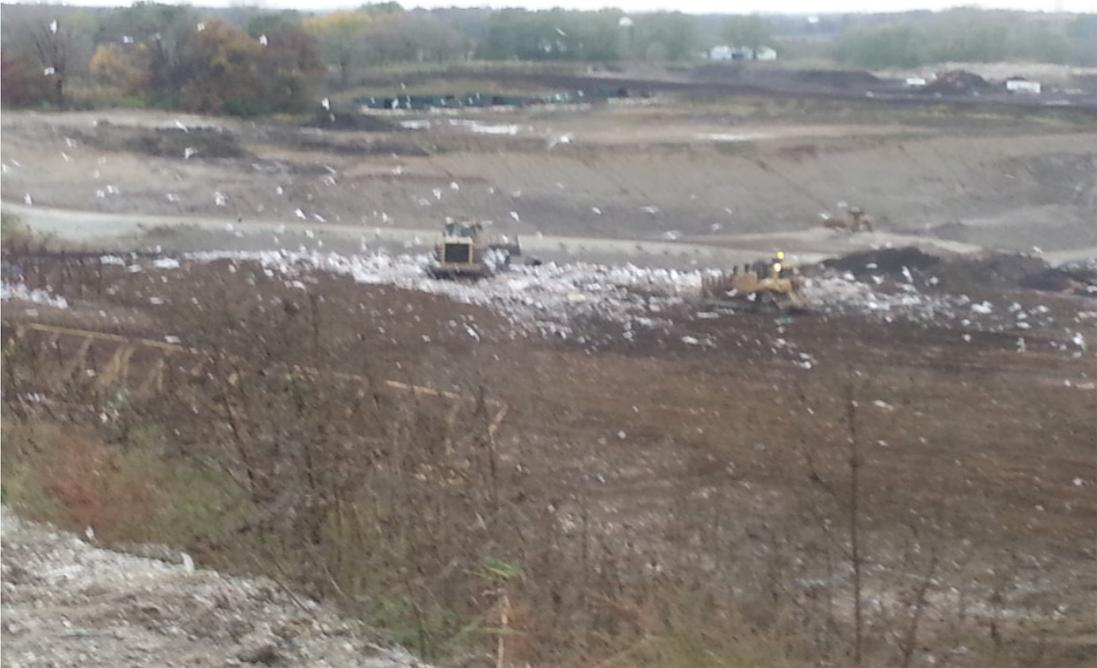
Working face viewed from Northeast

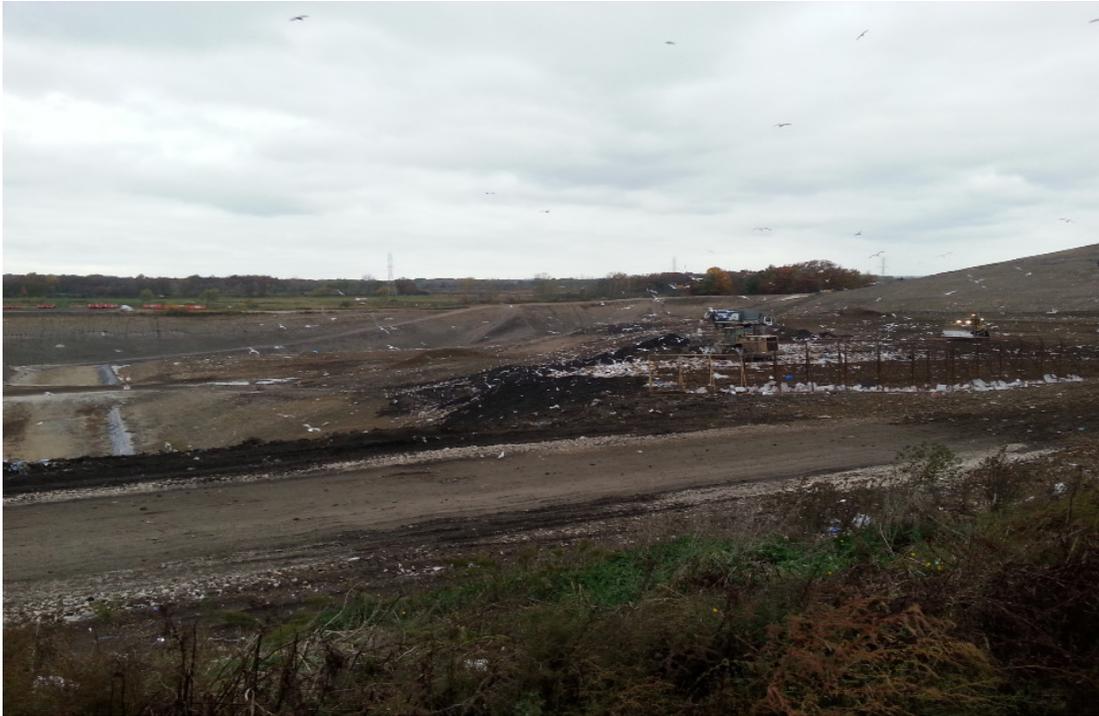
Phase 7B new access ramp and working face in the foreground. Ramp is at Southeast corner of Phase 7

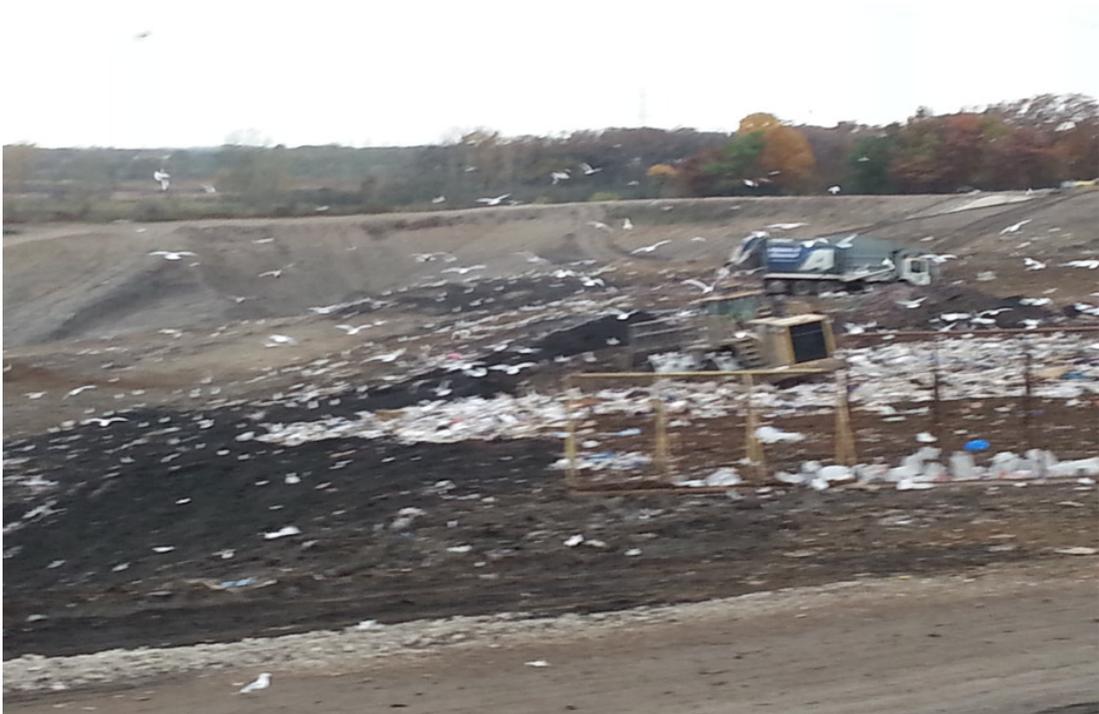
Working face in Phase 7B viewed from the East
