ADS Emerald Park Landfill Audit Summary

PROJECT NUMBER: 1012.10030

ADVANCED DISPOSAL SERVICES EMERALD PARK LANDFILL
 LANDFILL OPERATIONS AUDIT FORM
 CITY OF MUSKEGO

**ADVANCED DISPOSAL SERVICES
EMERALD PARK LANDFILL / CITY OF MUSKEGO
AUDIT PHOTOS**

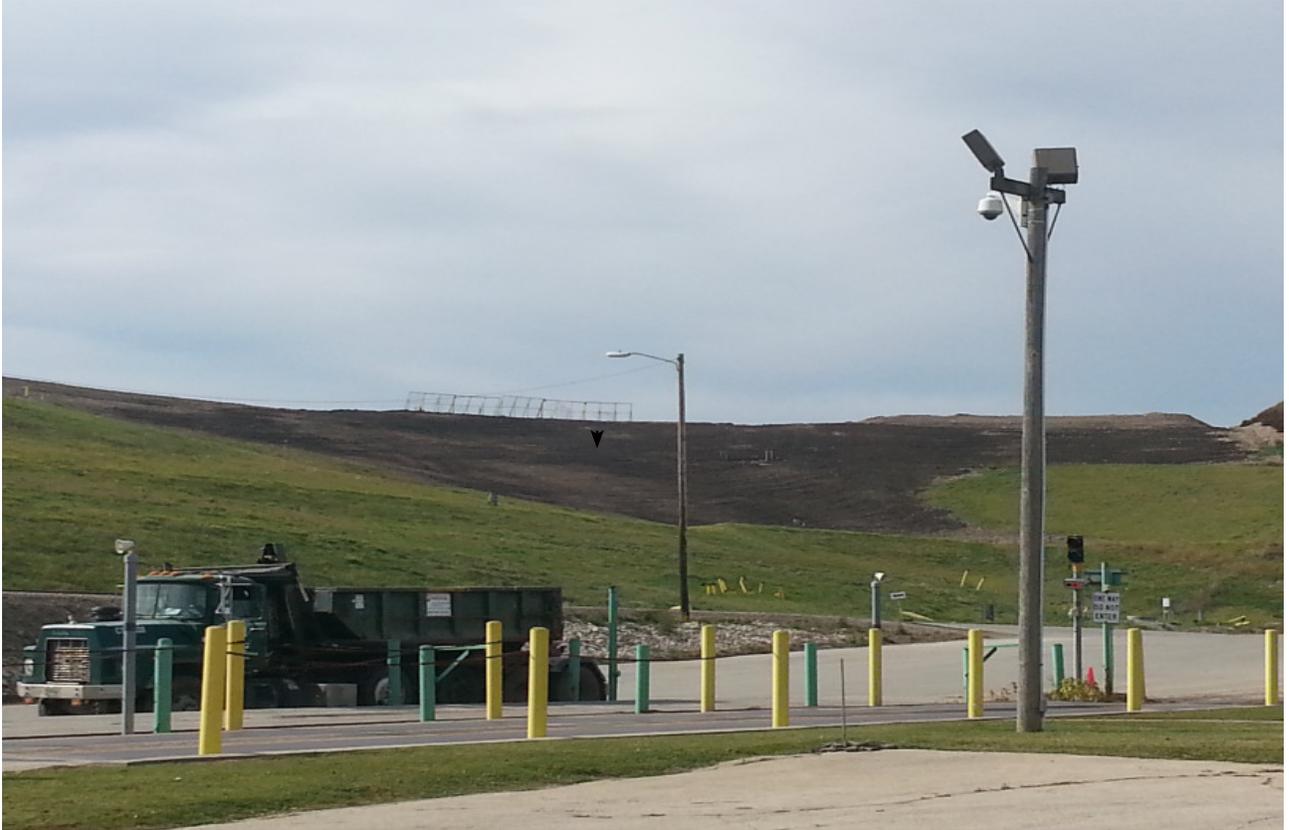
Area of Phase 3,4, & 5 above Closure areas, topsoiled and seeded.

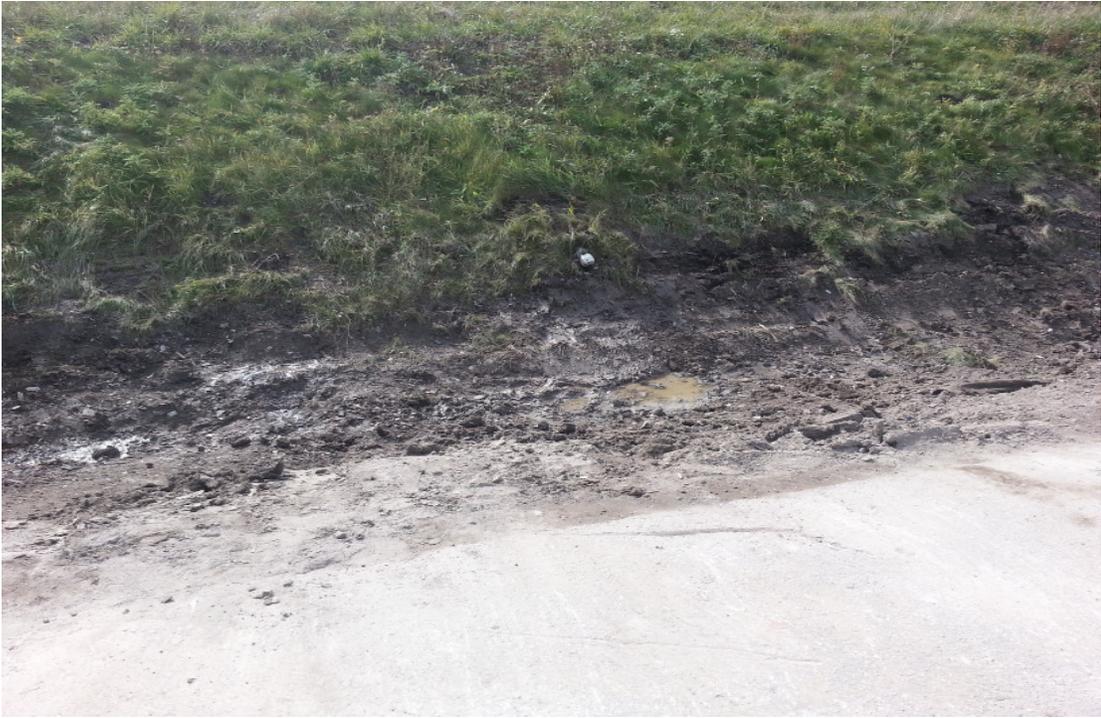
* 10/22/14 - Incident on access road, rolloff tipped loaded with shingles. No releases, waste and impacted areas collected & cleaned

Ditch cleaned after truck rolled and dumped shingles in ditch line

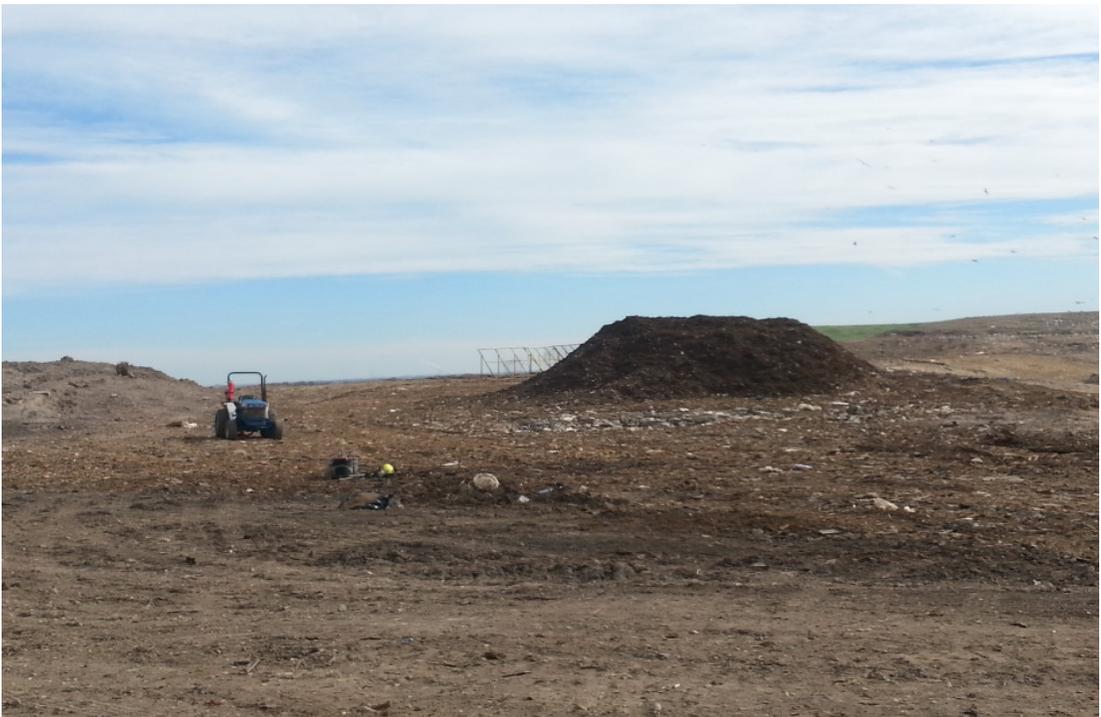
Side Soil, Fluff, & Foundry Sand
Autofluff supply reduced

Autofluff stockpile on Phase 6

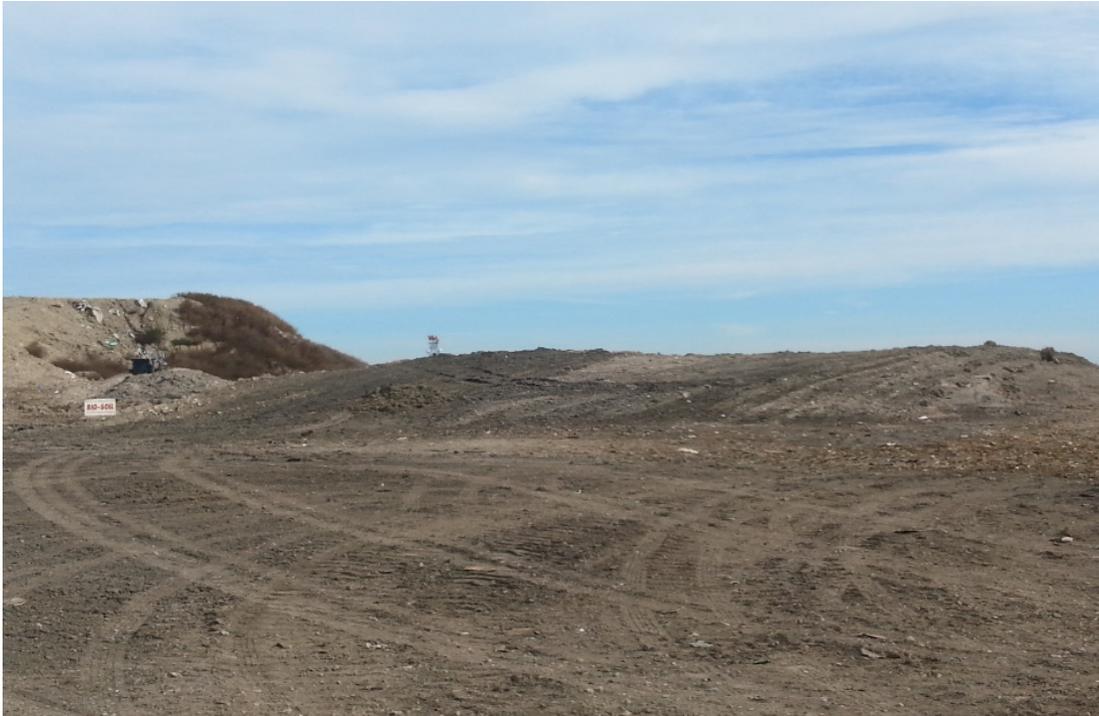
Bio Soil in Phase 4

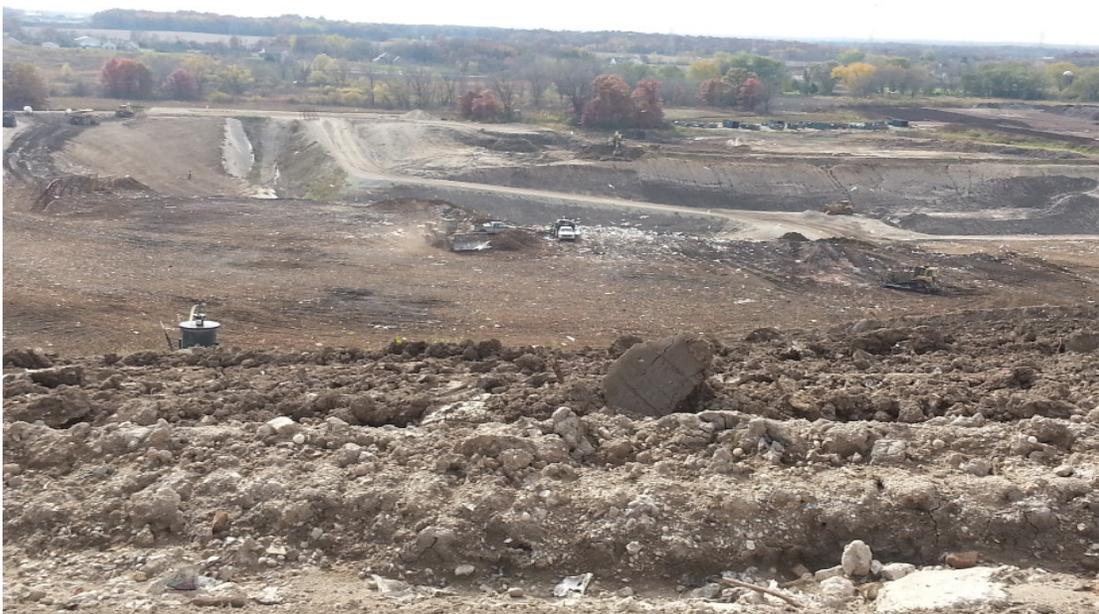
Active area, Phase 7B viewed from the North

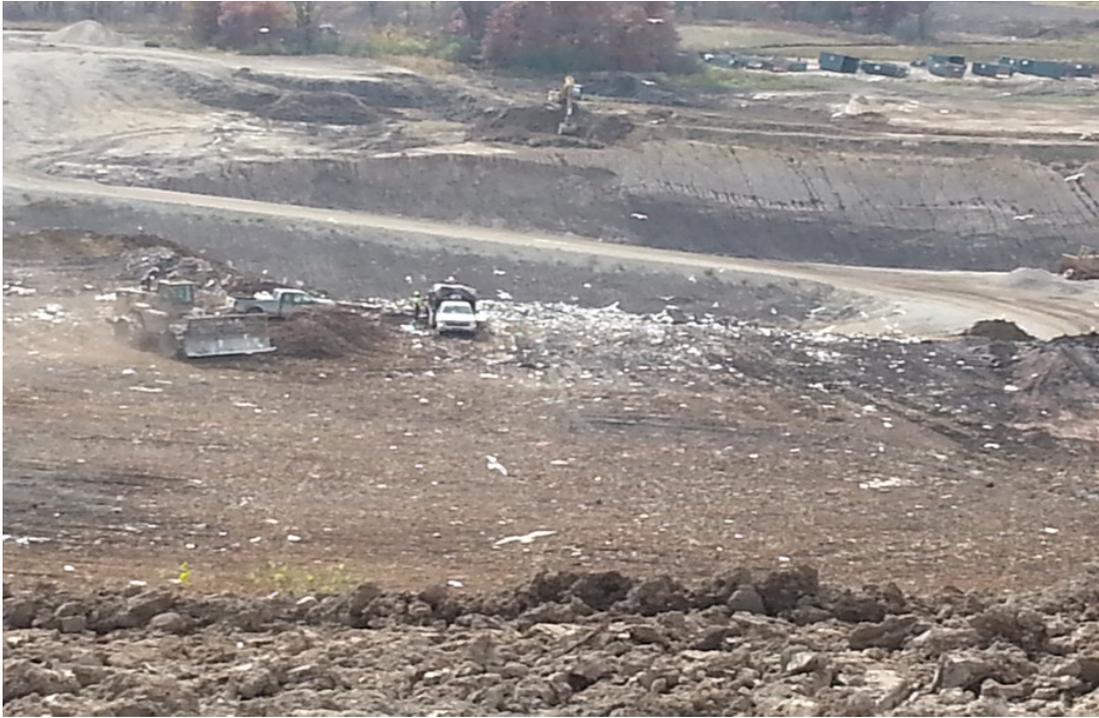
Working face in middle of Phase 7B. Working face very small and tight. Previous 2 intermediate cover well placed.

Working face in Phase 7B viewed from the North

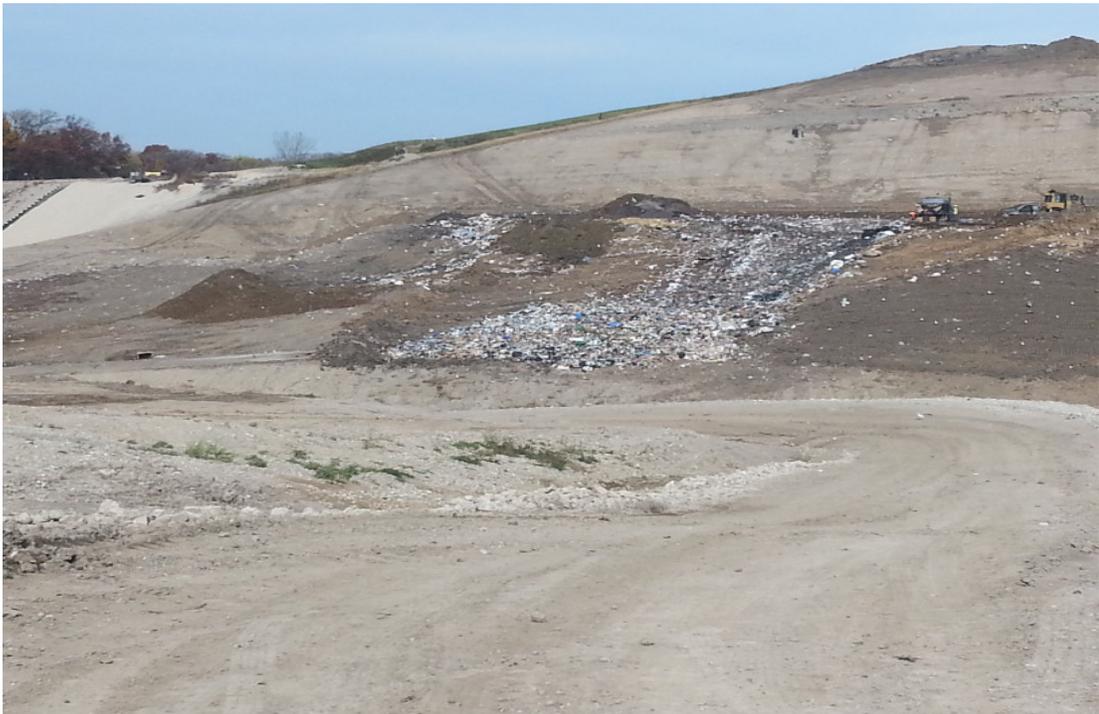
Working face in Phase 7B viewed from the South
