# ADS Emerald Park Landfill Audit Summary

**To:** ADS Emerald Park Landfill Standing Committee, City of Muskego  
**FROM:** Faith Spear.  
**COPIES:** File  
**DATE:** 11/21/14  
**PROJECT NUMBER:** 1012.10030

Attached is the audit report for activities at the ADS Emerald Park Landfill for the week of September 29, 2014. The audit was performed at 1:55 PM on **October 1, 2014** by Jo Spear, Jr. in the presence of David Greir, Operations Manager.

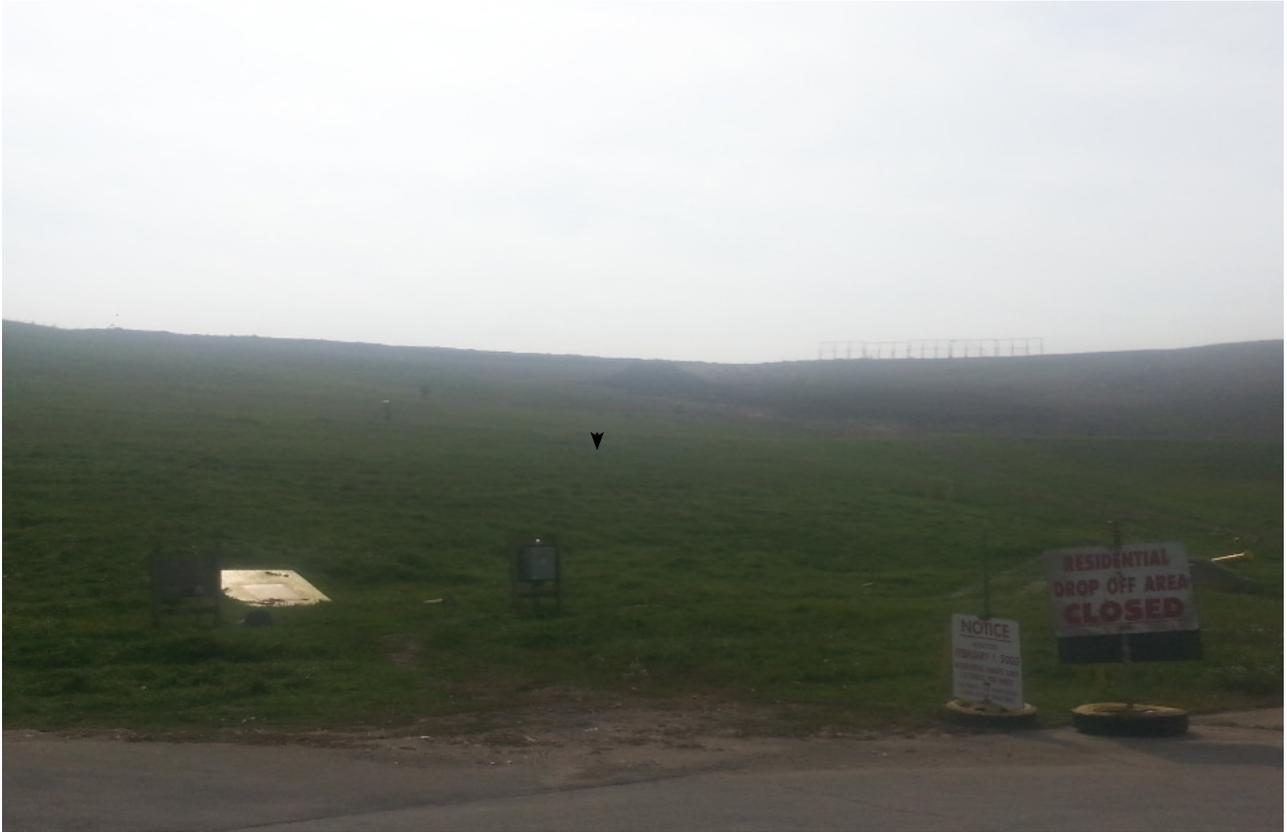
- Seep in North slope of Phase 4 repaired this week
  - Repaired area seeded
- Liner of West berm, Phase 7B punctured by dozer
  - Scheduled for repair by liner crew
- Soils from previous days being recovered from Phase 7
  - Stocked for use as cover material

\* Seep in Phase 4 North slope repaired this week and repairs seeded

Phase 3,4, & 5; North slope, seep repair in center of photo.

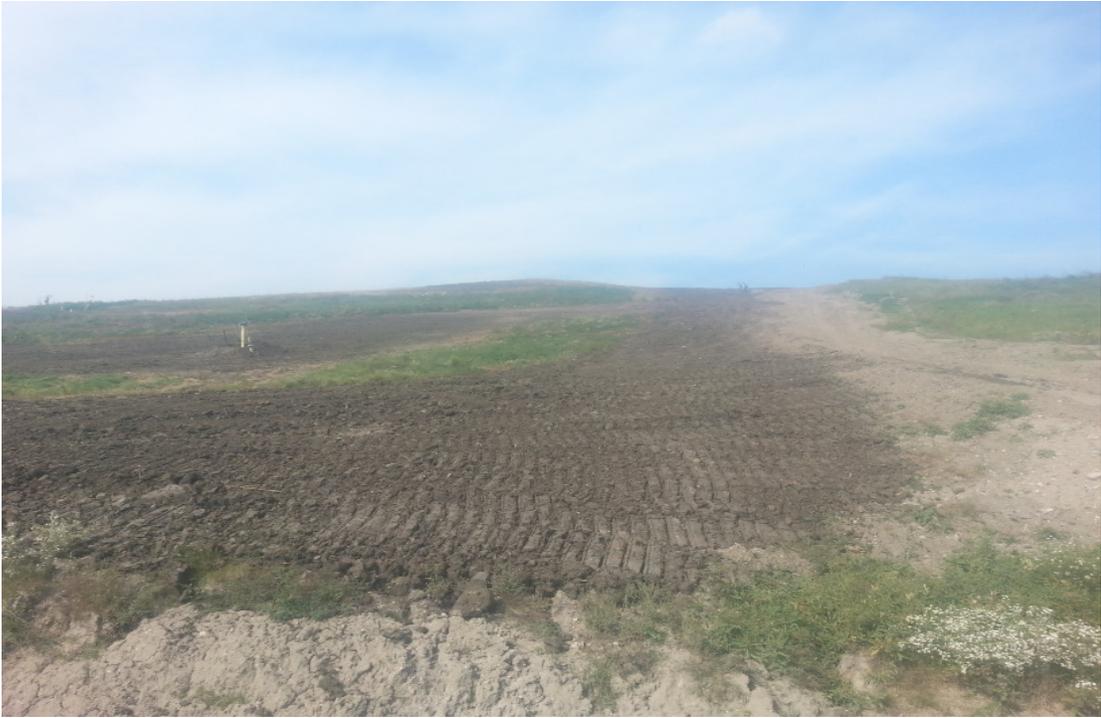
Basins draining, ditches have some silt  
South Slope of Phase 5, repairs needed.

South slope of Phase 5, erosion repaired, disked and will be seeded

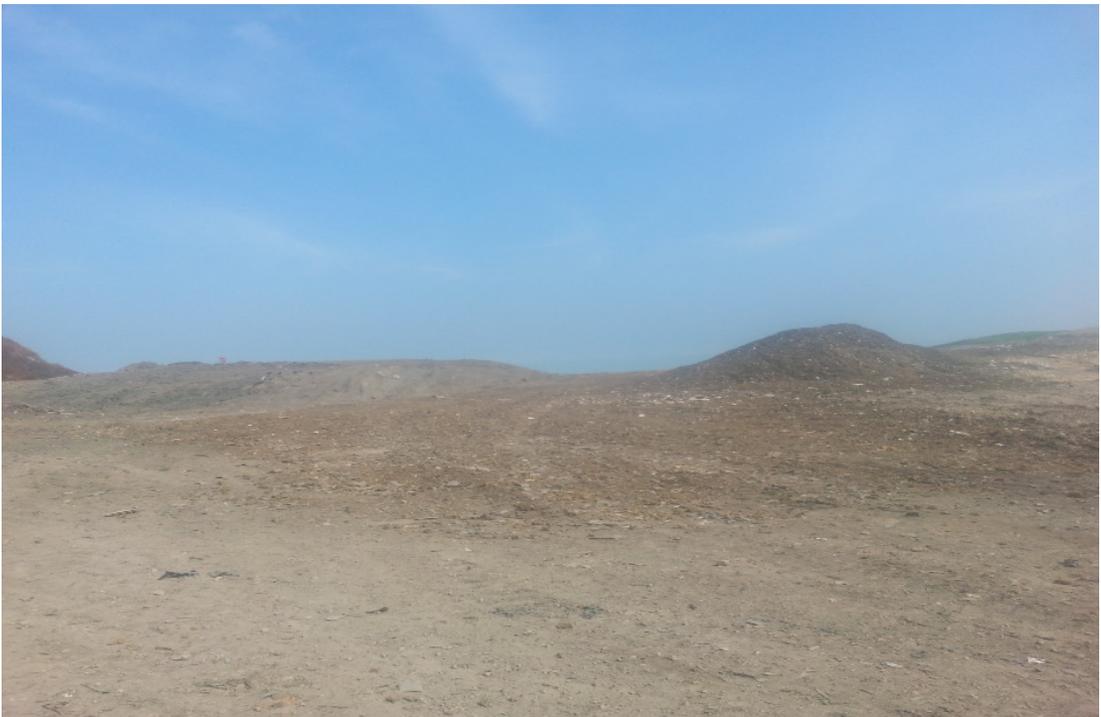
Seep repair on North slope of Phase 4 & 5, above the cap of Closure area III

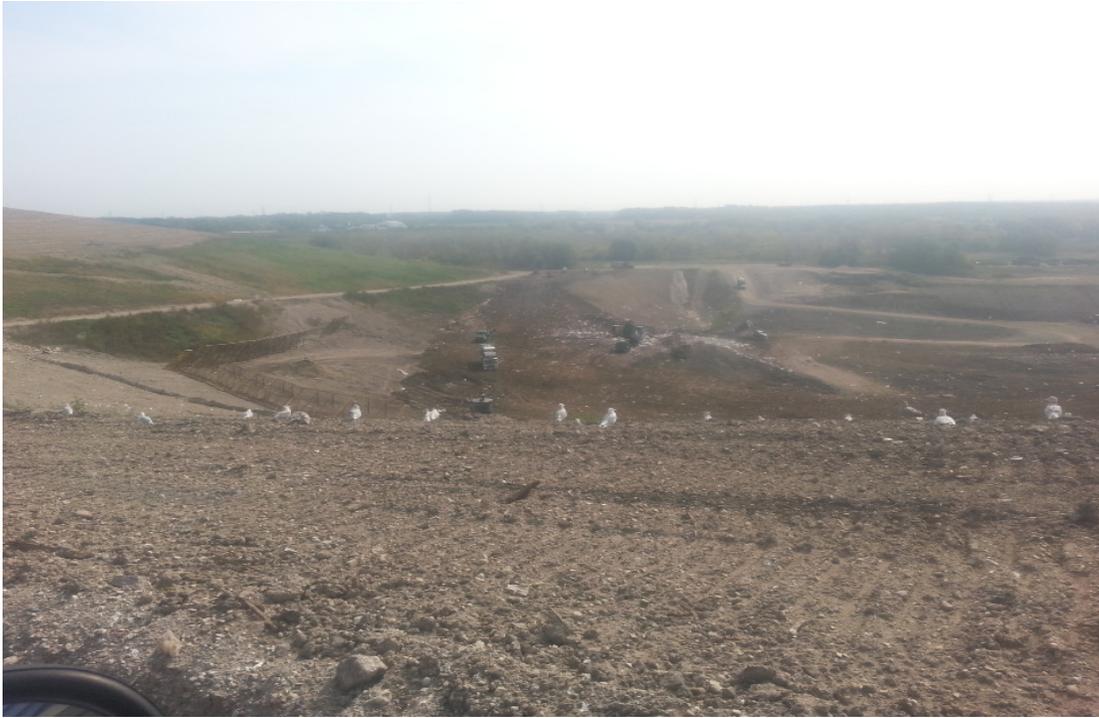
Phase 7B viewed from the North

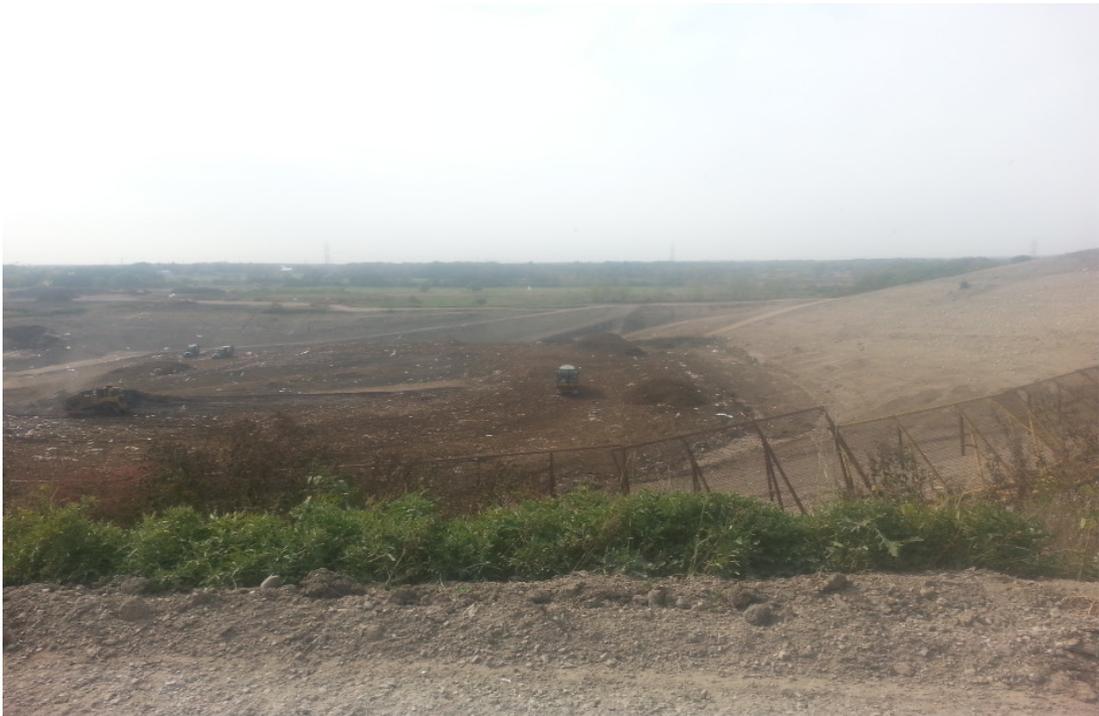
Soil cover spread over completed lift in Phase 7B

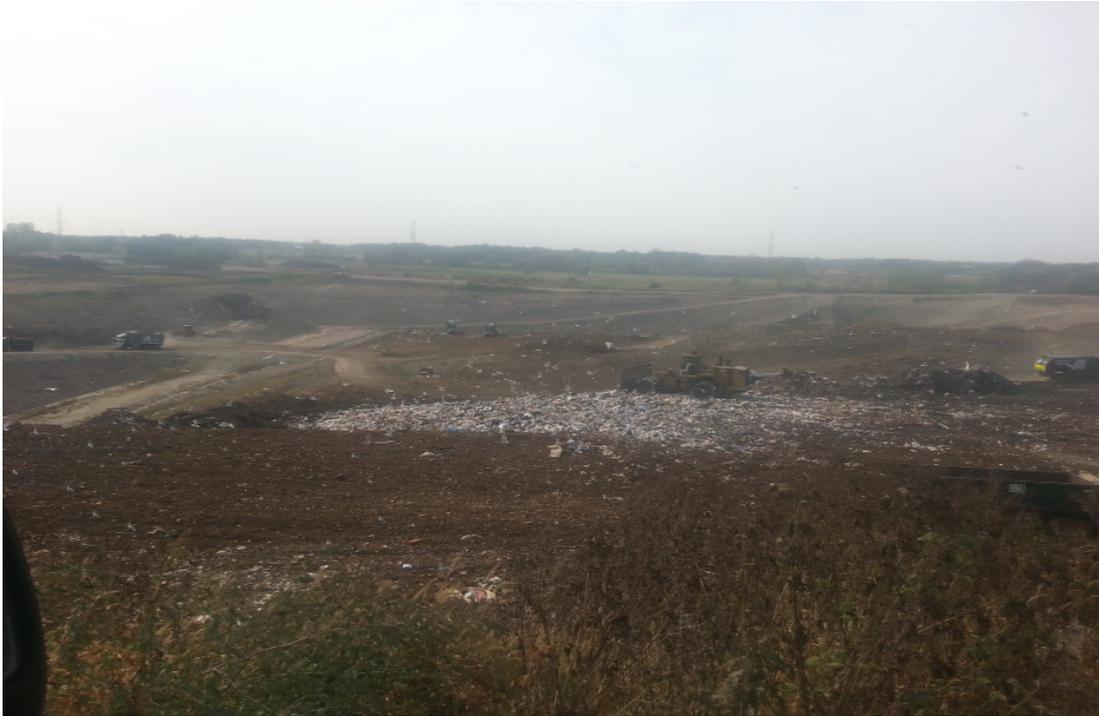
Working face in Phase 7B

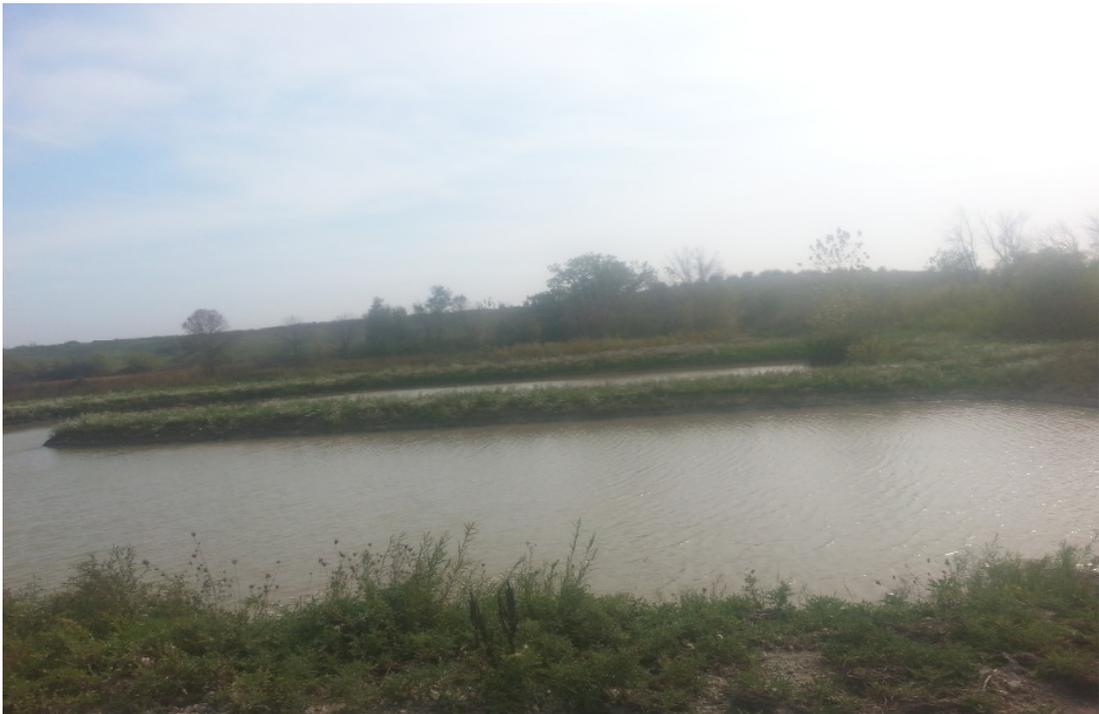
Basin #2 Draining after summer and early fall rains
