# ADS Emerald Park Landfill Audit Summary

**To:** ADS Emerald Park Landfill Standing Committee, City of Muskego  
**FROM:** Faith Spear.  
**COPIES:** File  
**DATE:** 11/25/14  
**PROJECT NUMBER:** 1012.10030

Attached is the audit report for activities at the ADS Emerald Park Landfill for the week of November 3, 2014. The audit was performed at 3:45 PM on **November 6, 2014** by Jo Spear, Jr. in the presence of Dean Driggett.

**ADVANCED DISPOSAL SERVICES  
EMERALD PARK LANDFILL / CITY OF MUSKEGO  
AUDIT PHOTOS**

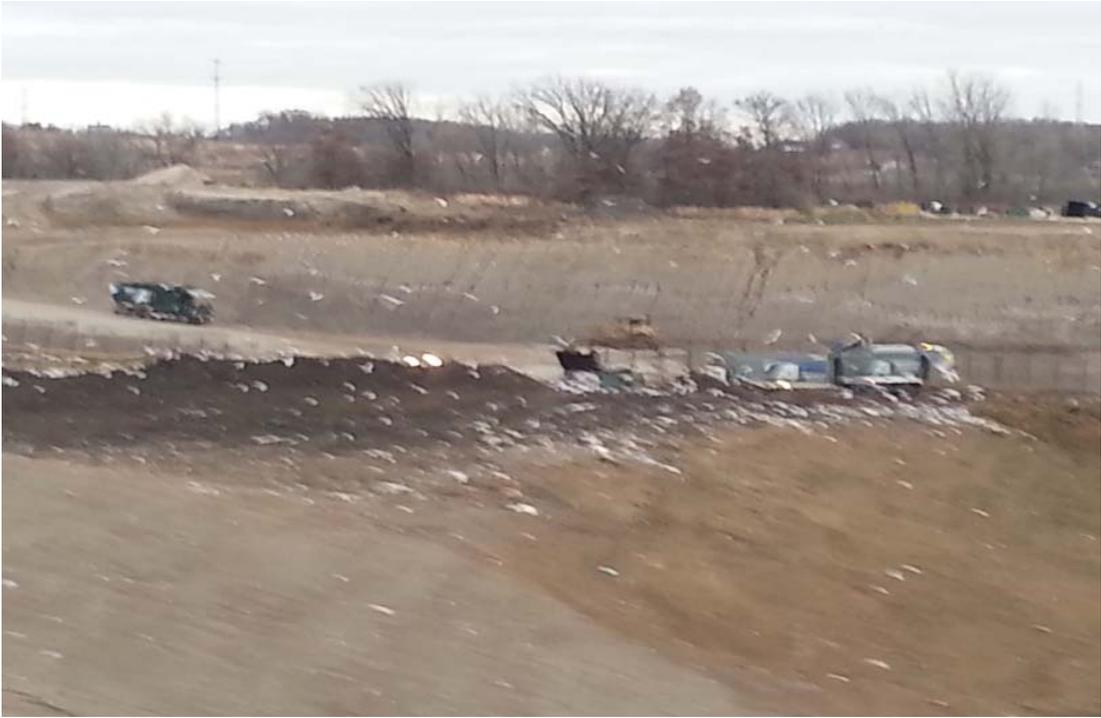
Working face

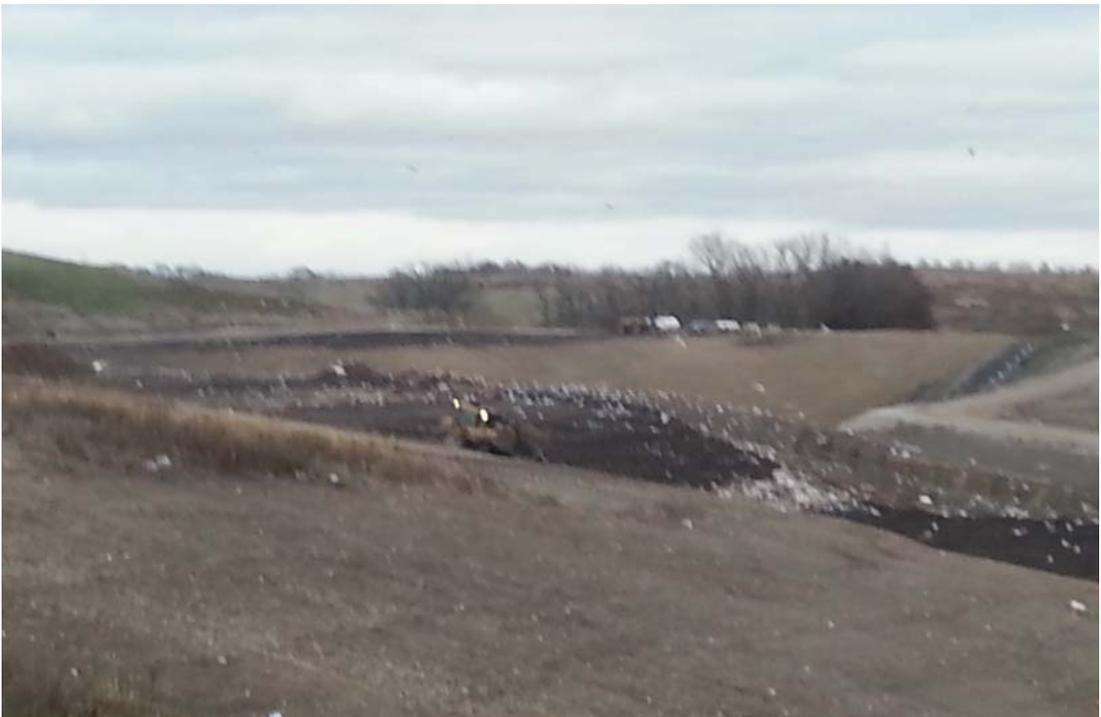
Active area

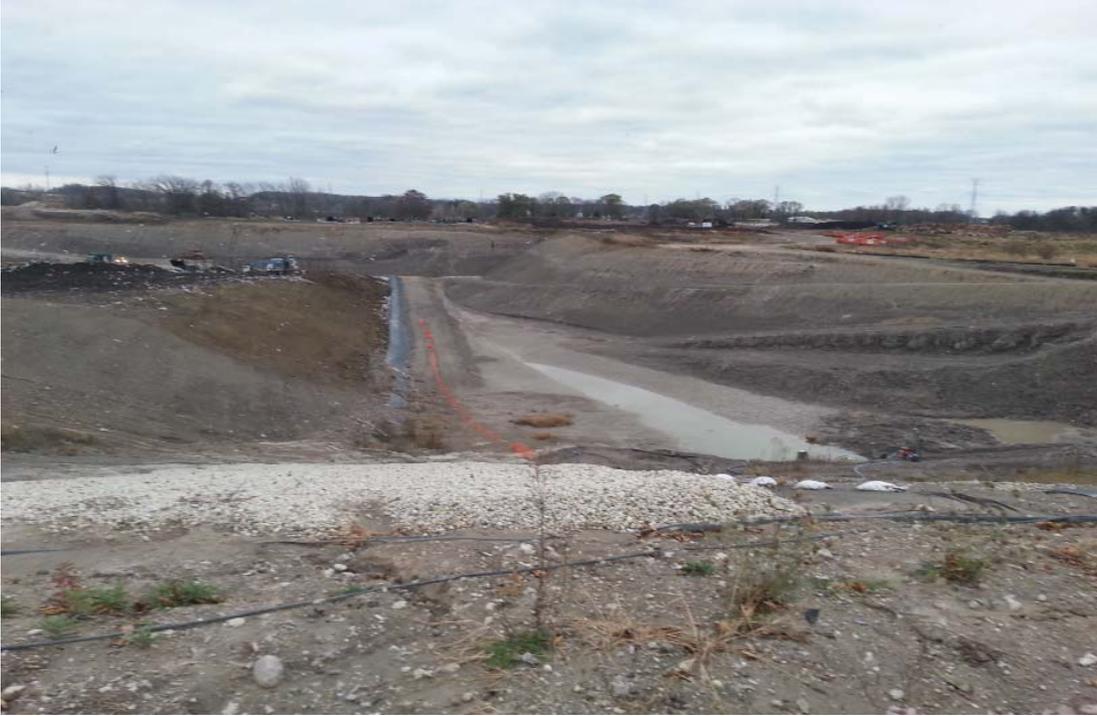
Sump/Temp Sed. Basin for Phases 6 & 7

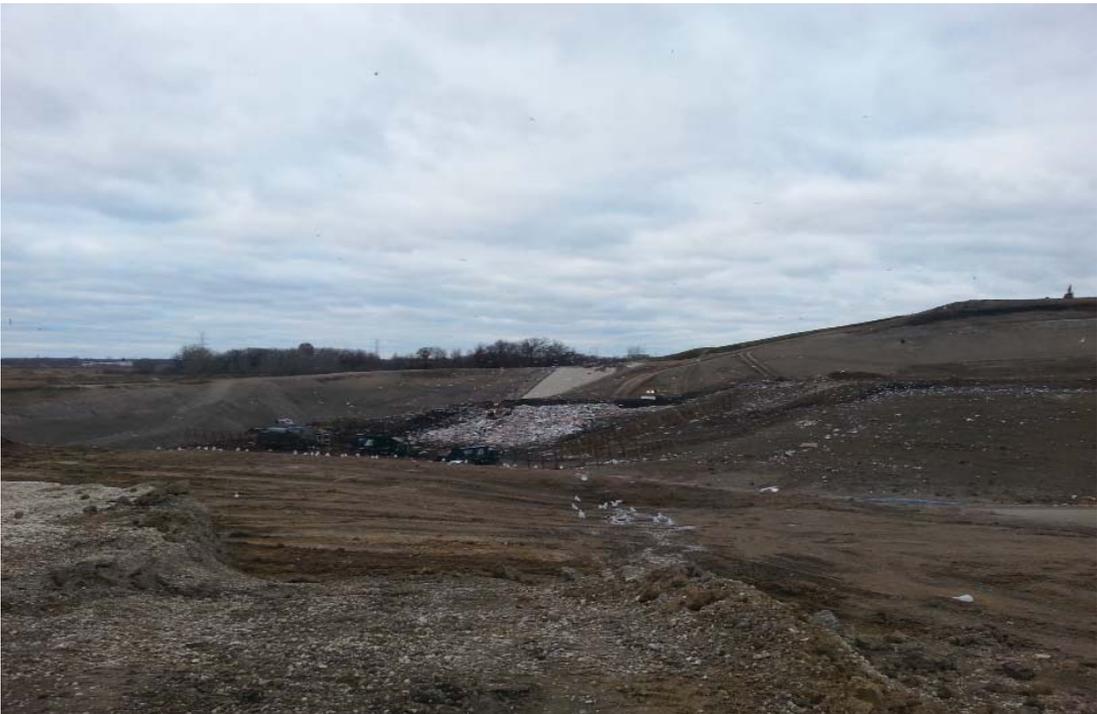
Working face in Phase 7B

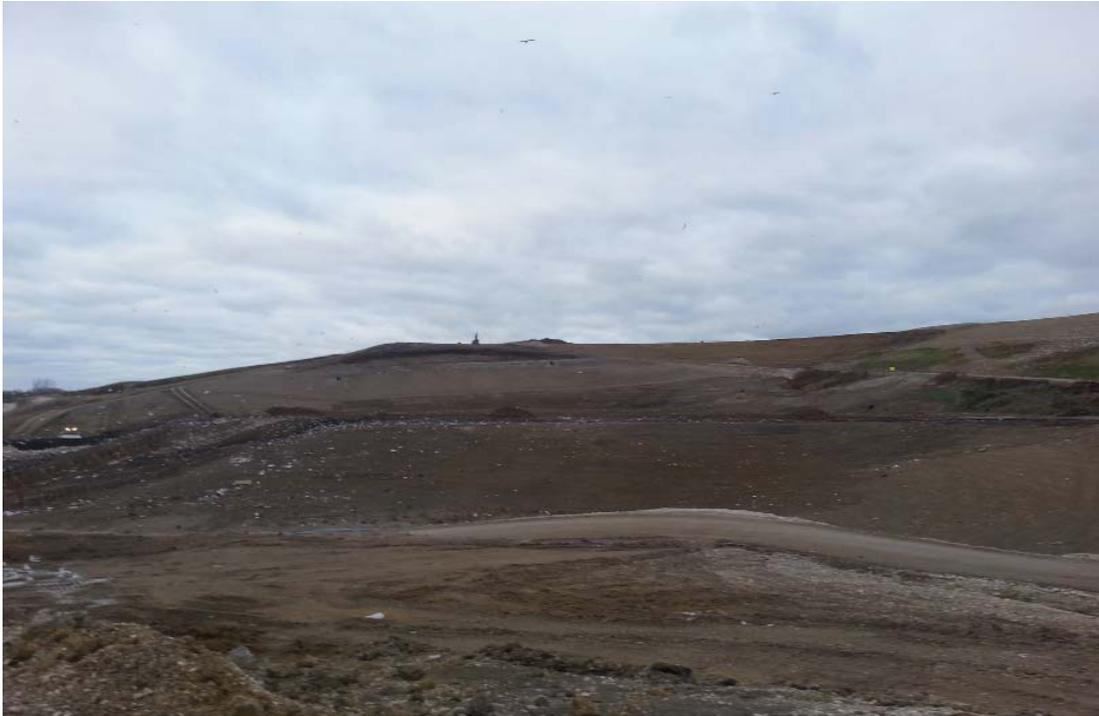
Previous working faces in active area, over Phase 7B and 7

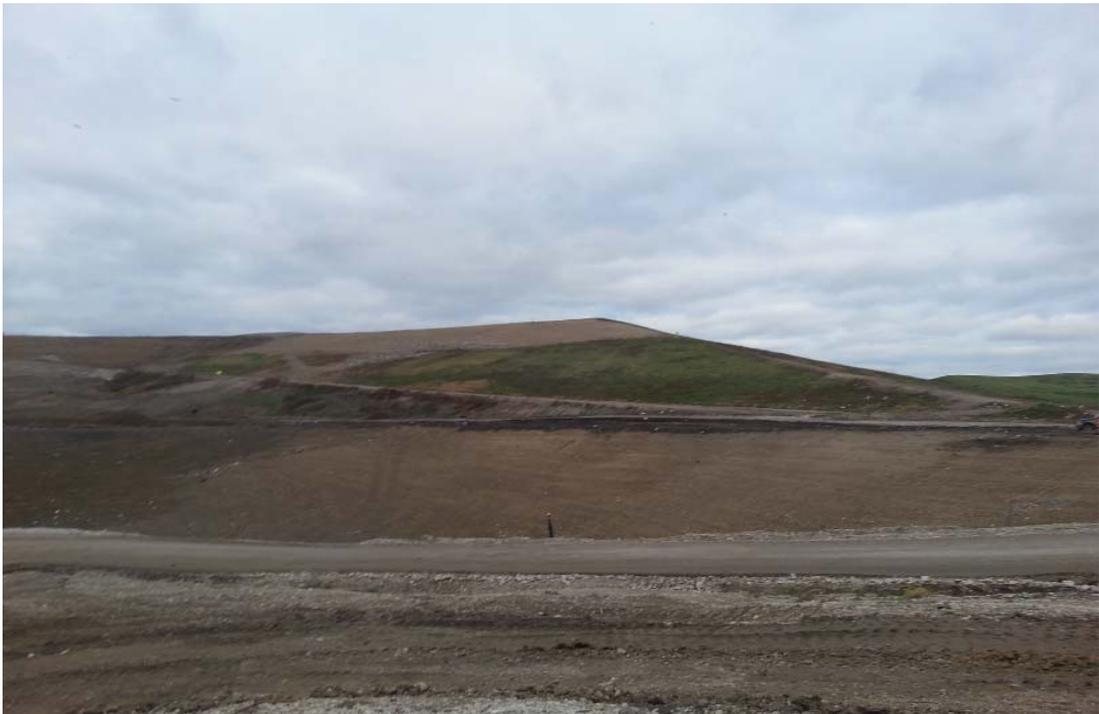
Phases 6 & 5 viewed from the Southwest
